STAFF REPORT: 07/08/2020 MEETING

APPLICATION NUMBER: 20-6758

ADDRESS: 1439 VAN DYKE

SCOPE: REHAB PORCH, PAINT HOME, REPAIR TRIM, AND INSTALL NEW STORM WINDOWS

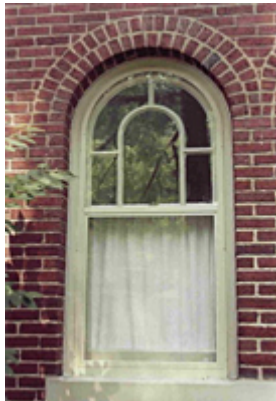
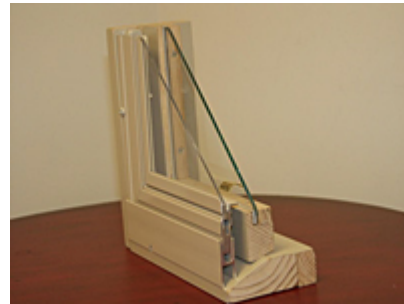
Item # HOL-B, Historic One Lite - Bottom Removable (HOL-B)

This is the normal and most popular unit for standard wood double-hung windows. The top is fixed and the bottom panel is removable to the interior. An interchangeable screen is available. The horizontal divider for the master frame of the (HOL) is aligned with the meeting rail on the existing window.

- Replace all storm windows. New storm windows will be Allied “Invisible” Operable Historic One Lite aluminum units at the sides and back of house, in black color to blend with window sashes. The new front storm windows will be wood storms, painted black.
- Original windows on the first floor are in need of reglazing, some broken pane replacements, which will be done with wavy glass to match, and will be repainted black to correspond with the new paint scheme.

- Storm windows will be Allied “Invisible” Operable Historic One Lite aluminum storms on sides and back of house, in black color to blend with window sashes. Front storm windows will be wood storms, painted black, for most appropriate historic appearance to the front facade.
- Original windows on the first floor are in need of reglazing, some broken pane replacements, which will be done with wavy glass to match, and will be repainted black to correspond with the new paint scheme.
