STAFF REPORT: OCTOBER 14, 2020 MEETING

ADDRESS: 2415 SEMINOLE

HISTORIC DISTRICT: INDIAN VILLAGE

**SCOPE OF WORK: DEMOLISH GARAGE (WORK COMPLETED / EXISTING VIOLATION);
ERECT NEW GARAGE / CARRIAGE HOUSE, NEW HARDSCAPING AND LANDSCAPING,**

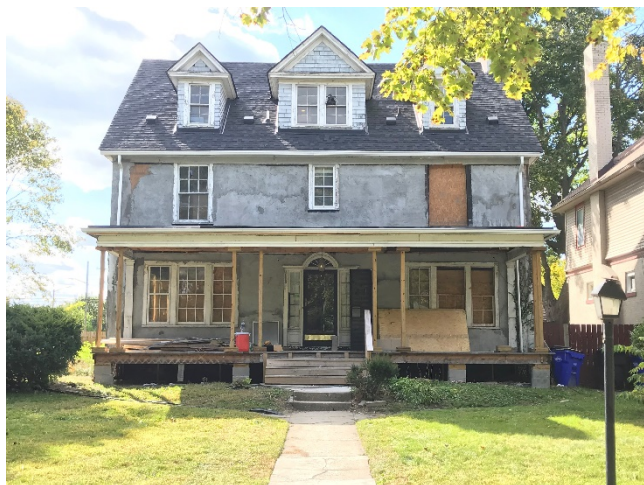
2415 Seminole, East elevation, Staff Photo

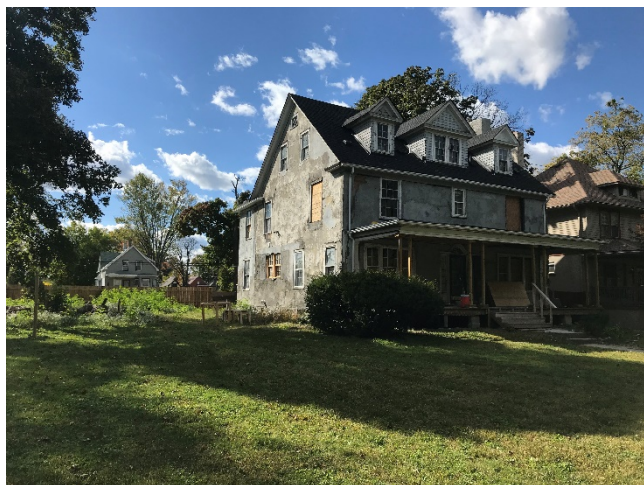
2415 Seminole, Southeast elevation, Staff Photo

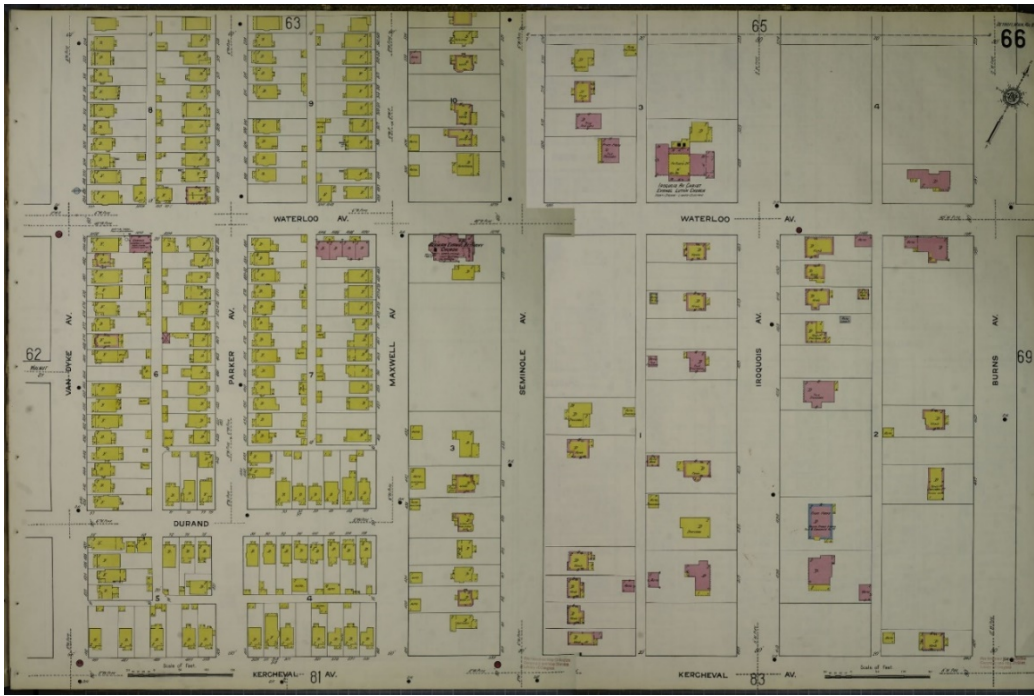
1915 Sanborn Map – Note that E. Vernor was formally known as Waterloo Avenue.

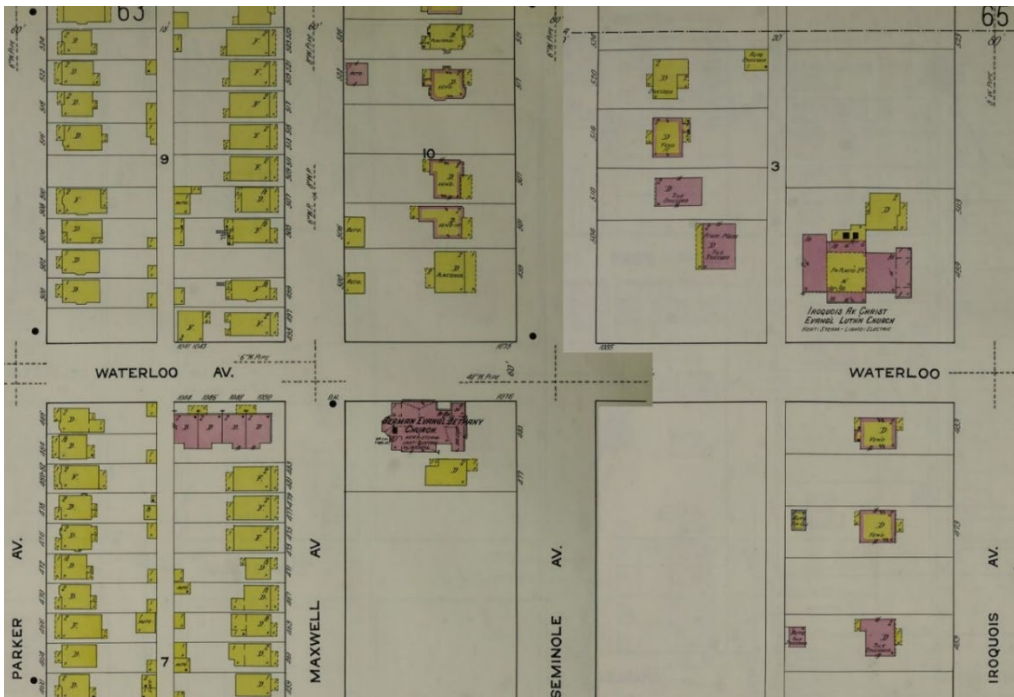
1915 Sanborn Map Detail -

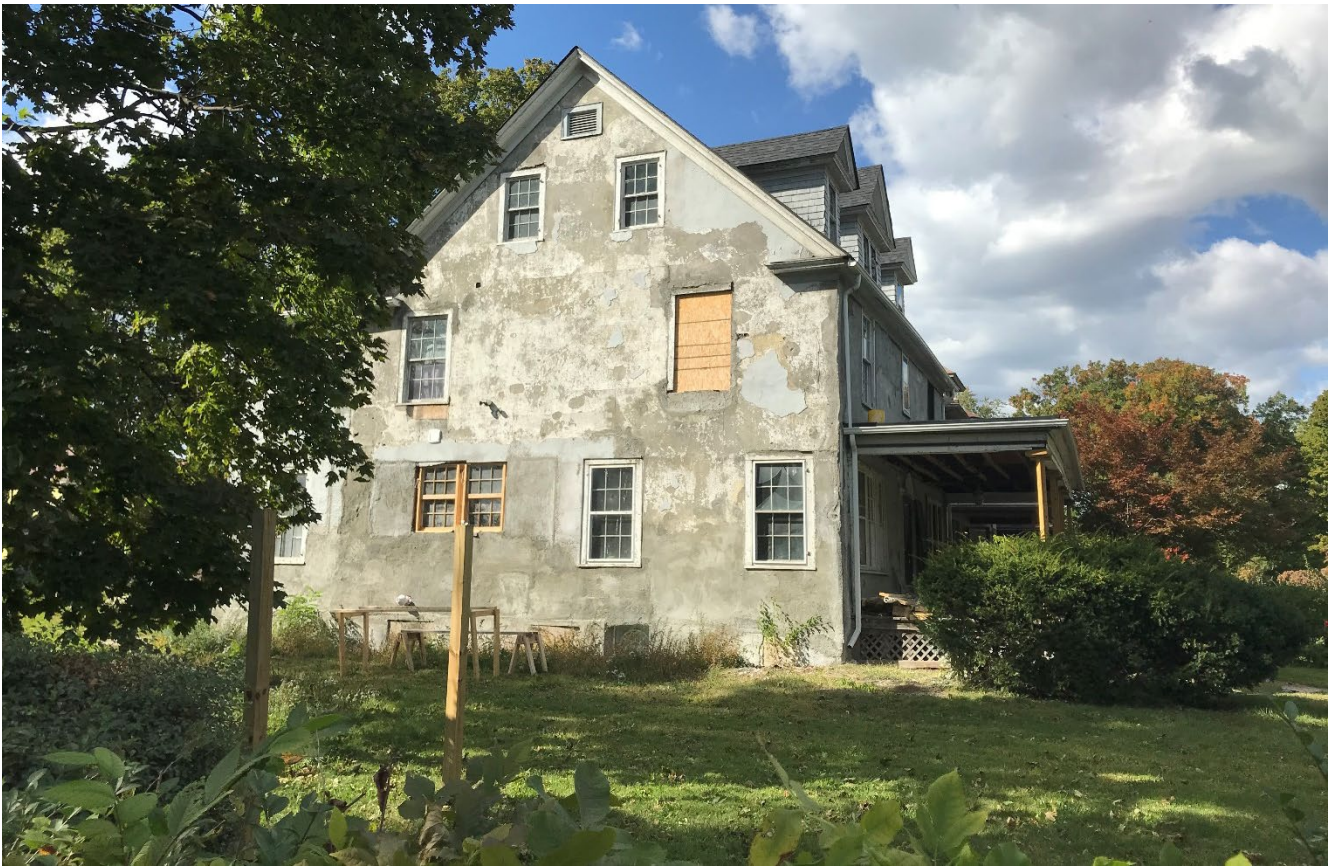
South Elevation- Staff Photo

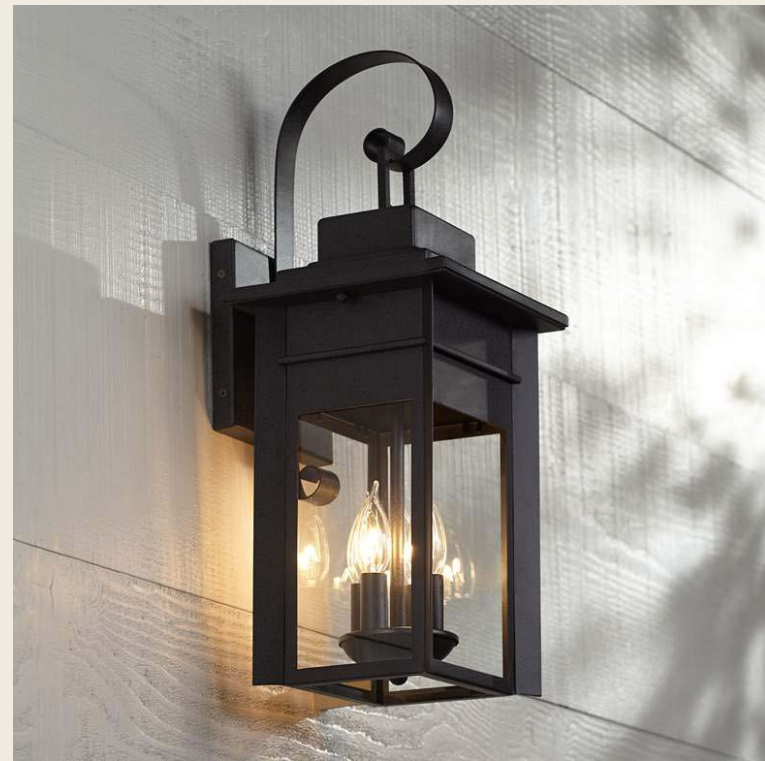
Located on both sides of front door

- Remove existing pole-mounted lamps in front yard and replace with new pole-mounted lamps (84"), in flat black color.
- Add (1) one new hanging porch lamp, mounted from ceiling, centered on porch of home, in flat black color.
- Add (2) two new wall-mounted lanterns mounted on each side of front door of home, in flat black.

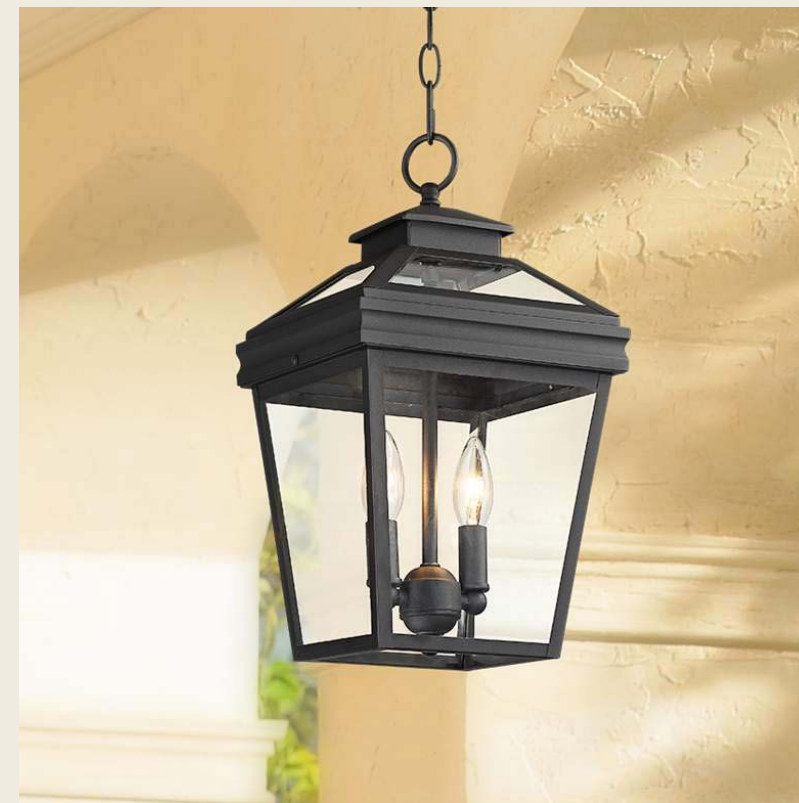
Centered on the porch

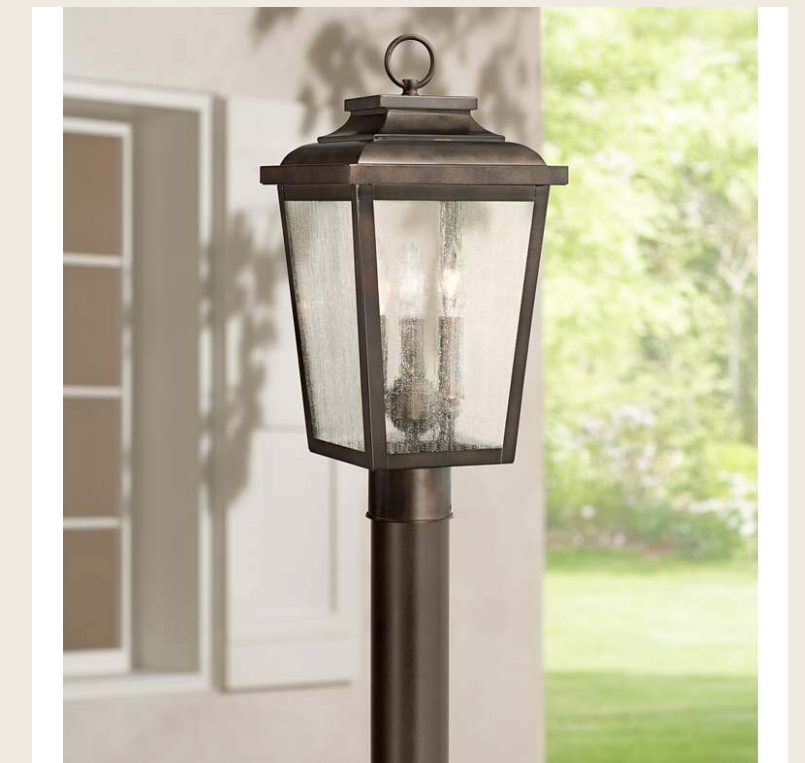
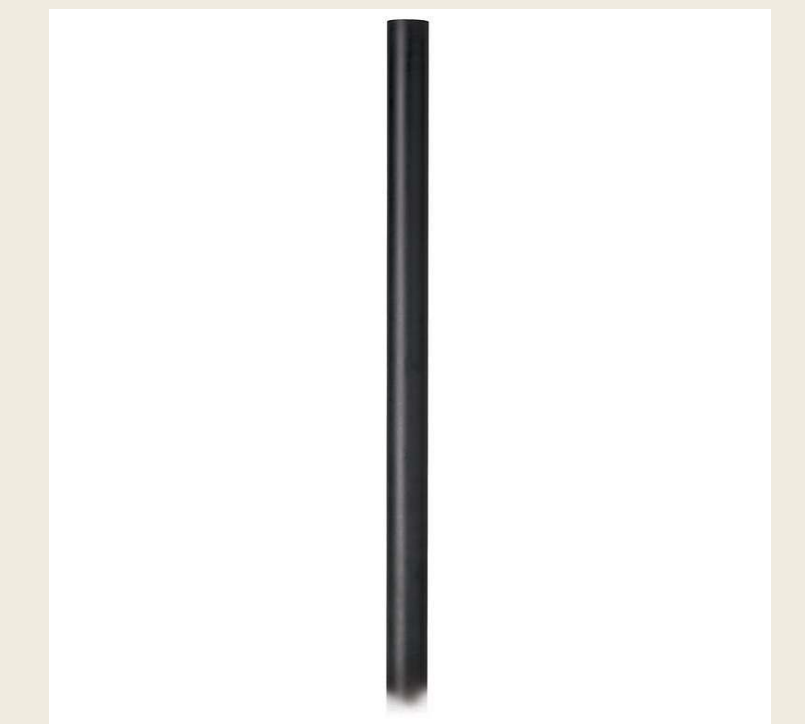
Both sides of the walkway

Replacement materials shall be flat black painted metal to replace existing lights. Both walkway lights will be attached to metal posts 84 inches tall to replace existing not functional lights

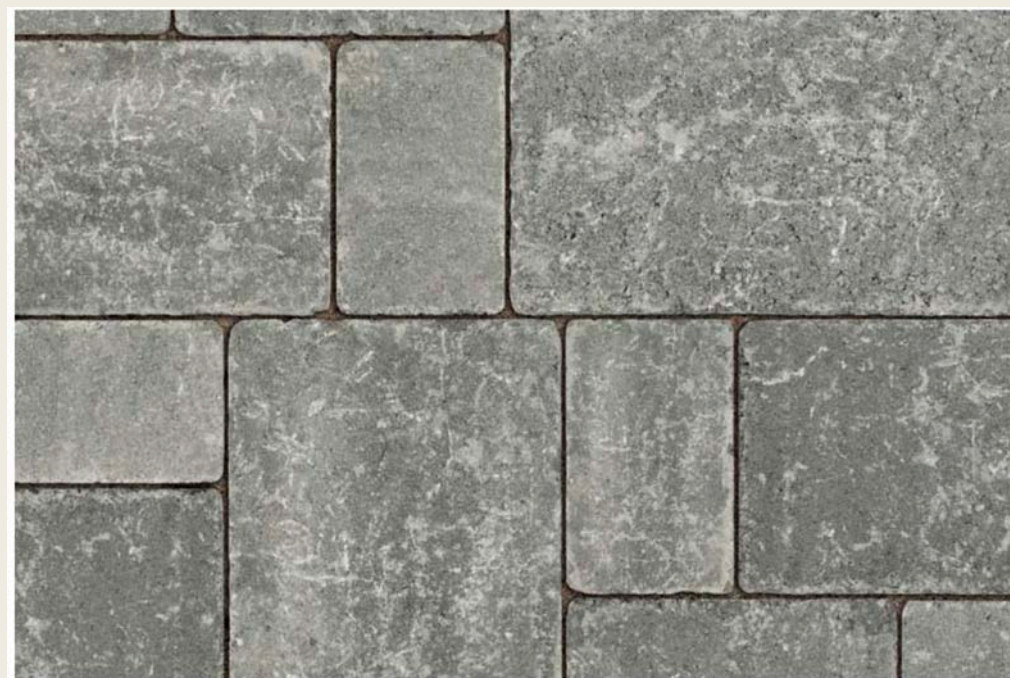
Driveway border paver material : Brick Paver Brussels block in limestone color

1. Driveway width : 10 feet
2. Material : Concrete
3. Distance from Vernor sidewalk: 30 feet
4. Distance from Vernor St: 40 feet
5. Distance from house: 6 feet
6. Driveway length : From front curb on Seminole St to the rear of the back yard ending with a parking pad 25 feet wide and 17 feet length at the rear of the yard.

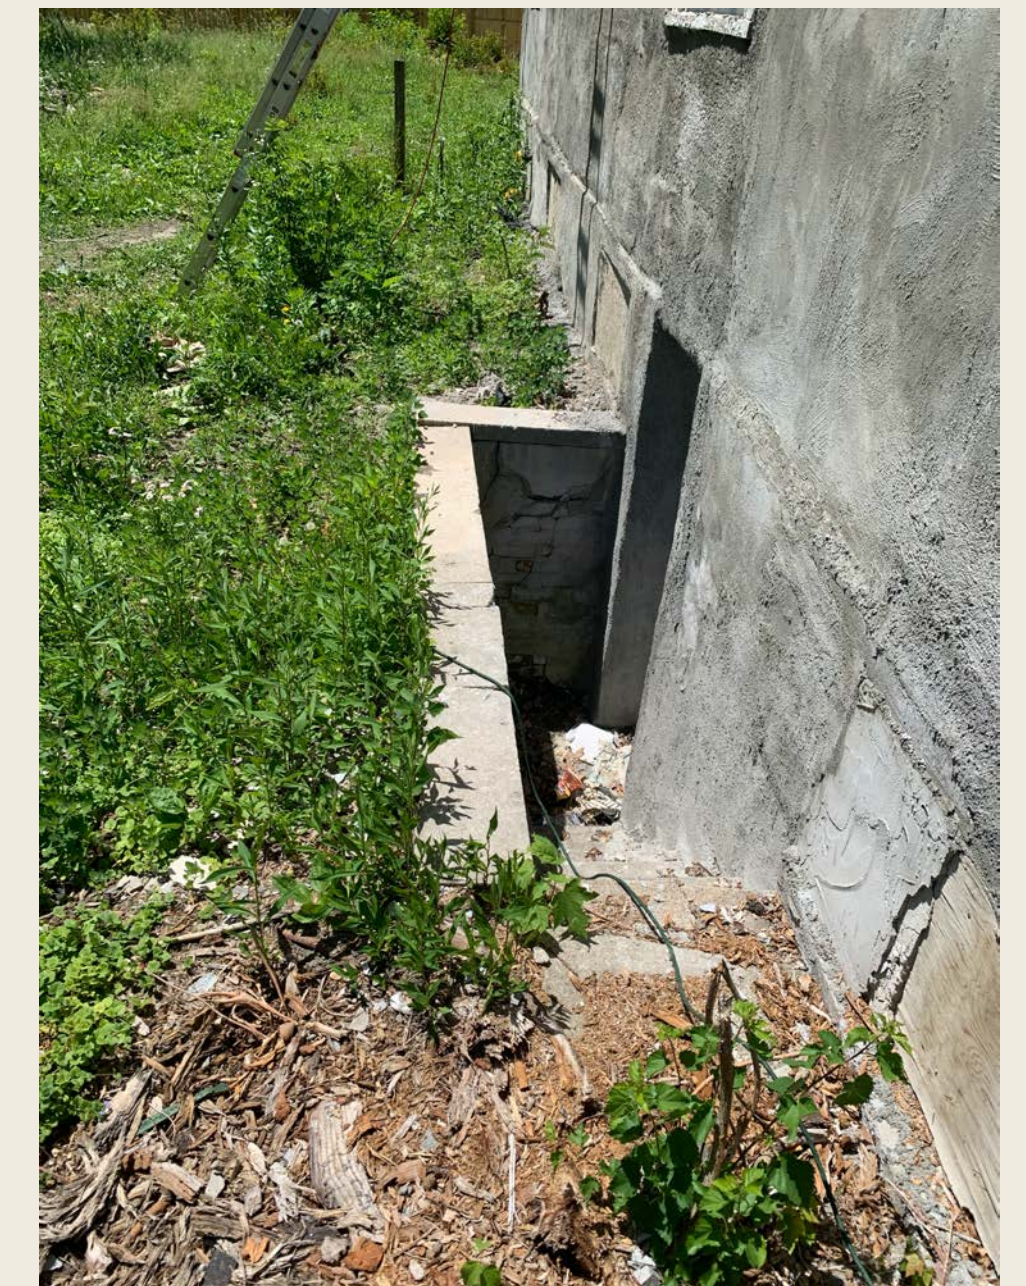
Existing side yard door the new driveway would need got be 3 feet away

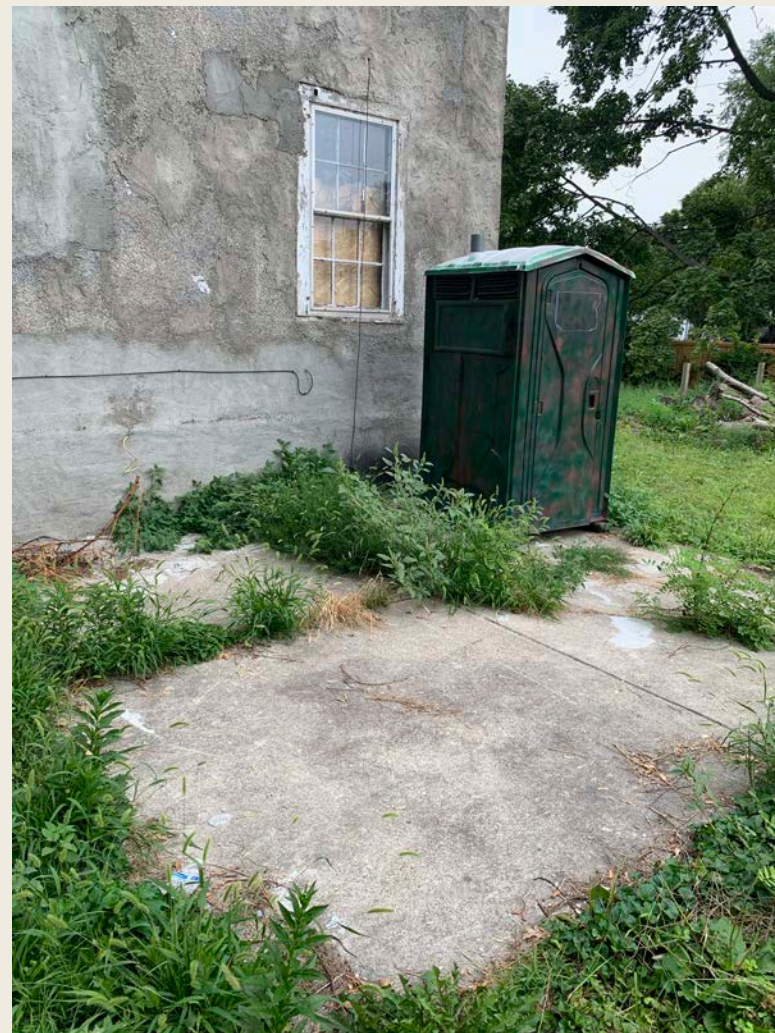
This the existing patio will be replaced with pavers and covered with a cedar wood pergola. The brick pavers would be continued from the front and driveway border.

Existing Patio

1. Existing patio will be reconstructed in the same place and current patio
2. Patio will be flat with no seat our built ins
3. Material : brick pavers
4. Dimensions : 17 by 17 feet
5. Pergola demensions : 16 feet by 16 feet
6. Paver walkway will continue to rear of yard and end with a circular fire pit

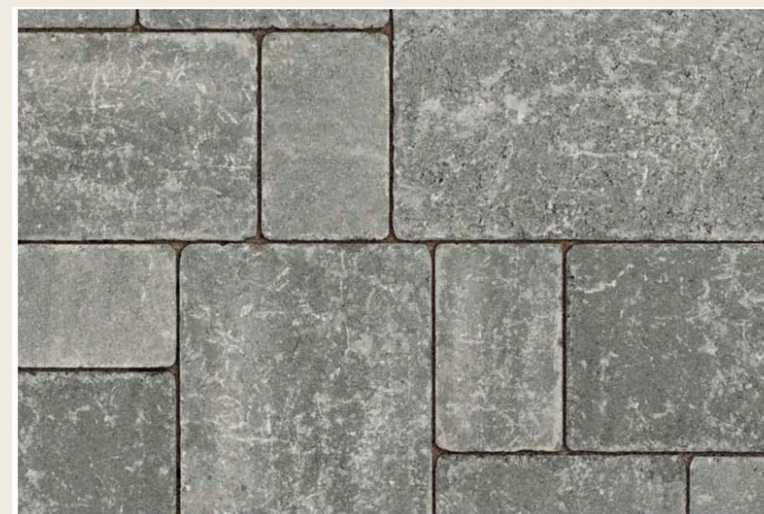
Driveway border paver material : Brick Paver Brussels block in limestone color

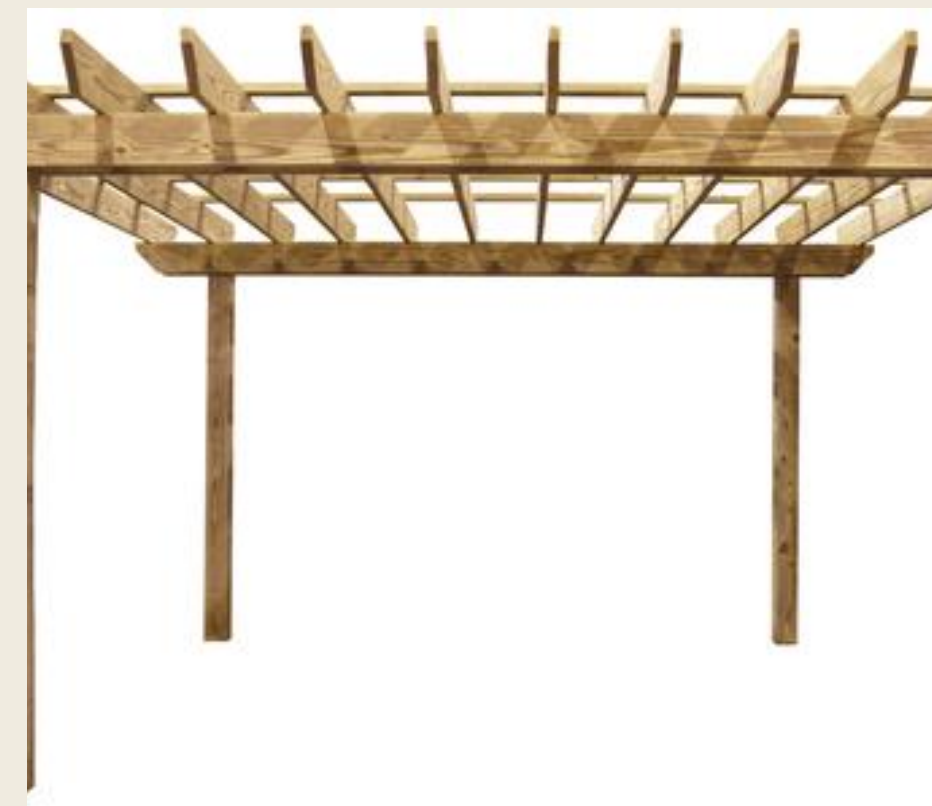
Pergula image

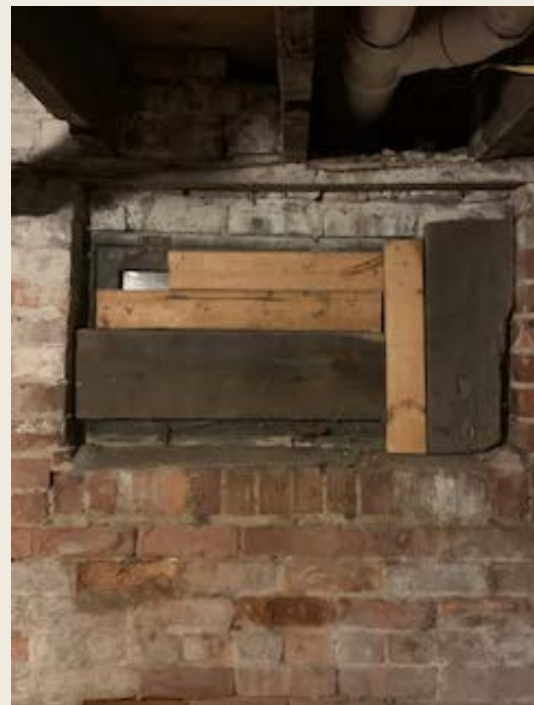
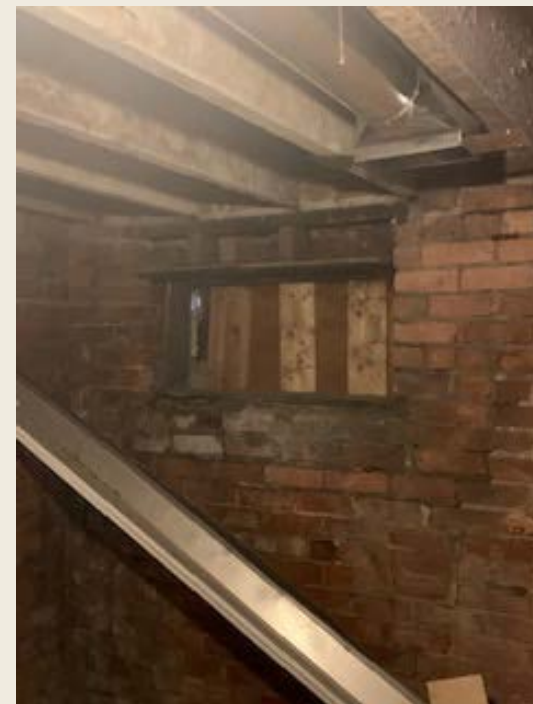
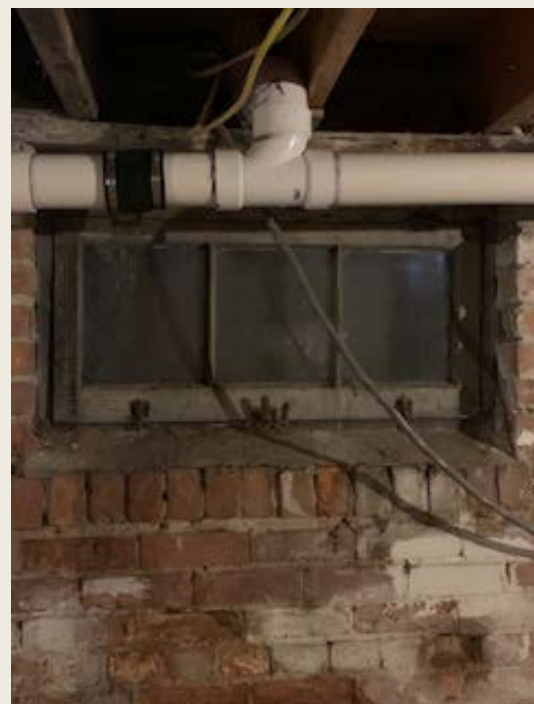
Many basement windows are missing or non functional. Under the proposal all basement windows will be replaced with glass blocks set in the original openings.

1. Window Size 8/12 by 39
2. Black window screens will be installed in each window di
3. Total number of windows: 6
 - 1.3 Vernor side
 - 2.3 Charlevoix side

Vernor Side

- Remove and replace the basement windows along the Vernor side of the home and the Charlevoix side of home and replace them with glass bocks windows.
 - Applicant will install black window screens on each window

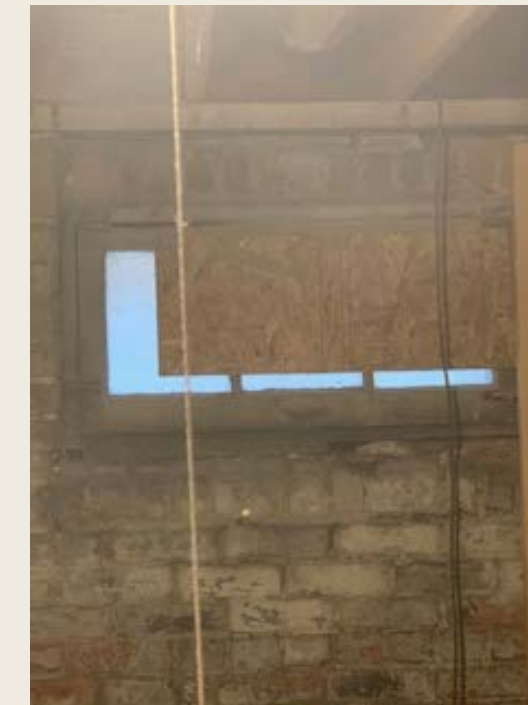
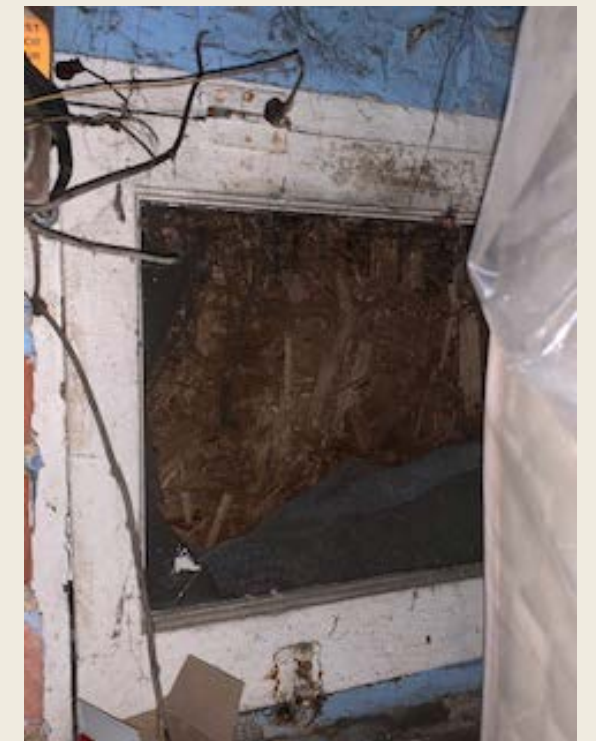
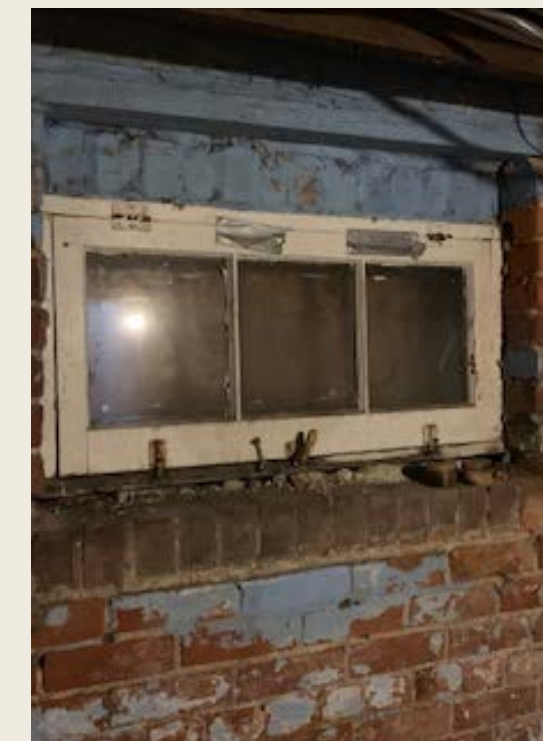
Charlevoix Side

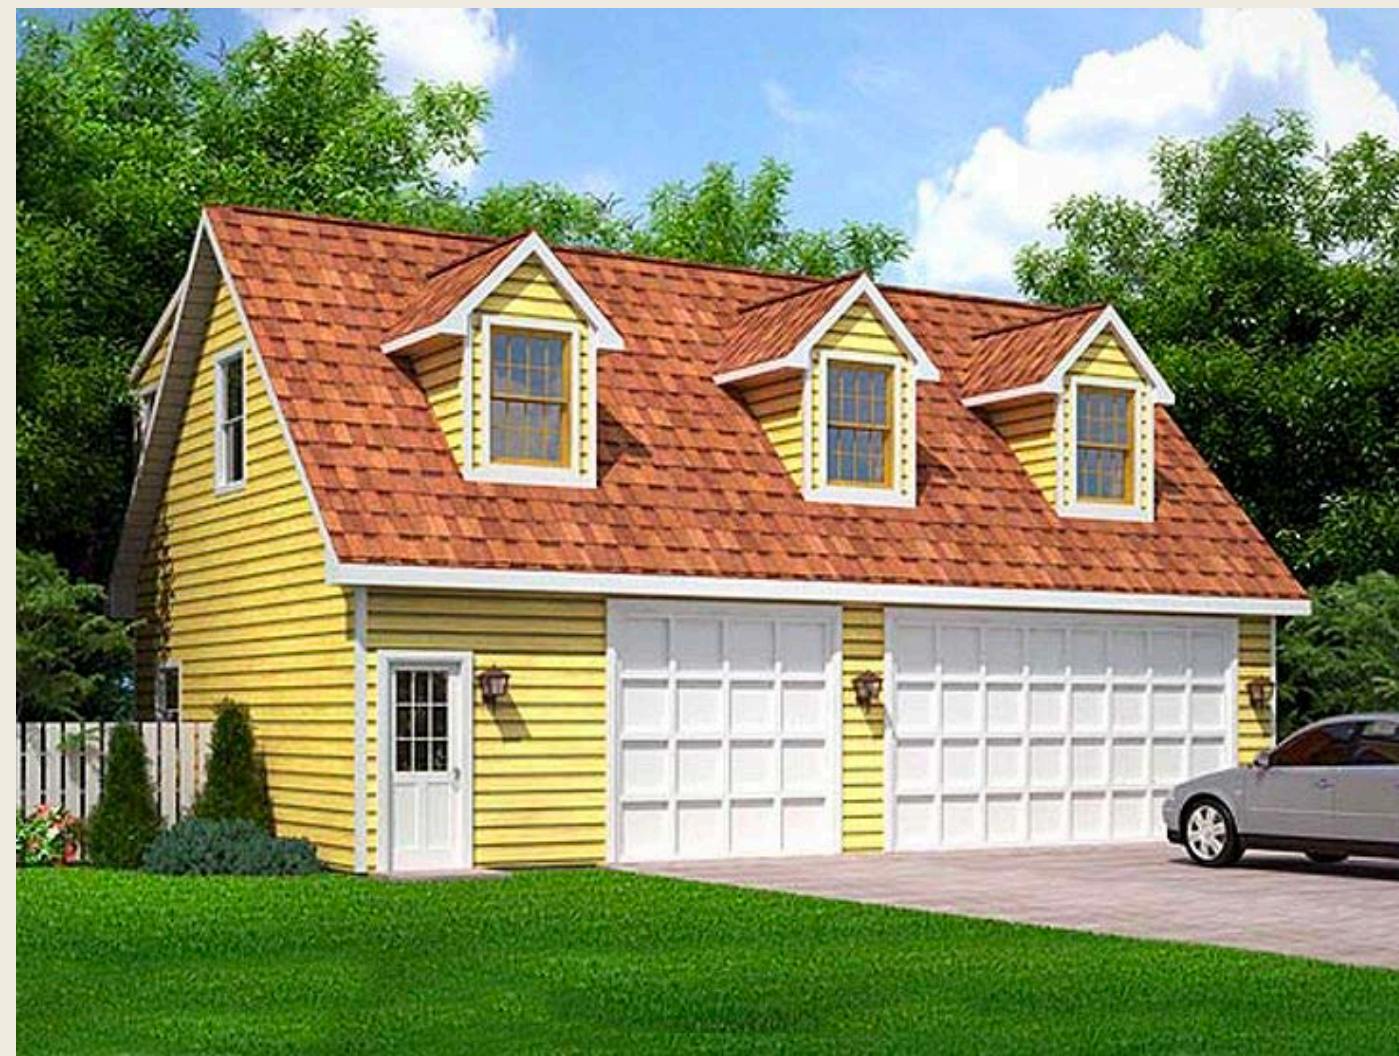
Proposed Garage

Exterior Design

Dimensions

- Width : 40 feet
- Height : 24 feet
- Depth: 26 feet

- The new garage will be 3 car with space for a small in law apartment above.
 - The Garage will positioned in the south west corner of the yard. Positioned in front of the driveway.
 - Structure dimensions:
 - Width : 40 feet
 - Depth : 26 feet
 - Height: 24 feet
 - Construction Materials
 - Walls wood siding
 - Roofing asphalt singles
 - Color
 - Exterior wood siding and trim will be white to match the color of main house.
 - Windows will be constructed of fiberglass which provides a look of wood painted black.
 - Door will be made of steel construction painted black.
-

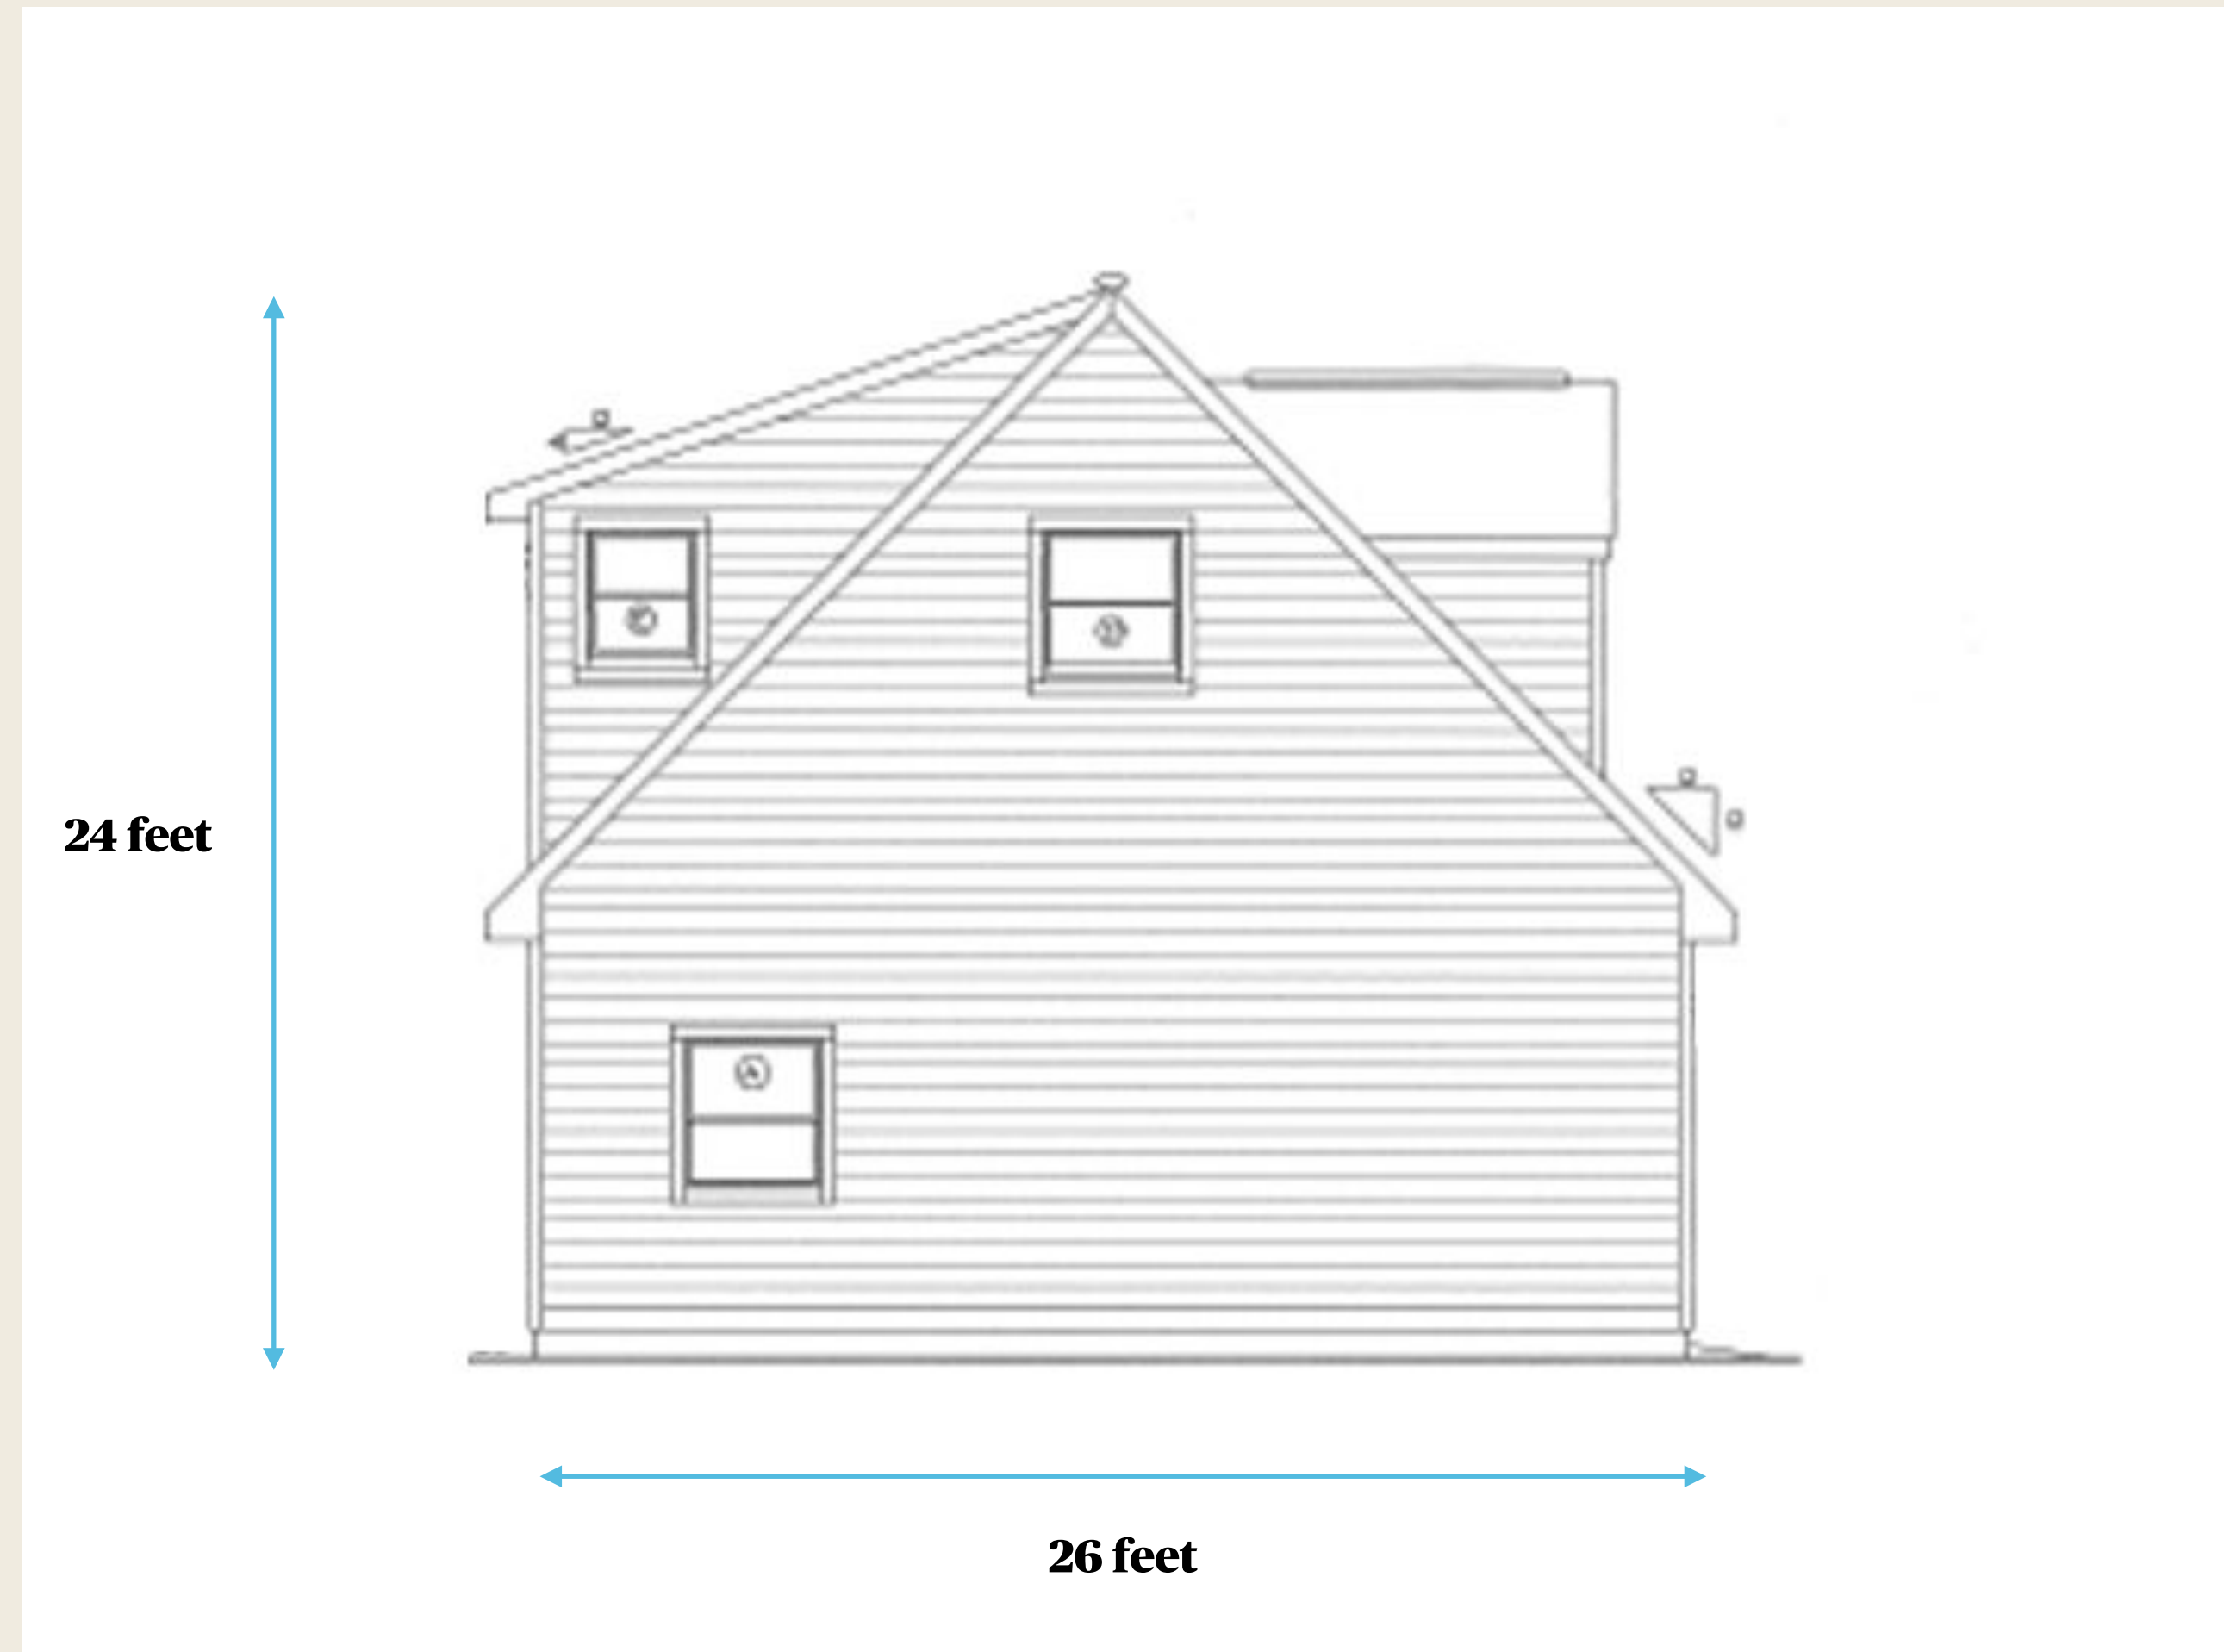
Front Rear Elevation

Note: Garage door on rear of structure shown will not be implemented.

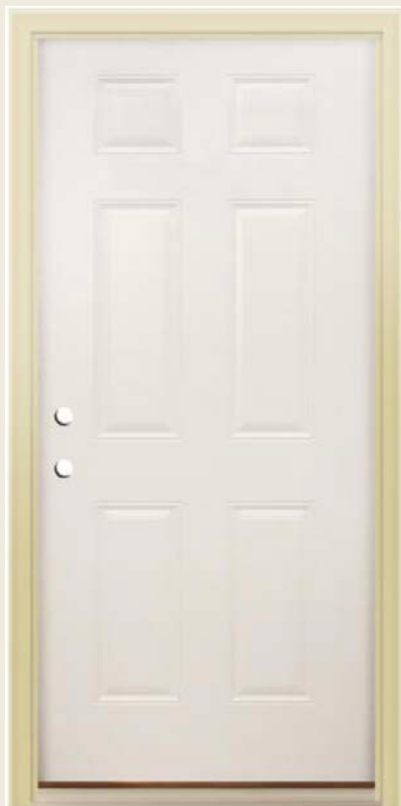
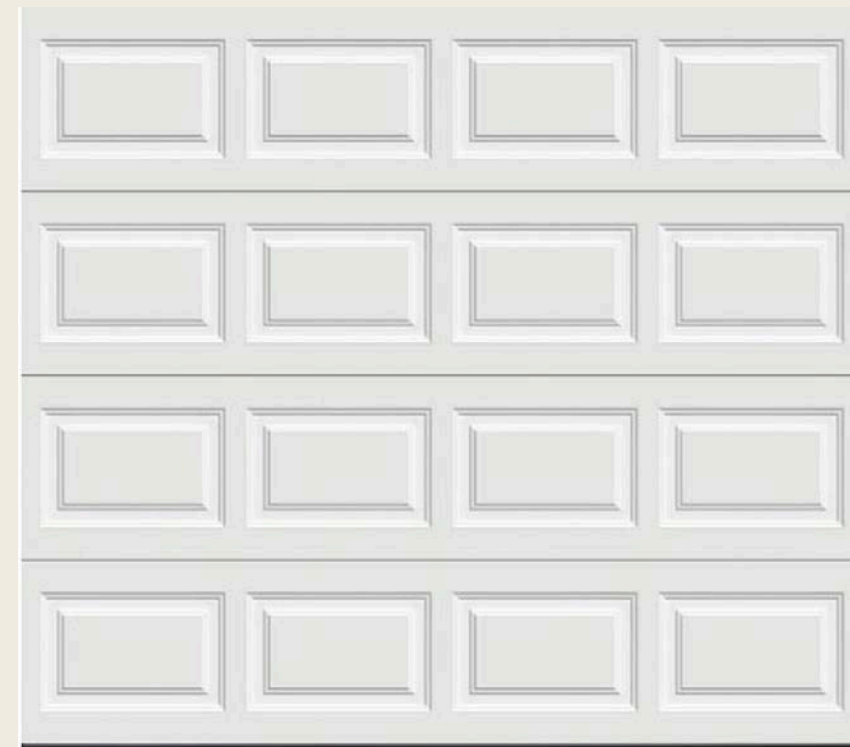
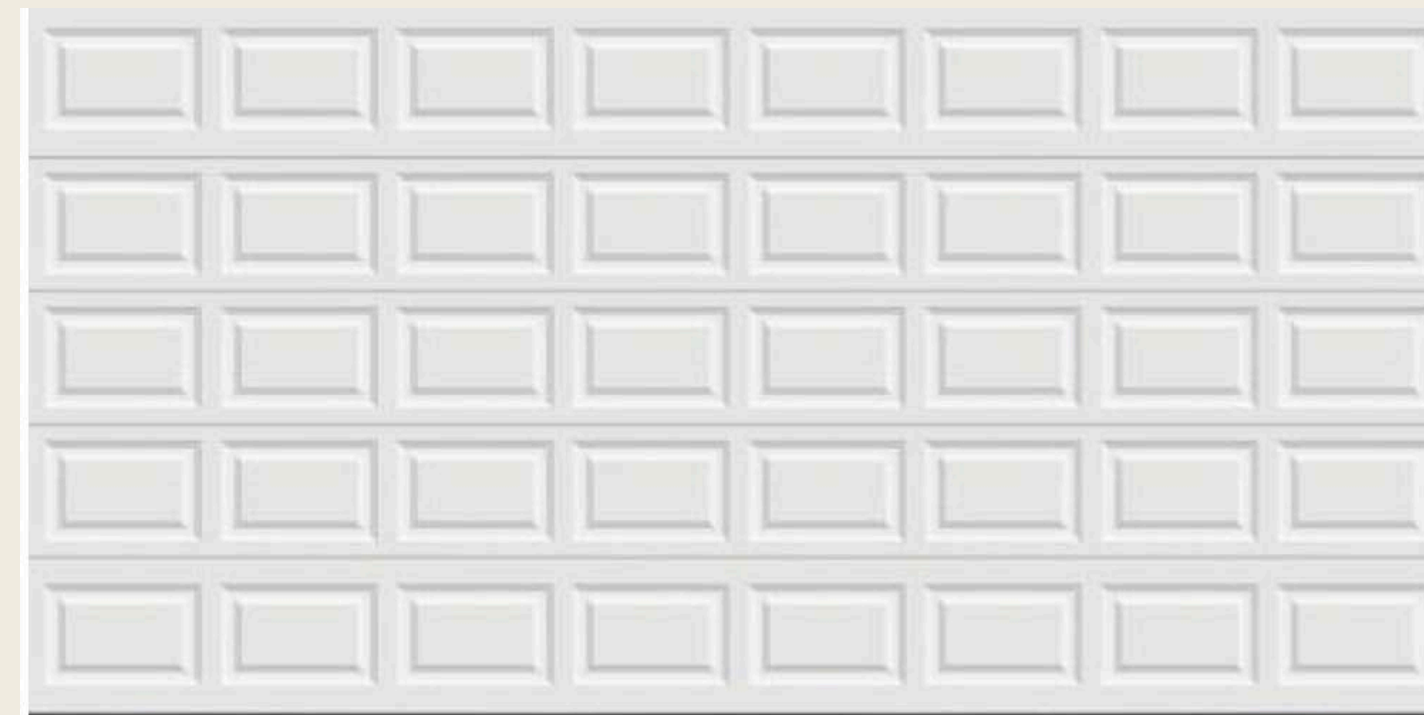
Garage Doors

- White steel construction (9 feet wide , 8 feet high)
- White steel Construction (16 feet wide , 8 feet high)
- White steel Construction pedestrian door (30 by 80)

Note: all doors will be white with wood trim painted black to match windows on door and house.

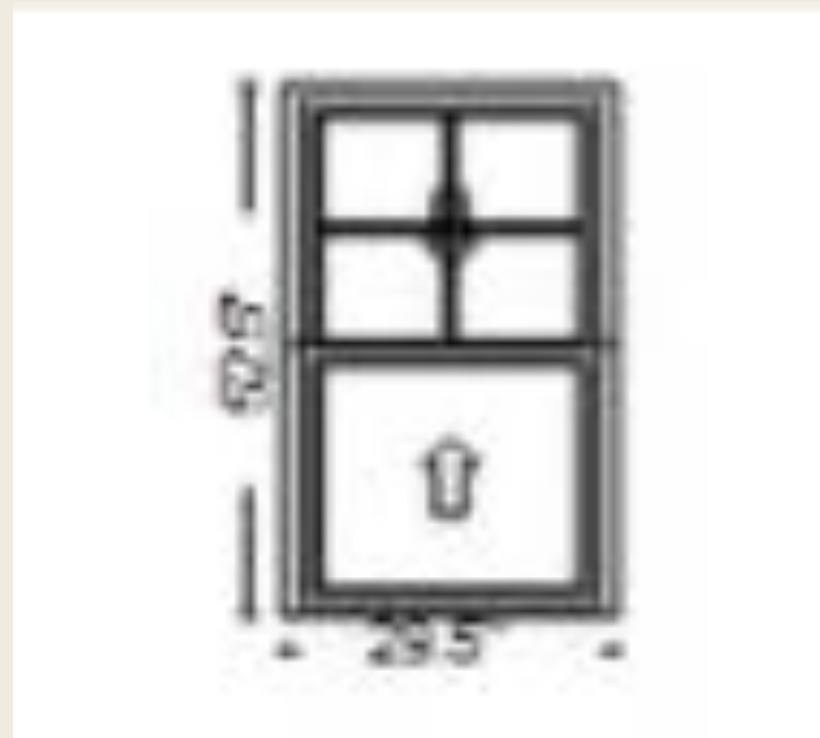
Garage window

- 2nd floor windows.
- 3 windows in the front elevation will be carried around the unit to match style and size of the home.
- Window material will be black paint fiberglass to simulate look of painted wood and match the house.
- 3 windows will be placed along front of unit.
- 4 windows with the sizing below will be placed long the back of the unit.

Note: No windows will be installed on the first floor with vehicle parking..

1: Non-Standard Size Double Hung, Equal
Frame Size: 31 1/2 X 52 1/2
General Information: Standard, Duracast®, Block, Foam Insulated, 3", 1 5/16", 1 11/16"
Exterior Color / Finish: Black
Interior Color / Finish: Black
Glass: Insulated Low-E Advanced Low-E Insulating Glass Argon Non High Altitude
Hardware Options: Cam-Action Lock, Matte Black
Screen: Full Screen, InView™
Performance Information: U-Factor 0.29, SHGC 0.25, VLT 0.46, CPD PEL-N-126-00862-00002, Performance Class LC, PG 30, Calculated Positive DP
Rating 30, Calculated Negative DP Rating 30, Year Rated 08, Egress Does not meet typical United States egress, but may comply with local code requirements
Grille: GBG, No Custom Grille, 3/4" Contour, Traditional (3W2H / 0W0H), Black, Black
Wrapping Information: Standard Fin, No Exterior Trim, Pella Recommended Clearance, Perimeter Length = 168".

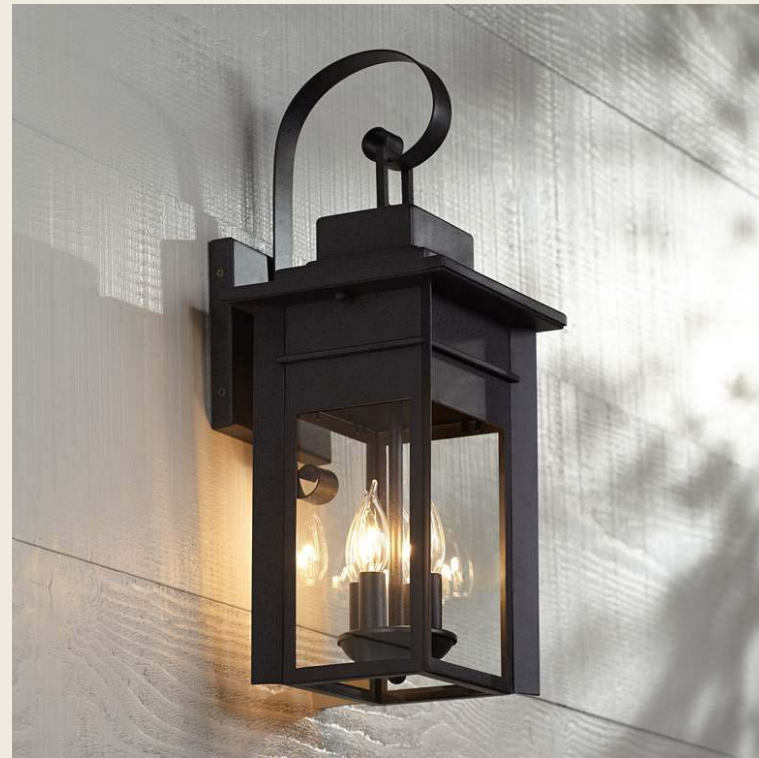
Garage lighting

- 3 lights will be placed between all doors including pedestrian doors.
- Material is metal and black in color to

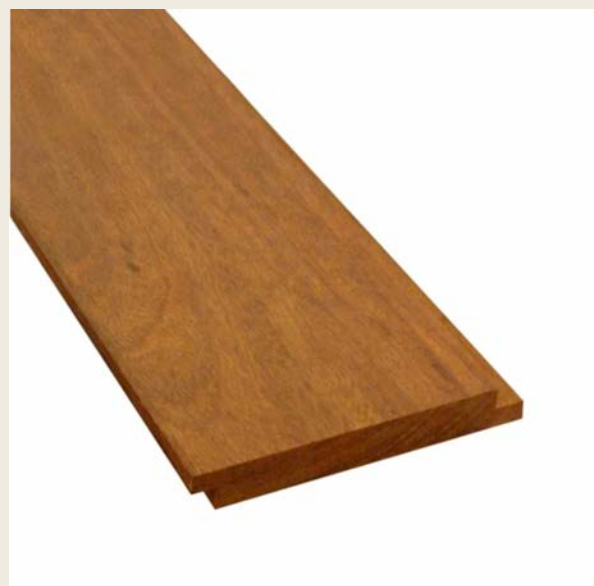
Garage Materials

- Wood siding will be used for exterior walls painted white
- Black asphalt shingles will be used for the roof to match the house.
- Wood trim will be used as seen in elevation images painted white to match the house.

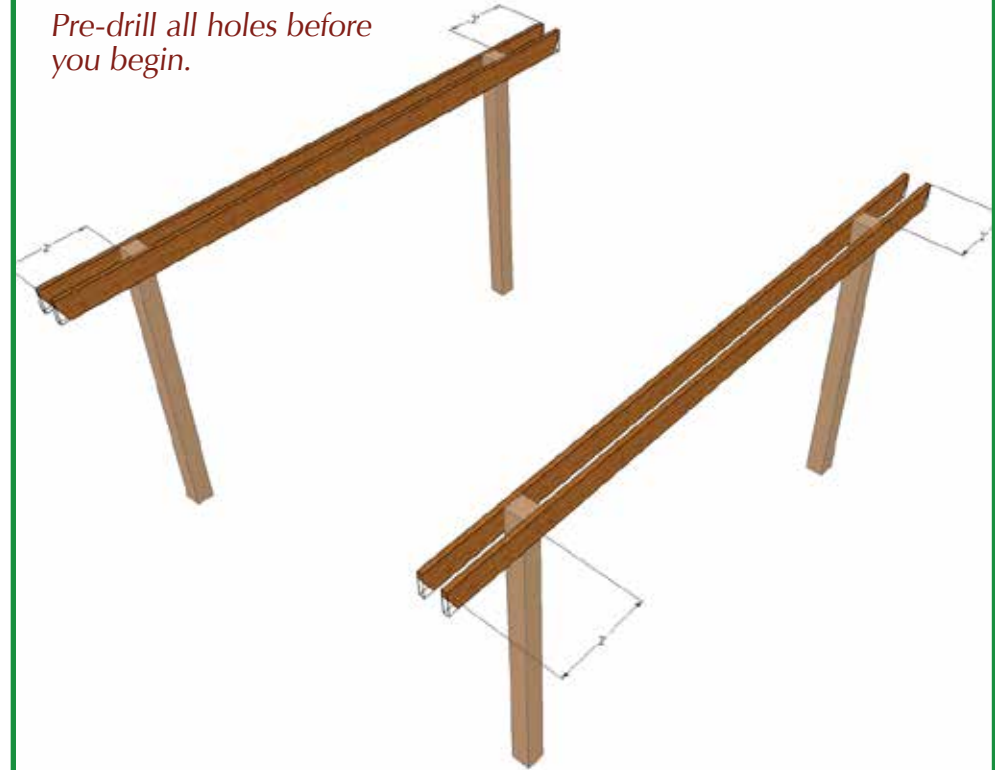
Level 2

- (4) 2x8x16 Boards
- (8) 10" Bolts
- (8) Hex Nuts
- (16) Washers

*Pre-drill all holes before
you begin.*

*All boards are cut at each
end in reference to the
specialty cut diagram on
page 2.*
