STAFF REPORT: OCTOBER 14, 2020 MEETING

ADDRESS: 2415 SEMINOLE

HISTORIC DISTRICT: INDIAN VILLAGE

**SCOPE OF WORK: DEMOLISH GARAGE (WORK COMPLETED / EXISTING VIOLATION);
ERECT NEW GARAGE / CARRIAGE HOUSE, NEW HARDSCAPING AND LANDSCAPING,**

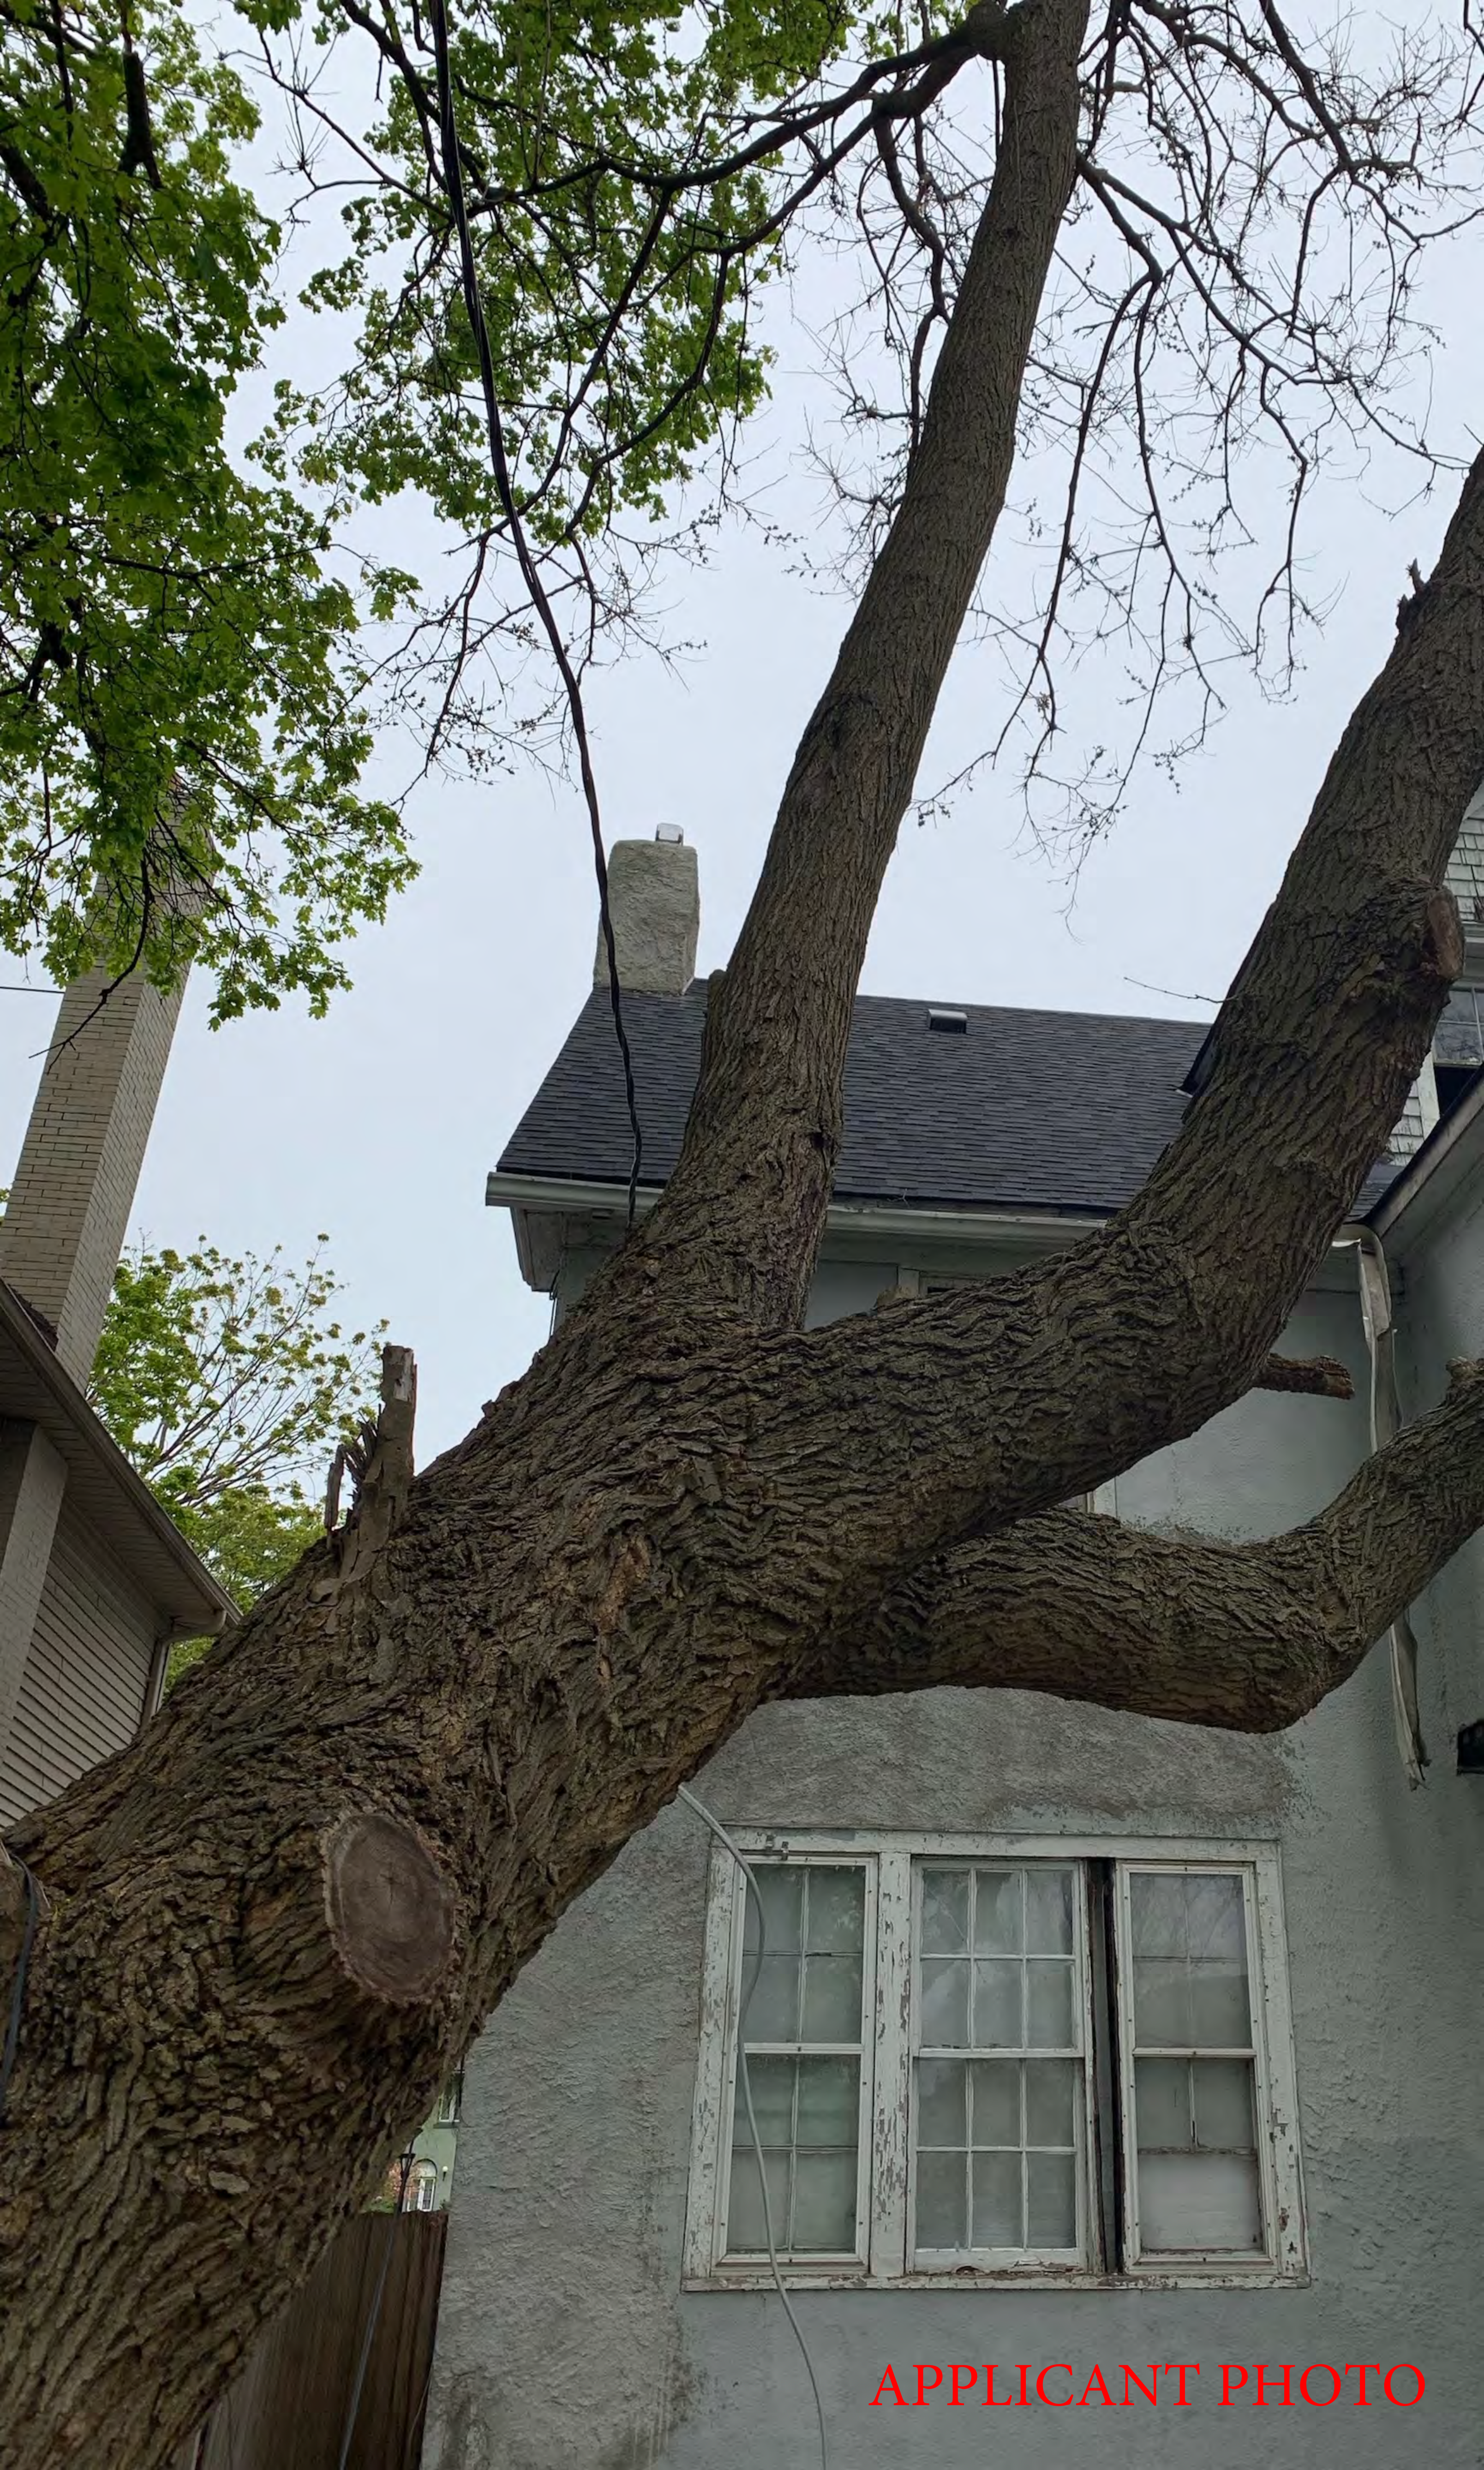
APPLICANT PHOTO

Overgrown weeds

Several trees are dead leaning and threatened to fall on the house or had already fell on the house causing damage. Additionally there were over grown weeds that had grown the size of trees.

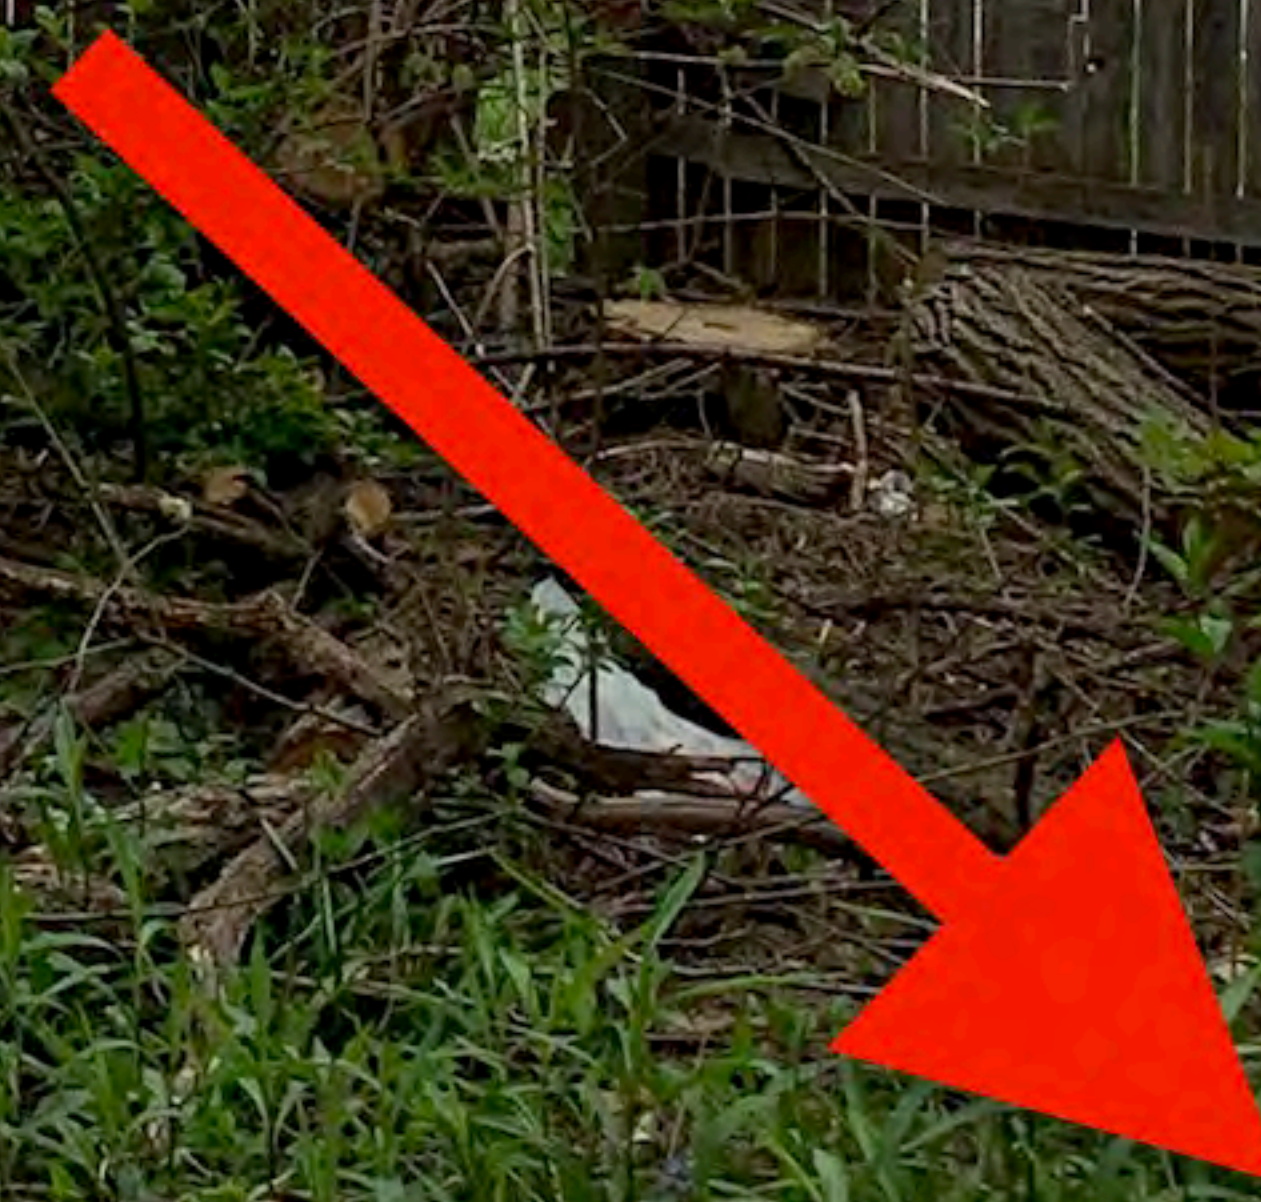
APPLICANT PHOTO

Dead Tree

Many trees were cut previously

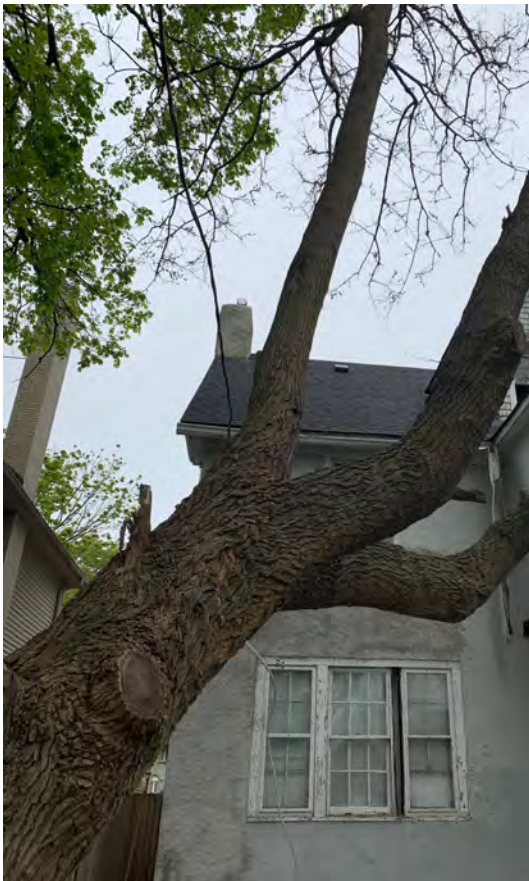
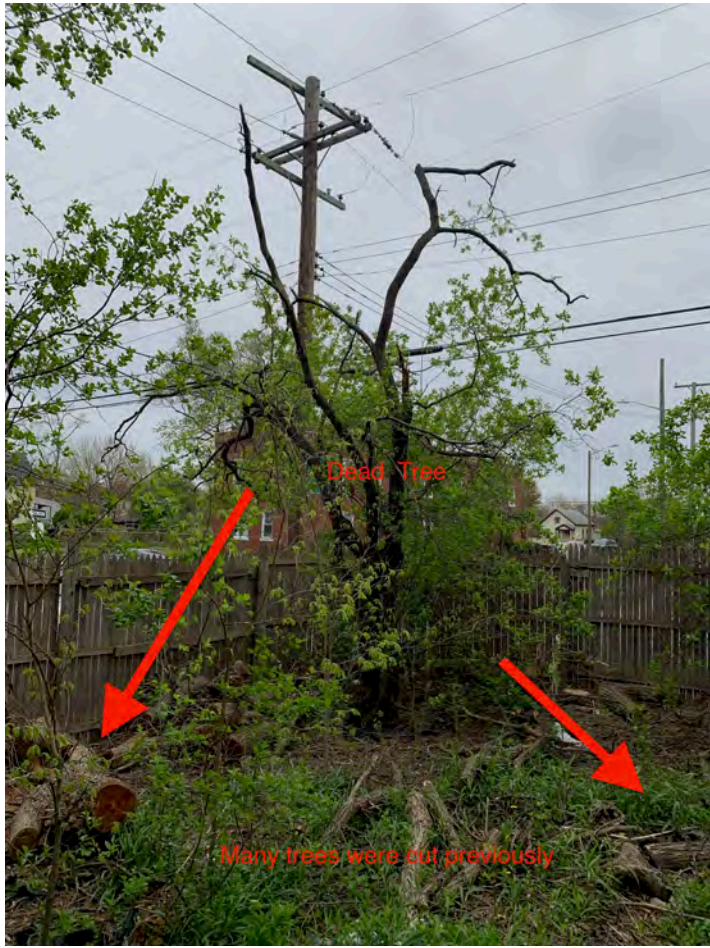
Dead Tree

Many trees were cut previously

Several trees in the rear of the proper we diseased and dying thus needed to be removed. Other trees were observed to have died in previous years and had become nuisance to your home as well as pedestrians walking at the rear (Maxwell St) and side (Vernor St.) near the property. Conditions such as leaning towards your home, dropping branches, could pose danger to anyone inside the house as well as in the yard. Two of the trees posed a danger of falling into Vernor Ave in the obstructing the sidewalk as well as vehicle traffic. Lastly, there were several large weeds that allowed to grow for 10+ years that were removed as well.

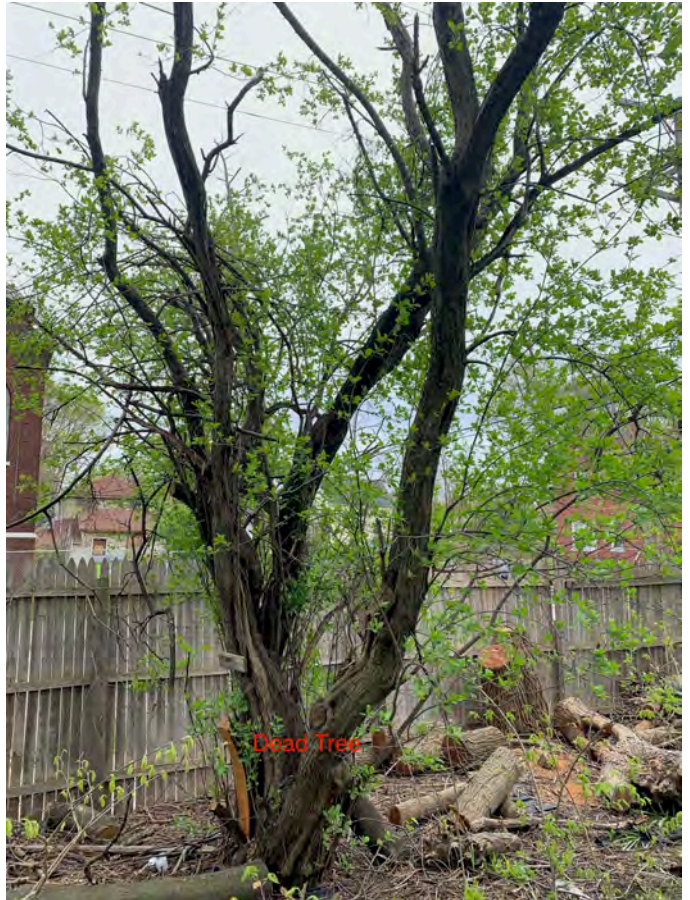
Dead Tree
