STAFF REPORT: FEBRUARY 9, 2022 MEEETING

ADDRESS: 1535 LEVERETTE

APPLICATION NO: #22-7656

SCOPE: ERECT NEW ADDITION AT REAR; REHABILITATE DWELLING

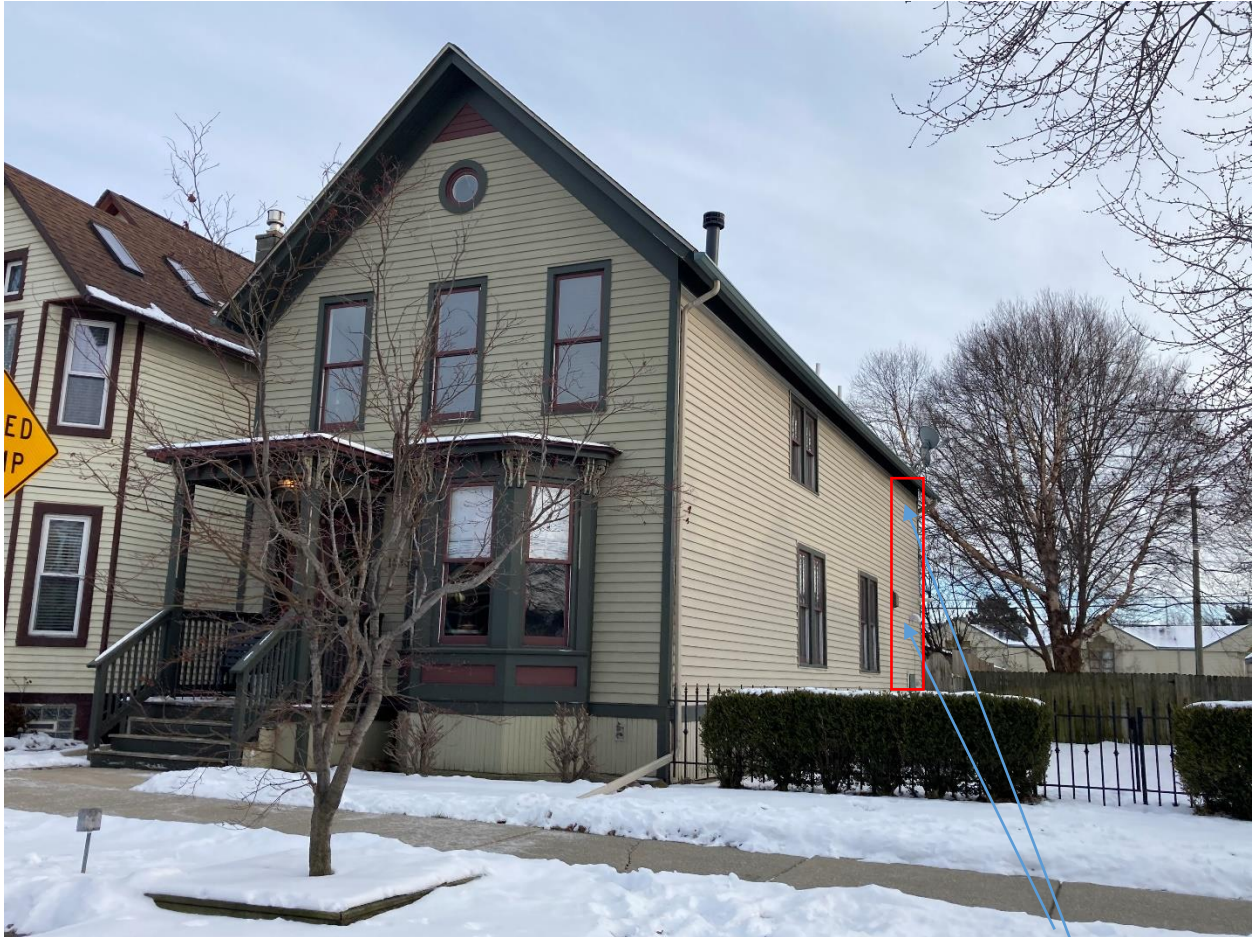
1535 Leverette, current appearance, New vinyl-clad windows to be installed at these locations. Area outlined in red shows location of 1985 addition

- The new casement windows proposed for installation at the west and rear elevations are vinyl-clad wood units (Anderson 400 series). The new windows proposed for installation at the rear elevation will not be visible from the public right-of-way and will be installed within a non-original portion of the home. The new windows proposed for installation at the west elevation will be located towards the rear of the wall, in the portion of the building that was erected in 1985.

- Although the new windows proposed for installation at the west elevation are located towards the rear of the wall, in the portion of the building that was erected in 1985, they will be visible from the public right-of way. The single, rectangular casement at the first story appears to be of a regular/compatible scale/size and shape. However, it is staff's opinion that the orientation of the new window proposed for the second story is not compatible to the building's historic character. Staff recommends that the shape of this window match the new casement proposed for the first story.

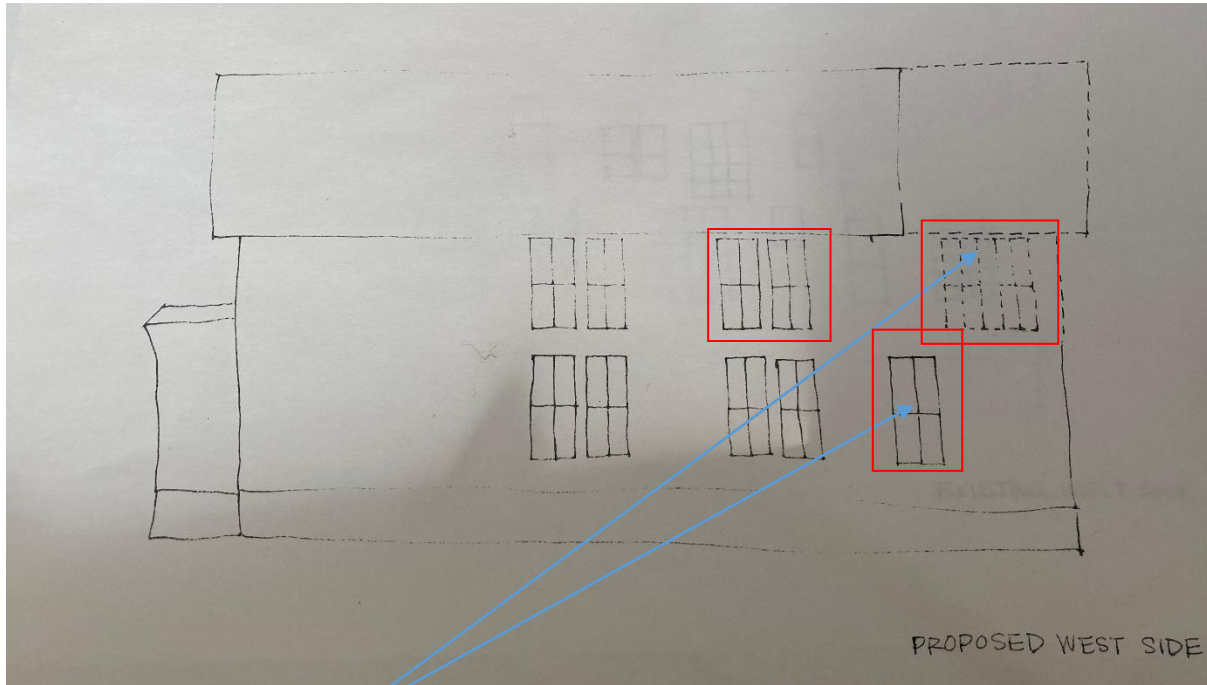
Sketch of west elevation from 1985 application, depicting area of rear addition (not to scale). New windows to be added in these locations. Note that the windows/window openings outlined in red were proposed in 1985 but were not added during the rehab.

- HDC records indicate that the property's original one-story rear wing was demolished and replaced with a two-story addition in 1985 (see below sketches from 1985 application). The existing second-story porch, siding, doors, and windows at the rear elevation date from the 1985 rehab. Also, all of the home's exterior siding (to include the insulbrick/asphalt siding and original wood siding beneath) was removed. In 2002, the existing front elevation porch and the rear first-story porch were installed, vinyl siding was added at the side and rear elevations, and new lapped wood siding was installed at the front elevation.
