**STAFF REPORT:** APRIL 13, 2022 MEETING  
**APPLICATION NUMBER:** 22-7748, 7749, 7750  
**ADDRESS:** 2224 - 2248 BURNS

**HISTORIC DISTRICT:** INDIAN VILLAGE  
**APPLICANT:** BLAINE RILEY  
**PROPERTY OWNER:** BLAINE RILEY  
**DATE OF PROVISIONALLY COMPLETE APPLICATION:** MARCH 21, 2022  
**DATE OF STAFF SITE VISIT:** MARCH 23, 2022

**SCOPE:** REPLACE FENCE AND GATE, REPLACE WINDOW WITH DOOR, ERECT STOOP

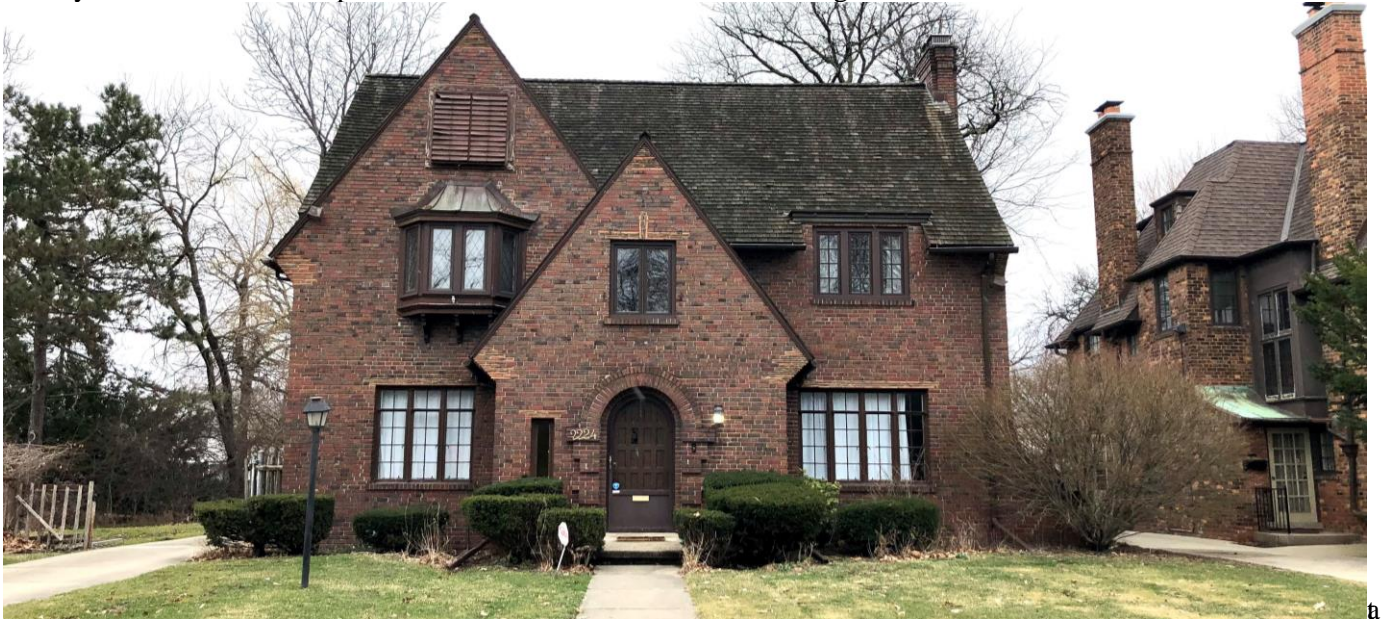
HDC staff photo, March 23, 2022 / Right: v8, 1915-1951 Sanborn Map

Erected circa 1927, the 2-1/2 story, 3-bay structure modifies the symmetrical placement of the front elevation’s openings by differently sized and shaped windows (and door), as well as differing muntin patterns. The two protruding, stepped down, cross gables contrast against the expansive roof surface. A signature character defining feature of this house is the contrasting narrow stone placed at the corners of the gables as well as above most of the window openings. Another dominant feature is the cedar shingle roof due to the steeply pitched reverse gable design. The large vent above the bay window has been in place since at least the time of district designation.

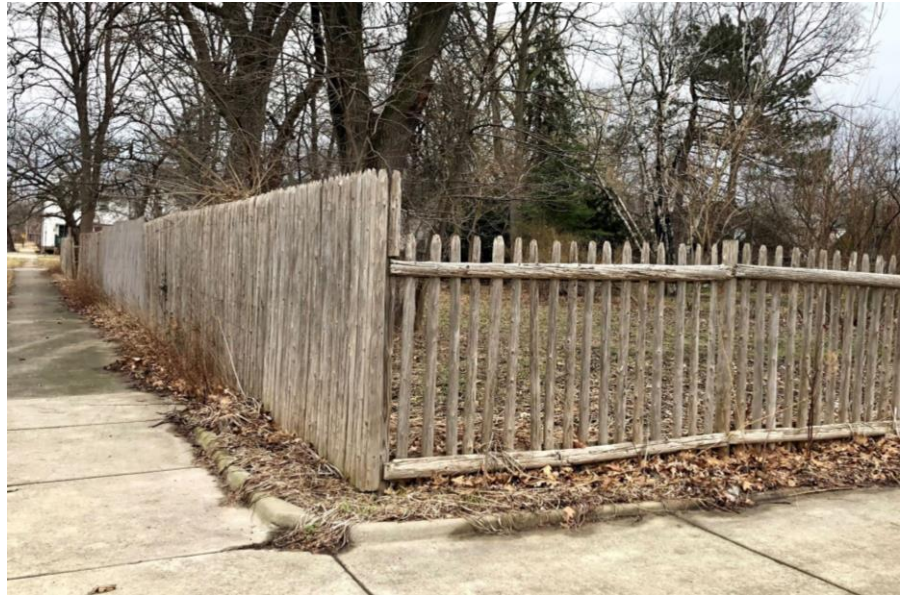
HDC staff photo, March 23, 2022

The adjacent lots are enclosed by a fence. A 6' tall wood stockade fence extends along the rear/alley and side (at E. Vernor) lot lines, while a lower 5' tall picket fence extends across the front of the two lots at Burns. The setback from the E. Vernor and Burns sidewalks is 18". At the southwest corner of 2236, the fence is placed at an angle before returning to run parallel with the lot line adjoining 2224 Burns. A wood gate, at the same height and design of the fence, is positioned at the front edge of the house and closes off the rear portion of the driveway (the gate is partially visible on the photo on page 1).

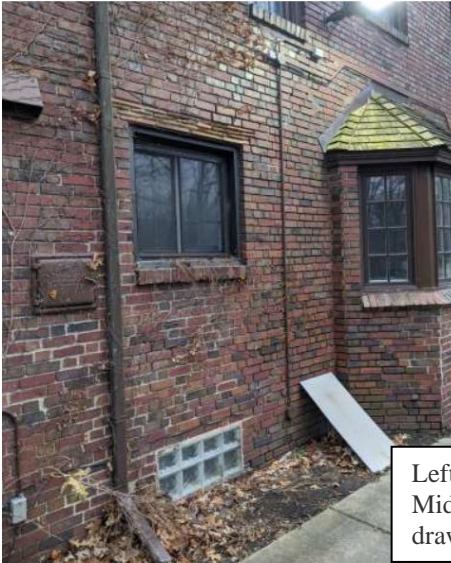
**Before**

Left: Applicant’s photo of existing conditions. Middle and right: Applicant’s positional drawing and elevation.

- The existing window unit proposed for removal is not character-defining, but the stone lintel above the window is a character-defining feature of the house.

- There are multiple sized openings on this elevation. It is staff’s opinion the alteration of the square opening for a wider/taller door is in keeping with the elevation’s patterning, and may offer a balance to the casement window opening on the other side of the bay window (as well as mimic the tall/short opening arrangement directly above at the second floor).
- As shown in the applicant’s mocked up photo (below right), the left edge of the door opening will match that of the existing window opening, allowing the vent, milk door and downspout to remain in place. It appears the header for the door may remain in line with the existing window header. If so, it is not clear if the applicant intends to retain the stone lintel.

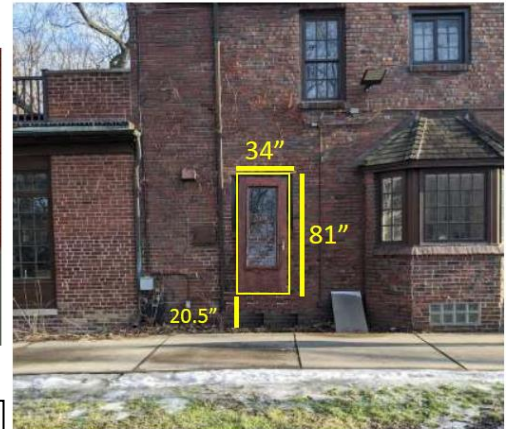
**After**

The door above is an actual snapshot of the door propped against the house. The colors are exactly as the finished product will be. The door has been digitally moved slightly up to show the finished install location.

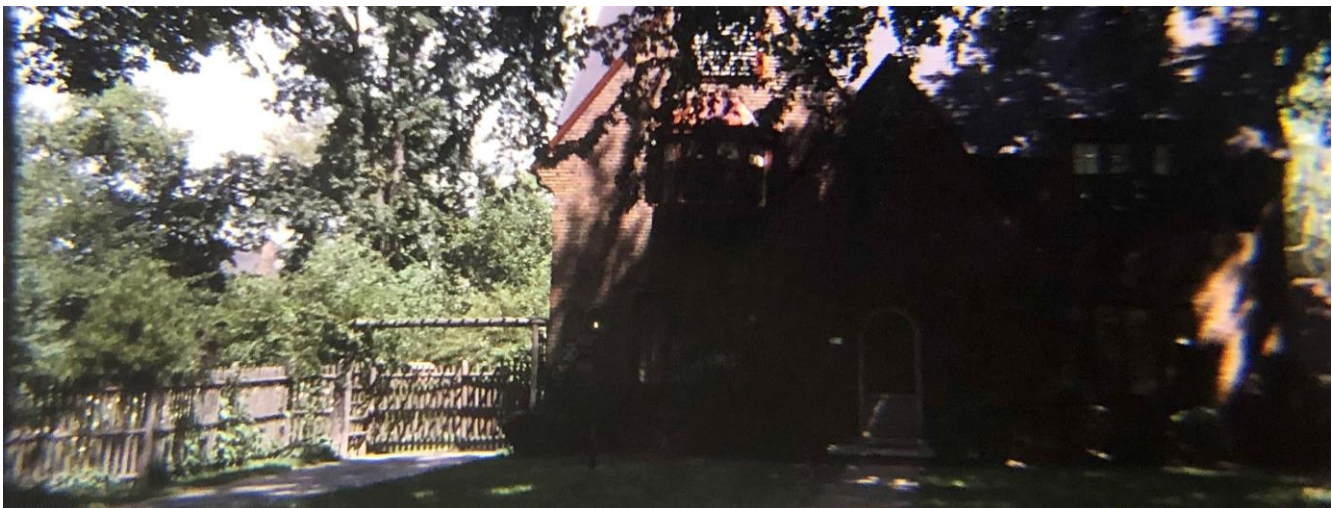
- The 1971 designation photographs of 2224, 2236 and 2248 Burns show a fence wrapping around the undeveloped lot. A stockade board privacy fence runs along E. Vernor, while a lower picket fence is located at the Burns sidewalk and returns to the setback of 2224 Burns. Also noted in the 2224 Burns designation photo, is a pergola and wood gate enclosing the back portion of the driveway.

2224 Burns designation photo, HDAB, 1971

- Staff suspects the existing fence is a replacement of the one seen in the designation photo, as the one in place at time of designation had a top, center, and bottom rail. The current fence has a top and bottom rail. It is staff's opinion that the existing fence designs, while charming in a homespun way, are not character-defining features of the lots.

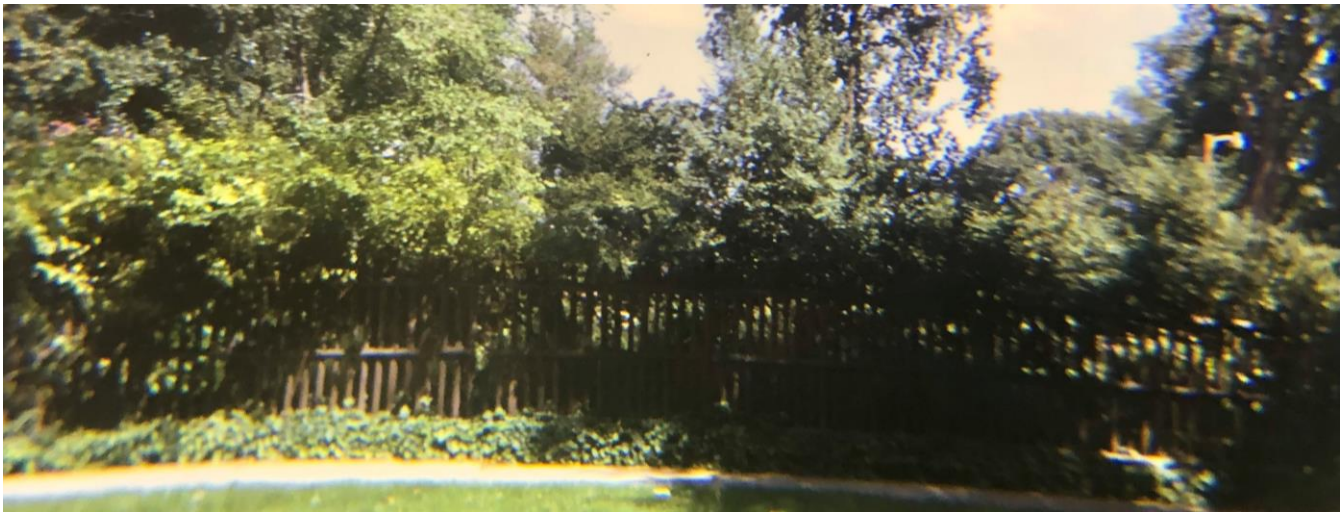
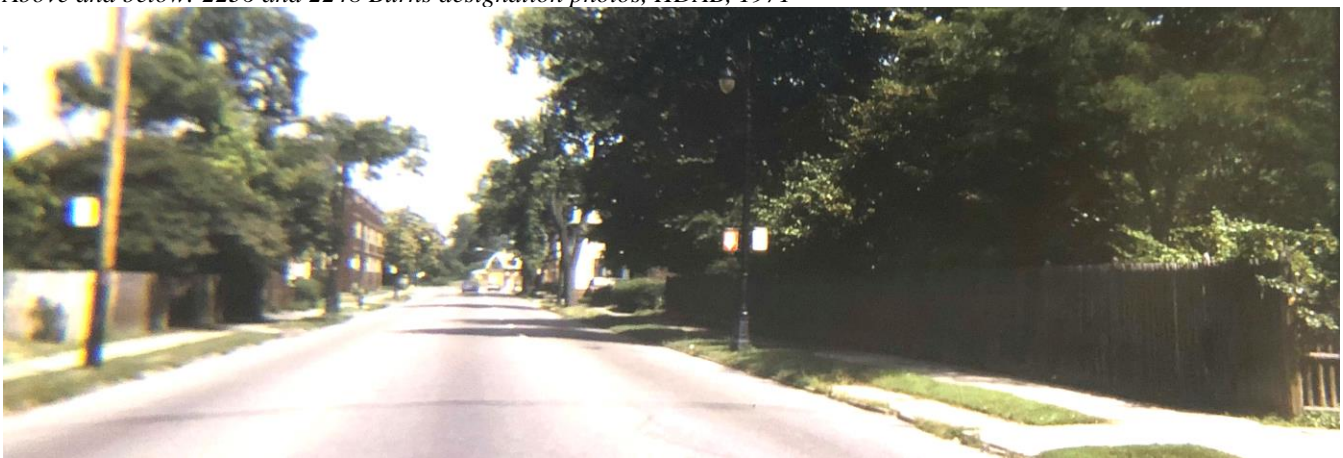
*Above and below: 2236 and 2248 Burns designation photos, HDAB, 1971*

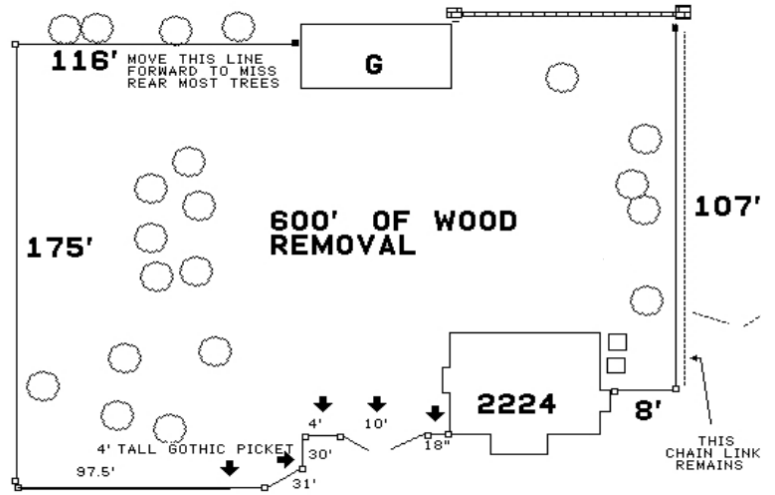
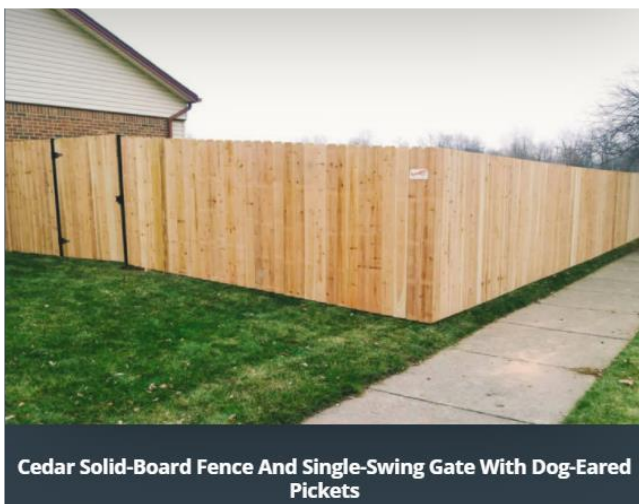
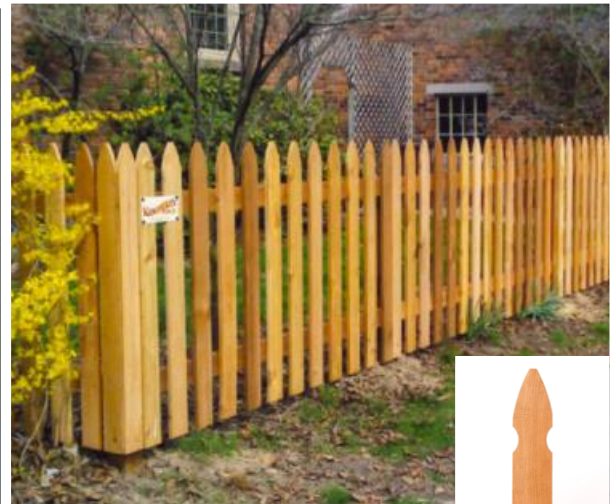
- The applicant’s proposal specifies the installation of a new fence in a similar arrangement as the existing fence. A 4’ tall picket fence (with 3-inch spacing between each picket) would enclose the side lot line adjacent to the house as well as along the Burns sidewalk. At the corner of Burns and E. Vernor, a 6’ tall solid board fence would run east to the corner of E. Vernor and the alley, and then continue south along the rear lot line. The double lined fence at the right corner of the rear yard denotes an existing brick wall that will remain in place.
- The proposed style and fencing material are consistent with the Fence and Hedge Guidelines and are appropriate to the district. The Guidelines allow for two types of fencing material on a single lot.

*Applicant photos showing installation of both fence designs. Gothic-style picket is proposed for the fence along Burns.*

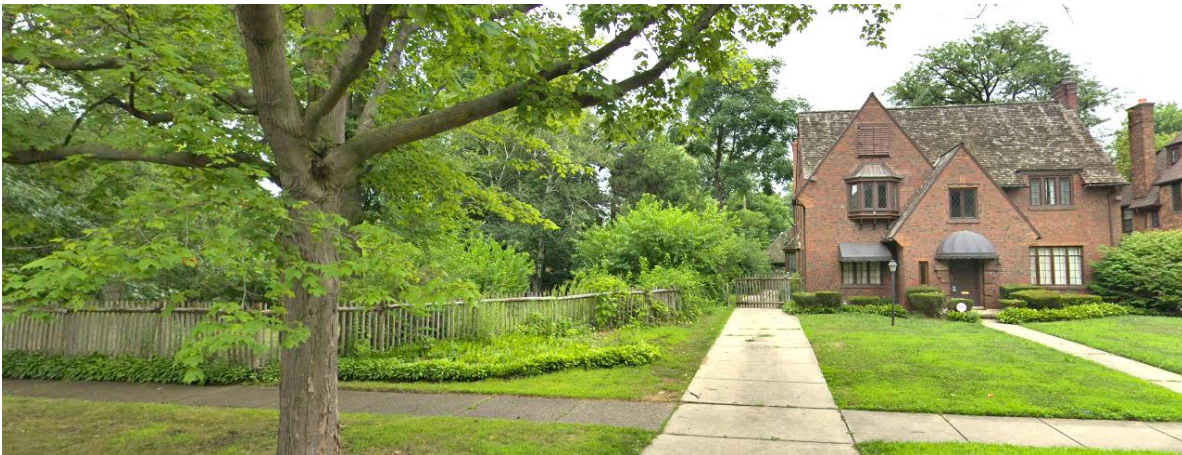
Google street view, August 2018

- The fence at 2236 Burns does not extend to the SW corner of the front lot, it angles towards the house at 2224 Burns just before the corner lot lines, giving more open space at this area of the side yard, and reducing the fence's visual impact on the house and streetscape. The applicant's proposed installation retains this angled wall.

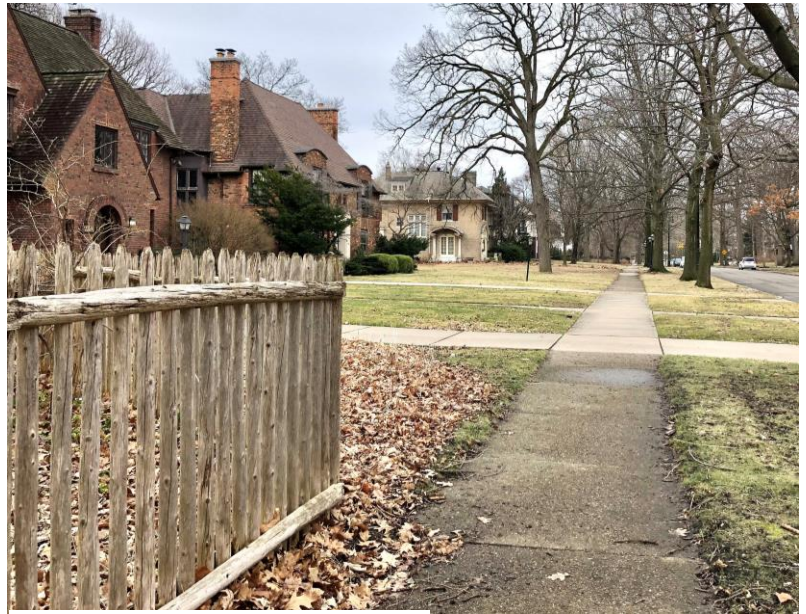
*HDC staff photo, March 23, 2022*

- The lower height and widely spaced picket fence at the Burns sidewalk offers the opportunity to see over the fence (as well as through the fence) into the yard and also keeps the viewshed open of the houses that extend south along Burns. Both fences are slightly set back from the sidewalk. A wide tree lawn is present at Burns, while a narrower tree lawn is present at E. Vernor.
- There are several examples of corner lot front yard fencing within the Indian Village Historic District, in which a house is not present. The consistent detail these installations share is a high degree of transparency.

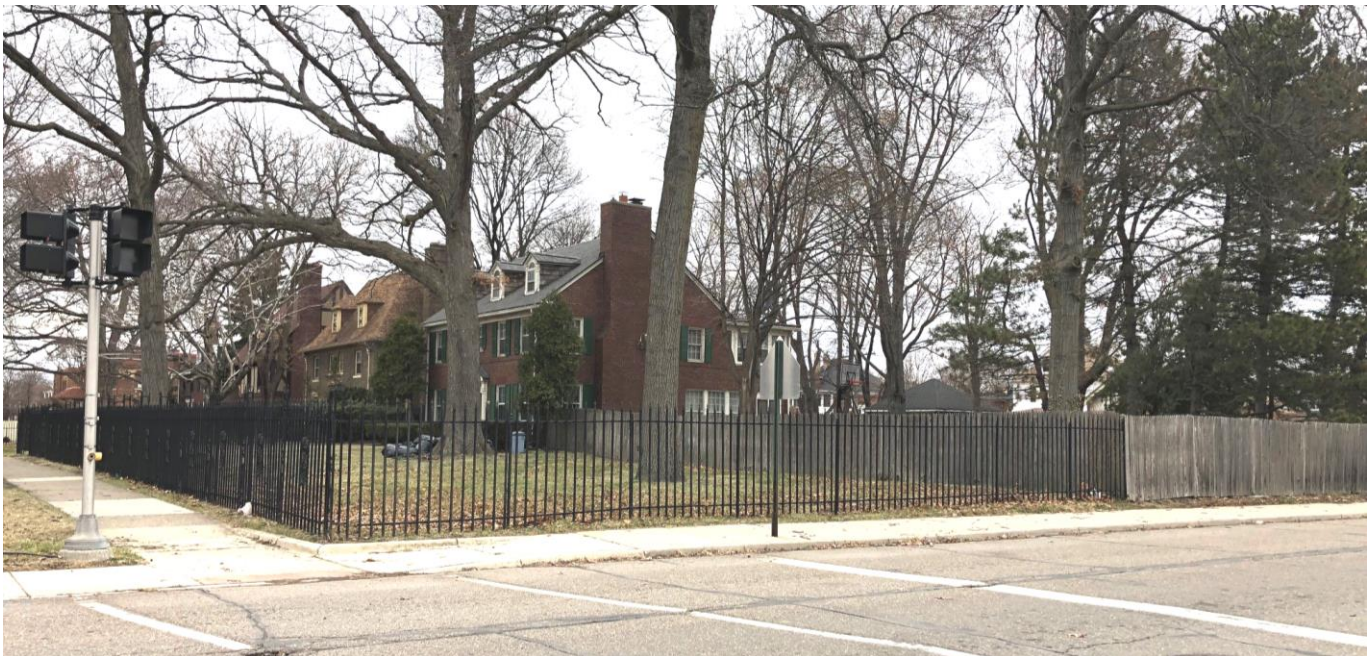
**#2 NE corner of Burns and Charlevoix, March 23, 2022.**  
Two material fence, multiple yard enclosures. Transparent fence at front yard, privacy fence beyond setback/rear yard. Both fences are only slightly set back from sidewalk. Important to note, there is no tree lawn buffer between Charlevoix and the sidewalk.

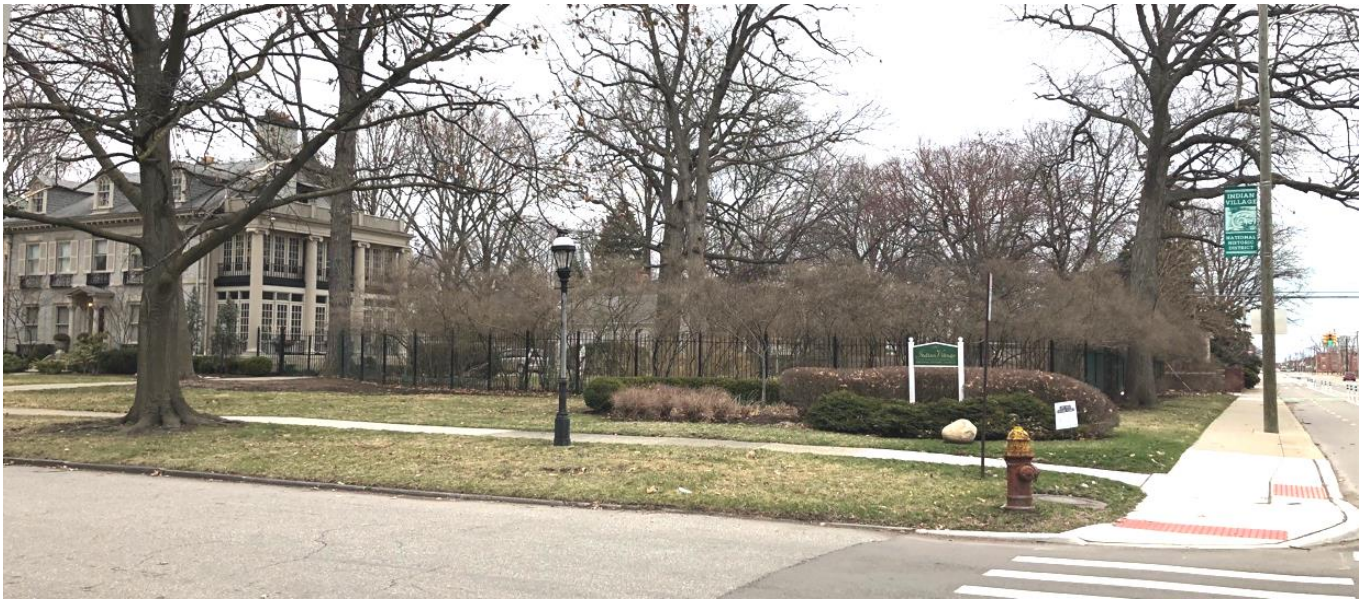
**#3 NE corner of Iroquois and Kercheval, March 23, 2022.**  
Seasonal transparency. Fully transparent fence at front setback line, fence is deeply set back from the Kercheval sidewalk.

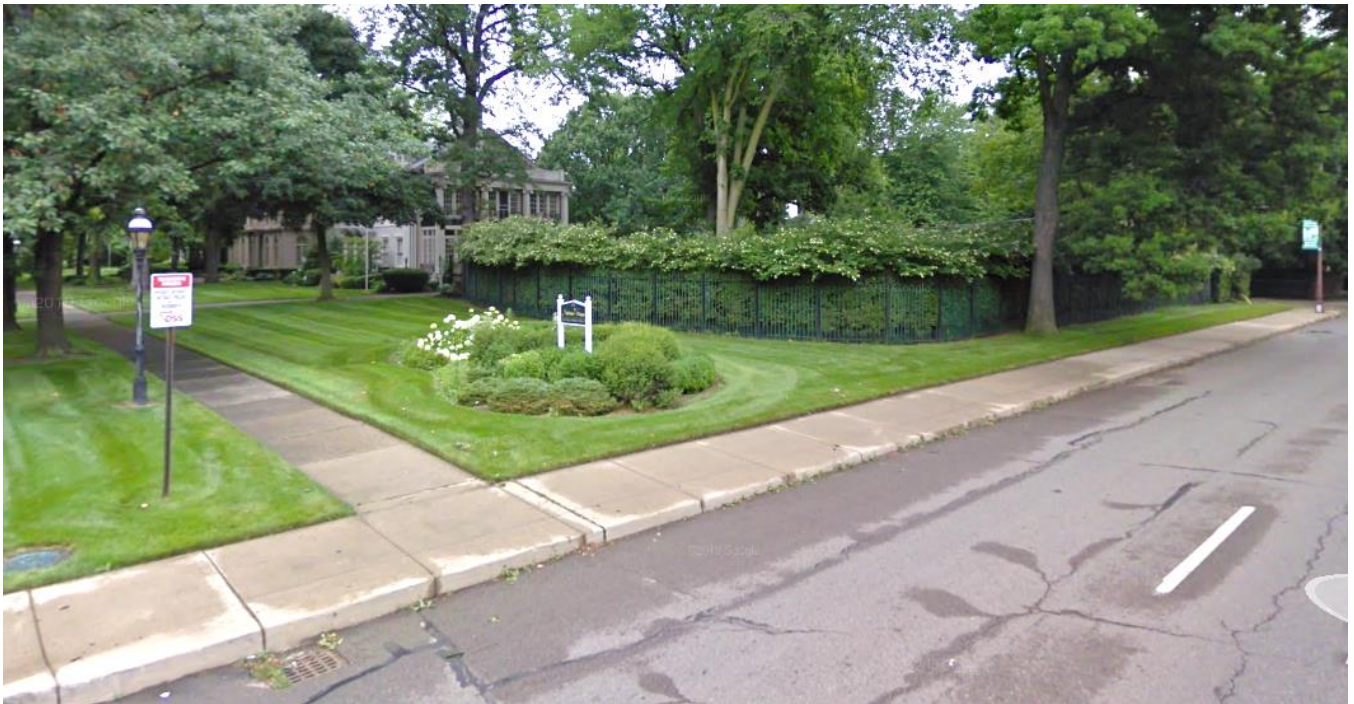
**#3 Google street view, July 2009**  
The yard behind the transparent fence is obscured by summer growth. The extended space between the sidewalk and fence creates a more open verdant environment for pedestrians, while offering full privacy for the interior of the rear lot. This additional greenspace is especially important along streets where the sidewalk ends right at the street, as it does here at Kercheval.

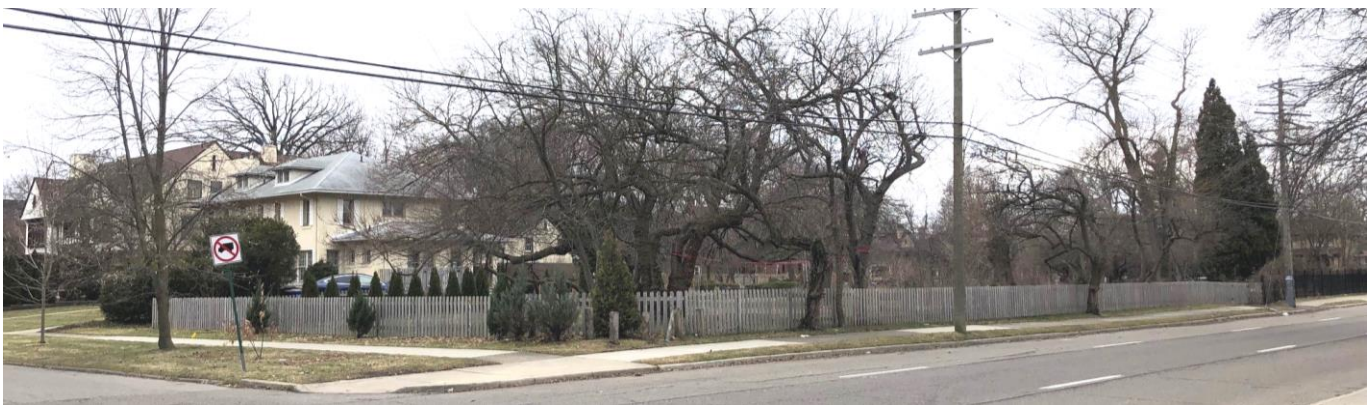
**#5 SW corner of Iroquois and Charlevoix, March 23, 2022.**  
 Semi-transparent wood fence (36 – 48” in height) that is set back from both sidewalks. A narrow tree lawn is present at Charlevoix.

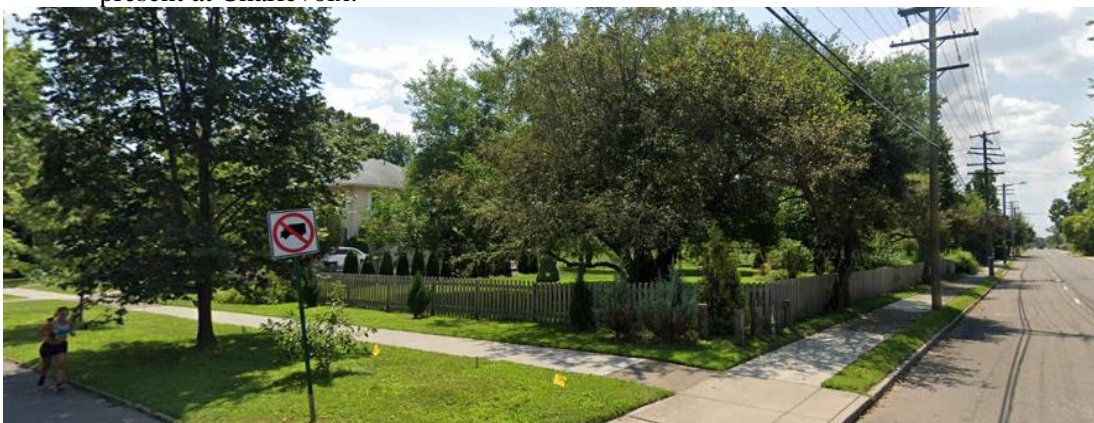
**#5 Google street view, August 2021.**  
 Pedestrians see over and through this fence. Since there is no interior privacy fence at the setback line to obstruct the view to the rear portion of the lot, an open viewshed for a fenced lot was created. The deeply set back fencing (and angled corner) allows for the planting of shrubs and trees that offer additional interest to the lot while creating occasional natural visual barriers.

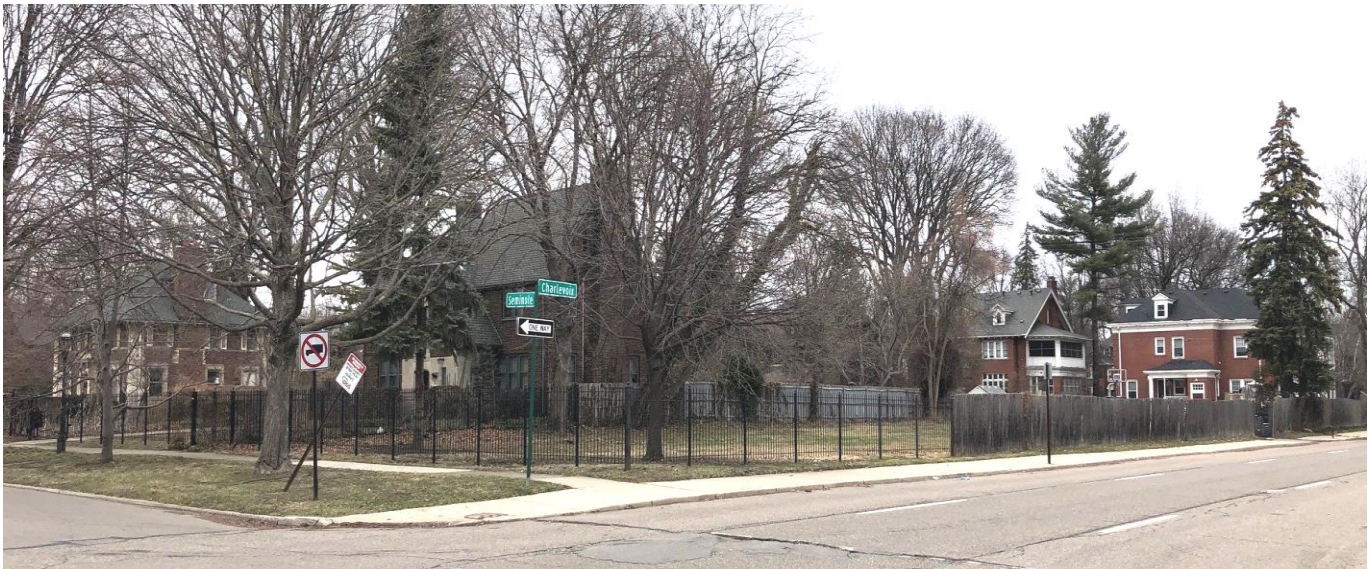
**#6 NE corner of Seminole and Charlevoix, March 23, 2022**

Two material fence, full yard enclosure. Transparent fence at front yard, privacy fence beyond setback/rear yard. No barrier at the setback line allows for a full view of lot. Both fences are only slightly set back from sidewalk and there is no tree lawn buffer between Charlevoix and the sidewalk.

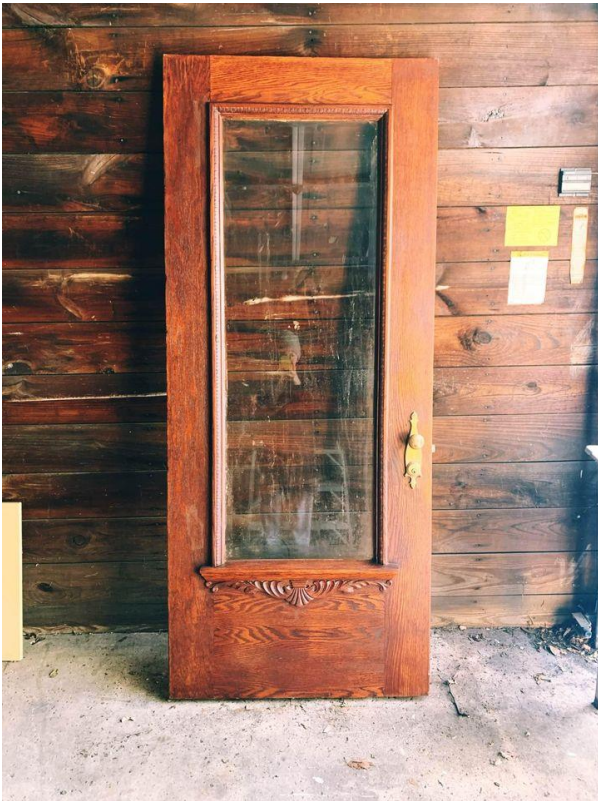
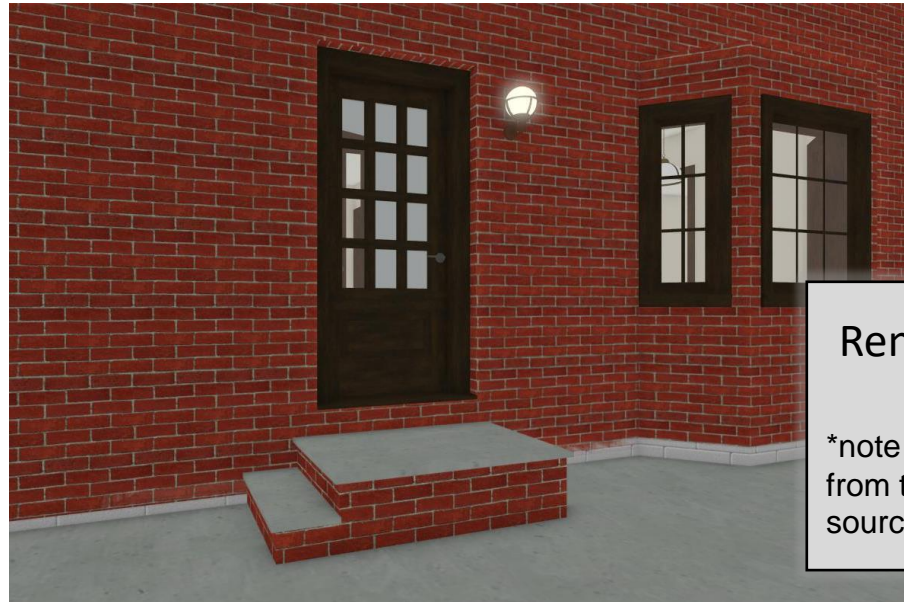
Rendering of new door with landing.

New door, solid oak  
historical door with glass  
pane

\*note that the door window has changed slightly from the designer's rendering to the actual door we sourced. The door at far left is what will be used.

The door will not go down to the grade. There will be 2 brick steps to get onto the ground with a 36"x48" landing. Stairs and landing will be made of matching brick, and when possible, use salvaged brick from the area being removed for a clean match. Stairs would be 6.5" rise, 36" width, 8" run.

At 36" wide, this landing will but up against, but not extend onto, the existing driveway. The width is largely enveloped by the existing nook that already extends out, just to the right of the planned door location as seen in the rendering. The door will rotate in-ward.

- The landing is specified at 36” wide by 48” deep. While it appears to HDC staff that the bay window extends less than 36” from the side wall, the applicant states the landing will not extend into the driveway.
- It is not clear if the applicant will remove the window opening’s stone lintel or leave it in place.

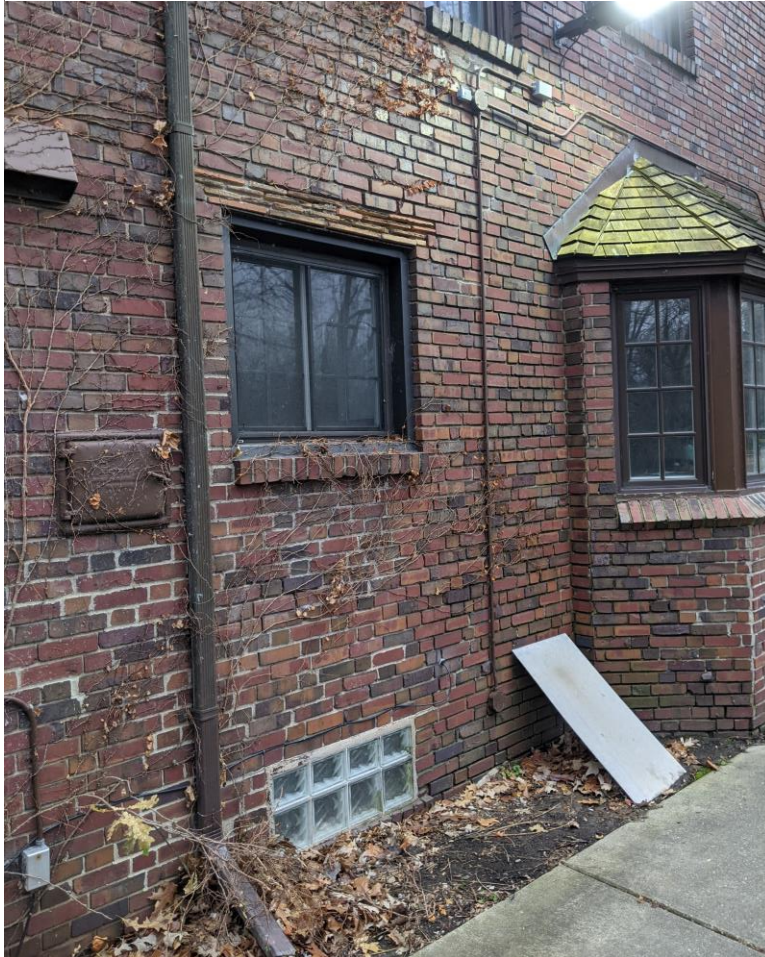
**Before**

# 2224 Burns New Door Dimensioned

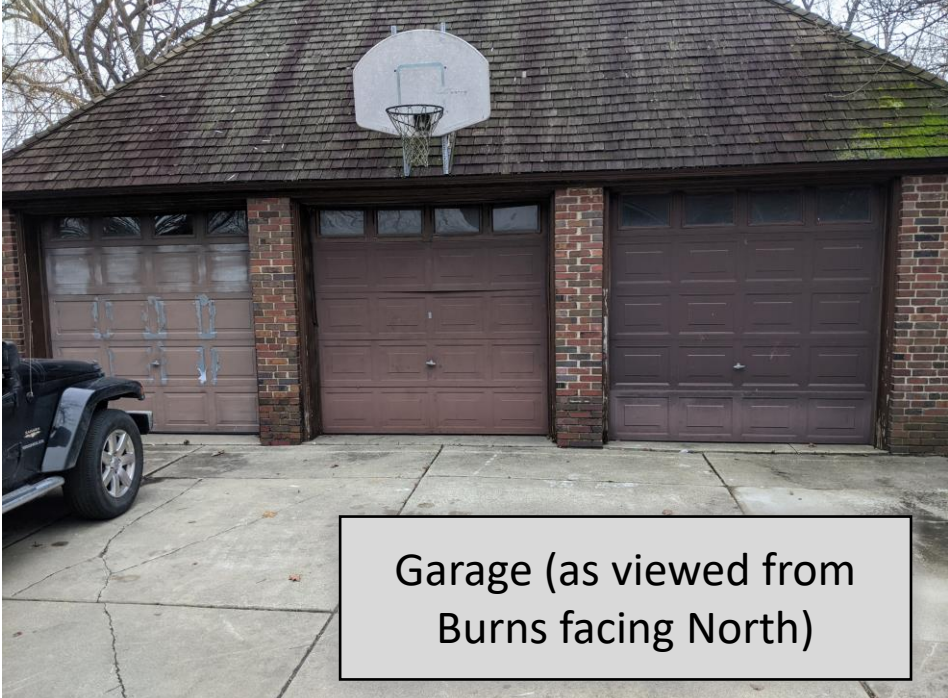
Garage (as viewed from Burns facing North)

- Exterior Trim & Garage Door –
  - Garage doors will be retained and repainted B18 Dark Reddish Brown
  - Garage trim will be repaired with wood filler or replaced directly with wood depending on severity of damage, and repainted B18 Dark Reddish Brown to match the garage doors

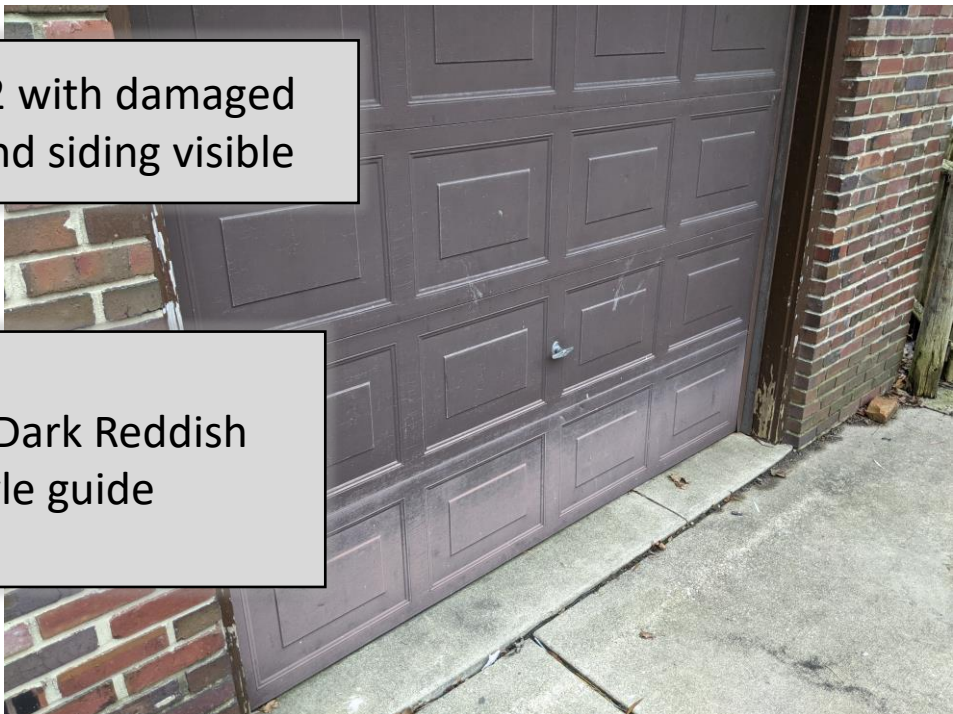
Door #2 with damaged paint and siding visible

Trim color will be B18 Dark Reddish Brown per the style guide

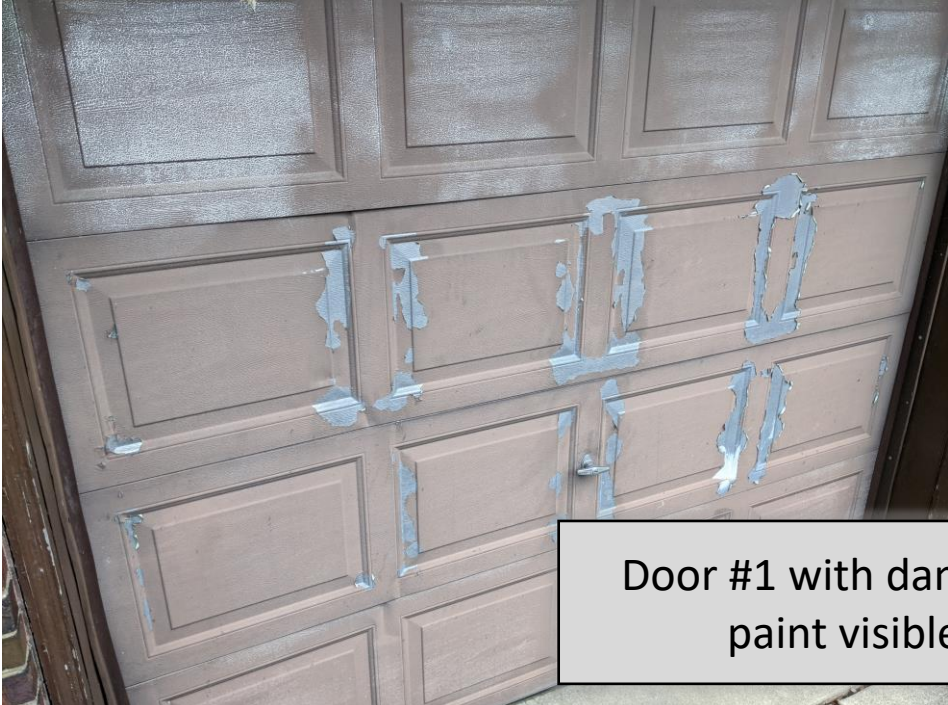
Door #1 with damaged paint visible

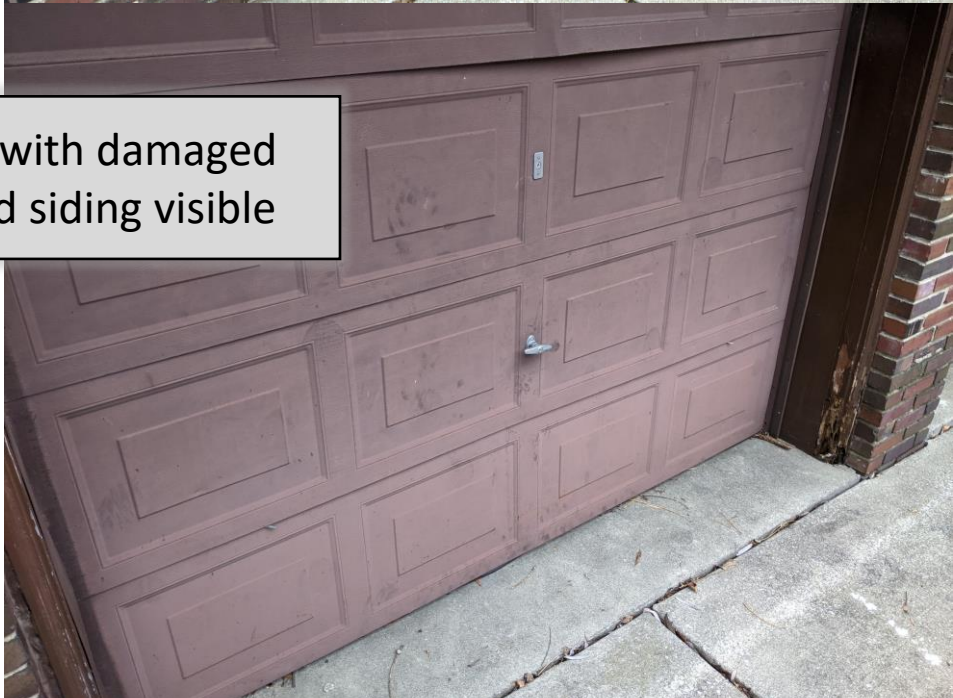
Door #3 with damaged paint and siding visible

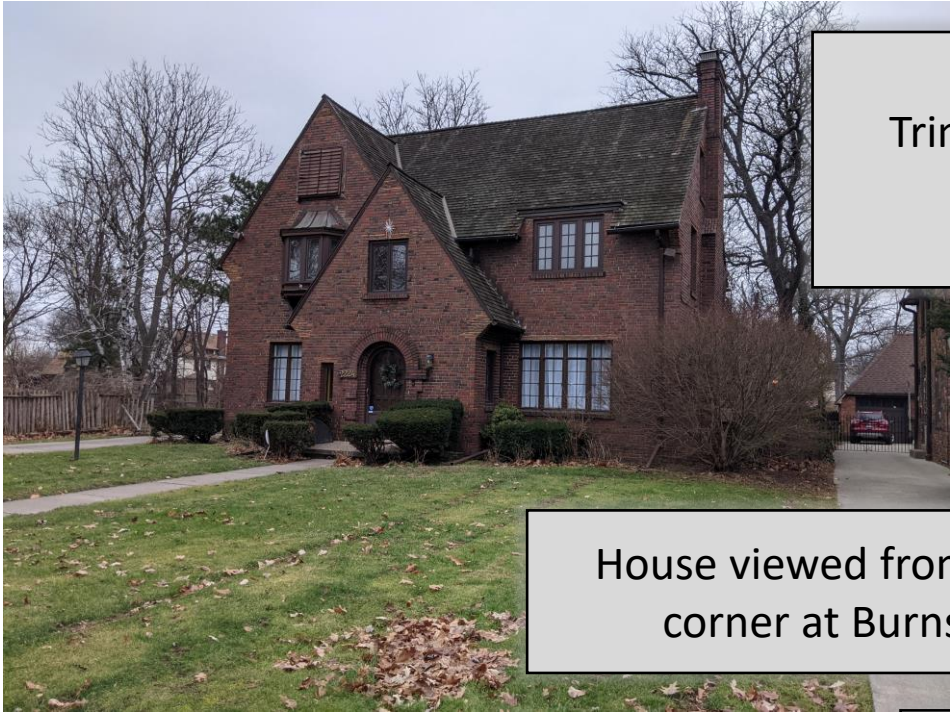
House viewed from SE corner at Burns

Trim color will be B18 Dark Reddish Brown per the style guide

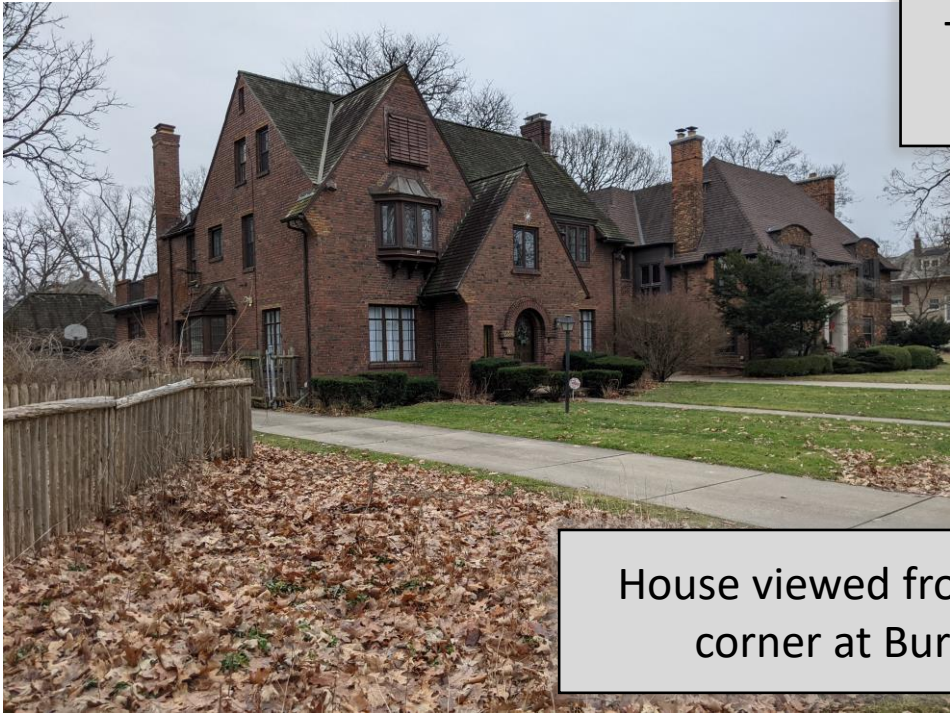
House viewed from SW corner at Burns

Trim and window frames will all be painted black

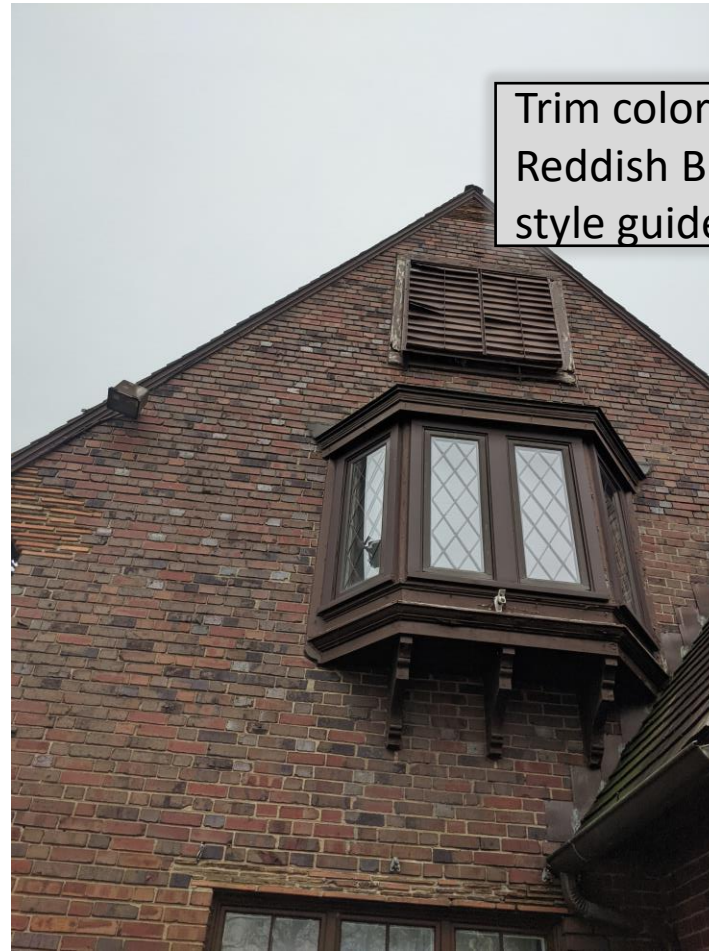
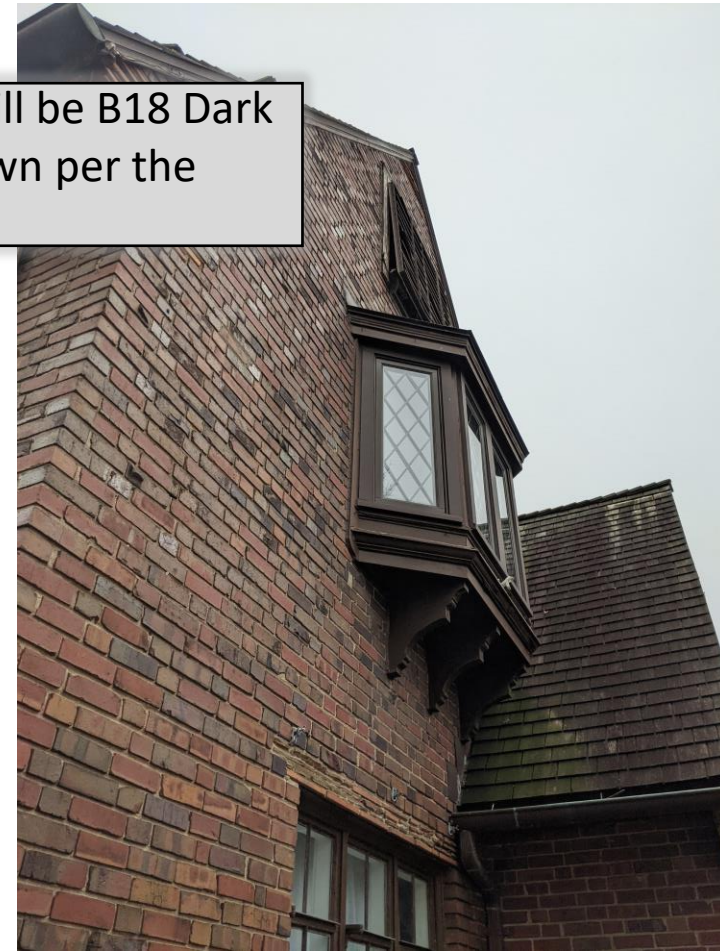
New door will remain historic stained oak color, in accordance with the intent of the style guide

Similar houses in Indian Village are shown at left

Proposed implementation at right

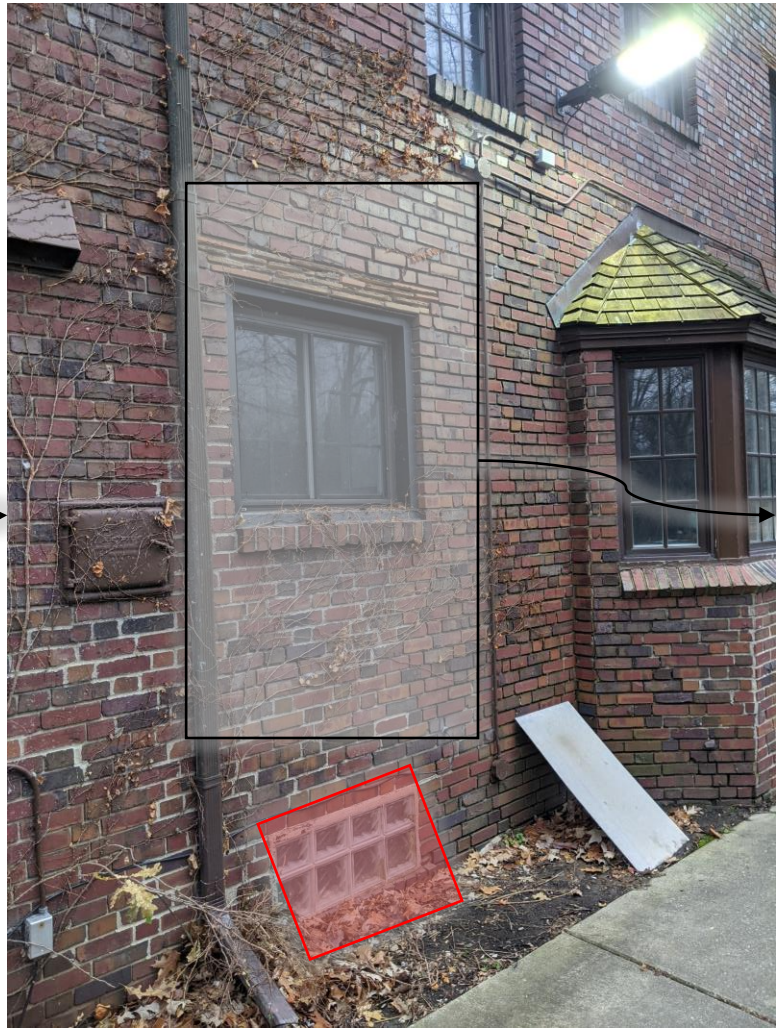
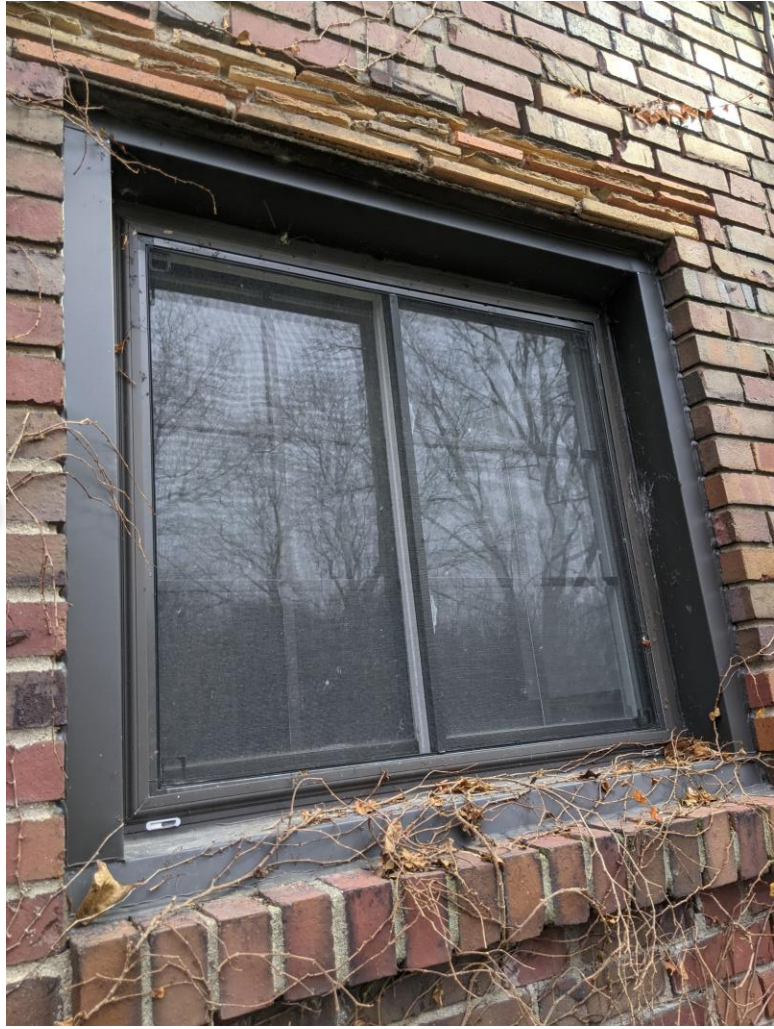
The current window opening is 38". The new door is 34" wide, so it will fit within the existing opening with room for framing & lock mechanism.

The basement window (red) will be obscured by the planned steps or landing referenced on page 5. This is acceptable to us as the windows are largely internally obscured already by plumbing and ducting.

- Vinyl Window –
  - Replace with a period-era wooden door. Doing this will allow us to have better access to the side yard and improve the flow and functionality of the house while improving the historical nature of the property

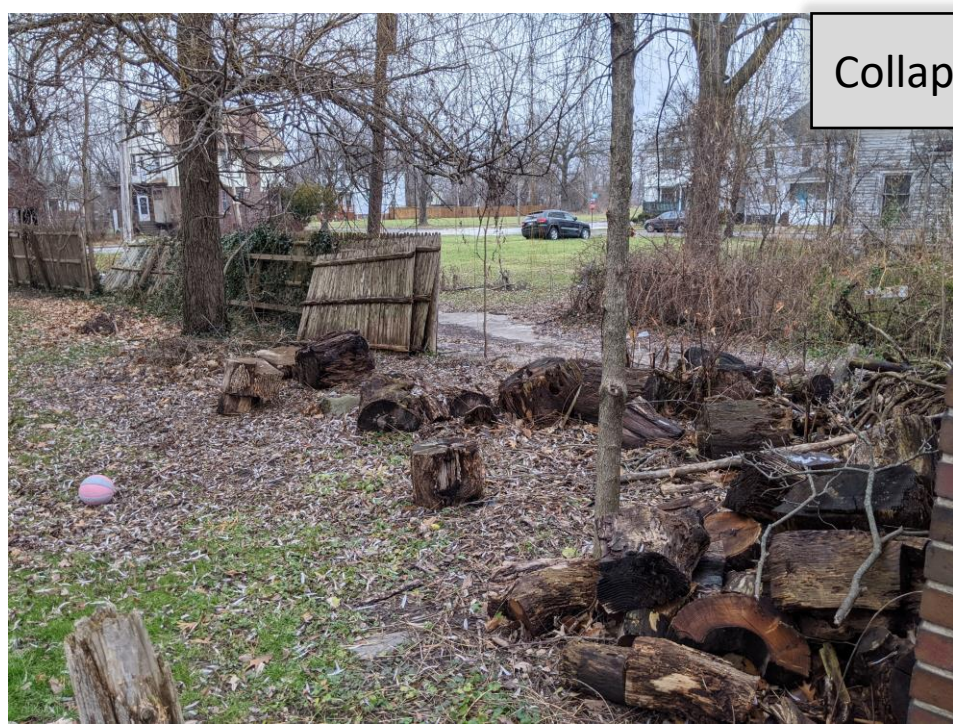
Collapsed fence along alley
