**STAFF REPORT:** APRIL 13, 2022 MEETING  
**APPLICATION NUMBER:** 22-7748, 7749, 7750  
**ADDRESS:** 2224 - 2248 BURNS

**HISTORIC DISTRICT:** INDIAN VILLAGE  
**APPLICANT:** BLAINE RILEY  
**PROPERTY OWNER:** BLAINE RILEY  
**DATE OF PROVISIONALLY COMPLETE APPLICATION:** MARCH 21, 2022  
**DATE OF STAFF SITE VISIT:** MARCH 23, 2022

**SCOPE:** REPLACE FENCE AND GATE, REPLACE WINDOW WITH DOOR, ERECT STOOP

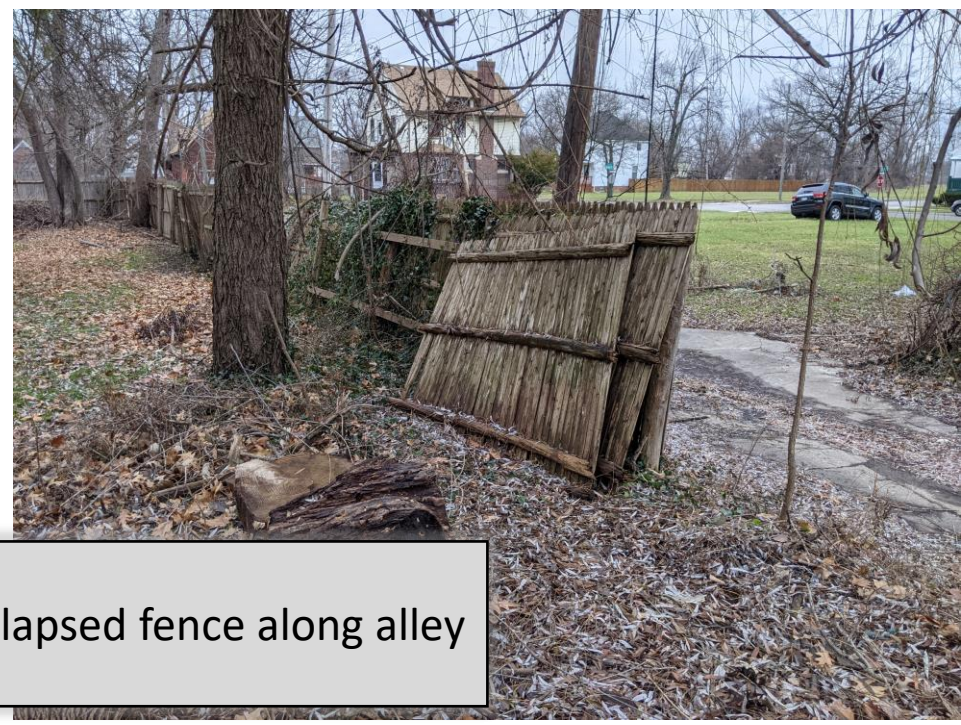
Collapsed fence along alley

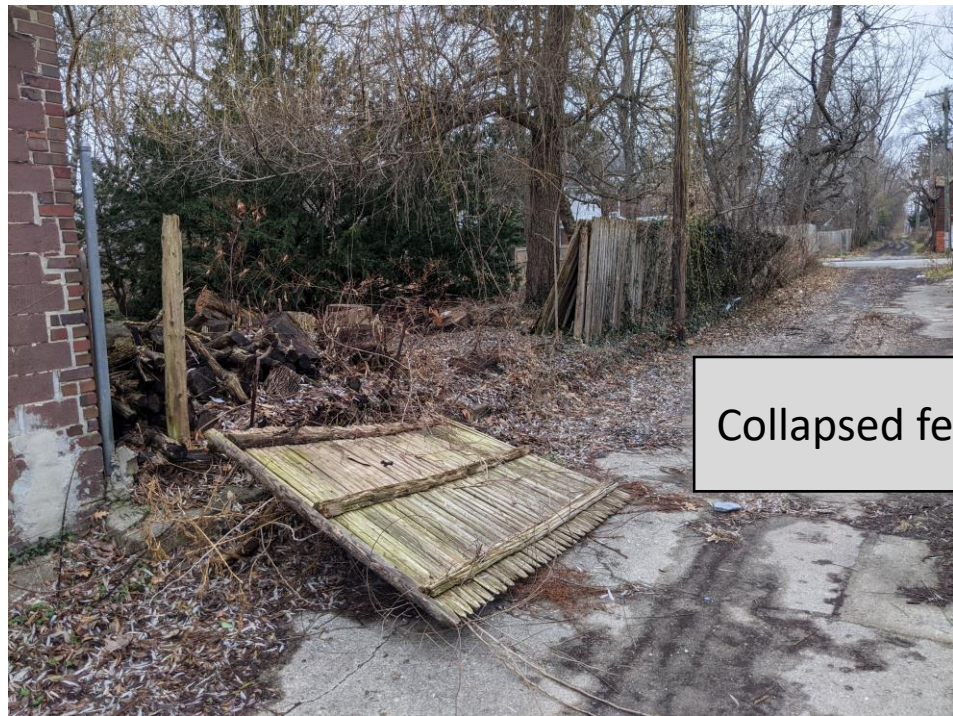
Collapsed fence along alley

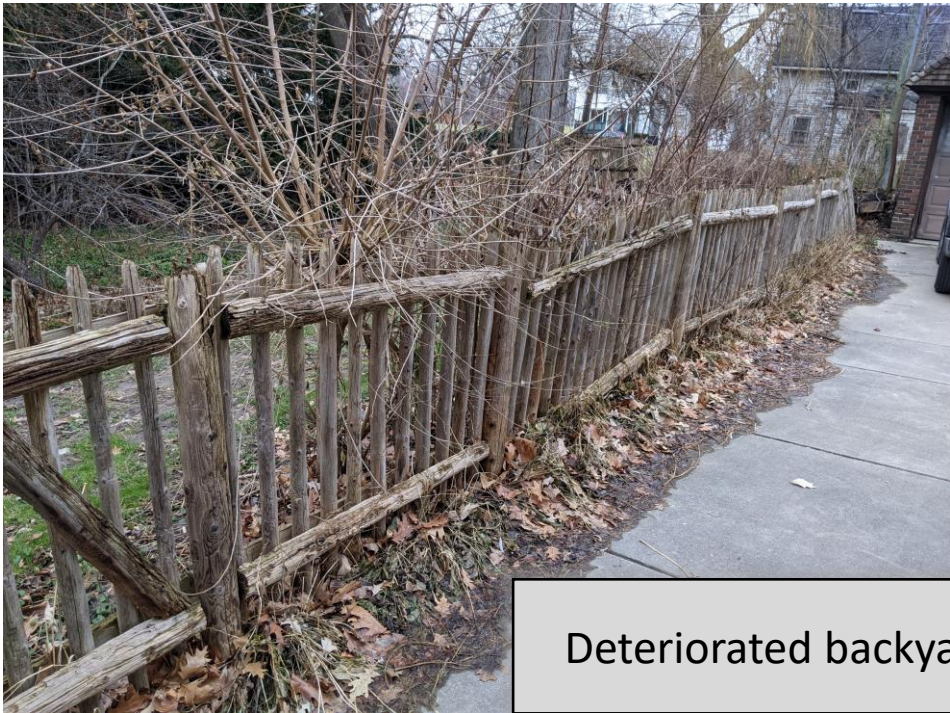
Deteriorated backyard fence

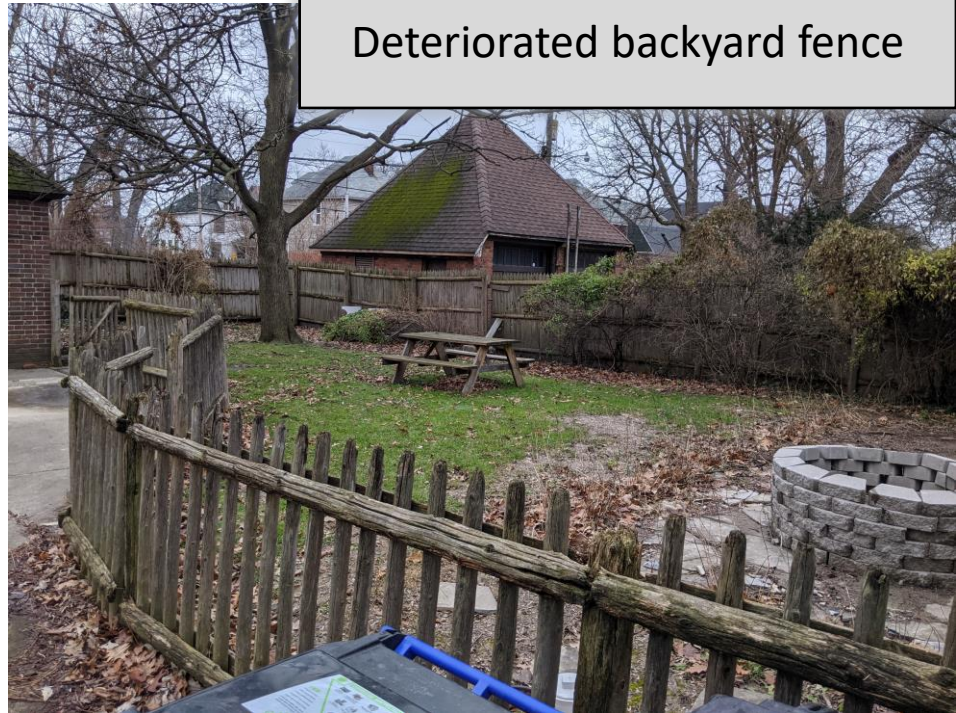
Deteriorated backyard fence

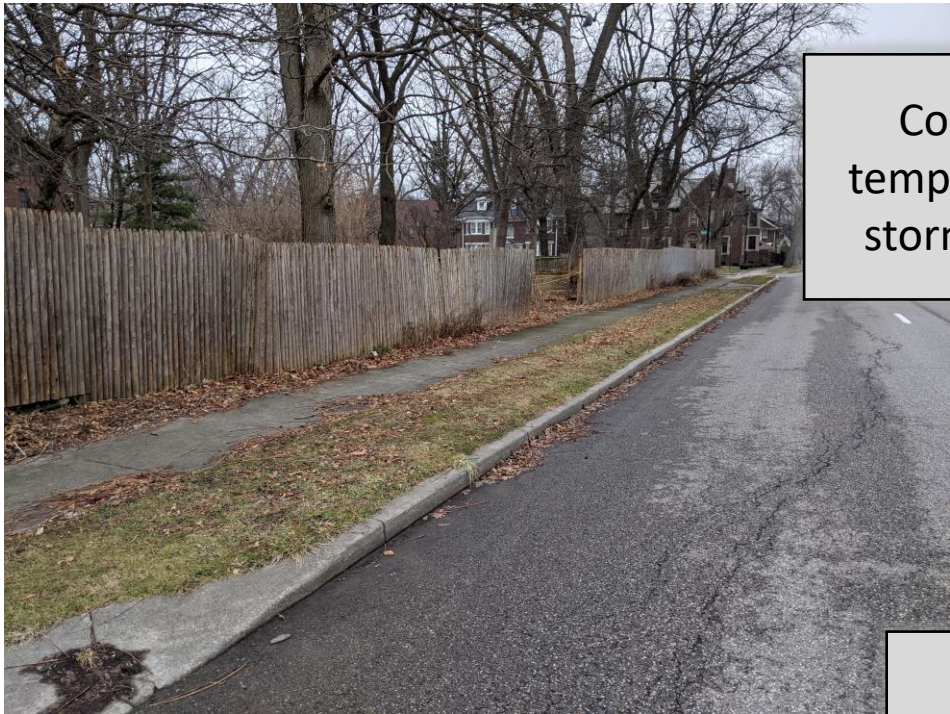
Collapsed fence along Vernor,  
temporarily restrained after recent  
storm to prevent further collapse

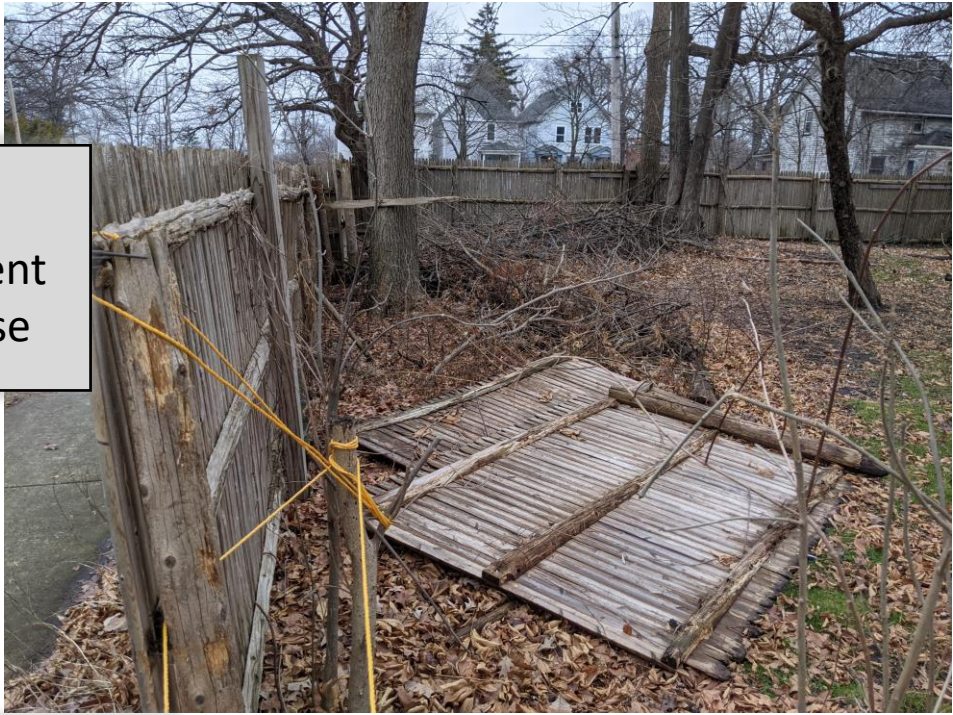
Collapsed fence along Vernor,  
temporarily restrained after recent  
storm to prevent further collapse

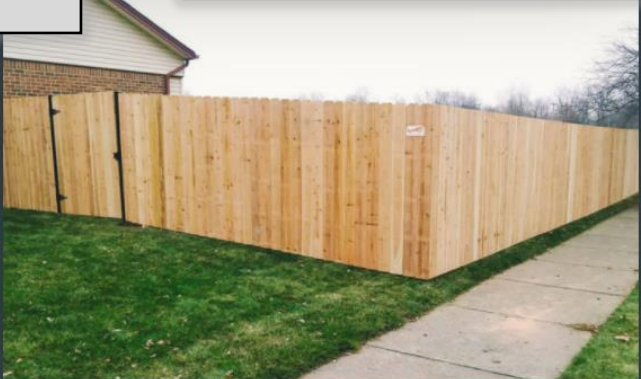
Cedar Solid-Board Fence And Single-Swing Gate With Dog-Eared Pickets

A natural color stain will be applied for weather protection. The gap between each picket is approximately 3 inches. The picket fence is 4' tall, the dog-ear fence is 6' tall. Final look will be like the below. Please note that the proposed implementation will use gothic pickets as shown below, not the pointed pickets depicted.

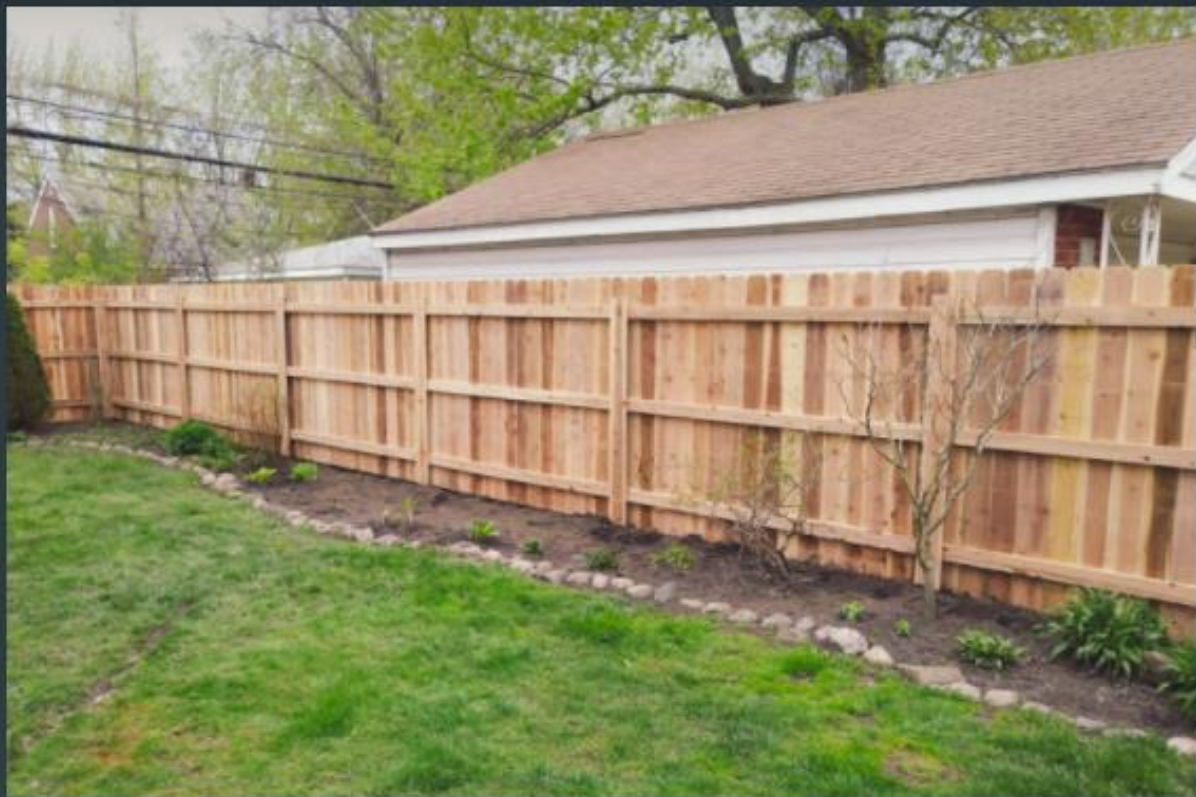
**Cedar Solid-Board Fence (Interior View)**

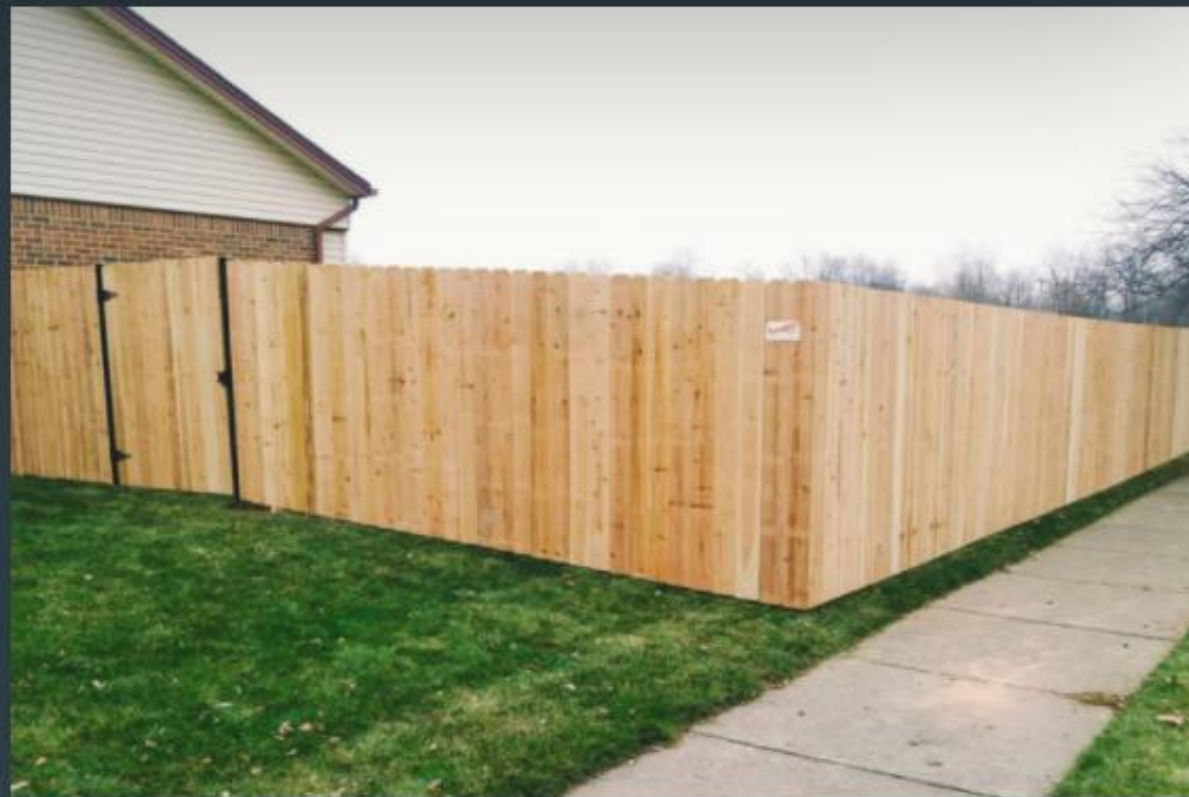
**Cedar Solid-Board Fence And Single-Swing Gate With Dog-Eared Pickets**

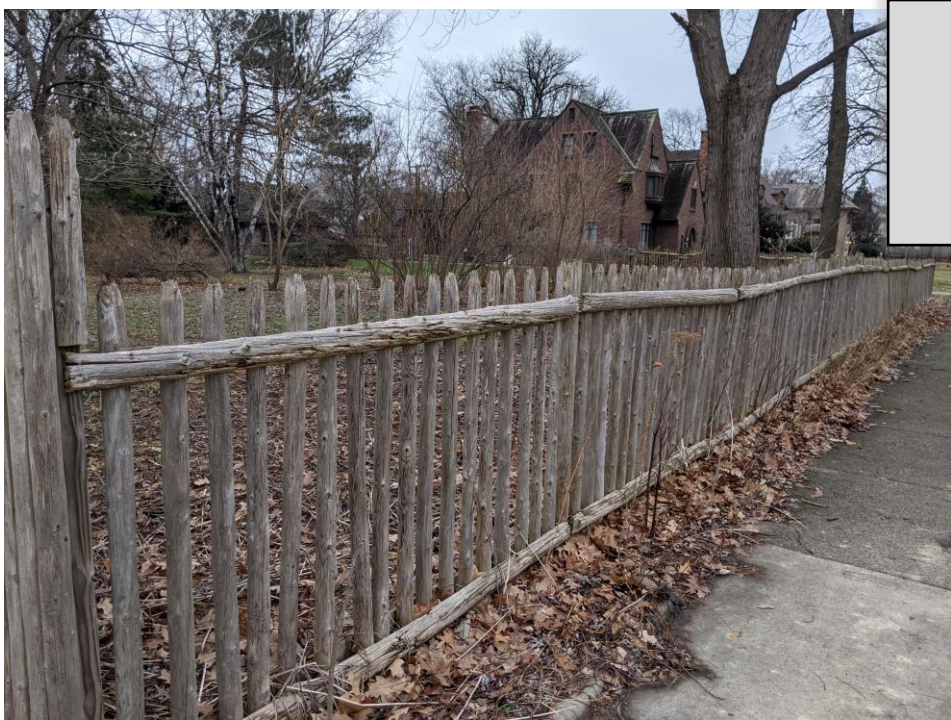
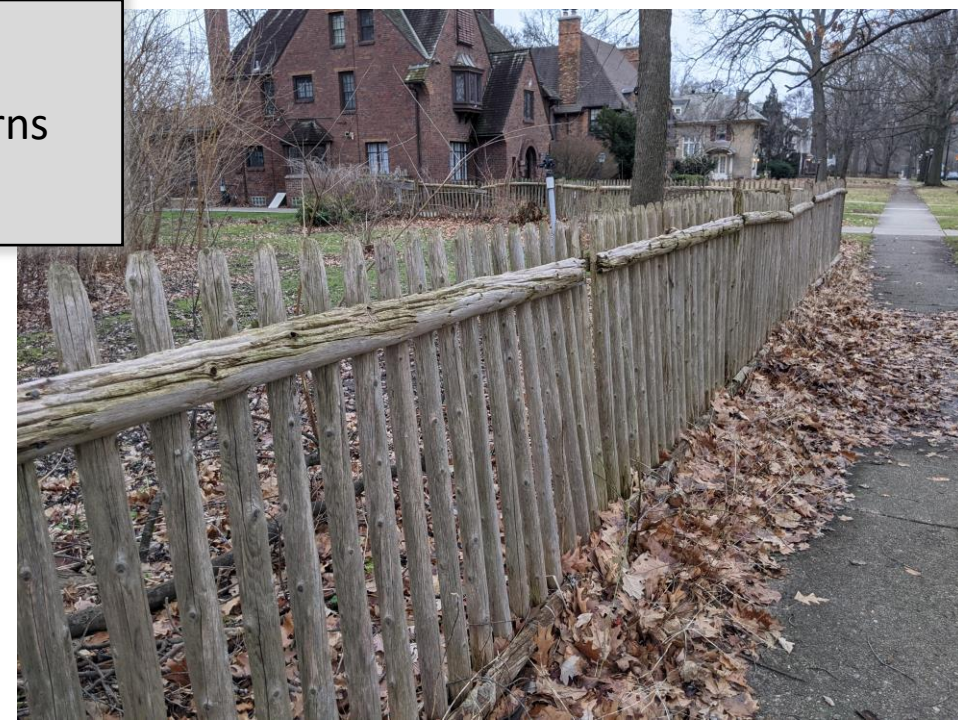
Deteriorating fence along Burns

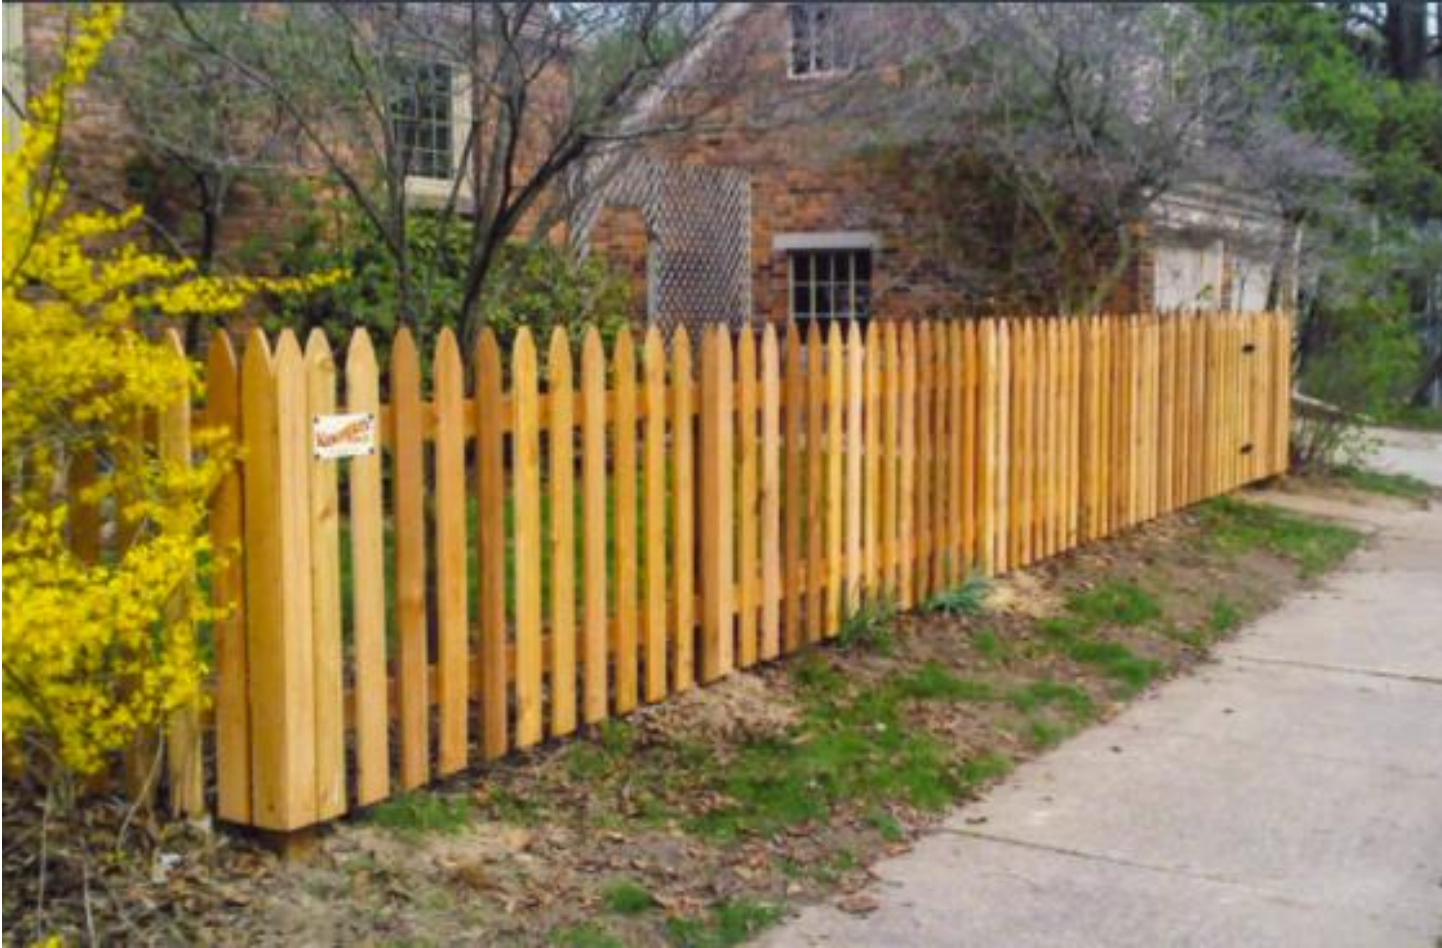
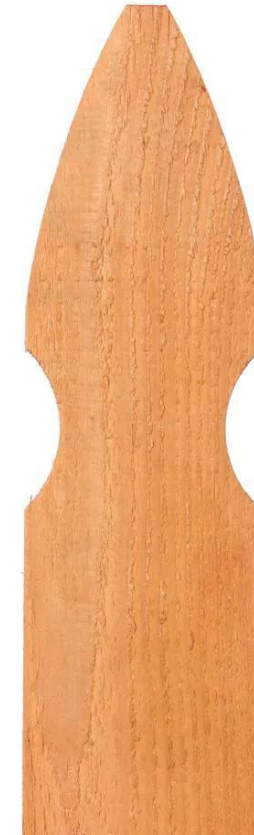
Please note that general 4' fence images depict pointed pickets, but the actual build will be made with gothic pickets. The image at right is a French gothic picket
