STAFF REPORT: DECEMBER 14, 2022 MEETING

APPLICATION NUMBER: 22-8151

ADDRESS: 1451 BAGLEY

SCOPE: ERECT ADDITION, REPLACE WINDOWS, REPLACE STOREFRONT, ADD LIGHTING

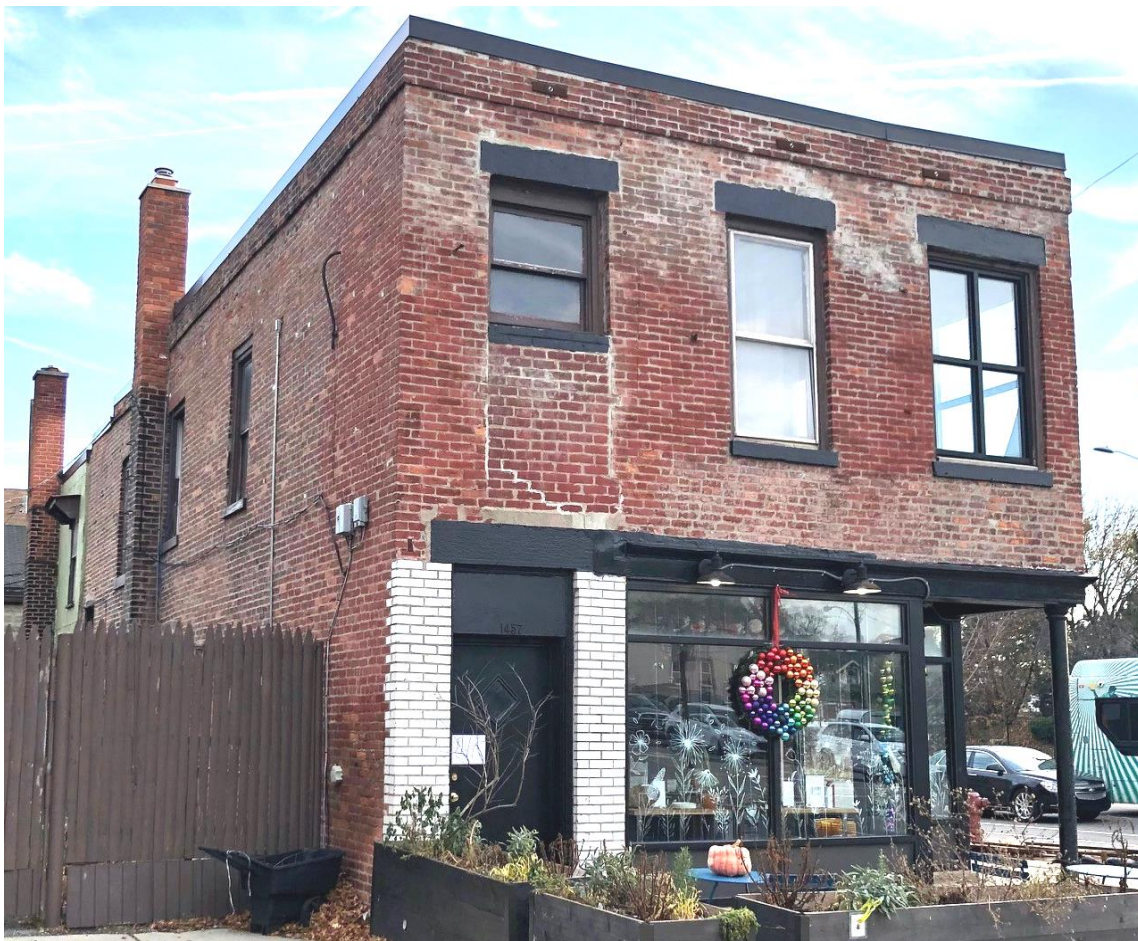
Bagley elevation looking southwest. Staff photo, November 29, 2022

Previous changes to the exterior elevations are evident through the ghost outline of a removed front-facing second floor door, white brick flanking two first floor entrances and the southwest corner of the building. A metal coping system offers a finished edge at the roof. A non-historic storefront system wraps the corner of the building; the historic supporting column remains in place. The window openings have vinyl sash; the wood brick mold remains intact and uncovered within many of the existing openings.

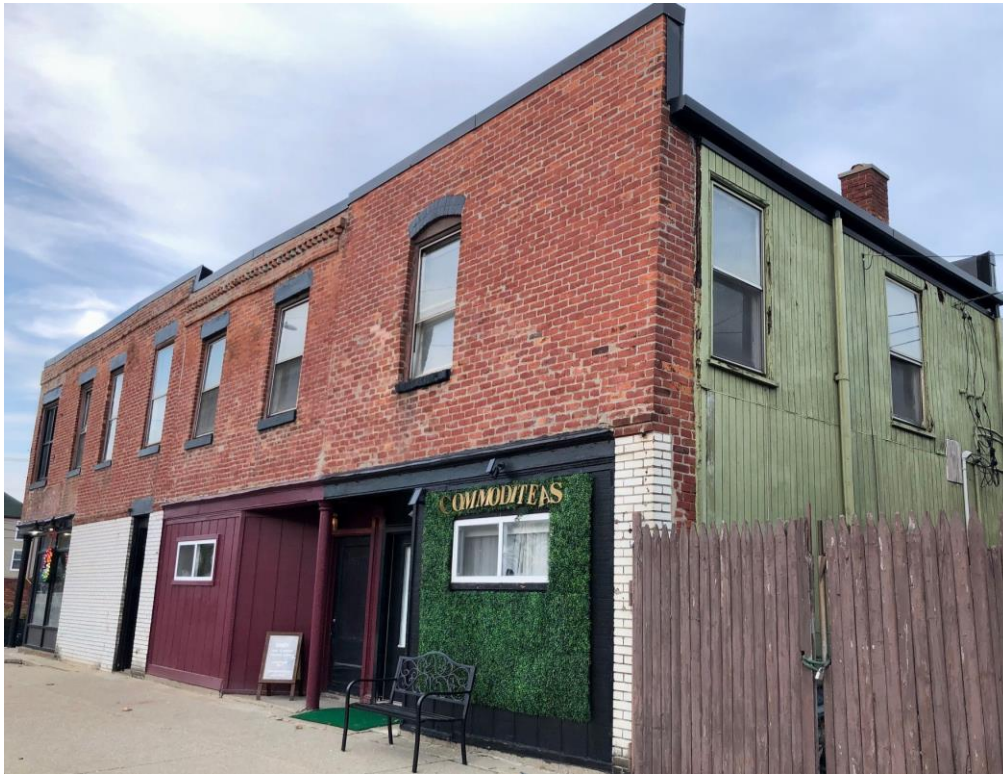
Trumbull elevation looking northeast. Staff photo, November 29, 2022

Evidence of additions to the original structure are noticeable through changes in roof height, vertical joints within the masonry, and differing window openings and decorative masonry details. According to the Sanborn maps, all of the Trumbull facing additions were in place by 1884; whereas the addition at the southeast corner was in place by 1897.

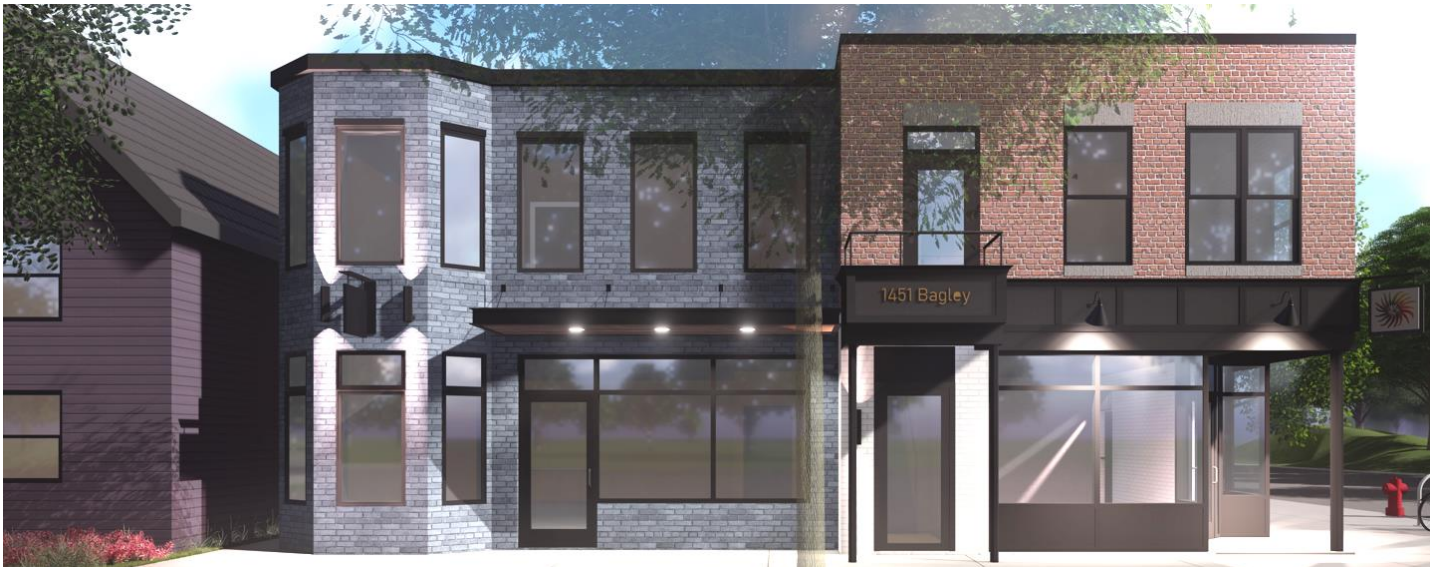
Applicant site plan and rendering

Per the applicant's cover letter, the existing building is to be rehabilitated and a two-story addition erected at the east elevation. Staff has listed the larger elements included in the application.

- Erect two-story structure on vacant lot
- Storefront window system at Bagley elevation – Kawneer Trifab 451
- Windows – Anderson E series (wood, aluminum-clad fixed pane single lites)
- Masonry cladding – Ravenswood Ironspot Velour
- Wall cladding – Tru-Exterior V-Rustic Siding, Smooth Fiber Cement

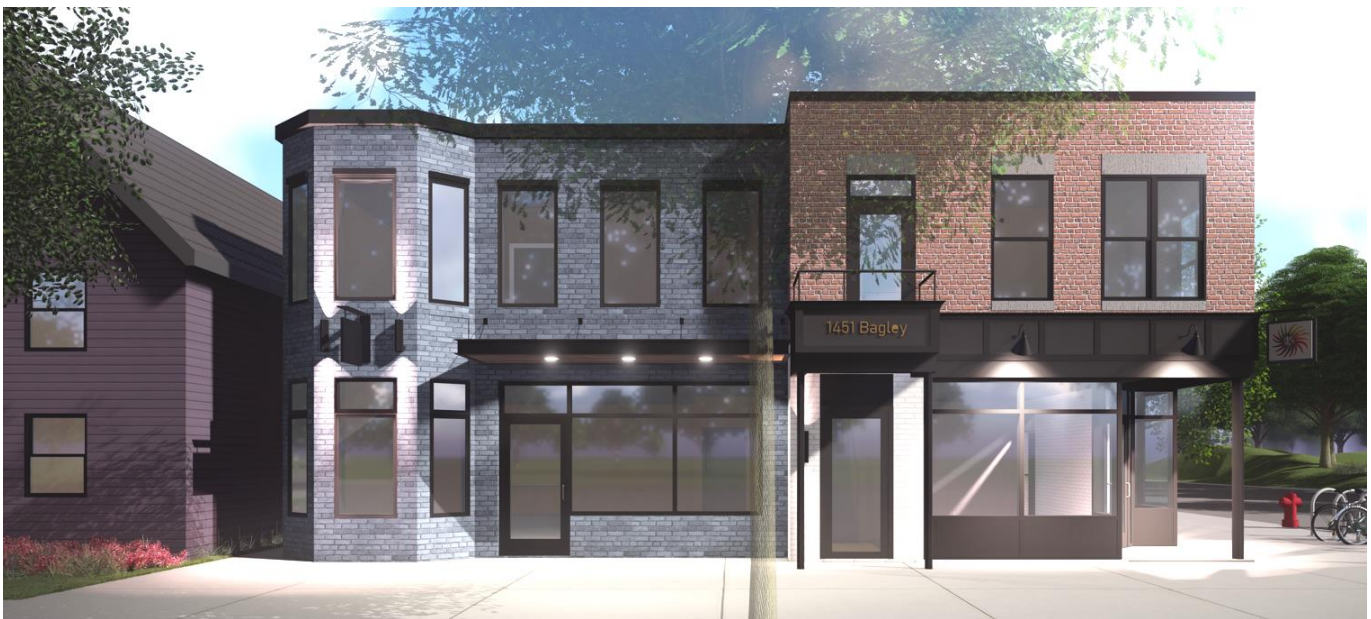
Applicant rendering

- It is staff's opinion the slightly recessed building and the contemporized detailing creates a deferential and sympathetic structure that fits within the vernacular of the district while not emulating the detailing and patina of the historic buildings.
