STAFF REPORT: 4/12/2022
PREPARED BY: T. BOSCARINO
REVISED ON APRIL 12, 2023 (revisions shown in bold red type)

APPLICATION NUMBER: 23-8283
ADDRESS: 3509 AND 3521 SEMINOLE
HISTORIC DISTRICT: INDIAN VILLAGE
APPLICANT: JACOB M. LUBIG, VENTURE DESIGN
PROPERTY OWNER: HENDERSON, MARSHA & SONUYI, TOLULOPE
DATE OF PROVISIONALLY COMPLETE APPLICATION: 3/14/2022
DATE OF STAFF SITE VISIT: 3/23/2022

SCOPE: CONSTRUCT PERGOLA AND PATIO, REMOVE WINDOWS AND INSTALL SLIDING DOOR

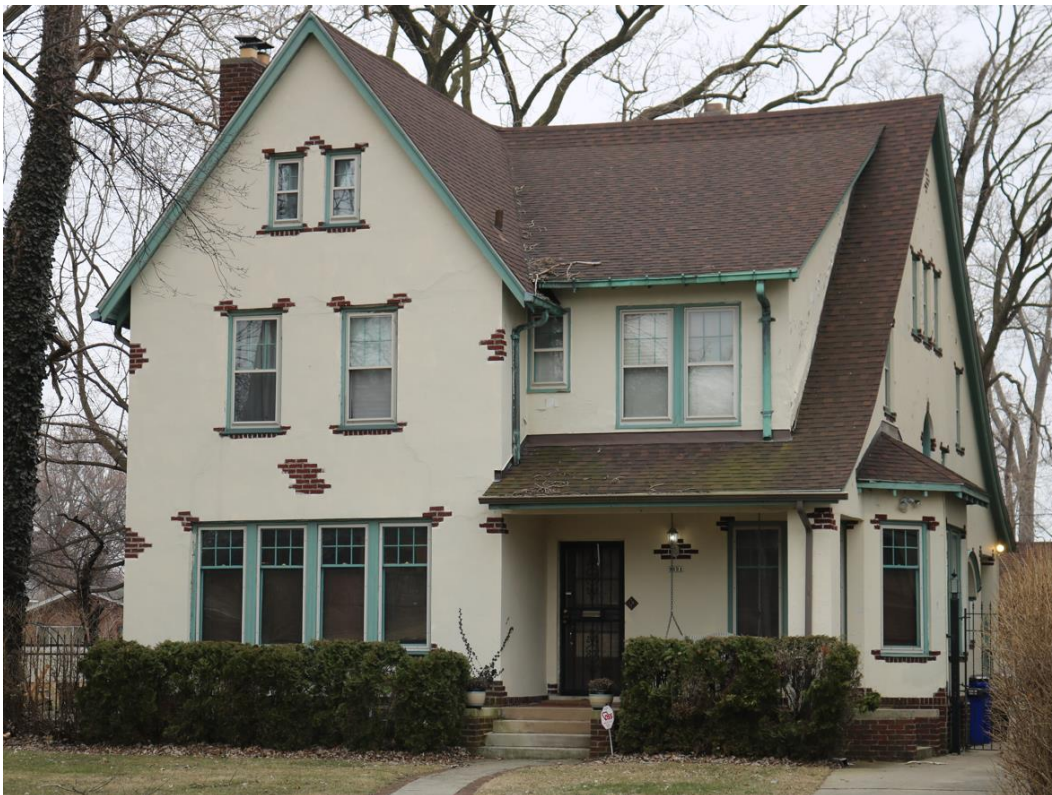
House at 3521 Seminole. March 2023 photo by staff.

The subject property consists of a house at 3521 Seminole and an open side lot at 3509 Seminole. The house appears to date from the 1910s (an exact construction date is not known) and is a two-and-one-half story, gabled-ell house with Picturesque, Arts and Crafts influence. The property incorporates a side lot that appears to have never been developed. Together, the lots are bounded by Seminole on the east, Maxwell on the west, an adjacent building on the north, and another undeveloped lot on under different ownership on the south. The side lot at 3509 Seminole is concealed behind a hedge and fence on the Seminole side and an opaque fence on the Maxwell side.

The proposed work includes the removal of two features of the house (both visible in the photo on the previous page): A bay of three, mullioned sash windows is proposed to be removed and replaced with a double sliding door. Also, a shed-roof overhang above a projecting bay window is proposed to be removed to accommodate the addition

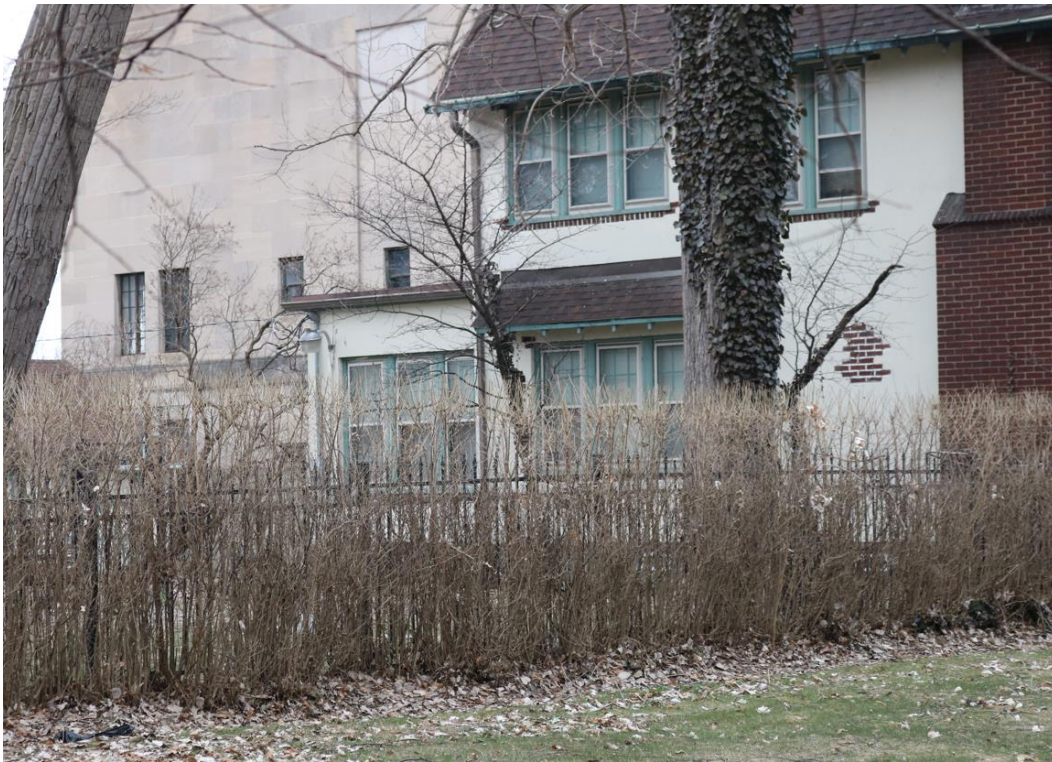
Side lot located at 3509 Seminole. March 2023 photo by staff.

- Staff consulted Sanborn maps and building permits and saw no indication that the side lot at 3509 Seminole has ever been developed.
 - The design of the proposed pergola is compatible with the Picturesque and Arts and Crafts style of the house and meets (with the potential exception of items noted under Issues, below) the Secretary of the Interior’s Standards for Rehabilitation, especially Standard #9: “new work shall be differentiated from the old and shall be compatible with the massing, size, scale, and architectural features” of the historic building, and Standard #10: “new additions and adjacent or related new construction will be undertaken in such a manner that, if removed in the future, the essential form and integrity of the historic property and its environment would be unimpaired.”

- Staff opinion is that the bay of windows and the shed roof overhang proposed for removal are not distinctive, character-defining features.
 - The landscaped open space of the side lot is a character-defining feature, as noted in the Elements of Design (quoted above). However, the proposed pergola and patio area, due to its modest scale, does not overwhelm or destroy the feature; neither does it change the relationship of the house to its side lot.

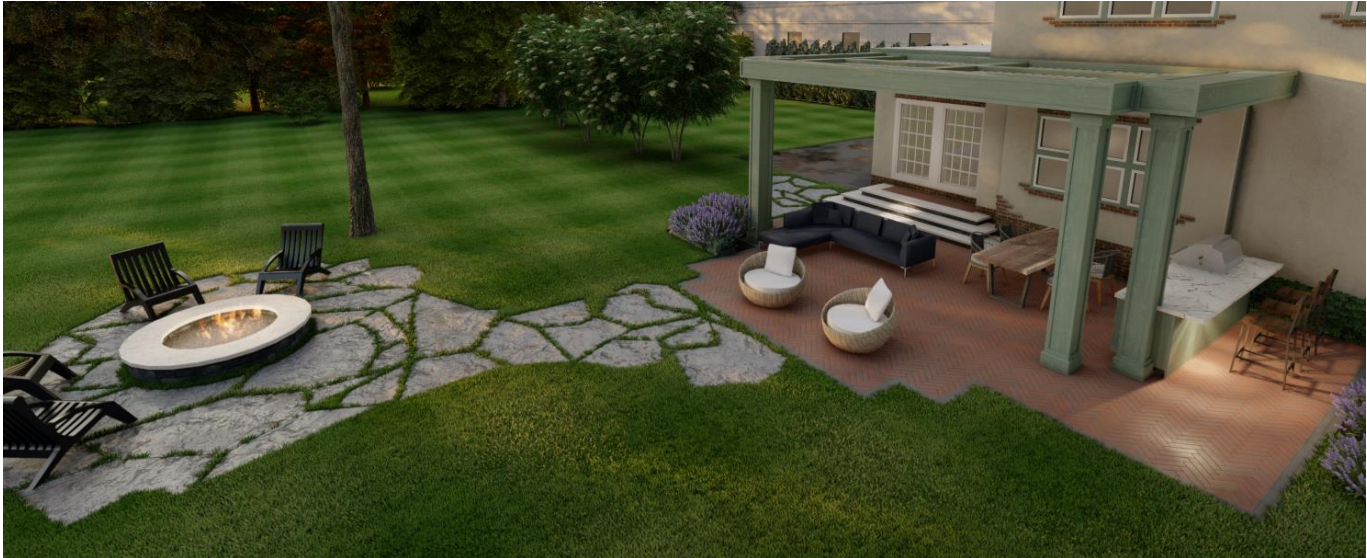
As shown in the submitted construction drawings, the applicant proposes to install a pergola, patio, and outdoor kitchen extending from the side (south elevation) of the house and continuing to the south into the area of the adjacent side lot.

Rendering of the proposed work as viewed from the Seminole (east and front) side of the property. Image from application documents.

The pergola is to be 12’2” tall, composed of treated lumber wrapped in pine or cedar. A paint color or finish is not specified, though a light green similar to the trim color of the house is shown in renderings. The proposed pergola features recessed downlighting.

The application also includes brick and stone pavers, a fire pit, and outdoor cabinets and a countertop. Specific brand and product names are called out in the application documents.

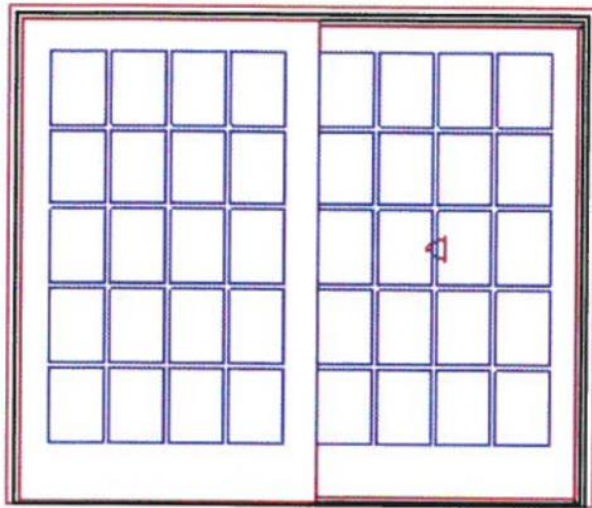
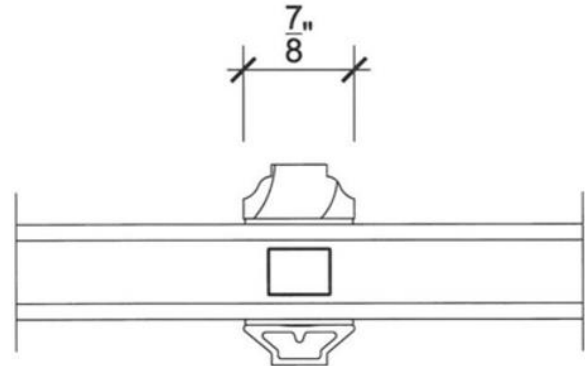
Proposed new door. Images from application documents.

The proposed door is a sliding, aluminum-clad wood door in “stone white” color. It has “7/8’ SDL” (simulated divided lites) with false muntins on the interior and exterior and spacers between the glass panes, closely approximating a true multilight door.
