STAFF REPORT: AUGUST 9, 2023 REGULAR MEETING **PREPARED BY:** T. BOSCARINO
APPLICATION NUMBER: 23-8476
ADDRESS: 949 W. CHICAGO
HISTORIC DISTRICT: BOSTON-EDISON
APPLICANT/OWNER: ANDRE WILLIAMS
DATE OF PROVISIONALLY COMPLETE APPLICATION: JULY 17, 2023
DATE OF STAFF SITE VISIT: JULY 19, 2023 AND AUGUST 3, 2023

SCOPE: DEMOLISH GARAGE, CONSTRUCT GARAGE, REPAIR AND PAINT HOUSE

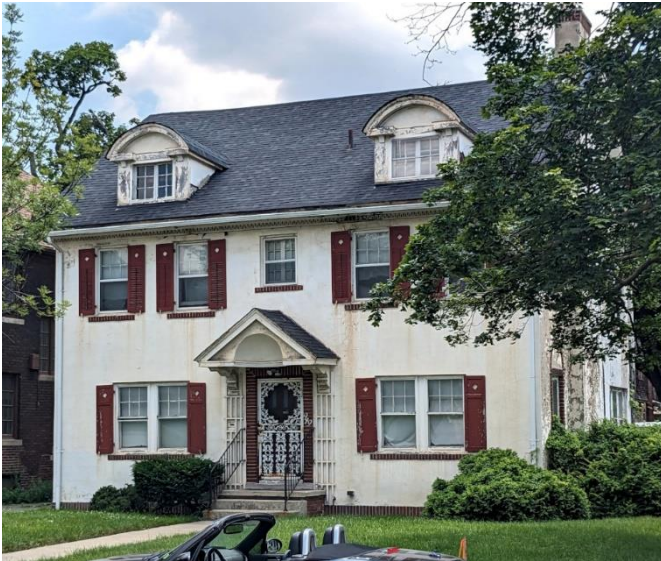
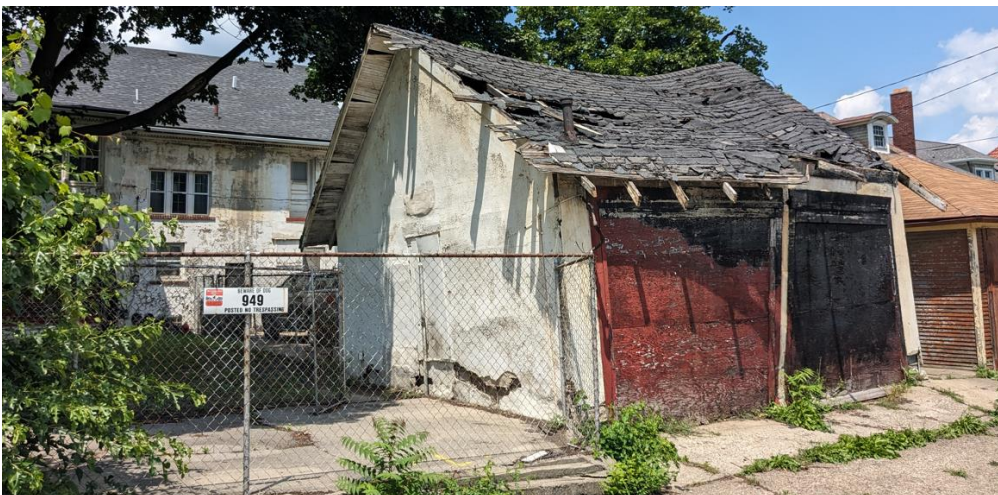
Left: House. Below: Garage, viewed from alley. July 2023 photos by staff.

Built in 1916, the property at 949 West Chicago Boulevard is a two-and-one-half story, stucco-clad house facing north onto the street. It is Colonial Revival in style; details include an entry portico with curved underside, semicircular dormers, a dentil cornice beneath the eave line, and soldier brick courses highlighting the foundation, chimney, doorway surround, and window sills. It is located on a corner, double lot. The garage, also subject of this application, is a two-bay, side-gabled building with stucco cladding and visible rafter ends. The garage was built concurrently with the house, according to building permits.

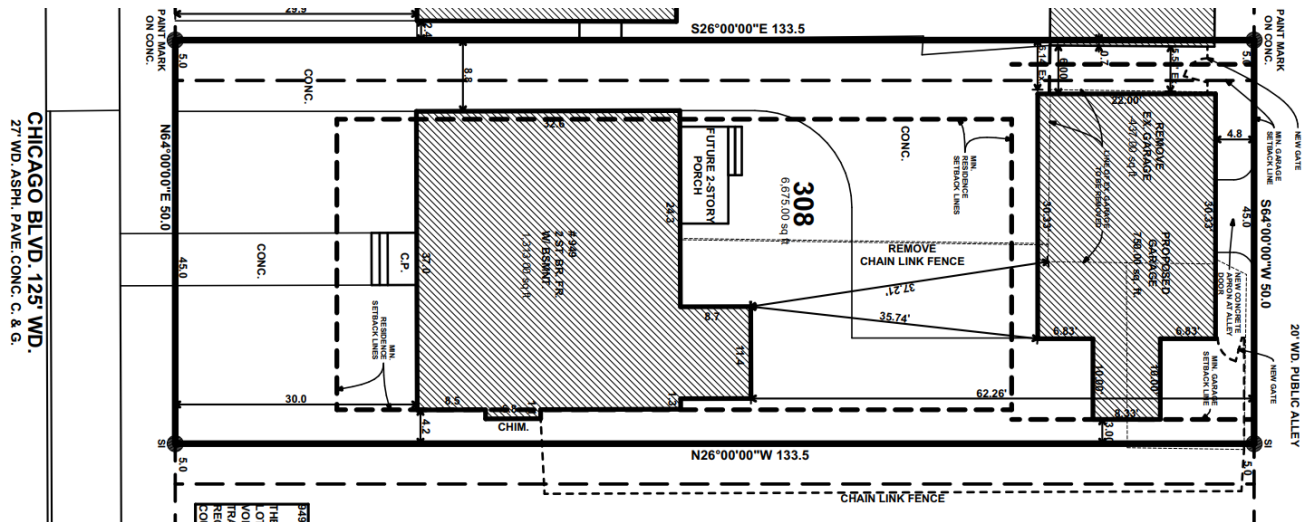
Site plan of property including proposed new garage. Image from application drawings.

- As written, the proposal is to replace the existing concrete driveway. However, staff notes that the site plan appears to depict a somewhat larger paved area and omits a maple tree observed in site visits (as an additional note, removal of this tree was subject of a March 2022 application to the Historic District Commission, but the application was withdrawn before a staff report was written). Staff’s position is that while individual trees are, themselves, seldom contributing historic resources on their own, the maintenance of a tree canopy is important to preserving the historic character of a residential district.¹ The importance of the tree is enhanced by its visibility from Hamilton Avenue, as the property is located on a corner double lot. Staff opinion is that the location and diameter of the tree suggests it was deliberately planted prior to the designation of the historic district, and is a historic feature. Further, staff sees no evidence that the tree is unhealthy or otherwise warranting removal. Its removal would constitute an “alteration of features and spaces that characterize a property” and “shall be avoided” according to Standard #2 of the Secretary of the Interior’s Standards for Rehabilitation.

- It is not clear from the application if the maple tree is intended to be removed or if it was merely omitted from the plan for clarity. However, it appears that the desired garage and driveway can be accommodated without removing the tree.

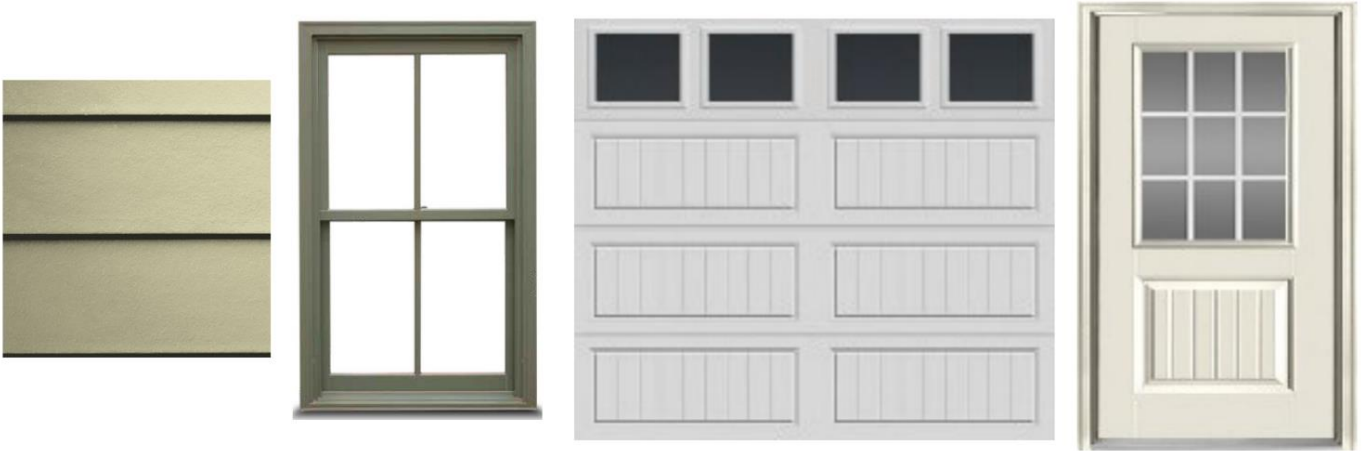
Images, from application documents, of proposed materials.

Specifications are included in the application materials for products including Lincoln Window aluminum-clad wood casement and double-hung windows with 7/8" simulated divided lights, Clopay 8'x7' overhead steel panel garage doors with and without glazing, a glazed steel panel pedestrian door, 5" aluminum downspouts, 3"x4" aluminum gutters, asphalt architectural shingles, and several types of light fixtures including gooseneck lights.

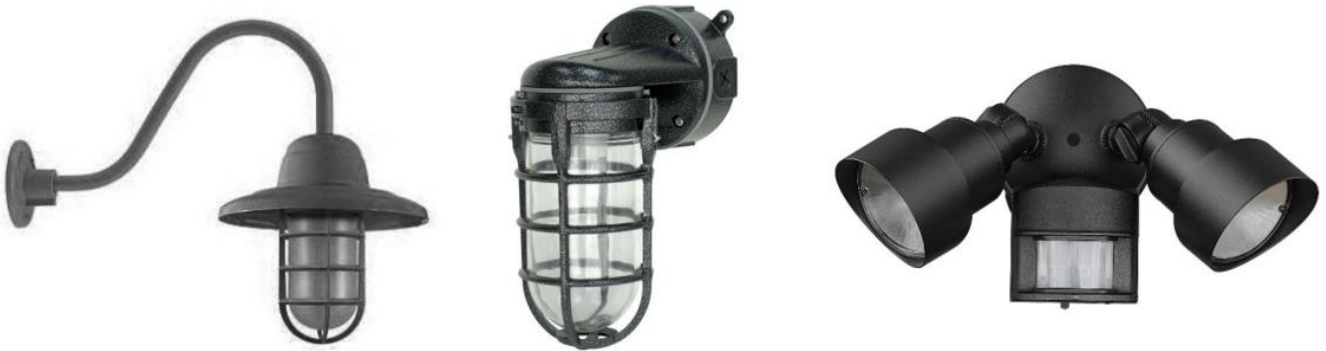
Proposed light fixtures as shown in application documents. Left to right: Barn Light Electric Industrial Guard LED gooseneck light, Southwire tamperproof alley light, Acclaim Lighting security floodlight.

- The proposed security lighting meets the 2023 *Security Lighting Guidelines*.
- The application materials specify appropriate colors consistent with the house and Color System C.
- Although front-facing driveways are not common in Boston-Edison (vehicle access is more typically from the alley) they do exist; this driveway is visible in a 1949 DTE aerial photo. Staff suggests that the driveway is a historic feature. Staff also observes that it is likely deteriorated beyond feasible repair; as such, its in-kind replacement is appropriate.

- The proposed light fixtures are stylistically more appropriate for a traditional industrial building or rural building (indeed, the gooseneck fixture is marketed as a “barn light”) or, arguably, a postmodern commercial or residential building. Staff opinion is that they are not “compatible with the historic materials, features, size, scale and proportion” of the historic setting, as required by Standard #9.

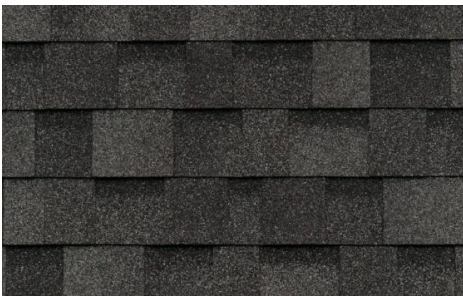
IKO Cambridge charcoal grey. Image from application.

The garage shingles are proposed to be IKO Cambridge architectural shingles in charcoal grey; the gutters and downspouts are proposed to be black.

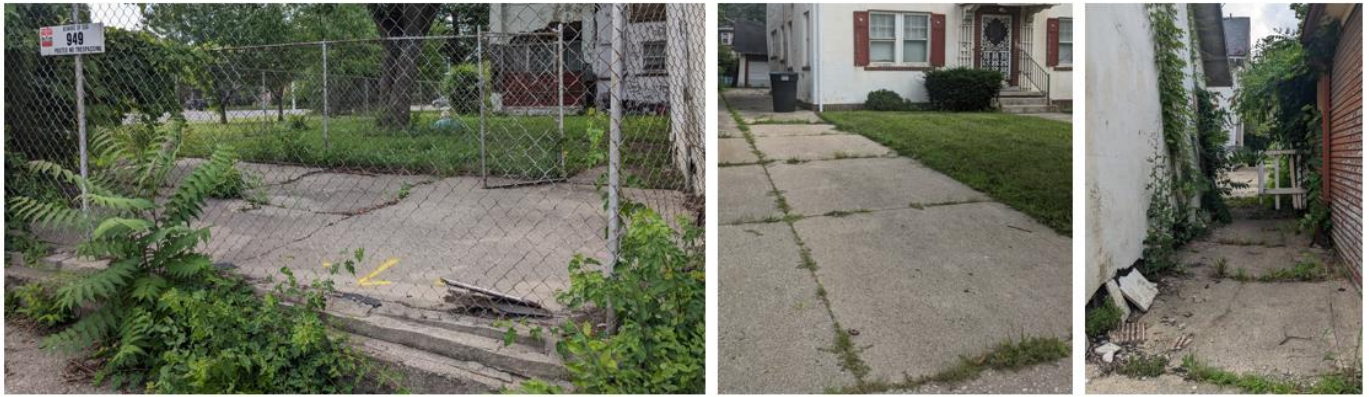
Areas of concrete proposed for replacement. August 2023 photos by staff.

Also included with the proposal is the replacement of a cracked and uneven driveway slab, as described in the application documents.

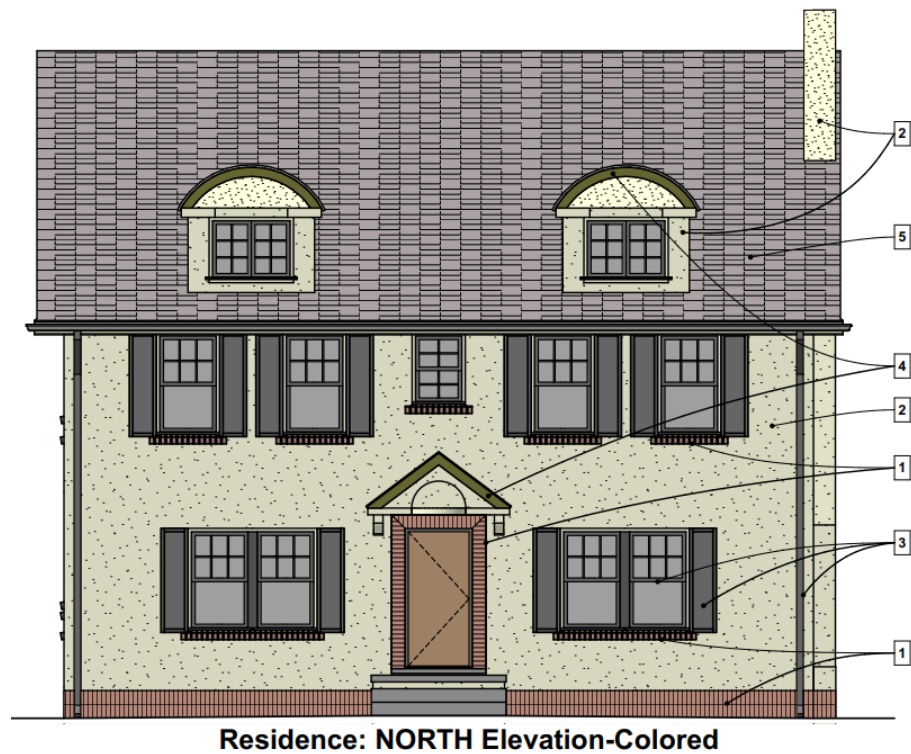
Proposed color scheme. Rendering from application documents.

Once the house is repaired, the proposal is to paint the entire building the same four colors as the new garage, mentioned above.

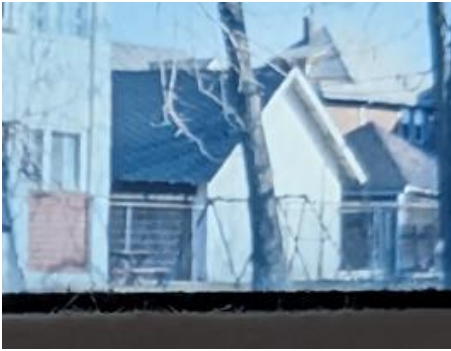
1988 Historic Designation Advisory Board photo.

- The garage is visible in a 1988 Historic Designation Advisory Board photo, in an intact condition. There are no other available records regarding the evolution of the building over time. The applicant states in an August 4, 2023 email to staff that it was damaged in a fire around 2002. The fire started in the alley and spread to the inside of the building. Staff observes that the rafters, eaves, and historic (alley-facing) doors, have been lost or irreparably damaged due to fire. This eliminates all former character-defining features other than the stucco cladding, which is also damaged and delaminating due to the lean of the building caused by the fire. The integrity of the building had already been reduced by a non-historic, yard-facing (north-facing) steel door added prior to the 1988 photo.

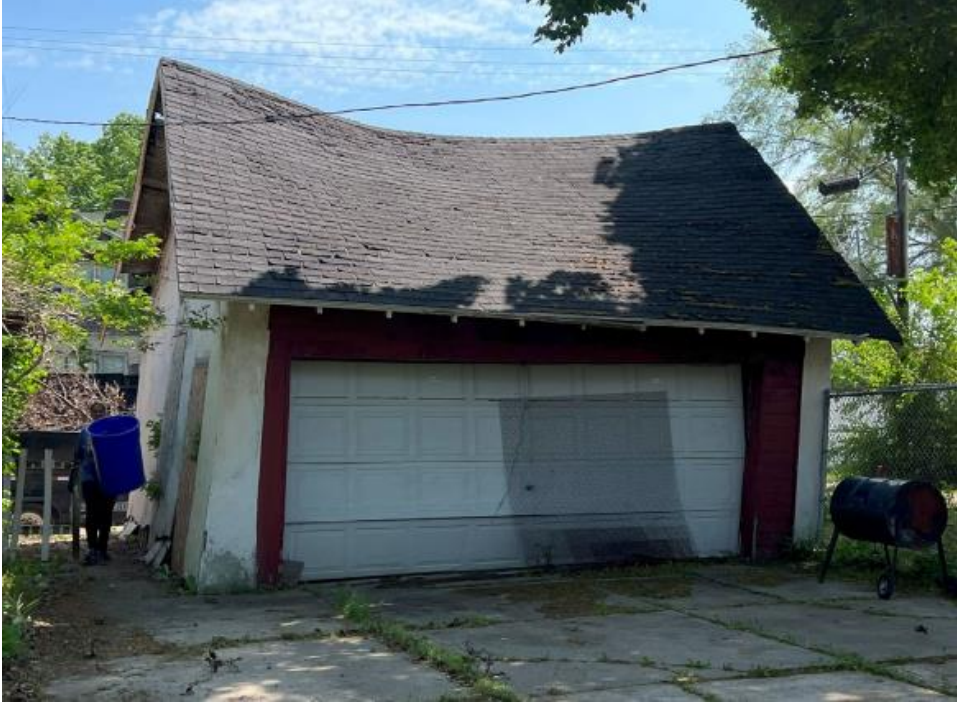
Photo by applicant indicating non-historic steel door and structural damage.

- According to the National Register Bulletin *How to Apply the National Register Criteria for Evaluation*, “Integrity is sometimes a subjective judgment, but it must always be grounded in an understanding of a property’s physical features and how they relate to its significance.” The Bulletin continues by providing several steps, including “define the essential physical features that must be present” and “determine whether the essential physical features are visible.” As mentioned above, the “essential physical features” are no longer visible in that they were destroyed by fire. Arguably, the form and massing of the building, itself, is an essential physical feature, but this, too, has been compromised as the building is now leaning from structural damage.

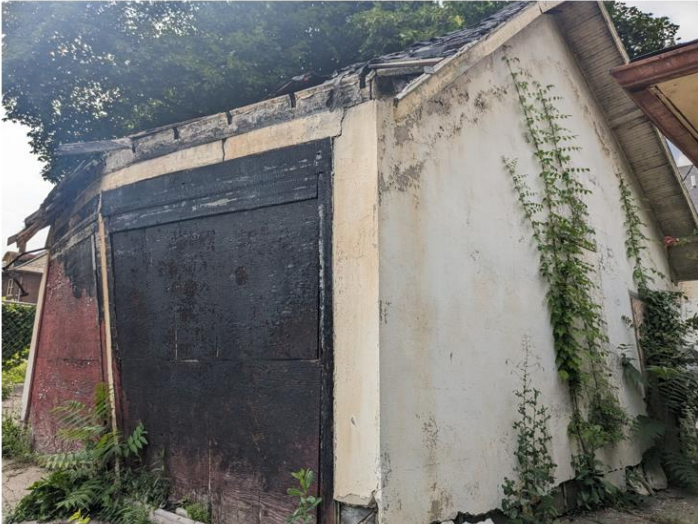
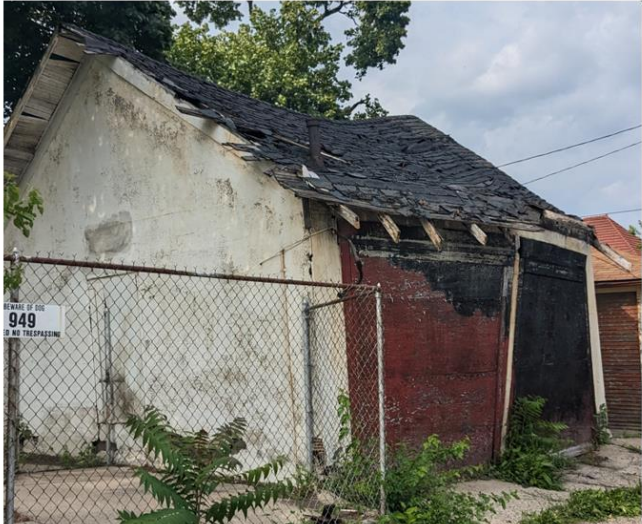
August 2023 staff photo highlighting fire damage.

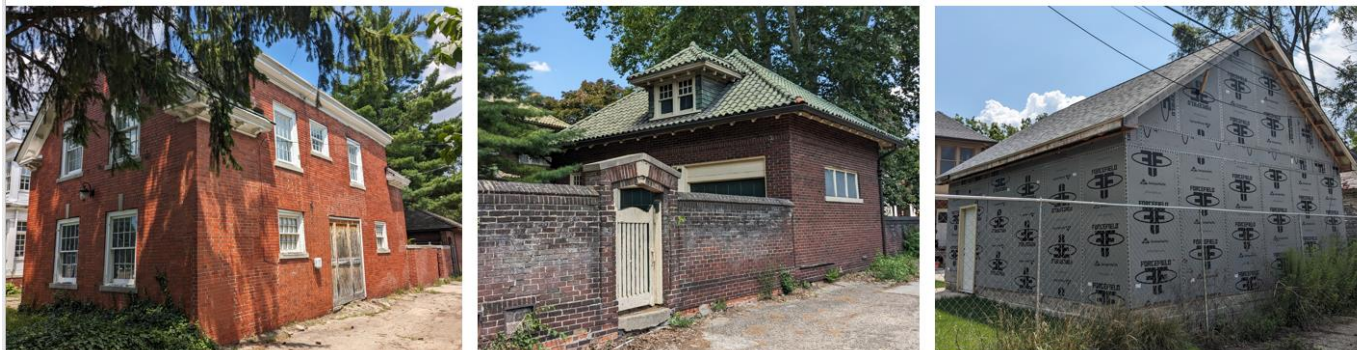
Example garages and carriage houses in the vicinity of the subject property. July 2023 photos by staff.

- The scale of the proposed garage building is larger than the current building, but nonetheless appropriate for the district. Within one block of the subject property, staff observed several large-scale garages and carriage houses.

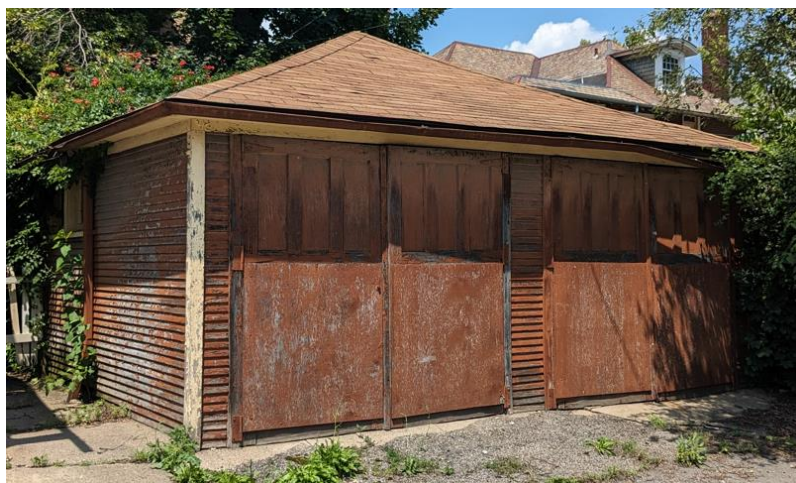
Garage at 937 Chicago. July 2023 photo by staff.

- Lap siding is not common for houses in Boston-Edison, but is it very common for garages. For example, the next-door property at 937 Chicago has a garage clad in lap siding.
