REVISED STAFF REPORT: 9/13/2023 MEETING

APPLICATION NUMBER: 2023-8524

ADDRESS: 4138 LINCOLN

SCOPE OF WORK: REPLCE WINDOWS (WORK PARTIALLY COMPLETE), INSTALL NEW DOORS AND DECK AT SOUTH SIDE WALL, REHABILITATE BUILDING)

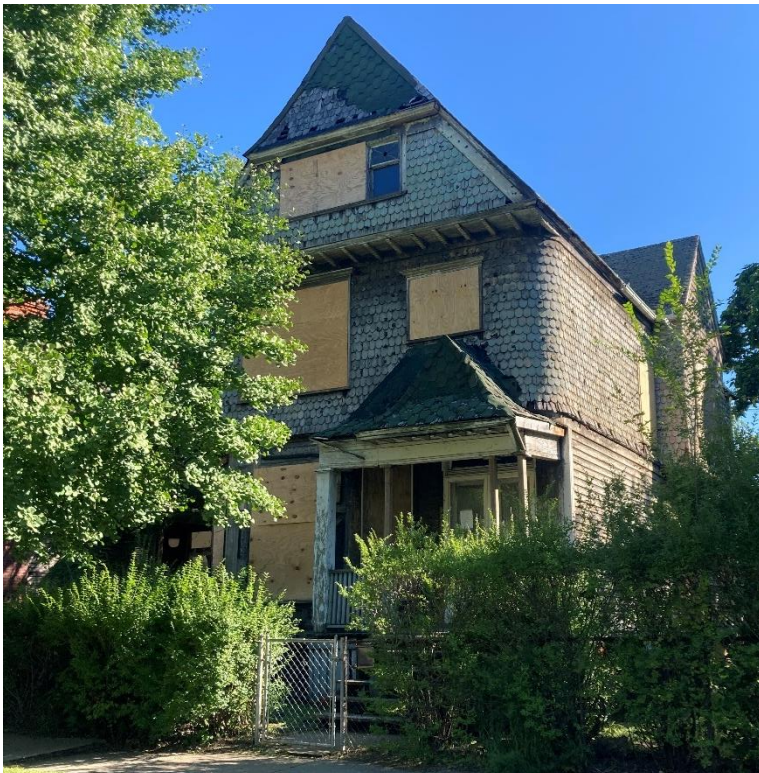
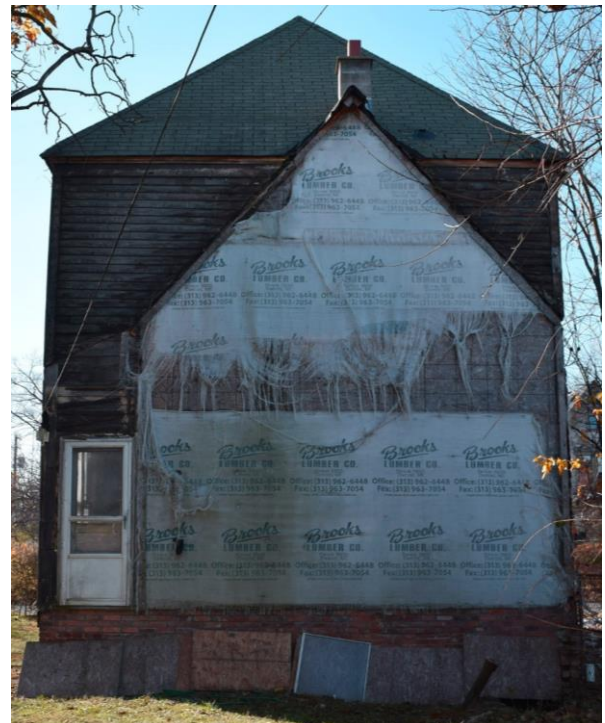
4138 Lincoln, current appearance. Staff photo, taken 8/31/2023

Erected ca. 1900, 4138 Lincoln is a single-family, wood-frame dwelling that is located at within the Woodbridge Farm Historic District. The building is 2 ½-stories in height and is rectangular in plan. Its primary mass is topped with a front-gabled roof, while the rear roof is hipped. A gabled-roof bay is located at the south elevation. With the exception of the three windows in the attic story's gable end and the windows at the north/side, all windows were recently removed without HDC approval. The window openings are now covered with plywood. Wood, fish-scale shingle siding is located at the building's upper stories. Lapped, wood clapboard siding is at the front elevation, first story, and at the side and rear elevations. Wood panel siding is also located at the front elevation, first story. According to historic Sanborn maps and a review of the submitted photos, a one-story gabled-roof wing and porch was removed front the building's rear elevation sometime after 1970. Brick foundation walls are visible at all four elevations and a brick chimney is located at the north elevation. The primary entry, located at the west elevation, consists of two historic-age paneled wood doors. A partial-width, hipped roof original porch with wood columns, floor, and steps shelters this entry The rear entry is a single, hinged historic paneled wood door.

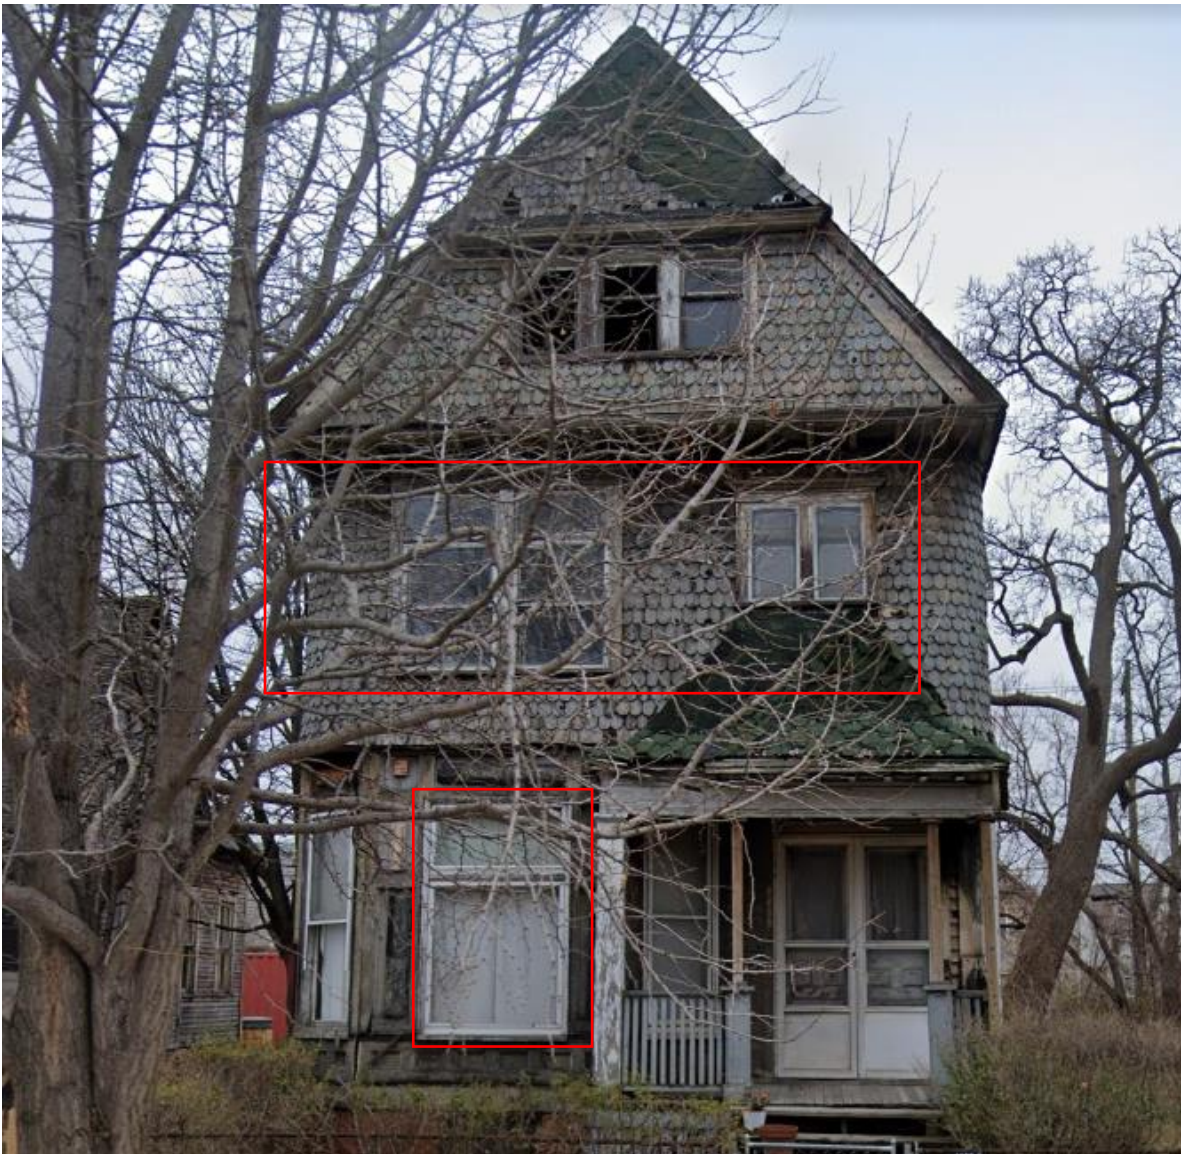
Google Streetview, prior to unapproved window removal. Note that windows outline in red include a fixed unit topped with a transom or a 1/1, double hung unit topped with a transom. It is not clear to staff that the current window product adequately replicates the windows/trim details of these units.

- The current document does not provide dimensioned detail drawings of the distinctive windows at the front façade first-story bay and the second story which included transoms (see the below photo). It is therefore not clear to staff that the proposed new window product will serve as an adequate replication for these distinctive, character-defining windows. The project architect has noted via email correspondence that he has “reached out to the window manufacturer to try and obtain shop drawings of the proposed fixed/transom windows at the front facade, in order to be able to compare the qualities of the horizontal mullions with those of the original windows. We only recorded measurements of the double-hung windows from the past submission in 2021, as those were the ones approved for replacement. So any comparisons with the front transom units would be limited to a visual comparison between the photos we have saved.” He further noted that he will share any additional information he receives from the manufacturer before the 9/13/2023 regular HDC meeting with staff for presentation to the Commission,
