STAFF REPORT: SEPTEMBER 13, 2023 MEETING

APPLICATION NUMBER: HDC2023-00024

ADDRESS: 2241 (2245) WABASH

SCOPE: ERECT REAR ADDITION AND SIDE PORCH

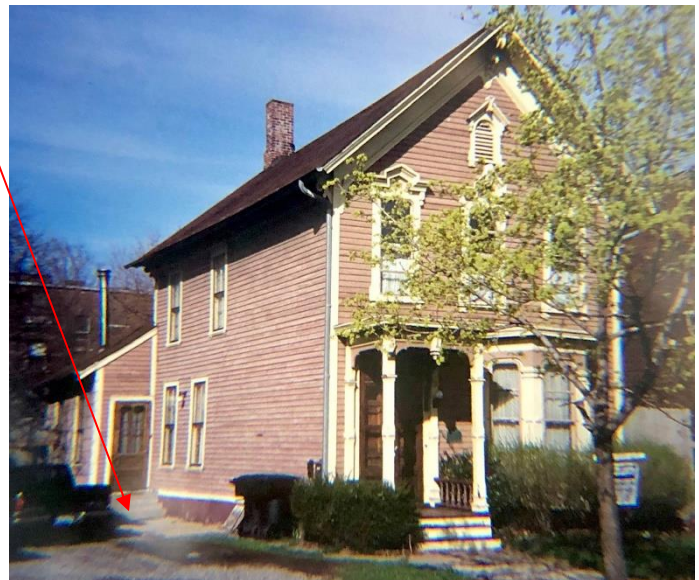
2245	
Wabash	018/27
58013	8/1/55
Use	Dwelling (1 to 2)
Cons.	Frame
Remarks	\$500.00 O.K.
General repairs & convert from 1 family to 2 families as per plan.

Above: 1984 designation photo, HDAB.
 Left: Building permit card, BSEED.

- The 1884 and 1889 Sanborn maps show a deep side porch, which was gone by 1897. A shorter porch was erected by 1921 and remained until at least 1950. It was not present in 1984 at the time of district designation.
- The Final Report states members of the Esterling family lived in the house until 1954. Staff located a building permit card that shows the house was converted to a two-family dwelling in 1955.

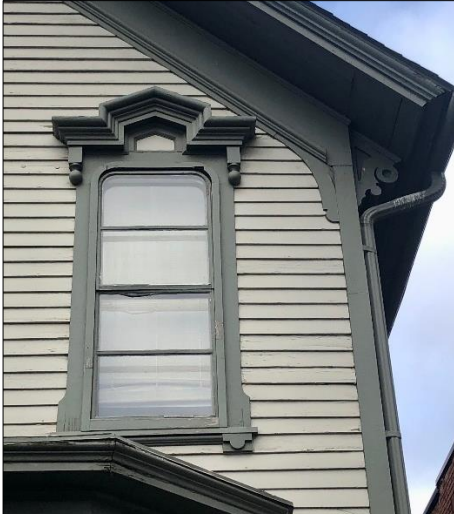
The front window openings are deeply detailed with elaborate window hoods, two-over-two double-hung windows with upper sash rounded corners, and dimensional/profiled window casings and sill brackets.

- The design of the house shows a clear hierarchy of elevations which is most evident when comparing treatments to the window openings.

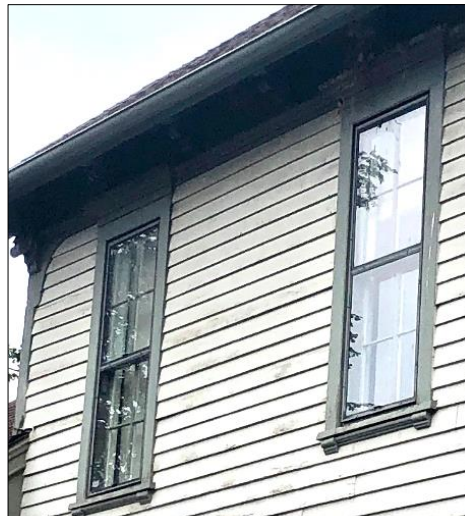
The side window openings have narrow rectangular projecting hoods, four-over-four double-hung windows with rectangular corners, flat and straight-edged window casings, and simplified, yet still dimensional, sill brackets.

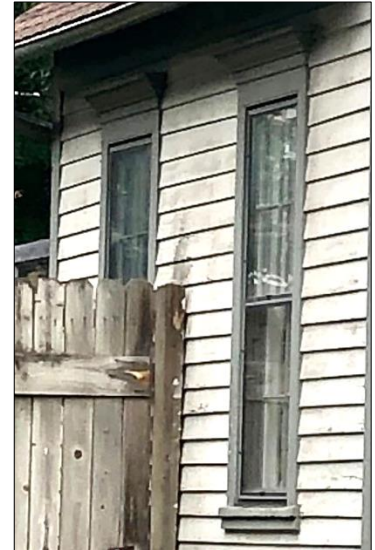
The window openings on the extension have window hoods and double-hung windows similar to the main house's side windows, but the sills have utilitarian trim pieces instead of decorative brackets.

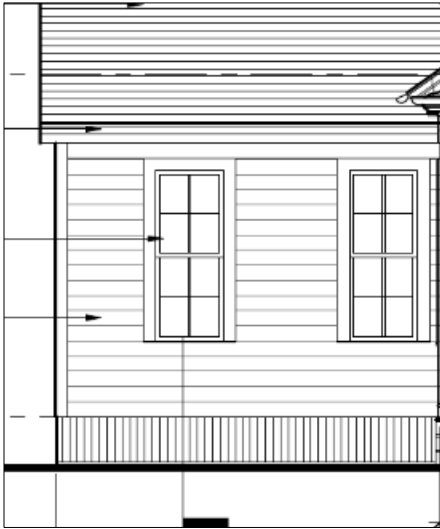
The new window casings (in comparison to the historic casings discussed on page 3) take a further step toward simplicity, which is in keeping with the decrease of complexity of window openings relative to their distance from the front facade.

The side porch will have chamfered posts and corner brackets similar to the front porch, but the posts will not have the decorative medallions nor intermediary post caps. The side porch railing will have straight, square spindles, unlike the thick turned balusters at the front entrance.

- The selection of materials and design details will let the new construction read sympathetically against the existing house, yet as a product of its time.

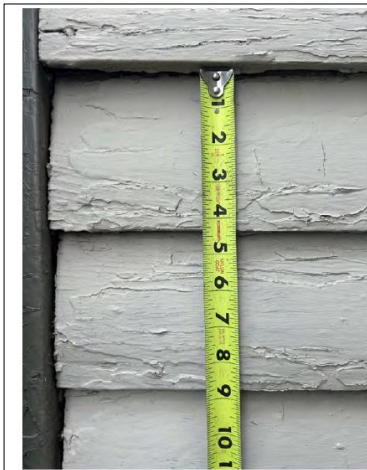
7. PHOTO OF EXISTING CONDITIONS

EXISTING SIDING

PROPOSED SIDING
HARDIEPLANK LAP SIDING
6 1/4" BOARD WIDTH
4 3/8" TYPICAL EXPOSURE
SMOOTH FINISH, PAINTED
