STAFF REPORT 10-11-2023 MEETING

APPLICATION NUMBER: 23-8517

ADDRESS: 20119 WISCONSIN, AKA 8730 CHIPPEWA

SCOPE: REHABILITATE SCHOOL BUILDING, ERECT MULTI-FAMILY BUILDINGS

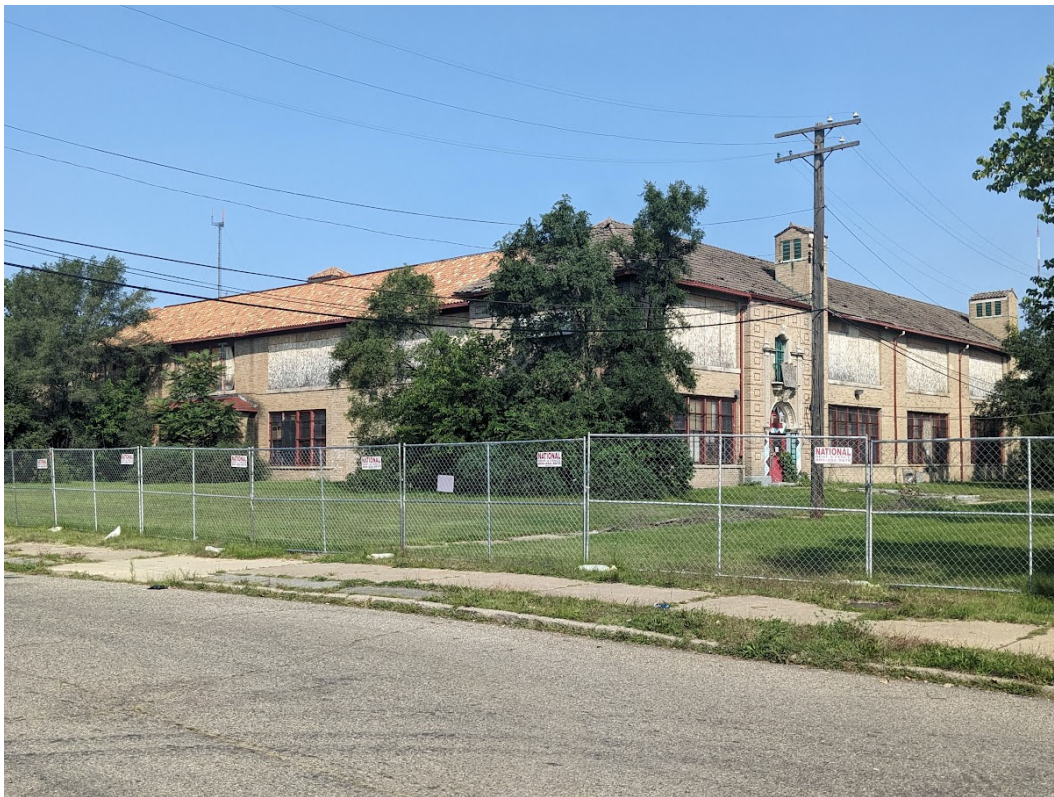
View of existing conditions at Higginbotham, looking to the northwest Staff photo, September 1, 2023.

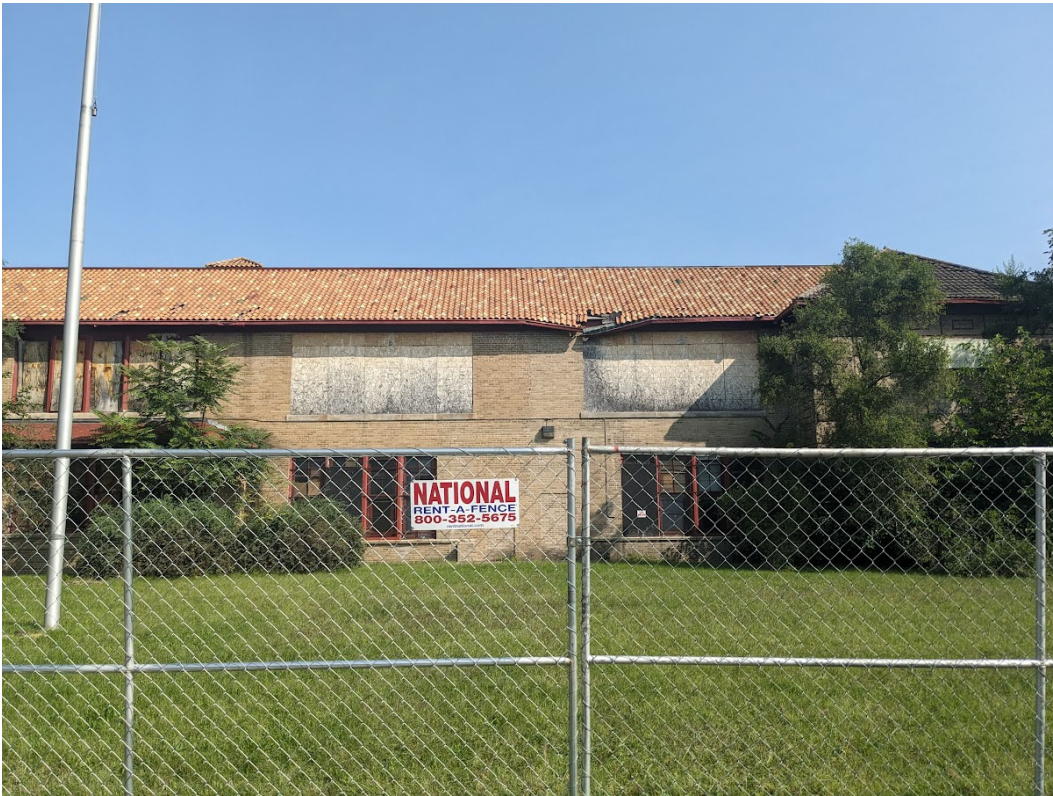
View of existing conditions at Higginbotham, looking north from Chippewa. Note damage to roof and boarded windows. Staff photo, September 1, 2023.

The context of the Higginbotham School site is medium-density, single-family residential. The property itself is suffering from deferred maintenance and obvious deterioration, with many damaged windows, failure of roofing, and other work requiring immediate attention. The property is currently encircled by a perimeter chain-link fence which has been compromised in at least one location (along Indiana Street). Dumping has occurred

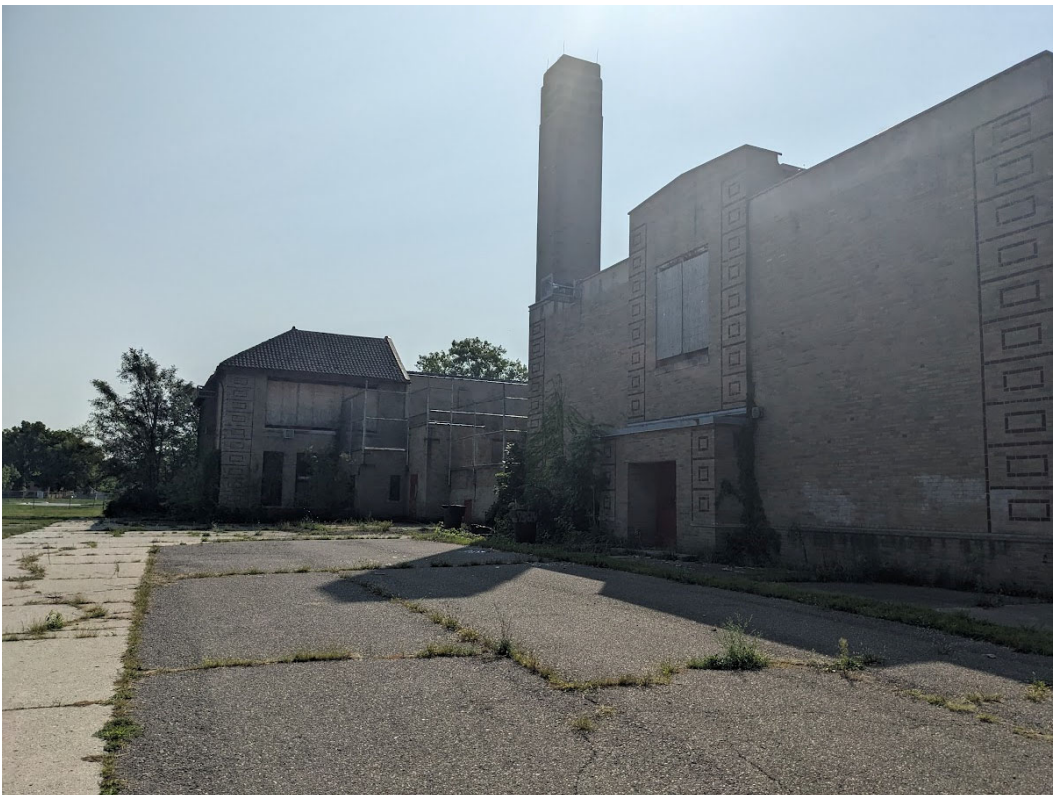
Existing conditions at the rear, showing areas of flat roof and utility parking lots. Staff photo, September 1, 2023.

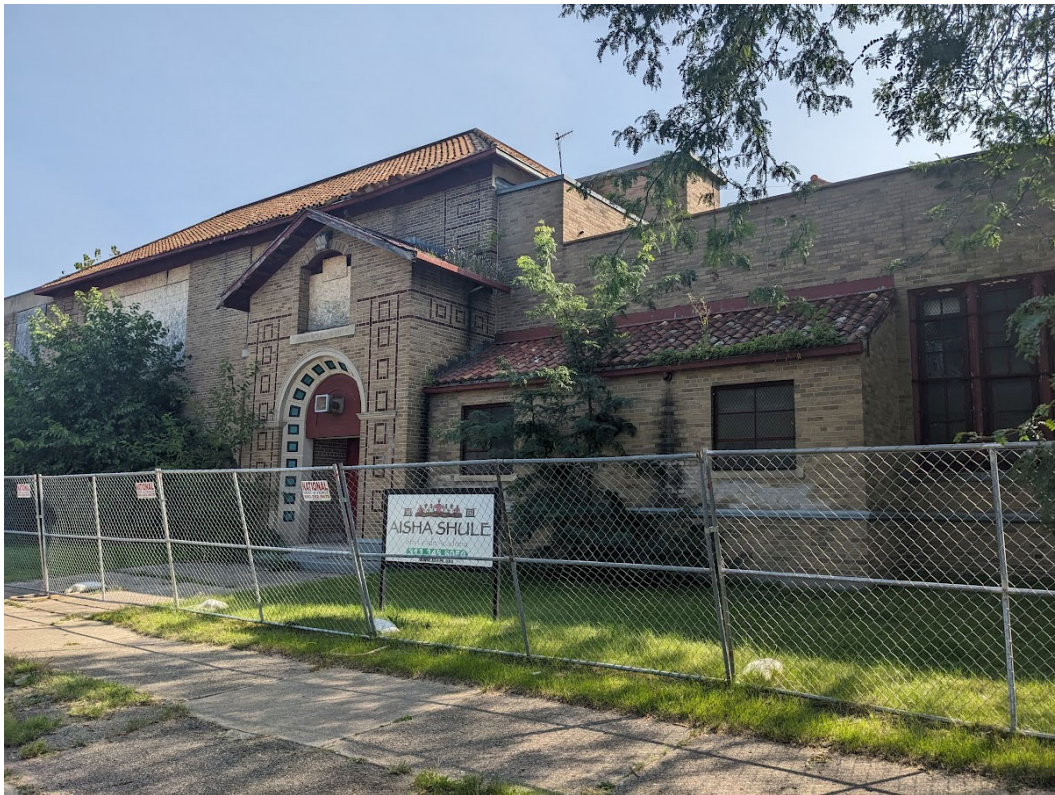
View of west-facing "front" entrance from Indiana Avenue. Staff photo, September 1, 2023.

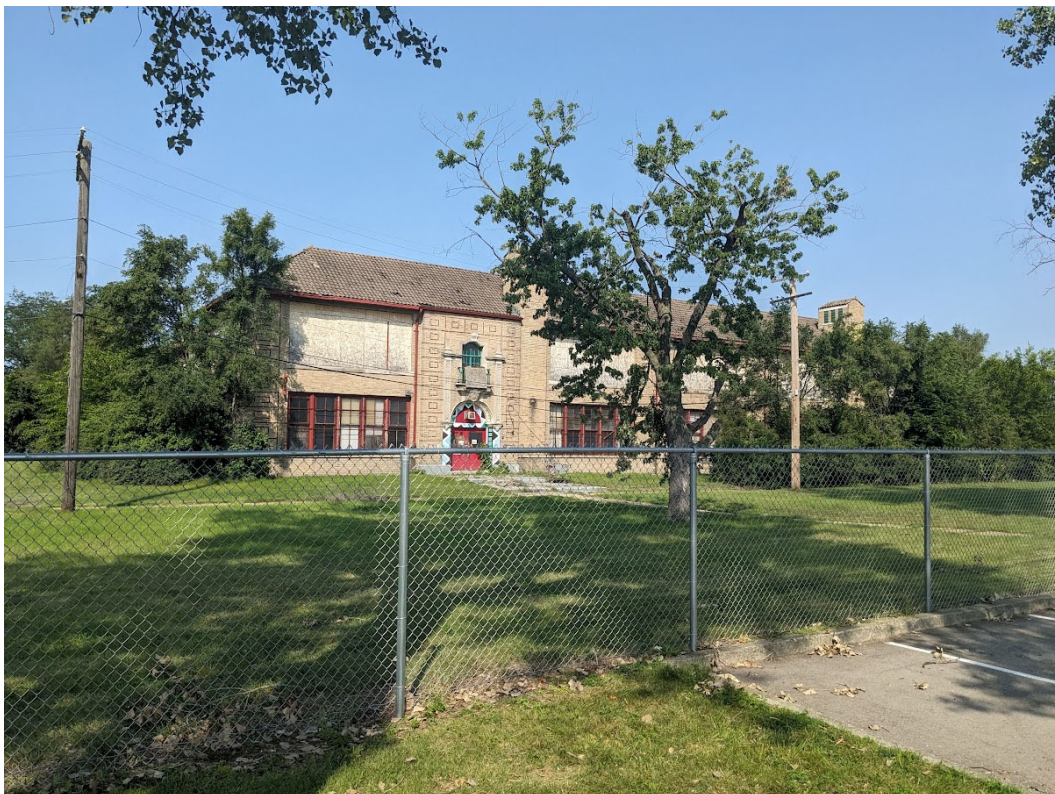
View of east elevation (on vacated Wisconsin Street), nominally described as the "front" elevation in the HDAB Report. Diseased tree is in approximate location of new building footprint. Staff photo, September 1, 2023.

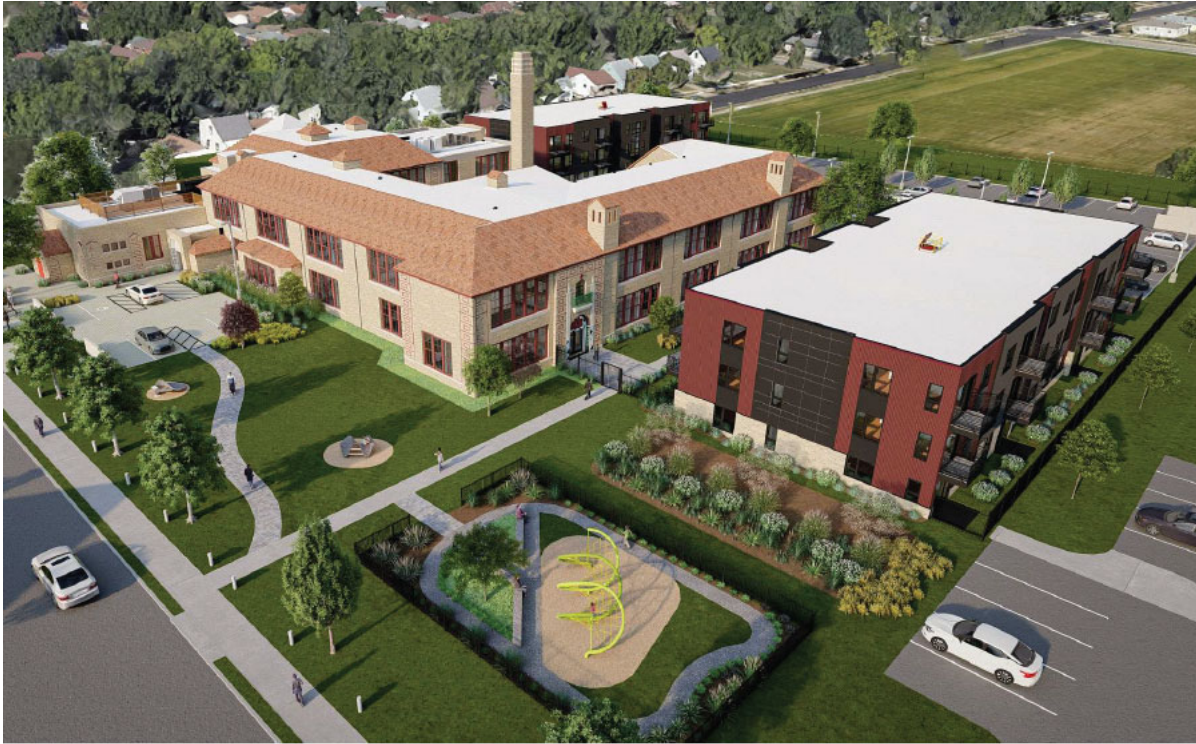
SITE PLAN KEY

Per the submitted drawings, narrative, and presentation deck, the applicant is proposing to redevelop the former Higginbotham Elementary School into residences. The historic school building's exterior will be rehabilitated. Included in the project are two new construction buildings flanking the historic building to the east and northwest. Landscaping changes include incorporation of footpaths, parking areas, fencing, planting beds/trees, a sculpture garden, and a public tot lot. The images below and on next page are excerpted from the application materials, separately available to the Commission.

- Staff notes also the addition of a small parking lot at the Chippewa side, nominally a "front" elevation as discussed above, to accommodate community and public use of the auditorium block, and to provide accessible parking. The lot is woven into a landscape which commendably resists the incompatible use of a perimeter fence while accommodating a beneficial adaptive reuse. Staff assesses that this parking lot, directly supporting and integral with the historic rehabilitation of a building with multiple "fronts", should be found appropriate under the NPS standard of cumulative effect, which states:

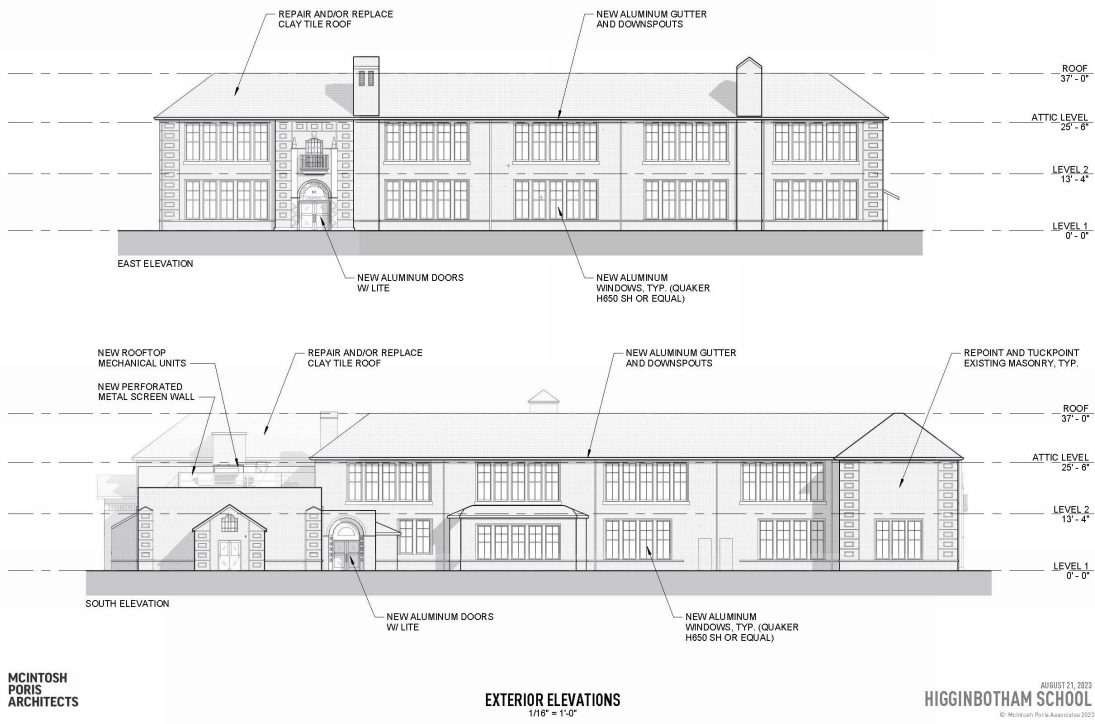
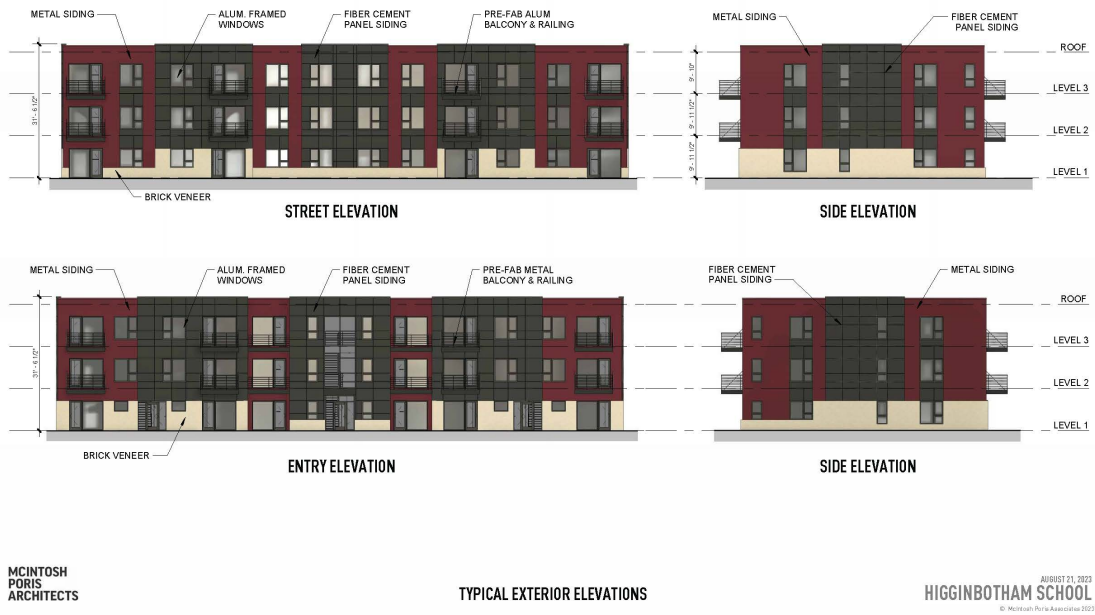
Proposed rehabilitation of historic building, above. Proposed elevation of new buildings, below.

- **HDC Staff Comment:** The proposal maintains the proportions of the original building as part of the rehabilitation. The proportion of the new buildings are wider than tall, consistent with the historic prototype.

- **HDC Staff Comment:** The solids to voids rhythm in the original building is preserved by the proposed rehabilitation; the new buildings have a compatible rhythm which does not compete with, and respects, the complexity and primacy of the historic building.

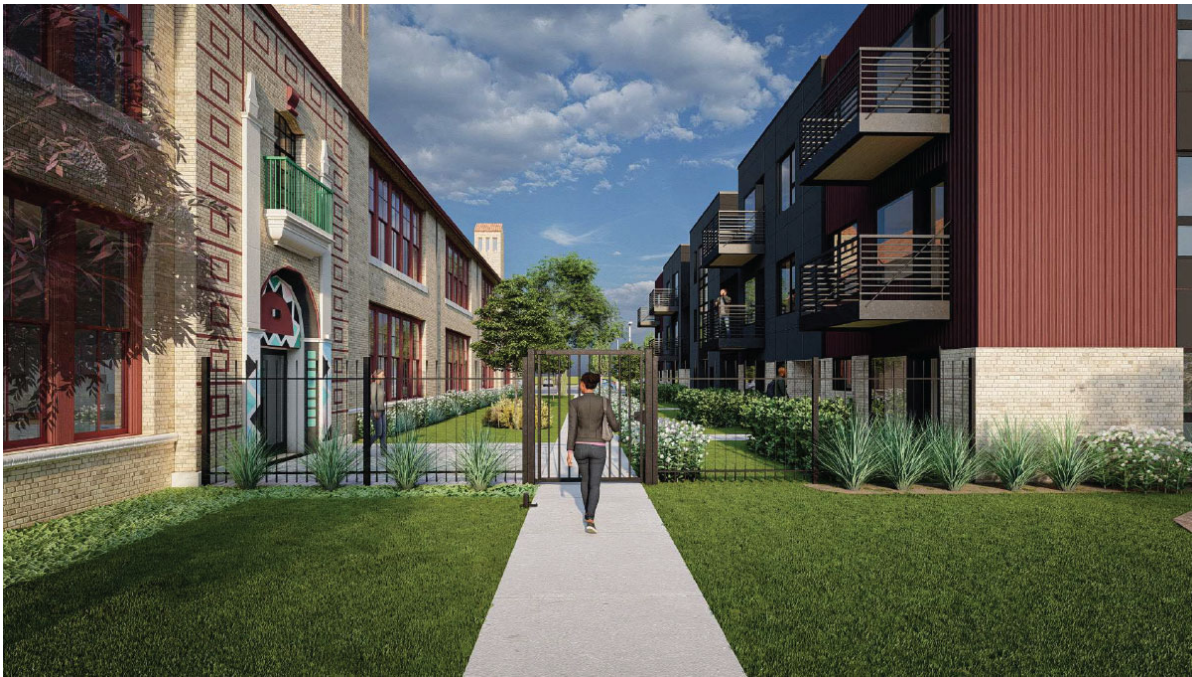
Rendering of historic building (left) with new building (right) from the applicant's materials. Note the conceptual similarity of several design elements (window rhythm, colors, textures, materials, height, entrances, balcony projections) that the modern building uses.

- **HDC Staff Comment:** The proposal preserves historic entrance features while sympathetically introducing new aluminum doors. The entrances for the new buildings occur in several locations and are conceptually consistent with the prototypes on the historic building in terms of recess and projection.

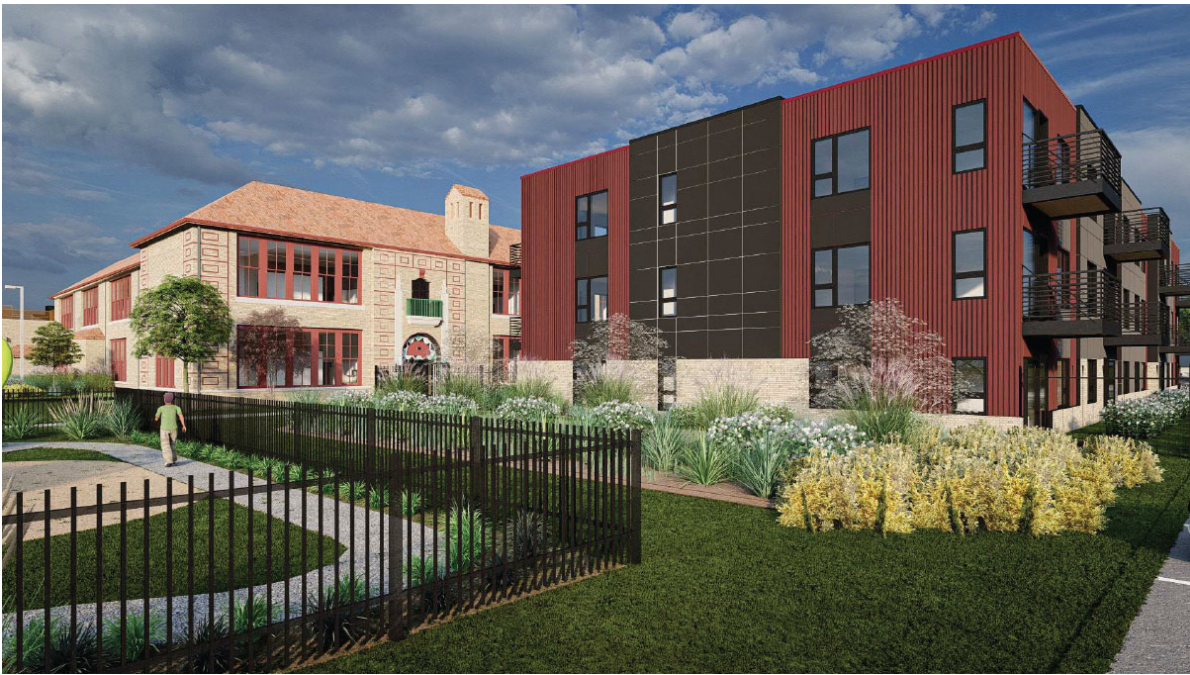
The newly proposed site buildings are of a strikingly contemporary design. However, stylistic conformity is never a requirement under NPS Standards and Guidelines, and can instead detract from truly historic buildings by creating sub-par facsimiles that fail to measure up to the hand-made quality of the historic context. The architect here has incorporated a range of textures, combinations of horizontal/vertical elements, and compatible colors (earthtones) that clearly reference the historic design elements of the original building.

- **HDC Staff Comment:** The proposal preserves and restores historic textures on the original building. The new building uses several textures, including brick at the base and ribbed metal panel, to create textural interest and shadow lines befitting its contemporary design.

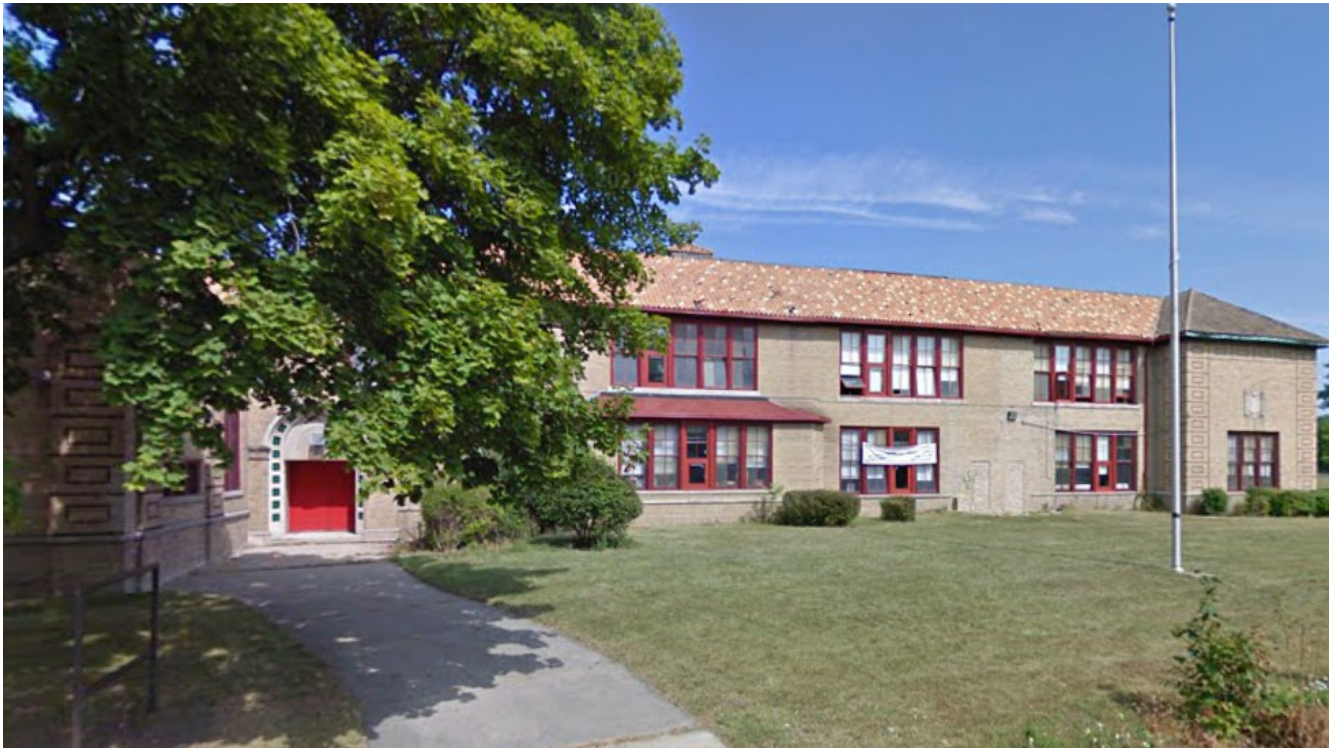
View of south-facing “front” entrance facing Chippewa Avenue (from Google Street View, September 2009). This view is now overgrown. The auditorium block, which has its own Chippewa-facing entrance, is cut off at the extreme left of this image.

- **HDC Staff Comment:** A key feature of the historic building is the seeming absence of a unique front entrance, and by extension, a corresponding front elevation. There are existing historic entryways on the west, south, and east sides that could all (and may have at various times) serve as a “main” entrance. The building is addressed on Wisconsin, at the east side, which is now a vacated street. Architecturally grand entrances exist on both Chippewa Street (to the south), and Indiana Street (to the west). The building as a result does not, in staff’s opinion, have a convincing “front elevation,” suggesting that all of the facades (east, south, west) are important and character-defining, and should be given similar weight. The new building skillfully adopts the horizontal block character of the historic facades, and wisely resists the urge to create a new directional expression or dominant front entrance. The proposal manages to add two additional buildings to the site without disturbing or altering the multi-directional expression of the historic core.
