STAFF REPORT: DECEMBER 13, 2023, REGULAR MEETING
Revised December 12, 2023, to include additional information on finishes

APPLICATION NUMBER: HDC2023-00133

ADDRESS: 7810 KERCHEVAL (ALSO KNOWN AS 1826 SEYBURN)

SCOPE: ERECT ADDITION CONNECTING DWELLING AND COMMERCIAL BUILDING, REMOVE REAR PORCH AND STAIRWAY ENCLOSURE, RESTORE FRONT PORCH, ALTER DORMERS

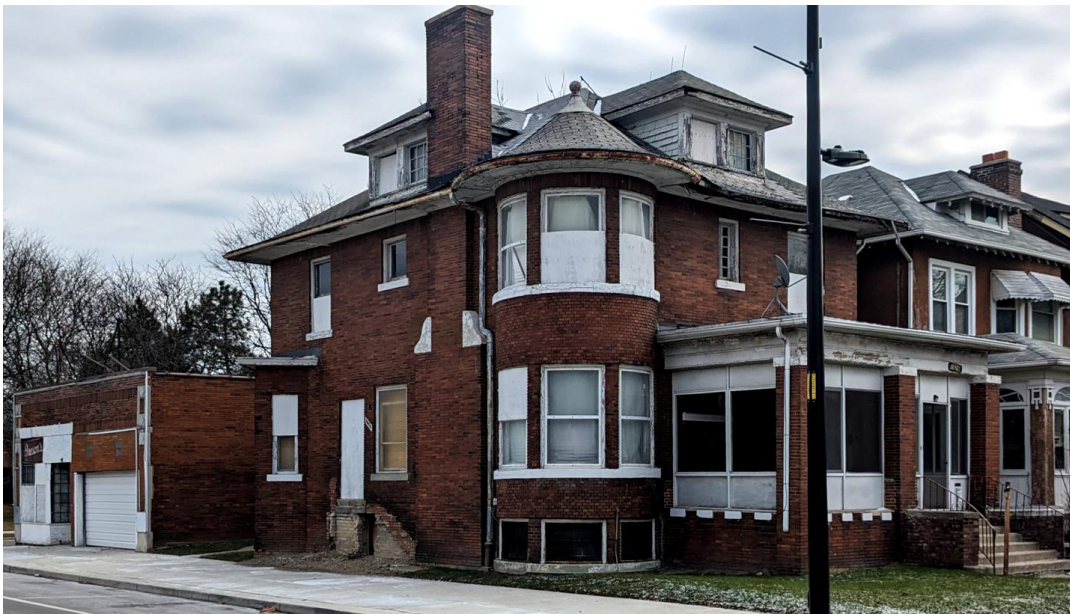
November 2023 photo by staff.

Built in 1913, the house faces east onto Seyburn. It is a two-and-one-half-story brick house, likely Free Classic or eclectic in style, though details particular to a specific architectural style are largely not present. Noteworthy features include an engaged tower at the northwest corner, with curved sash windows and a conical roof, as well as an angled, single-story bay at the northeast corner. A front porch with a wide, simplified Classical entablature has been enclosed, likely sometime in the mid-twentieth century. A rear porch has also been enclosed. The building is topped by a hip roof with three dormers.

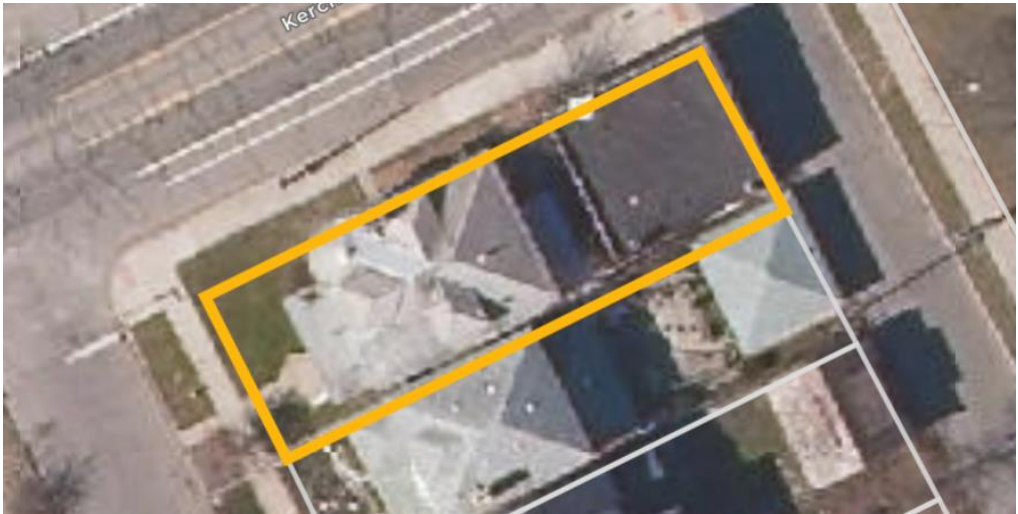
Site plan from Detroit Parcel Viewer.

The property at 7810 Kercheval consists of two buildings on a shared parcel.

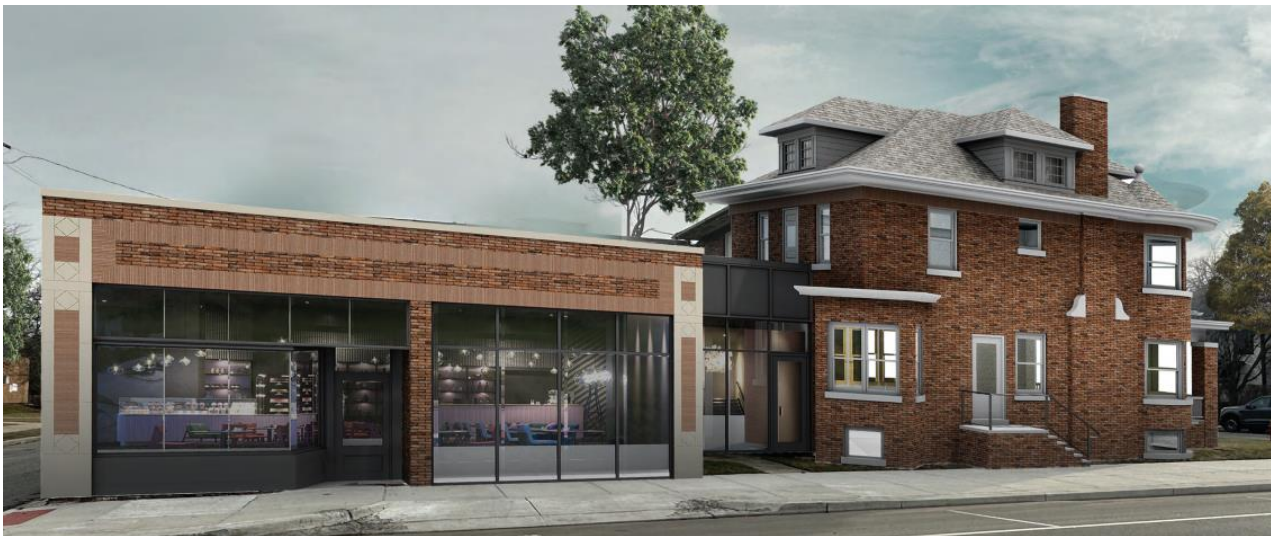
Rendering of proposed work viewed from Kercheval. Image from application documents.

The applicant proposes a comprehensive rehabilitation for both buildings with multiple scope items, including the addition of a single-story, connecting “hyphen” joining the two buildings.

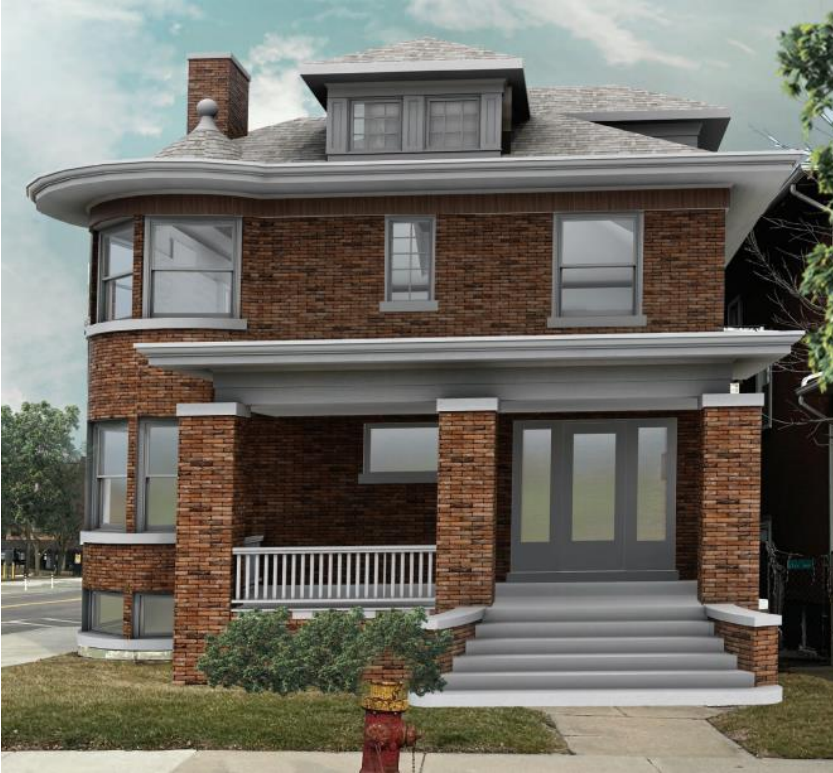
Rendering of proposed work viewed from Seyburn. Image from application documents.

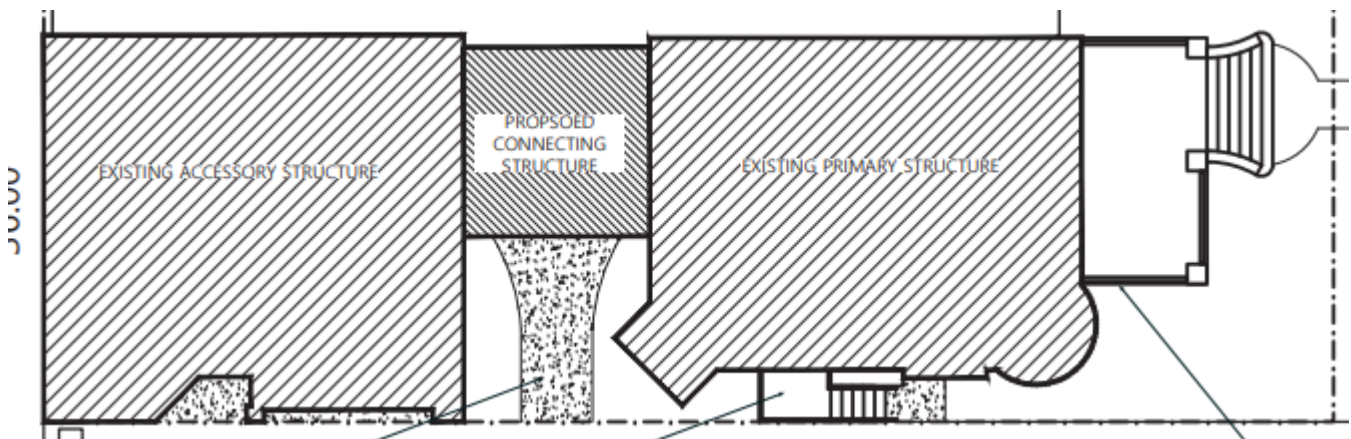
Site plan showing connecting addition. Image from application documents, cropped by staff.

A single-story addition is proposed to connect the two historic buildings. The addition would be clad in metal composite material (MCM) panels **in matte black** and feature a Tubelite proprietary aluminum storefront system. The storefront would include a single door at its west end, serving as a primary entrance to the combined building.

- The massing, height, fenestration pattern, and material of the proposed addition render it compatible with the adjoining historic buildings. Its dark color and recessed placement cause it to visually recede to avoid distracting from the historic buildings. While an entrance is located on the addition, its location behind a projecting bay of the historic house helps to deemphasize its prominence. These qualities satisfy Standard #9: “The new work shall be differentiated from the old and shall be compatible with the massing, size, scale, and architectural features to protect the historic integrity of the property and its environment.”

- *New Exterior Additions to Historic Buildings: Preservation Concerns* (Preservation Brief 14) elaborates upon the requirements of Standard #9. Suggested design approaches including “incorporate a simple, recessed, small-scale hyphen” and “avoid designs that unify the two volumes into a single architectural whole” are effectively incorporated in the design of the proposed addition.

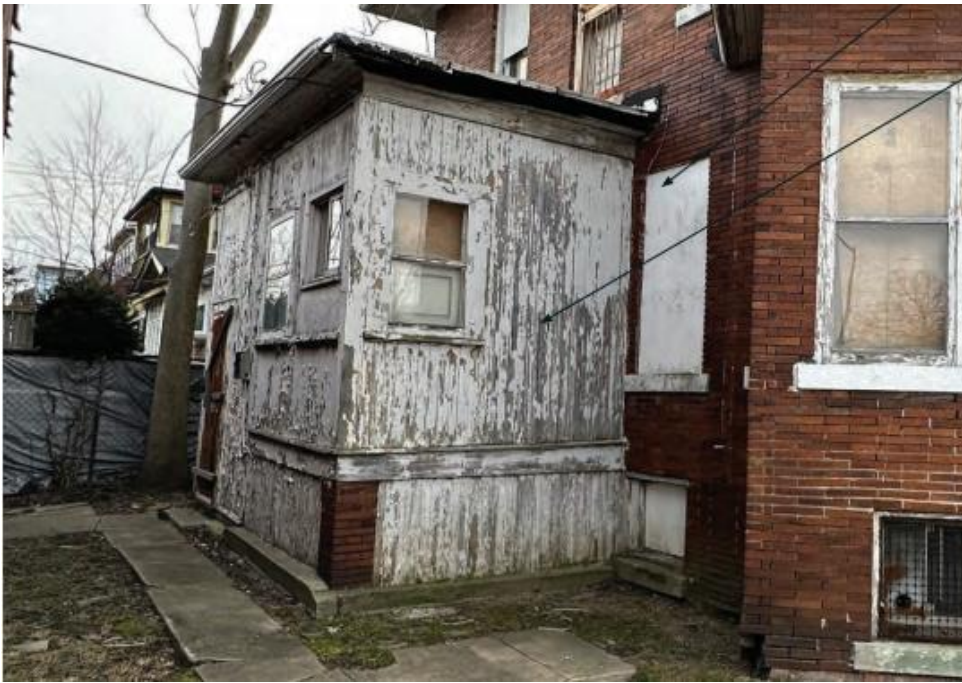
Enclosed area proposed for removal. Image from application documents.

The addition would require the demolition of a historic rear utility porch and stairway enclosure.

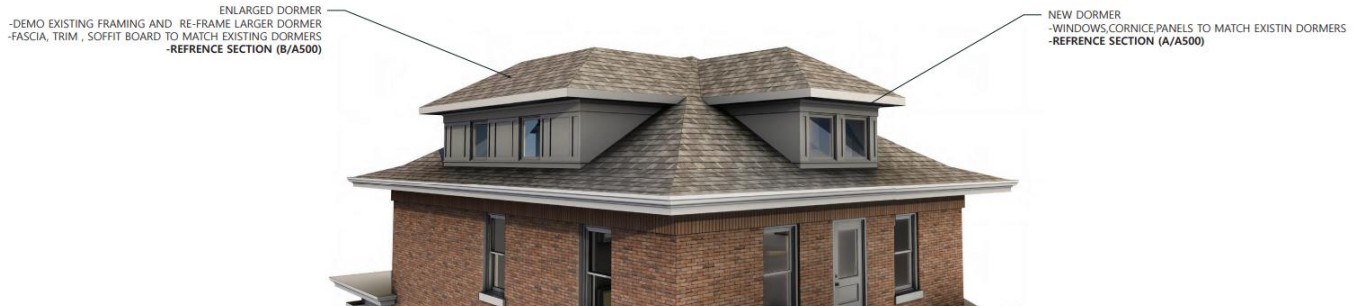
Rendering of altered (left of image, south face of building) and new (right of image, east face of building) dormers. Image from application documents.

One new dormer is proposed to be added to the rear (east) of the house; an existing dormer on the south side of the house is proposed to be enlarged.

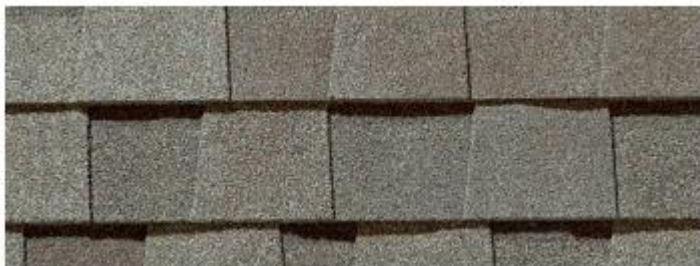
Proposed shingles. Image from application documents.

The replacement of the existing asphalt shingle roof is proposed. The new shingles would be CertainTeed Landmark shingles in Weathered Wood color.

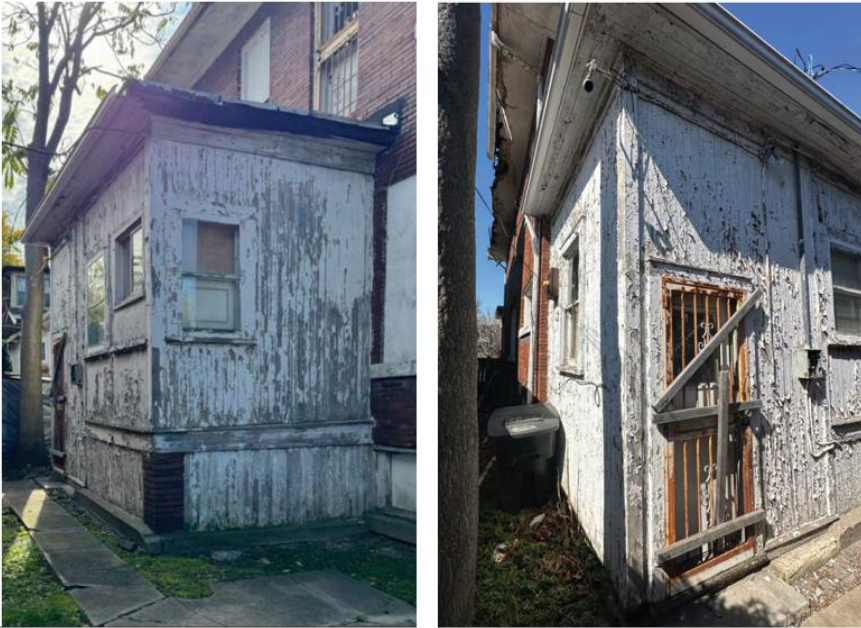
Left: North (street-facing) side of enclosure. Right: South side of enclosure. Images from application materials.

- The addition will require the removal of a rear (east-facing) projection from the house. In plan, this projection consists of two distinct elements. The north half (closest to Kercheval) of the projecting area is a true porch, likely to have originally been of a similar brick and wood composition as the front porch, but enclosed at some point in the building’s early history. The south half (furthest from Kercheval) is a stair enclosure connecting a rear door on the building’s first floor with a bulkhead door accessing the basement. Together, these areas are enclosed with the same beadboard cladding, suggesting the alterations were

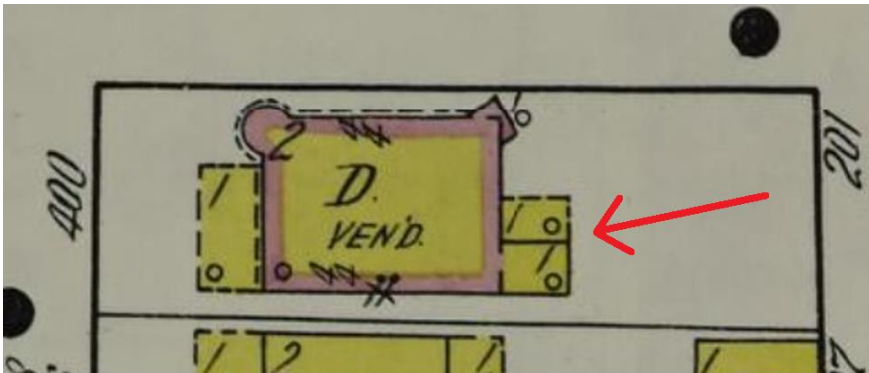
Rear porch and stair enclosure (denoted by arrow) visible in of plan view. (Note that the commercial building has not yet been built.) Sanborn Map Company, 1915.

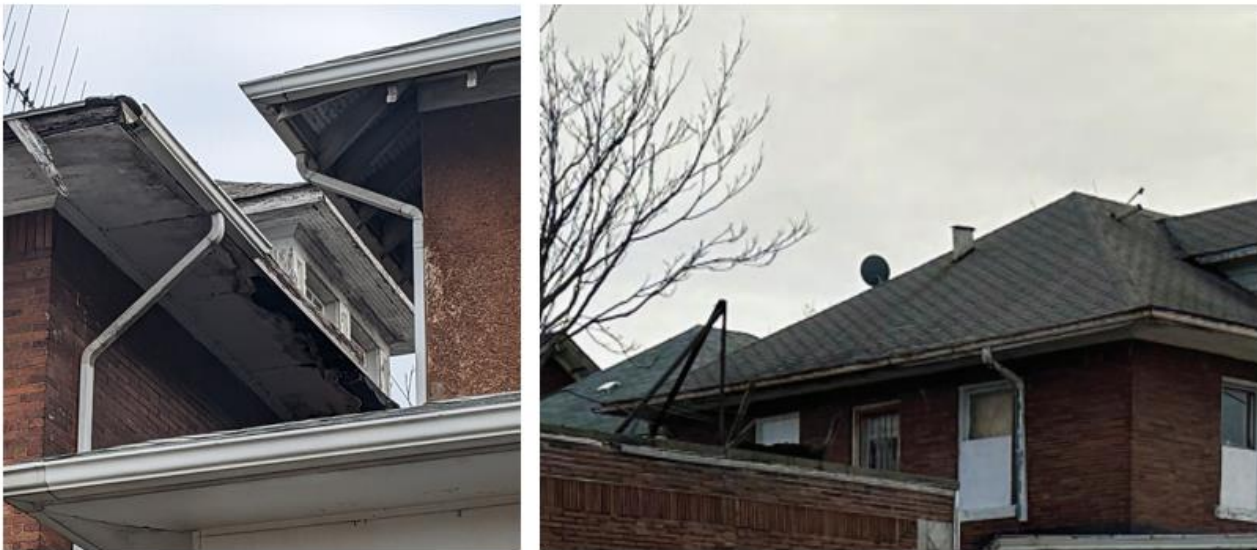
Left: South-facing dormer. November 2023 photo by staff. Right: East-facing plane of roof. Photo from application materials.

- The south-facing dormer, proposed to be enlarged, is in a location that is not readily visible from the street as it is obscured by an adjacent building. The enlarged dormer would retain the same hip-roof, paired-window configuration. Staff opinion is that the proposed alteration does not substantially change the character of the roofline or the building as a whole.
- The proposed new dormer, on the east side of the roof, is located on a non-primary elevation and would not destroy or obscure any character-defining features of the property.

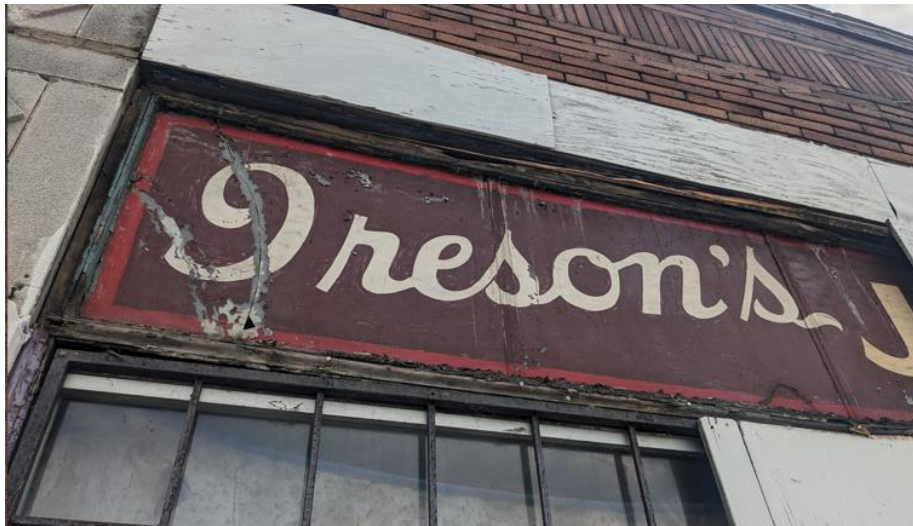
Historic transom window. December 2023 photo by staff.

- Most historic window and door openings on both buildings are proposed for restoration, including sashes, trim, sills, and casing.
- One exception is the proposed removal of a historic, wood transom window from the east storefront bay. The wood frame components of the transom are visibly split, deformed, and otherwise deteriorated to the extent that staff is convinced the transom is beyond feasible repair.

- The proposed aluminum transom closely matches the thickness, profile, and pattern of the historic transom.
- A hand-painted sign, painted directly on the transom glass, provides visual interest to the façade, but it is unlikely to be a historic feature as transoms were historically intended to provide illumination to the

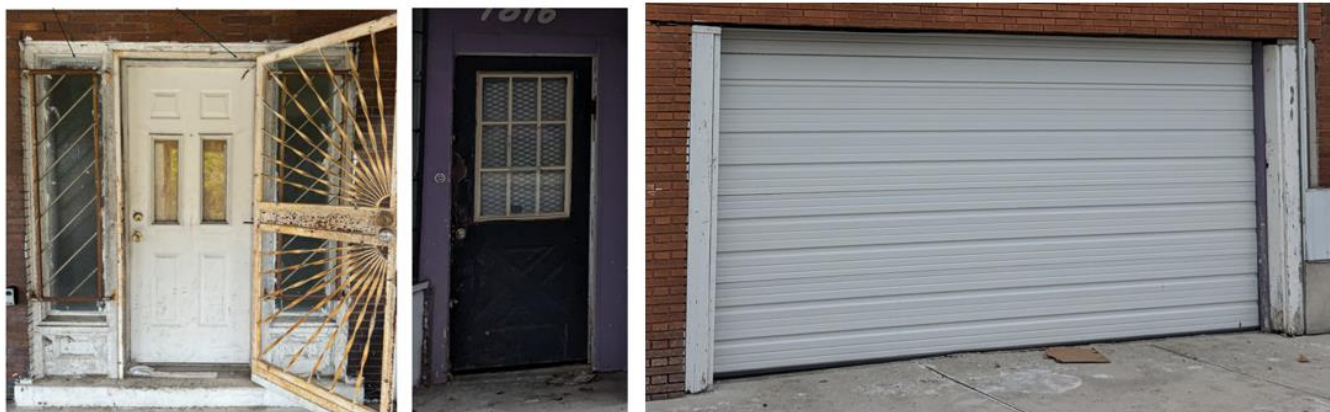
Non-historic doors to be replaced. Leftmost image from application materials, other images from December 2023 staff site visit.

Several non-historic doors are proposed for replacement. Other than the front (Seyburn-facing) door of the house, replacements are not specified.

- Some non-historic windows and doors are proposed for replacement. Although the replacement of these elements is acceptable, specifications for the new units are not provided. New windows and doors must be compatible with the property and its environment. The National Park Service guidance “Replacement Windows that Meet the Standards” applies here. In most cases, a one-over-one wood sash window would be appropriate; replacement windows need not exactly match the historic windows presently or formerly on the property.
