STAFF REPORT: FEBRUARY 13, 2024 MEETING
APPLICATION NUMBER: HDC2024-00031
ADDRESS: 1760 WABASH
HISTORIC DISTRICT: CORKTOWN
APPLICANT: GUSTAF ANDREASON, @PROPERTIES
PROPERTY OWNER: SHARIF AFFAS, DETROIT DEVELOPING PROPERTIES, LLC
DATE OF PROVISIONALLY COMPLETE APPLICATION: FEBRUARY 19, 2024
DATE OF STAFF SITE VISIT: FEBRUARY 21, 2024

SCOPE: ERECT ADDITION, DEMOLISH SHED

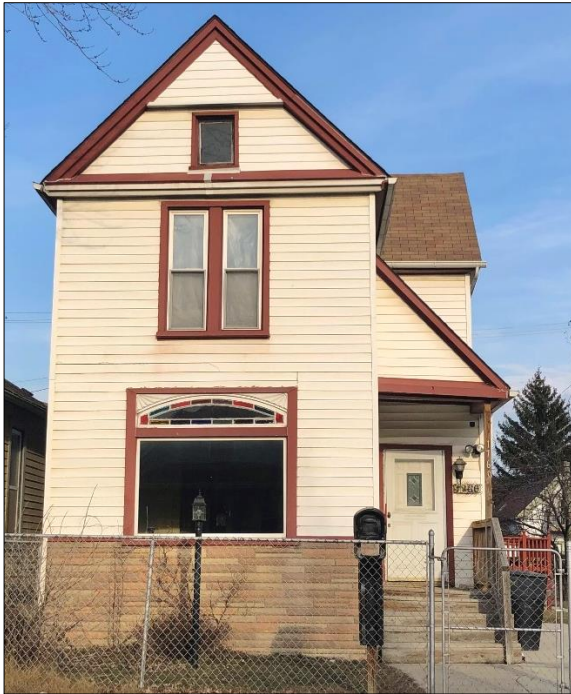
Front wall.

The two-story wood-framed dwelling is located on the east side of Wabash Street, between Marantette and Bagley. The dwelling and rear additions were erected between 1889 and 1897.

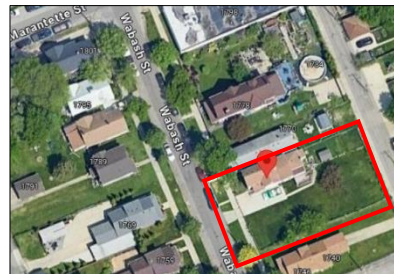
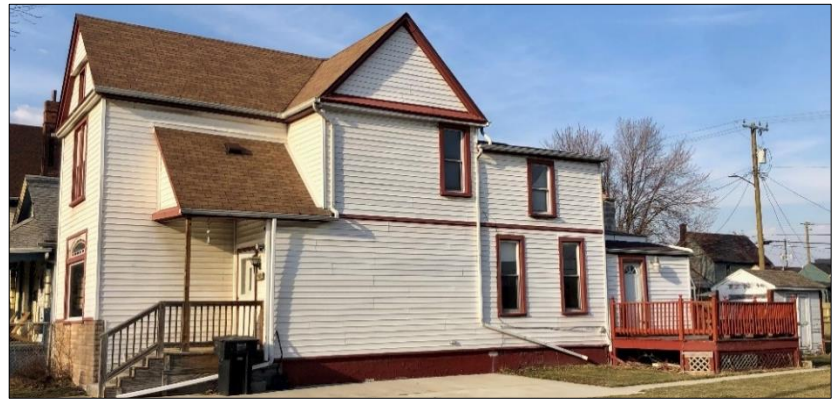
Top: Google aerial view, above: side (south) wall looking from Wabash.

The cross-gabled structure features a 2-1/2 story front elevation and a one-story covered porch. The roofs on the main structure and front porch are steeply pitched, whereas the additions have low pitched hip roofs. The existing window openings on the front elevation are centrally placed, while the window openings on the remaining elevations are asymmetrical in placement. .

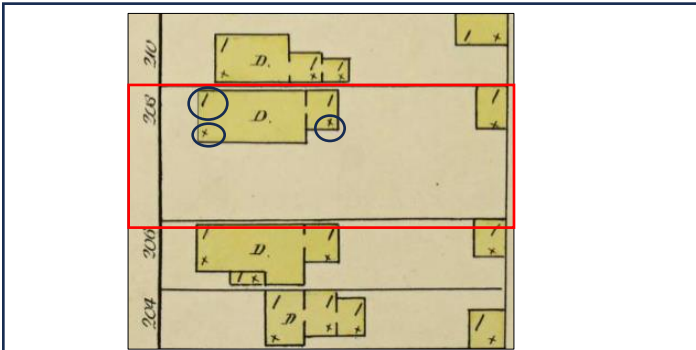
Vol. 3 1889, Image 64

The original structure, erected between 1884 and 1889, was a single-story, wood-framed dwelling with wood shingle roofing. A single-story accessory structure was at the rear of the lot, which also had a wood shingle roof.

1 – identifies number of stories
x – identifies wood roofing material

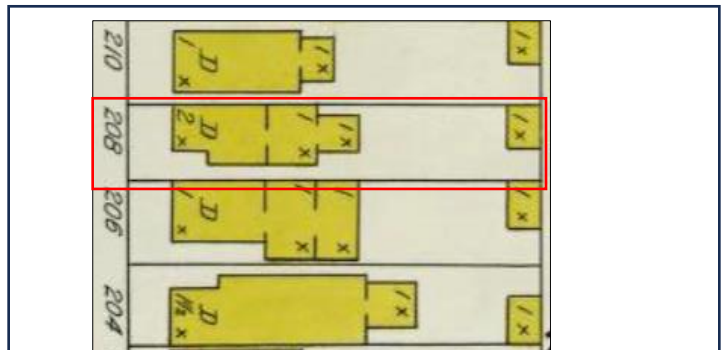
Vol. 1 - 1897, Image 34

By 1897, it is staff's opinion that (based on the footprint shown here and the massing of the existing structure) this map indicates that an entirely new two-story structure with a setback front entrance had been erected, along with two, one-story additions. The accessory structure remained the same

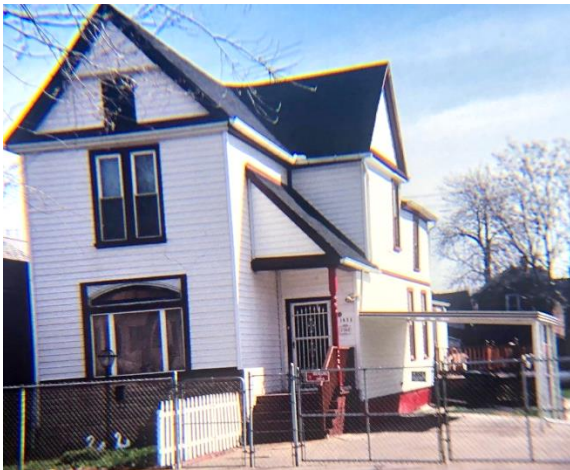
1984 Designation photo, HDAB.

The 1984 designation photo shows the window openings increased in number and width as they went from floor to floor: a single opening at the third floor became two mullioned openings at the second floor, and then three mullioned openings and a decorative transom at the first floor.

While operable windows were not in the three openings at time of designation, the alteration from a three-part window to an undivided opening destroyed the pattern and proportions of the window opening and altered this character-defining feature of the dwelling.

- At the time of designation, the large front window had two mullions and each opening had plate glass. The mullions were removed after September 2013 and undivided glass was installed. There is no record of this alteration being reviewed by the Commission.

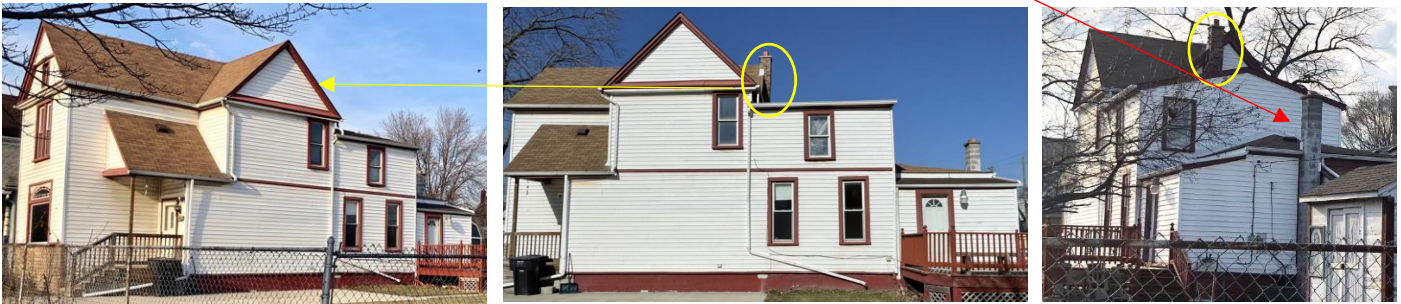
- The application proposes to remove the chimney stack that is in the middle of the house. The stack is not visible from the front elevation nor from an angled view at the sidewalk; it is only visible when standing in the middle of the adjacent vacant lot and from the alley. It is staff's opinion that, with its small width and depth, and low height, the stack is not a prominent feature and doesn't offer historic and architectural significance. The other chimney stack, on the outer rear wall, will be retained.

Far left and far right: staff photos, February 2024. Middle photo provided by applicant.

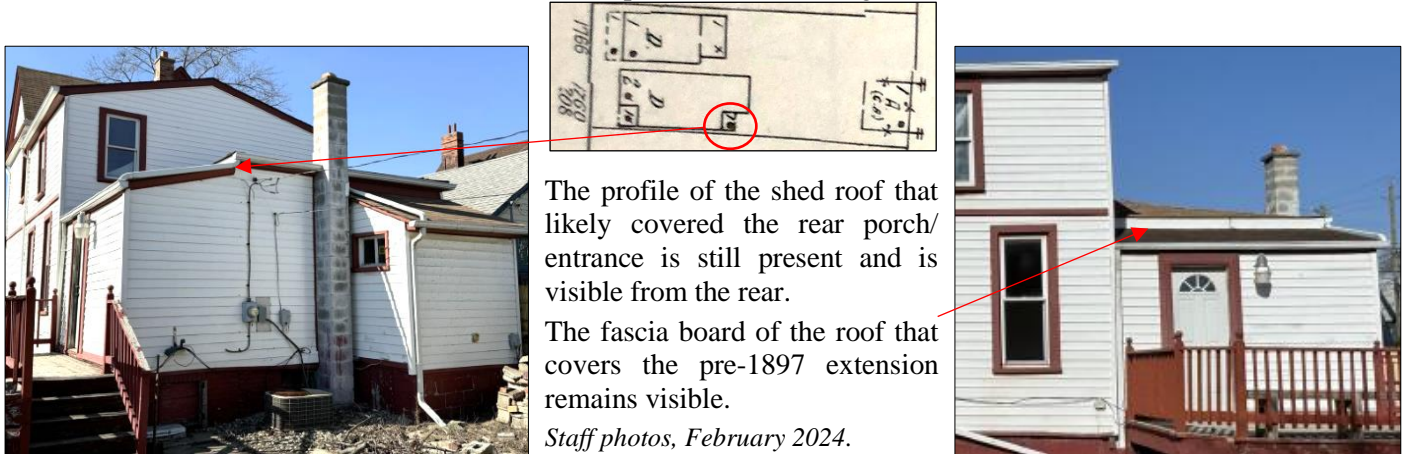
- Another change that appears to have occurred after 1991 that did not receive HDC approval, is the enclosure of the covered rear entrance. (The deck was in place at time of designation.)

The profile of the shed roof that likely covered the rear porch/entrance is still present and is visible from the rear.

The fascia board of the roof that covers the pre-1897 extension remains visible.

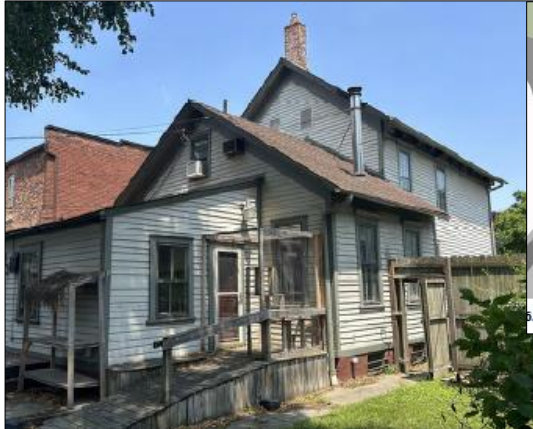
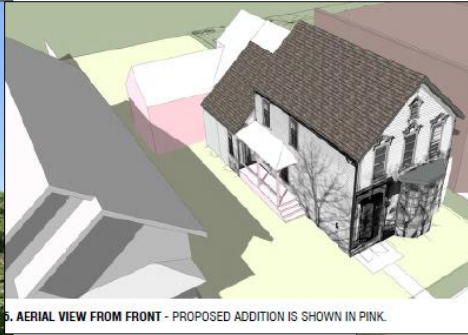
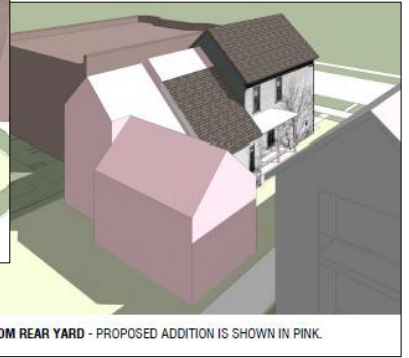
Applicant drawings/photo

2245 Wabash – The 2023 application included the retention of the first historic extension and the erection of two additions (changes identified in pink).

- The proposal retained deference to the original structure.
- The increased height of the historic extension remained below the ridge height of the house's roof.
- The two additions were designed to appear as separate extensions, in keeping with the historic pattern of building.

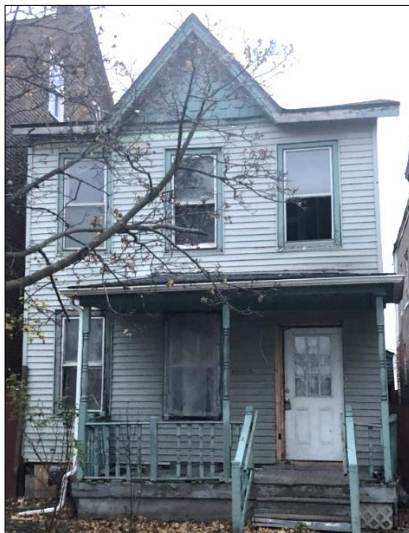
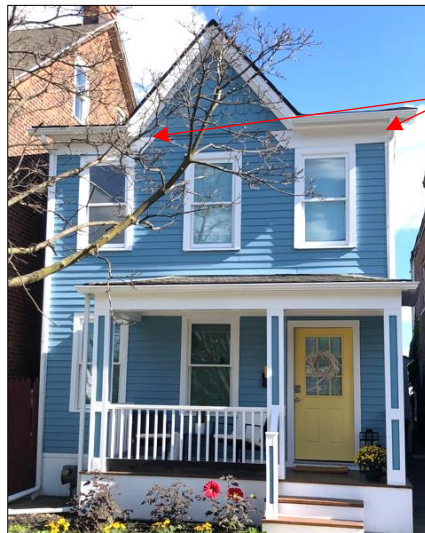
Applicant photos.
Original details uncovered includes this frieze board.

1409 Bagley – This dwelling's historic footprint didn't change, but the exterior appearance was altered.

- The Commission denied the applicant's 2021 proposal to replace the existing vinyl siding with new vinyl siding.
- The applicant instead restored the historic wood siding which reintroduced original details that had been hidden for at least 60 years.
- An architecturally compatible front porch replaced the highly deteriorated non-historic porch.
- The in-progress photo of the rear elevation shows stepped down additions, which according to the Sanborn maps, have been in place since the 1880s.

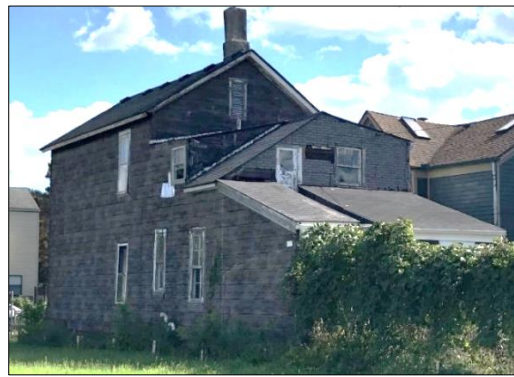
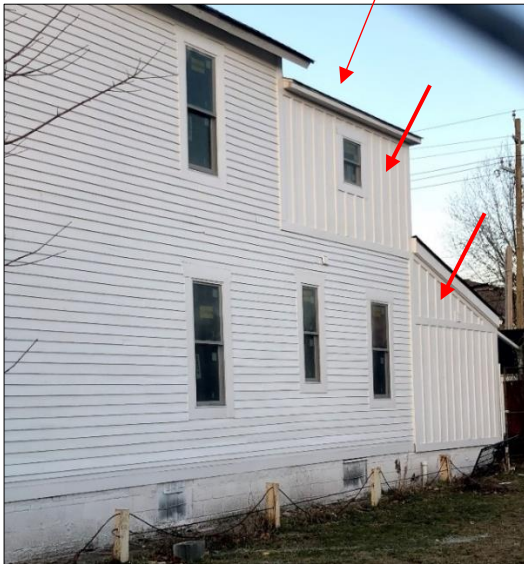
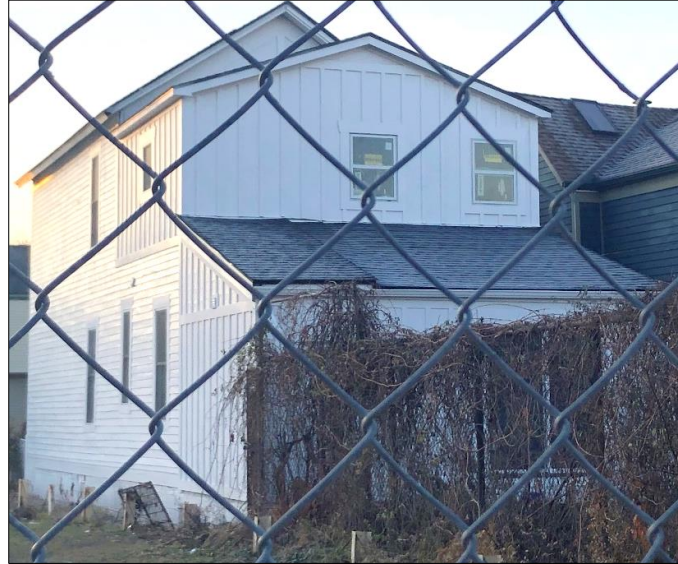
1556 Bagley – This 2022 application included an increased height for the second story historic extension (boxed out in upper left photo).

- The increased wall height remains below the original structure and retains the historic pattern of a stepped down eave. Similarly, the ridge of the new roof and its pitch are lower than the main house.
- Vertical board and batten siding installed on the new walls (arrows above) allows the new work to read as contemporary, yet compatible, elements.
- The existing chain link fence running the perimeter of the double lot is to be removed and a wood privacy fence will be installed closely following the historic/original lot line. The proposed fence location and design meet the HDC’s Fence and Hedge Guidelines, and the applicant agreed to paint the fence. Color to be determined.

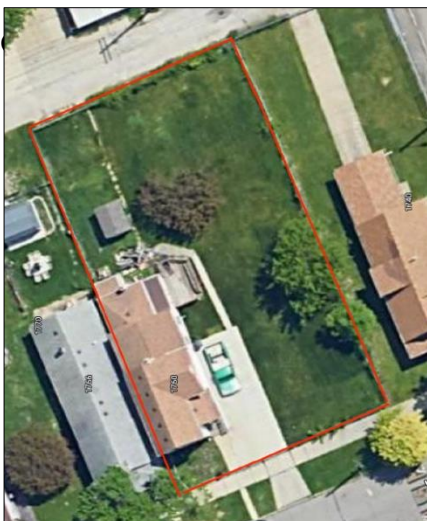
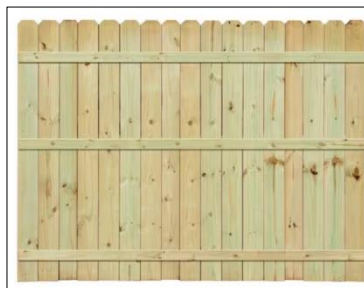
*Applicant photos.
 Left: Footprint (red lines) of existing chain link fence.
 Right: New footprint (blue lines) for wood fence.*

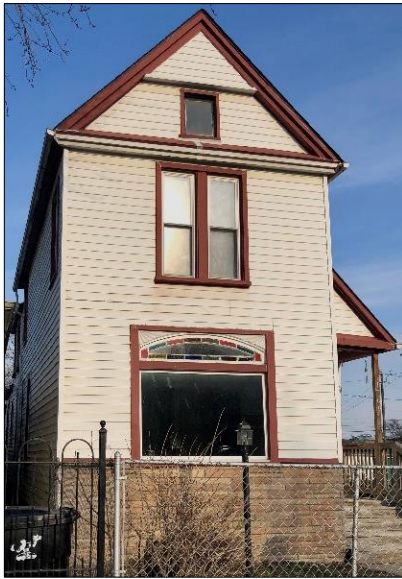
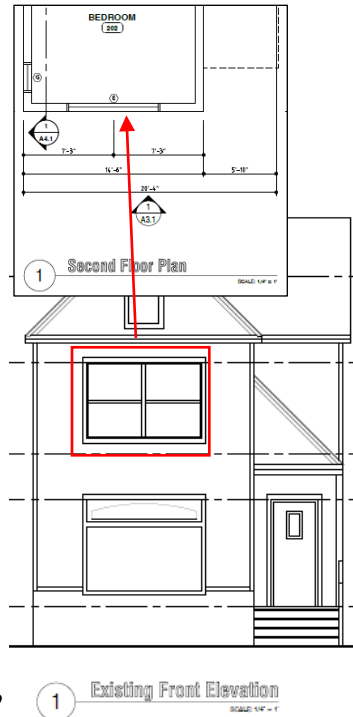
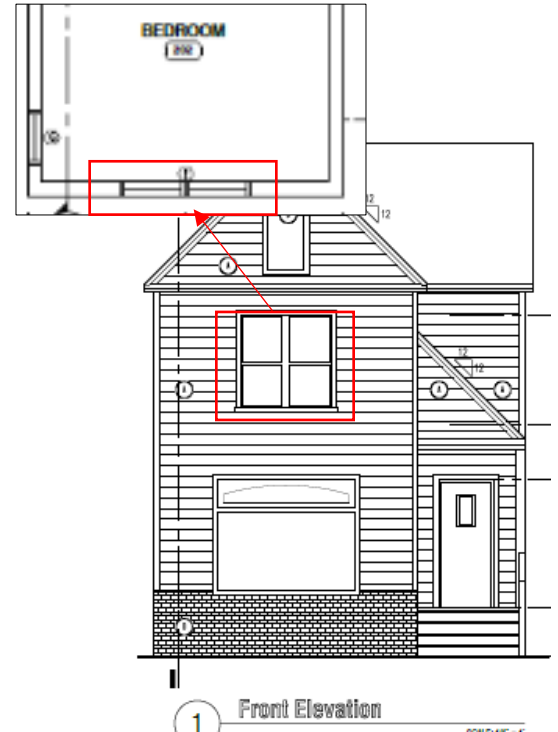
- The dimensions of the existing second floor windows (and central mullion) are typical of late 19th century dwellings and are character-defining features of the dwelling. The drawing of the front elevation shows exceptionally wide windows, and a factory-installed mullion at the second floor, matching the width of the window opening at the first floor. The applicant noted this was not intentional and the existing window openings will remain. The elevation and floor plan will need to be revised with correctly sized openings, including the dimension and placement of the historic mullion.

3/12 – The applicant revised the elevation and second floor plan to reflect the existing second floor window opening.

Staff photo.

Applicant Drawings.

Left: Previous elevation/plan.

Right: Corrected elevation/plan to show retention 2nd floor window openings.

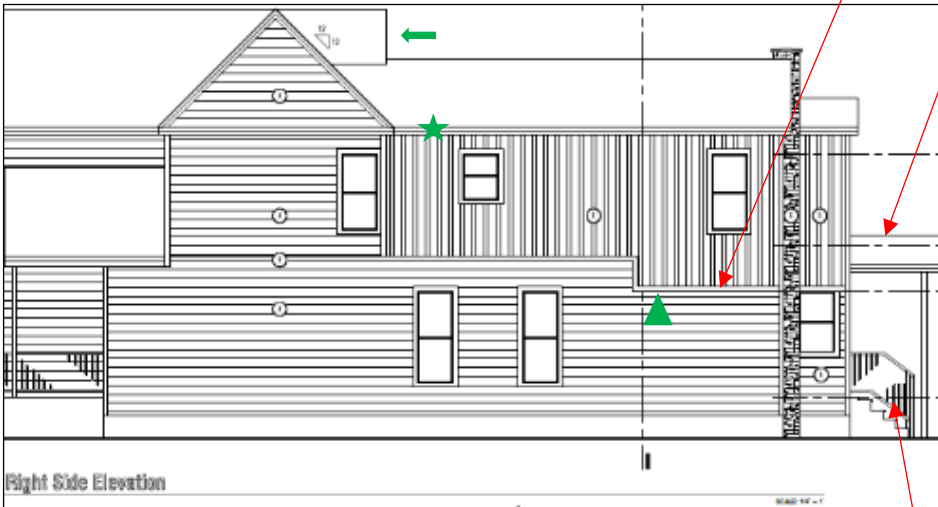
Applicant's current elevation drawing of south wall.

New details for second floor addition:

- Vertical siding is specified for the new second floor walls. The proposal shows a lower finish height of the vertical siding to suggest the historic eave height at this wall location.
- The ridge of the addition's roof has been lowered and is well below the ridge of the historic 12-over-12 pitch roof. (Original proposal extended the historic ridge height through the new construction.) ←
- A roof has been added to the rear entrance.

Staff concerns with revised design:

- The height of the eave of the new second floor wall remains in line with the historic house and removes the historic stepped down eave. ★
- The setback of the existing first floor addition hasn't been retained. ▲
The matching eave and solid wall plane of the south wall continue to create a large boxy massing for this highly visible area of the dwelling. As stated on page four, staff didn't find HDC approval of the rear porch expansion and enclosure. However the existing non-historic southern wall at this area retained a small setback from the main structure (see existing condition photo).

- Comparing the original and current application, the revisions of a lower roof height and siding change offer improvements to the design, but it is staff's continued opinion that the massing must be further modified for this project to meet the Standards.

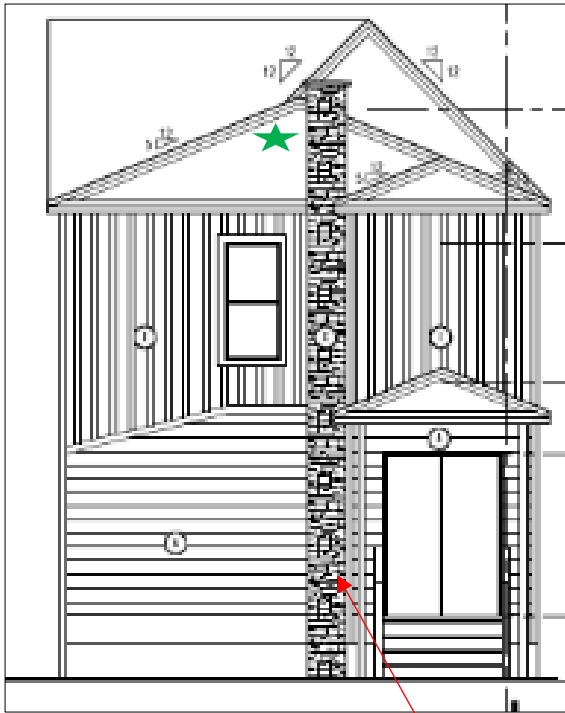
Applicant's current design at rear

New details for rear wall:

- *Vertical siding is specified for the new second floor walls. The proposal shows a siding detail to suggest an approximation of the former single-story extension's roof.*
- *This view shows how a lower and independent roof retains the essential form and integrity of the historic property, while being differentiated from the original steeply pitched roof. ★*
- *A roof has been added to the rear entrance.*

Staff concerns with revised rear wall design:

- *As staff mentioned on the previous page and earlier in the report, the historic massing of 19th century additions / extensions are distinctive character-defining features this property and the district.*
- *Lower roof heights (i.e. ridges, eaves, roof pitch) and at times recessed walls, allow additions/new construction to retain the essential form and integrity of the historic property.*
- *A material sample/cut sheet for the stone veneer at the chimney, confirming stone pattern, profile and color(s) must be submitted for staff review.*

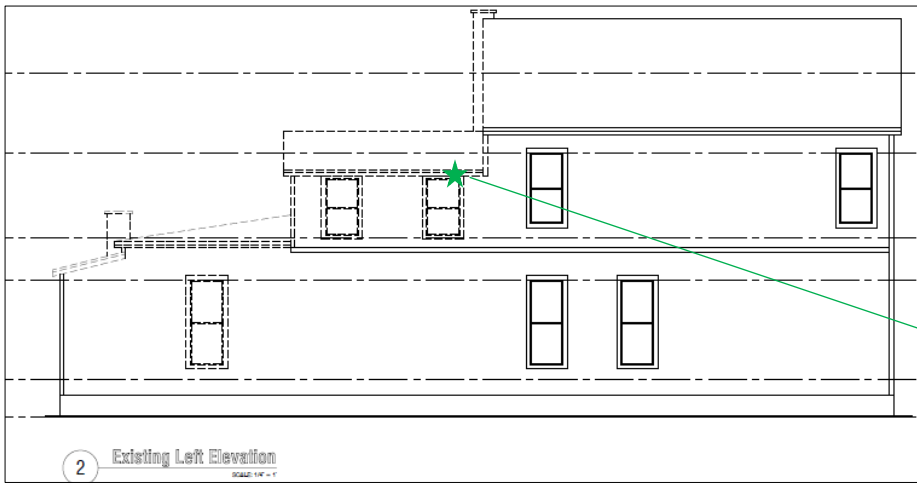
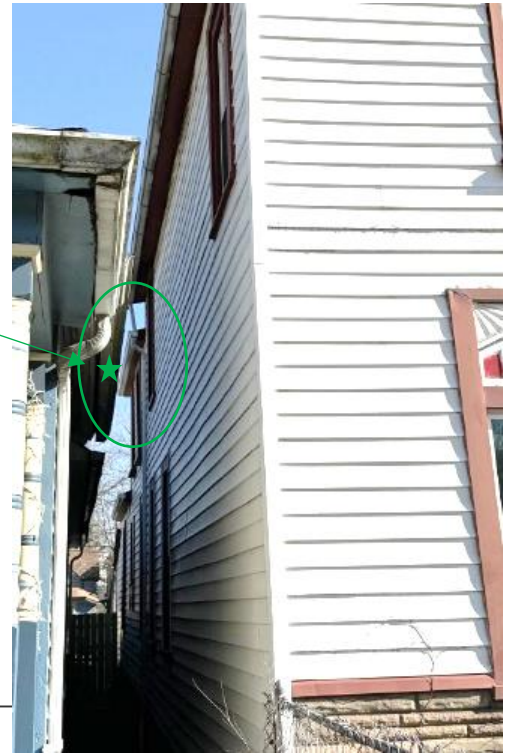
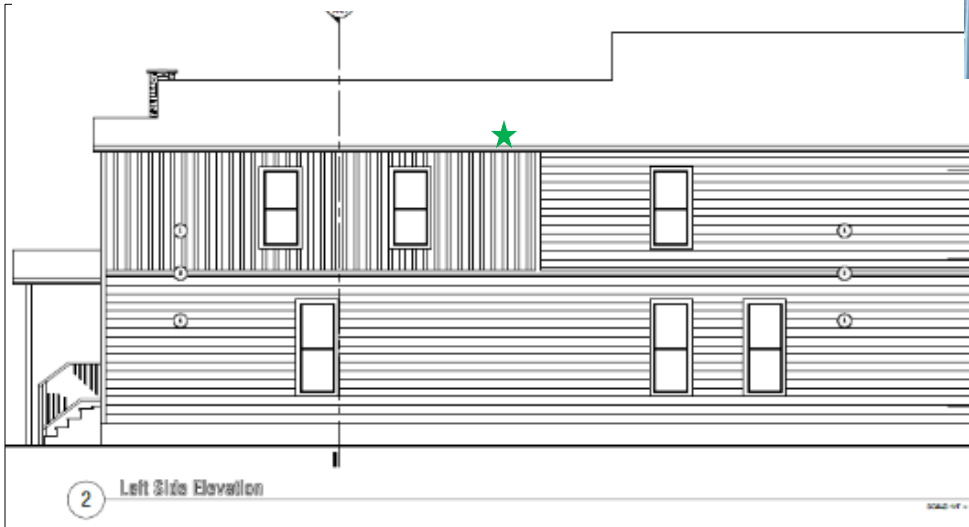
Above: Applicant drawing of existing north wall.
 Above right: Applicant's photo of the north wall. Due to the proximity of the neighboring property, this side isn't visible from the right of way. Also, the historic extensions at this wall were, and remain, in line with the original structure.
 Below: Applicant drawing of currently proposed design for the north wall.
 Bottom: Applicant's previous design for the north wall.

- New details for north-side wall:
- Vertical siding is specified for the new second floor walls.
 - A roof has been added to the rear entrance.

- Similar to the previously discussed south and east walls, a lower eave height should carry around from the other elevations. This would match the existing historic condition, as noted in the existing north wall drawing and photograph. ★
