STAFF REPORT: MARCH 13, 2024 MEETING

APPLICATION NUMBER: HDC2024-00038

ADDRESS: 2905 GARLAND (AKA THE OSSIAN SWEET HOUSE)

SCOPE: INSTALLATION OF SECURITY CAMERAS

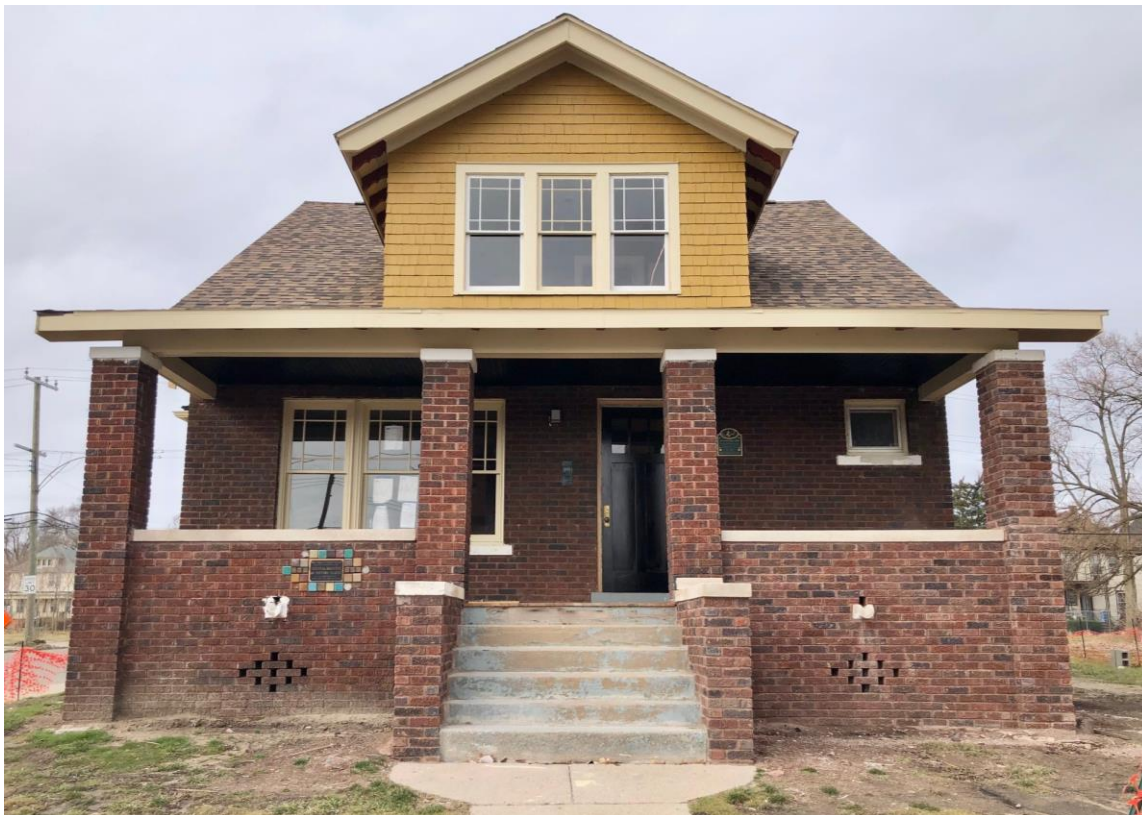
The centrally placed main entrance contains a single door that is now covered with a security door. A picture window is located to the left, or south, of the door, and a single small square window is located to its right, or north. The opening in the roof dormer contains three-double hung sash windows separated by mullions.

Front (east) wall.

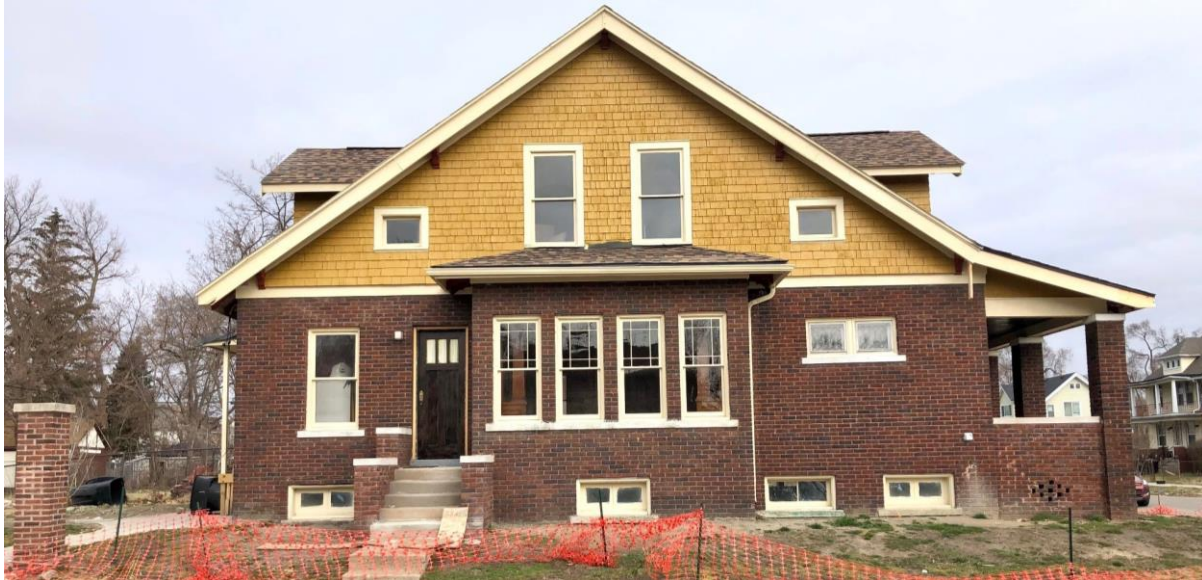
The large side-facing gabled ends of the roof have raking verge boards. The south side elevation, facing Charlevoix, features a secondary entrance and a box bay. A pair of small, horizontally rectangular leaded glass windows, quite typical of bungalows, punctures the wall eastward of the box bay, though they appear to be later replacements. Similarly sized and shaped basement windows circle the perimeter. The box bay is covered by a shallow hipped roof. Its depth is one elongated double hung sash window; its width contains four similar windows sharing a common sill.

Side (south) wall.

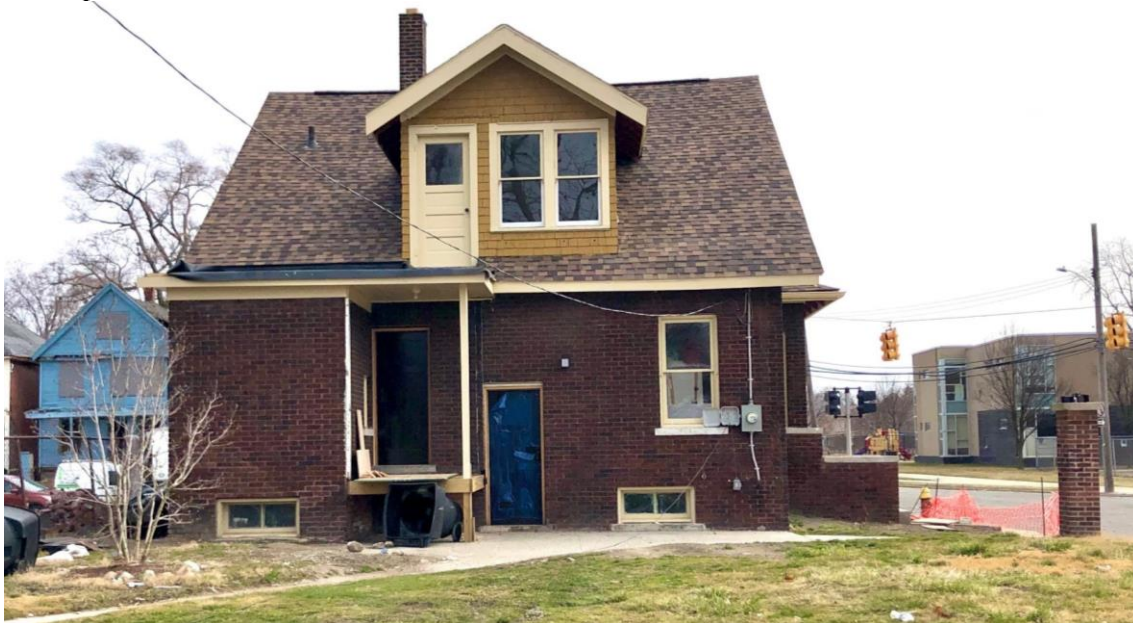
Rear (west) wall.

The massing of the rear elevation is similar to the front elevation. A centrally placed gabled dormer protrudes from the steeply sloped roof, and is faced with wood shake shingles that matches the walls of the front dormer and side gable walls. The dormer wall is filled with two mulled double-hung windows and a single wood/glass door which leads to an upper porch.

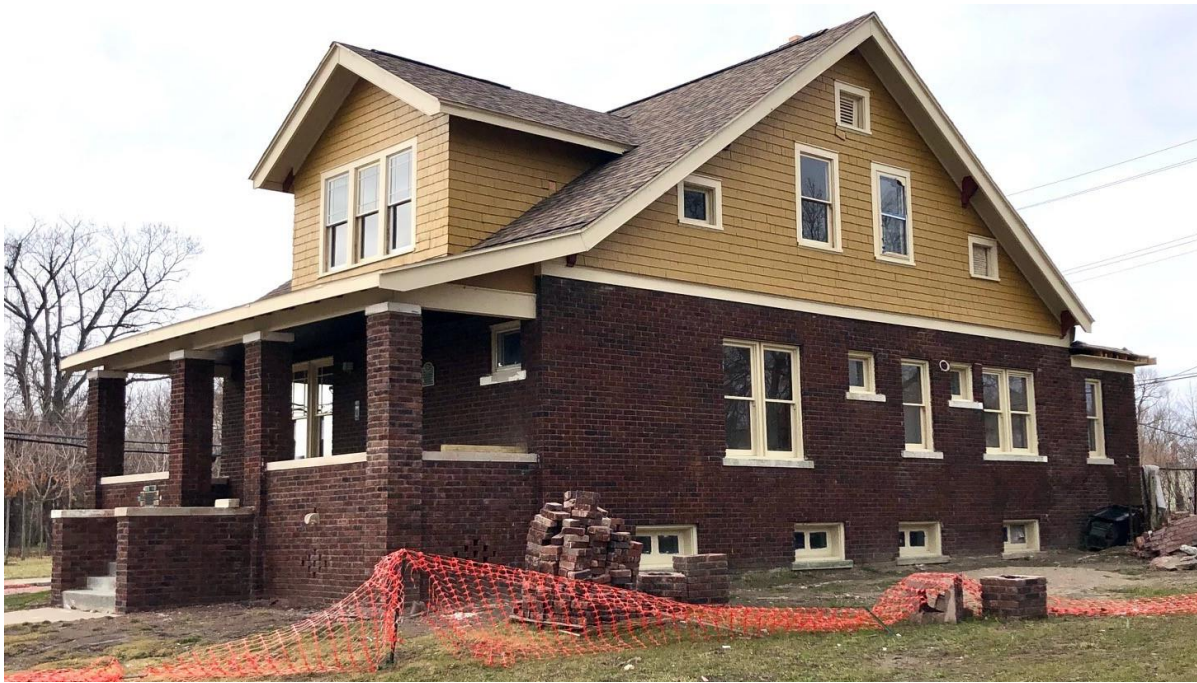
NE corner of house, view looking southwest from Garland.

On the north side, the window openings are fairly symmetrical in placement; the window openings at the second floor gable wall echo the openings (placement and operation) of those on the south side. The western rectangular window (at right in above photo) is covered due to its internal location within the bathroom. A louvered attic vent is located near the peak of the gable.

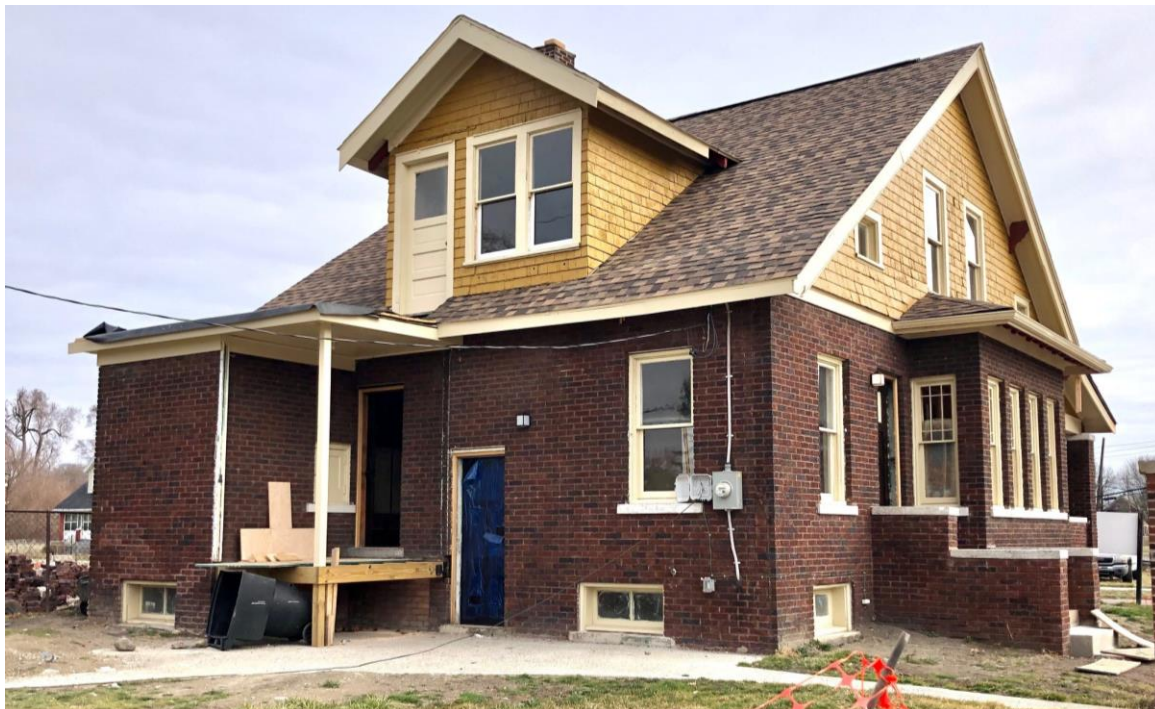
SW corner of house, from Charlevoix looking northeast.

Wide, rectangular basement windows are located on the sides and rear. The north and south side openings are original/historic wood framed inswing hopper units (each sash has two clear glass panels equally divided by one wide wood vertical muntin bar), whereas the remaining units are new replicas. The sills are cast stone.

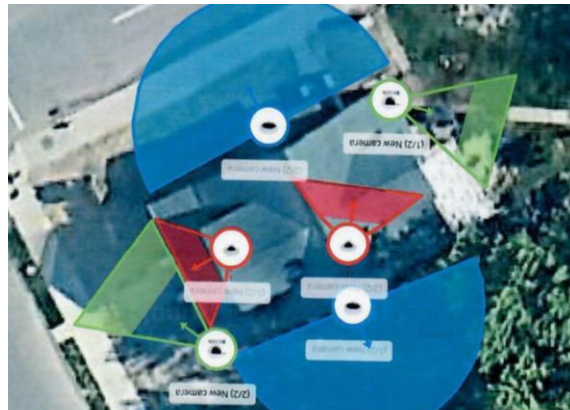
- Install 4 (four) security cameras on each exterior wall of the structure.
 - One camera near the front and rear entrances (2).
 - One camera centrally placed on the north and south walls (2).

Applicant diagram. Red identifies range of interior cameras. Green identifies range of front and rear entrance cameras. Blue identifies range of side wall cameras.

North and south side walls (blue on diagram)

NE corner of front wall & SW corner of rear wall (green on diagram)

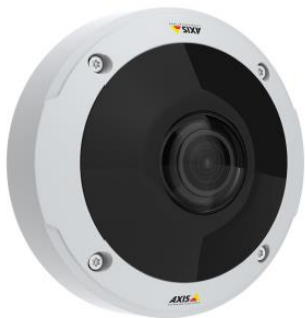
M3058PLVE –outdoor-ready dome with 360° panoramic view and IR illumination

2-1/2” deep // approx. 4” in diameter

Factory white finish – product can be painted with proper preparations

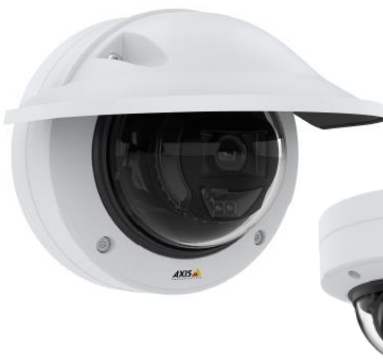
P3265-LVE –fixed mini dome with HDMI, hood is optional

Camera w/hood: 6-1/4” deep, camera only: approx. 4” deep // 7-1/4” wide (w/hood)

Factory white finish – product can be painted with proper preparations

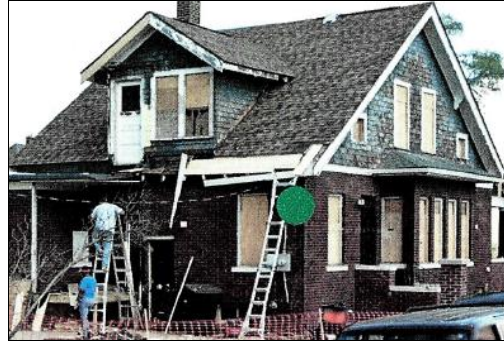
Green circles indicate locations for entry cameras.

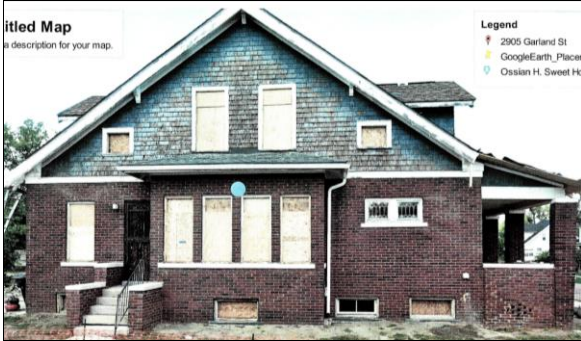
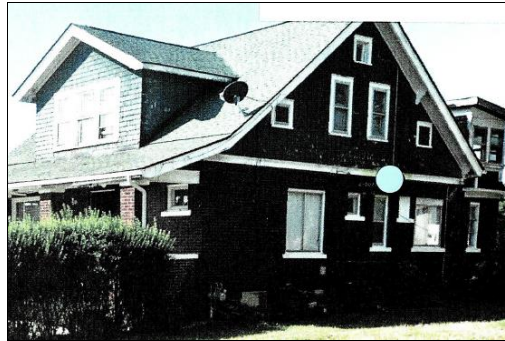
Blue circles indicate locations of side wall panoramic cameras.

- As stated earlier in this report, it is staff’s opinion that each side of the dwelling is historically and architecturally significant and is considered a distinctive character-defining feature.
 - The four cameras are to be located in visually prominent locations and will severely alter the features and spaces that characterize the property.
 - Three of the four cameras are proposed to be installed on masonry walls. It is not clear if the mounting hardware can be placed within mortar joints (regardless of where on a masonry wall the camera is proposed). Mounting on the brick would permanently damage a significant architectural feature.
 - Different cameras may be available within the marketplace that can be installed within the eaves.
