STAFF REPORT: MARCH 13, 2024, REGULAR MEETING
APPLICATION NUMBER: HDC2024-00065
ADDRESS: 9230 DWIGHT
HISTORIC DISTRICT: BERRY SUBDIVISION
APPLICANT: BORA GULARI
OWNER: BORA GULARI
DATE OF PROVISIONALLY COMPLETE APPLICATION: FEBRUARY 8, 2024
DATE OF STAFF SITE VISIT: FEBRUARY 21, 2024

SCOPE: ALTER GARAGE/BOATHOUSE

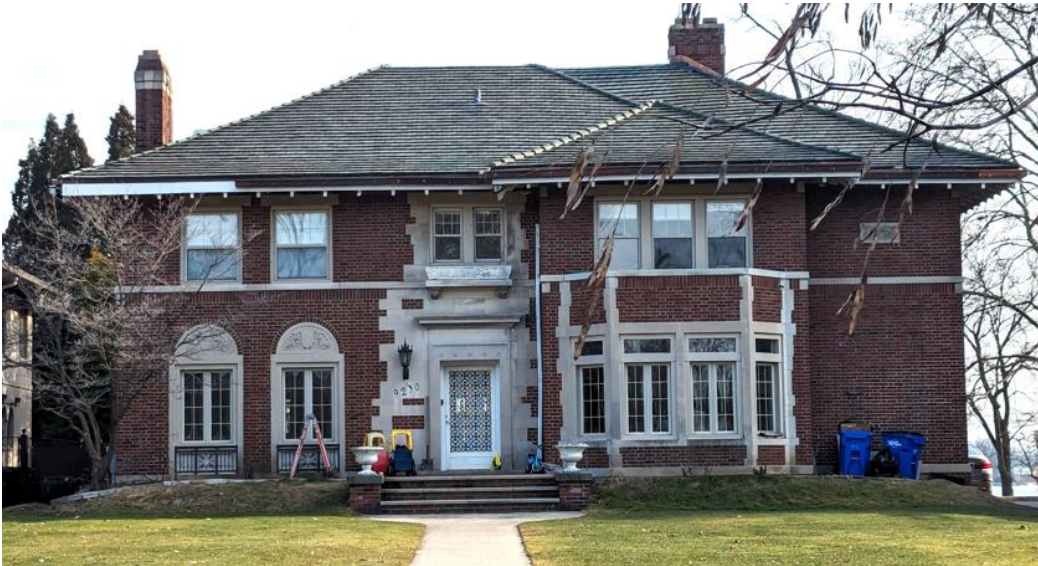
The house at 9230 Dwight; February 2024 photo by staff.

9230 Dwight is a two-story, hip roof house, built in 1921 and facing north onto Dwight. Italian Renaissance features include Flemish-bond brickwork, tabbed stone details and stone panels, and a green, clay-tile roof. The tile roof on the house is presently undergoing repairs according to a Certificate of Appropriateness dated June 5, 2023. Behind the main house, a large rear yard includes a garage that appears to have been built concurrently with the house. The garage, though more subdued in expression, continues the style, materials, and massing of the main house. This includes a rectangular form, Flemish-bond brickwork, green tile hip roof, wood, six-over-one sash windows, and wood panel doors. The three-bay garage opens to the east.

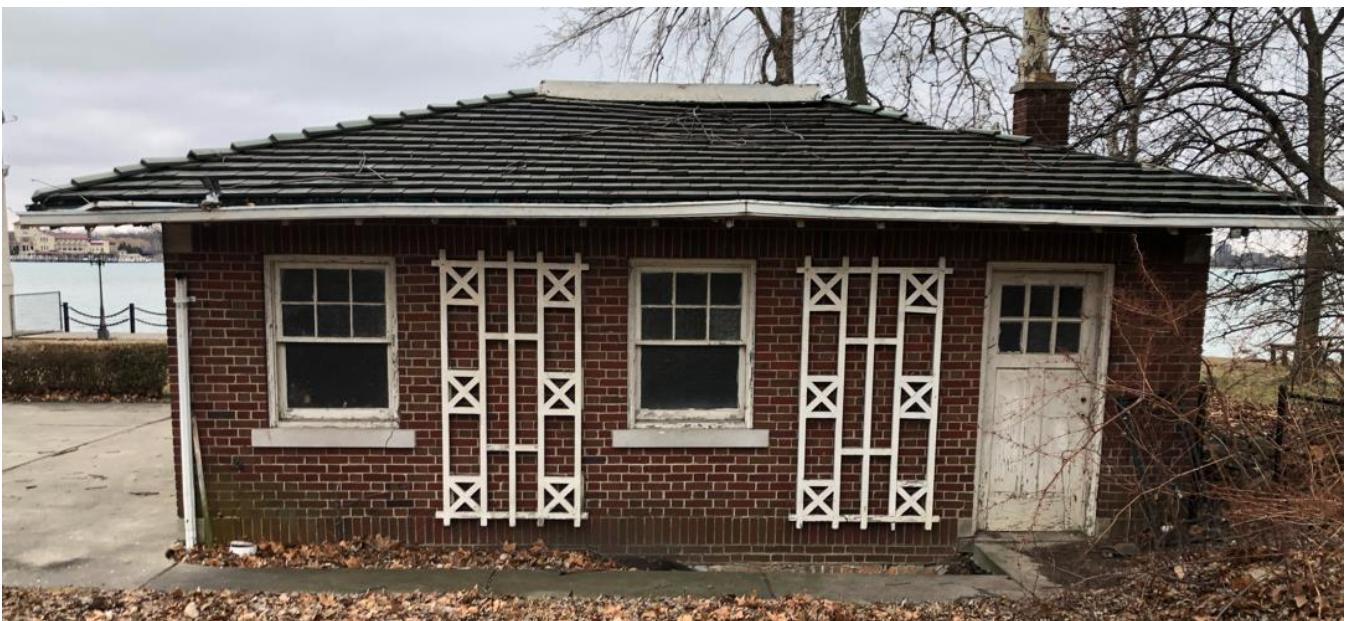
The garage/boathouse at 9230 Dwight, north elevation; Photo by applicant. Note the intentional design consistency with the main house, including the roof tile.

The garage was expanded decades ago with a single-story, flat roof, boathouse addition to the south. The addition is relatively deep and consists of brick masonry. The project architect states that the addition dates from the 1980s; staff was unable to confirm the date with available records. Together, the building is referred to as the “garage/boathouse” throughout this report.

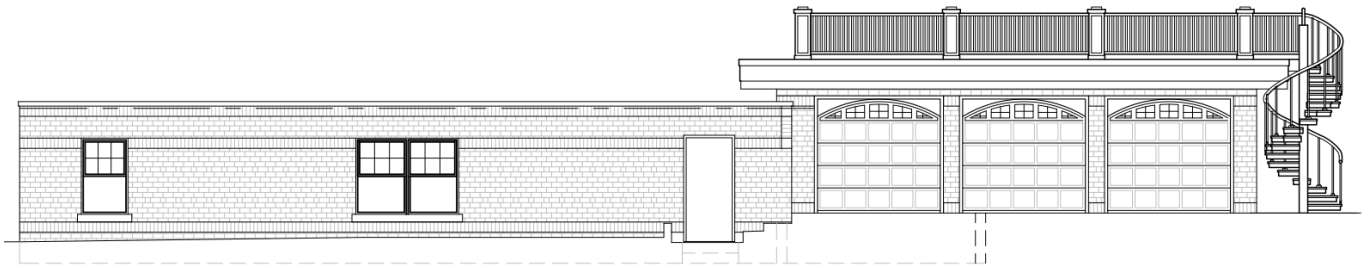
The applicant proposes to alter the garage/boathouse by eliminating the hip roof and constructing a flat roof. The flat roof would be topped by a deck, accessed by a spiral staircase. The submitted elevation also depicts three new garage doors.

East elevation showing proposed work; drawing from application documents.

- The proposed work eliminates a highly distinctive clay tile roof without showing that it is beyond repair. Even if it were beyond repair, the Standards would direct that it be replaced with a roof of similar design, color, and texture.
- The proposed work eliminates the hip roof massing that is a defining feature expressing the building's Italian Renaissance style and that creates an important visual relationship with the main house.
- The proposed work introduces a flat roof that conflicts with the Elements of Design and is visually incompatible with the building and the district.
- Not enough information is provided to confirm that the proposed work uses materials, colors, and textures that are compatible with the building and the district.
