STAFF REPORT: JUNE 12, 2024 MEETING

APPLICATION NUMBER: HDC2024-00181

ADDRESS: 441 W. WILLIS

SCOPE: ERECT MULTI-FAMILY BUILDING

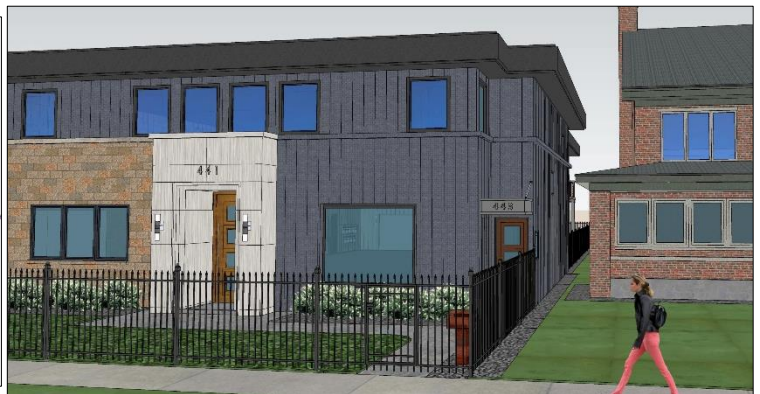
Applicant drawings

The facade has symmetrically placed windows and a dominant central door opening. The grouping of window openings, both mullied and single openings placed close together, creates a horizontal pattern at each floor. The second front door, which serves as the main entrance to three residential units, is deeply recessed from the primary wall, minimizing its visual impact on the facade.

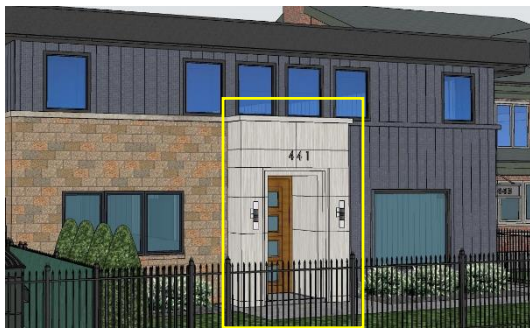
Applicant rendering. Google street view photos.

The limestone entrance echoes the first floor window and door openings of the former industrial building across the street.

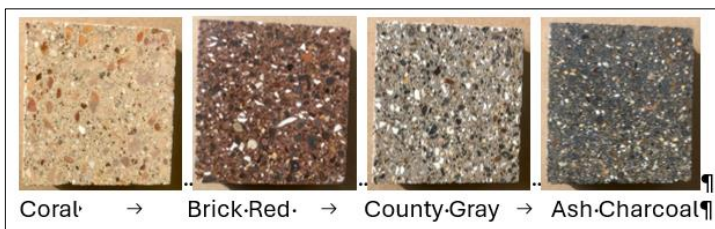
Above: Selected colors of CMU blocks, submitted by applicant and photographed by staff. Staff agrees the colors fall within the district’s dominate colors.

Staff’s concern is how the multiple cladding materials relate to the district as well as to each other. In contrast to the above streetscape photo, which shows two dominate wall materials and colors per building, the subject property has four wall materials and seven colors.

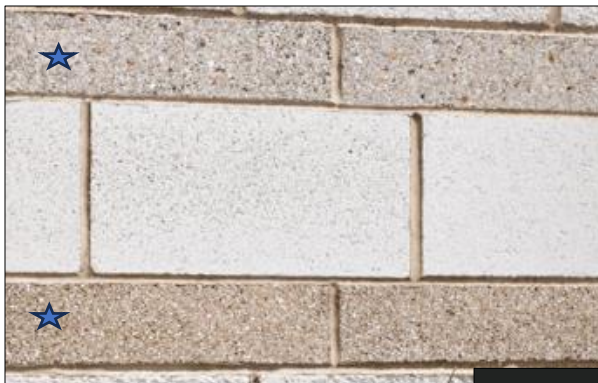
Left: Photo from Echelon Masonry’s Facebook page. Rows of Trendstone Plus units are identified with blue stars. This example shows the product in a size different than proposed by the applicant and is very likely “44F” (shown below). It is used as an alternating course with traditionally sized CMU.

Right: Page from Trendstone Plus website.

Selected product is CMU block and is boxed in red.

Dimensions:
7-9/16” deep x 7-9/16” high x 15-5/8” wide.

An additional size of CMU block is available and is boxed in blue.

Dimensions:
3-9/16” deep x 3-5/8” high x 15-5/8” wide.

It appears the company offers two dimensions of blocks: traditionally sized concrete blocks (similar to nominal block sizing of 8” deep x 8” high x 16” wide) and a narrow block (approx. 3-1/2” deep x 3-1/2” high x 15-1/2” wide) that offers a similar proportionality to Roman brick. The photo below shows both products together, offering a clear dimensional contrast between the two units. The applicant submitted samples of this product so the Commission can review the proposed colors and “terrazzo-like” surface finish.

The applicant selected the traditionally sized concrete block for the building, however the applicant calls it “stone veneer”. It is staff’s opinion that CMU walls are monolithic in appearance, even when multiple colors used, and the Commission has consistently denied the use of concrete block for exterior walls of residential buildings. As described in the Elements of Design, brick is the most common wall material, and this material translates well to contemporary designs and offers varied visual qualities, textures and brick patterns.

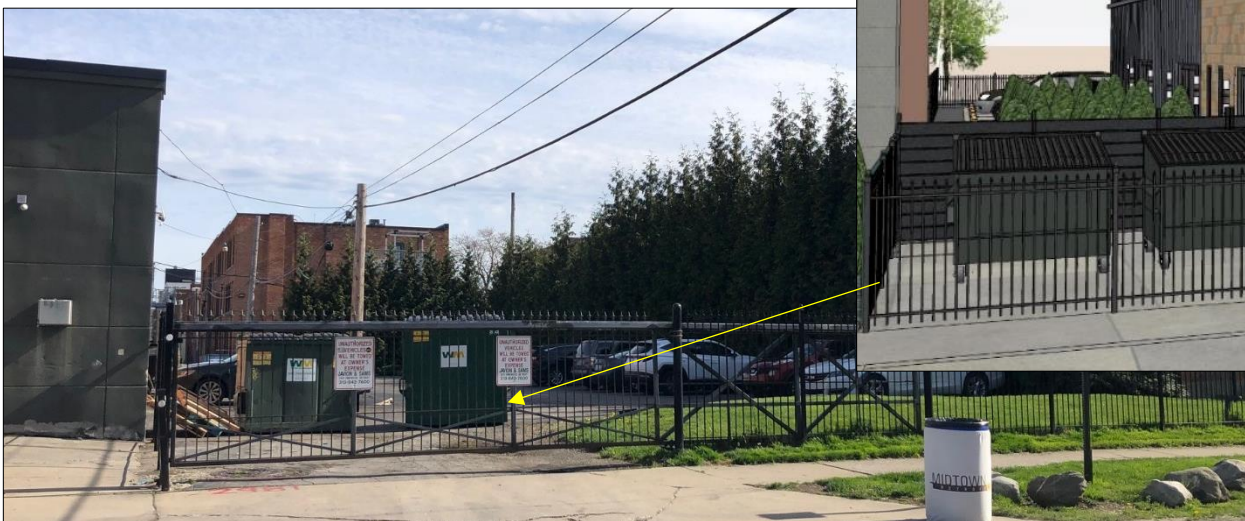
Above right: Magnified view of proposed enclosure.

Details of enclosure.

The placement and design of the garage enclosure, however, is not appropriate for this location and setting and does not meet Elements 12 and 13. The site plan shows the trash enclosure sits forward of the existing and proposed buildings. Additionally, three different wall materials are proposed for the four walled enclosure.

Front and East walls – The existing metal fencing and gates will remain as-is.

West wall - New metal fencing, to match the existing fence, will be installed. The applicant suggests attaching a privacy screen at this location. The product advertised in the cut-sheet is primarily used for jobs sites and tennis courts and is typically installed on chain link fencing. Color: green.

Rear wall – A 6'-0" plastic composite horizontal board fence will be installed. The shine and flatness of the manufactured material does not adequately match the profile, dimensionality, and appearance of wood or metal, the most common materials used in fencing and is incompatible for use in the historic district (and is in conflict with *Element 7 – Relationship of Materials* and *Element 8 – Relationship of Textures*).

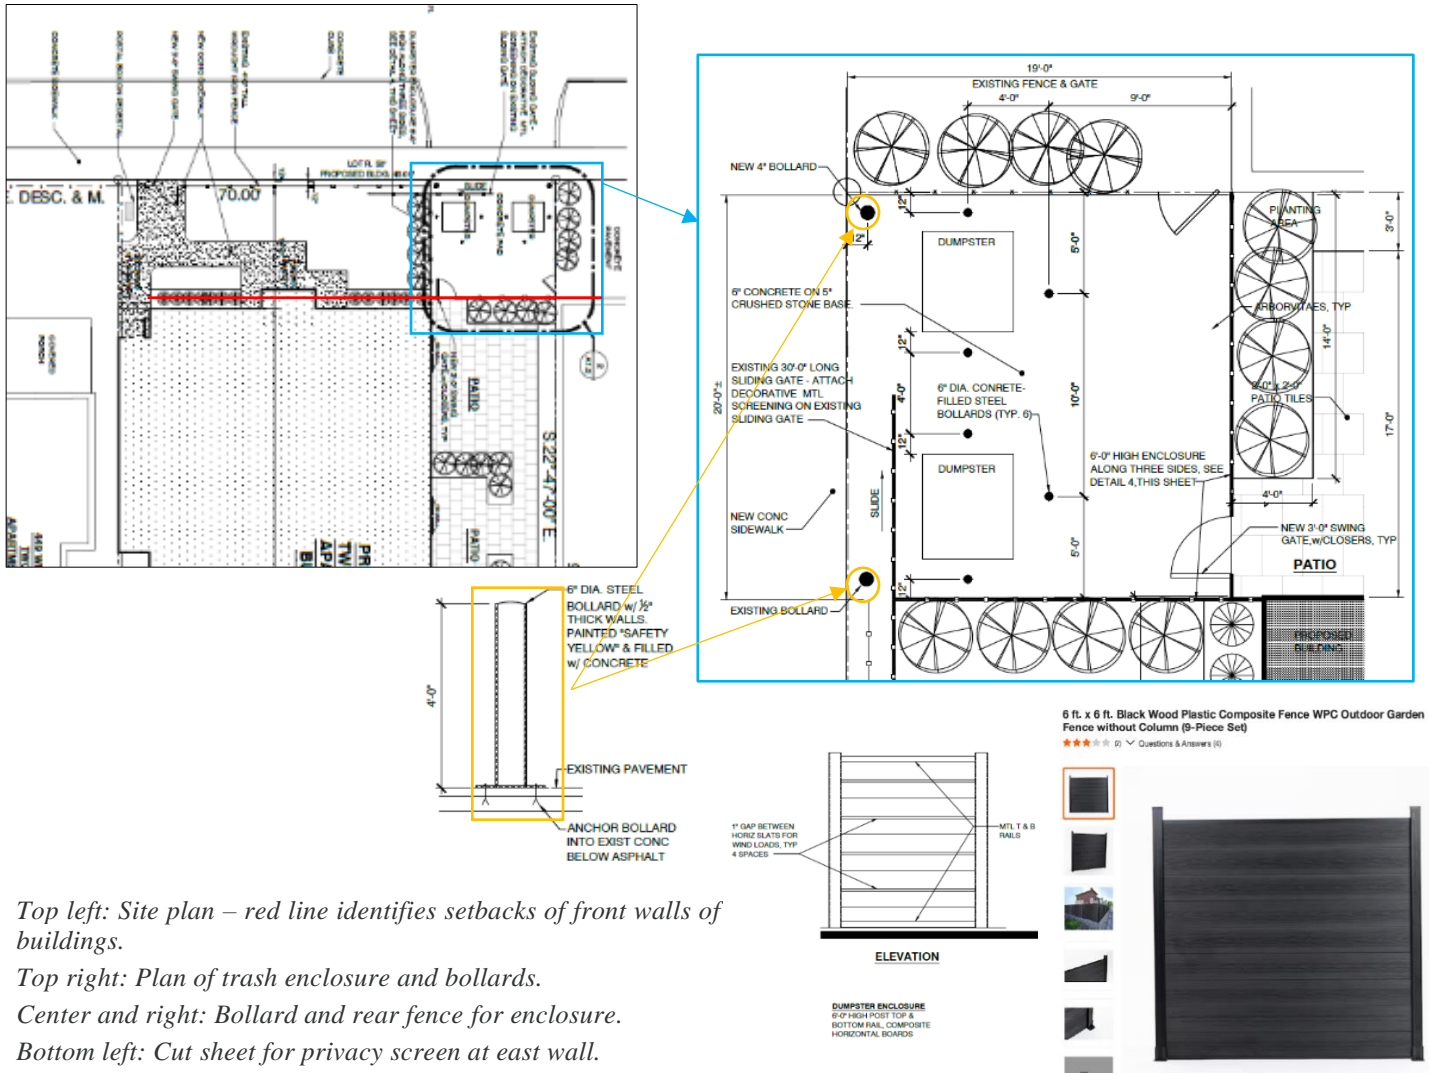
Top left: Site plan – red line identifies setbacks of front walls of buildings.

Top right: Plan of trash enclosure and bollards.

Center and right: Bollard and rear fence for enclosure.

Bottom left: Cut sheet for privacy screen at east wall.

Bottom right: Applicant rendering showing trash enclosure and front yard fencing. Staff added orange circles to denote location of bollards, based on the site plan. The rendering shows the fence at the edge of the sidewalk, whereas in reality it is setback about six inches, likely enough room for the bollards.

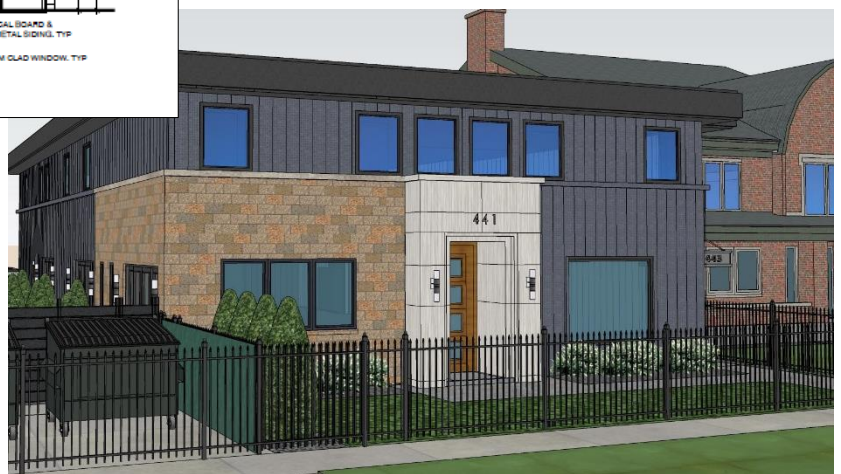
The proposed design includes vertically oriented window and door openings, similar to the surrounding buildings. The singular and mullied window openings create a uniform proportionality, with the exception of the large picture window. Staff recommends the large opening at the first floor be subdivided.

Applicant elevation and rendering. The windows at 449 W. Willis are depicted as casements, but they are 1-over-1 double-hung units.

The 3-1/2- and 5-1/2- story apartment buildings (469 and 479 W. Willis) offer highly symmetrical designs, as does the 2-1/2 story dwelling (455 W. Willis). The balanced massing and consistent window/door openings are emphasized by singular contrasting window trim. At 449 W. Willis, the building next door to the subject property, the asymmetrical massing of the house is balanced by the vertical and horizontal alignment of the window and door openings. It should be noted the windows at 449 W. Willis are one-over-one double-hung units, as shown above. The applicant's renderings consistently incorrectly show these window openings as casement units without any divisions.

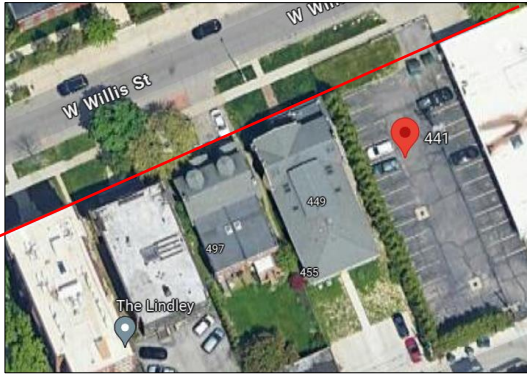
The red line drawn along the front walls of the commercial and residential buildings to the east and west of 441 W Willis shows the majority of the buildings have similar setbacks.

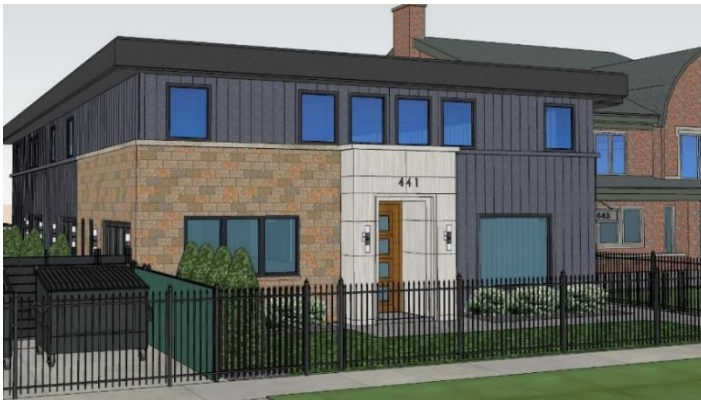
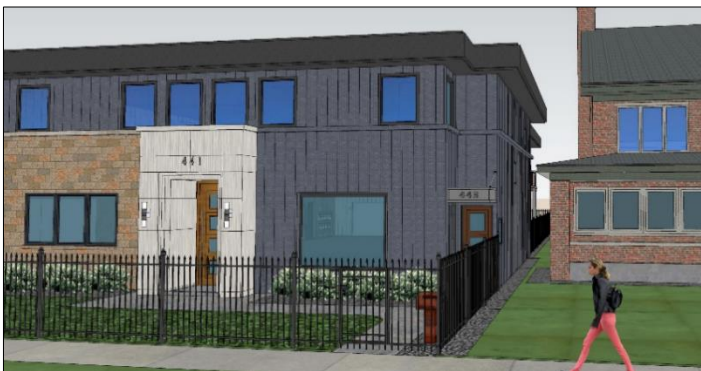
The renderings give the illusion that the new building sits well forward of the neighboring house. However, the site plan shows that the front wall sits minimally forward of the adjacent house, and matches the generally consistent placement of buildings on the south side of W Willis.
