STAFF REPORT: AUGUST 14, 2024, REGULAR MEETING
APPLICATION NUMBER: HDC2024-00364

ADDRESS: 134 ARDEN PARK

HISTORIC DISTRICT: ARDEN PARK-EAST BOSTON

SCOPE: INSTALL CONCRETE PAVEMENT IN FRONT YARD

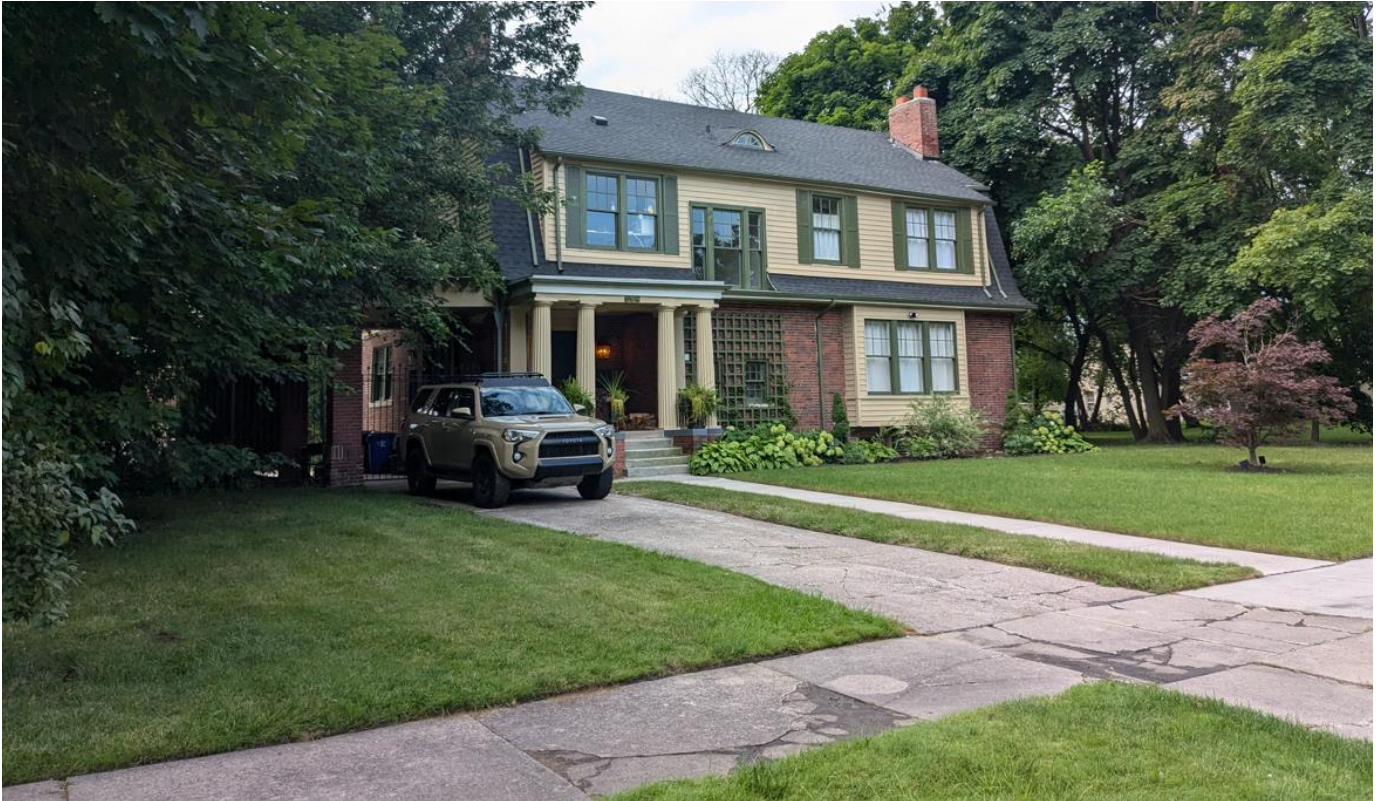
July 2024 photo by staff.

Built in 1912, the property at 134 Virginia Park is a one-and-one-half story house, facing north towards the street. It is Colonial Revival in style, clad in red-brown brick and yellow-painted wood siding. Character-defining features include the asymmetrical façade with gambrel roof, Tuscan-columned, recessed front entry porch, and a flat-roofed porte cochere or carport.

Pertinent to this application, a one-car-width concrete driveway extends from a rear, two-bay garage (built in 1913), through the carport, to the street. Parallel to the driveway, a paved pedestrian walk extends from the front entrance to the sidewalk. The walkway has been truncated, without approval from the Historic District Commission, and formerly extended all the way to the street. The latter work was performed between 2015 and 2021, according to Google Maps and staff photos.

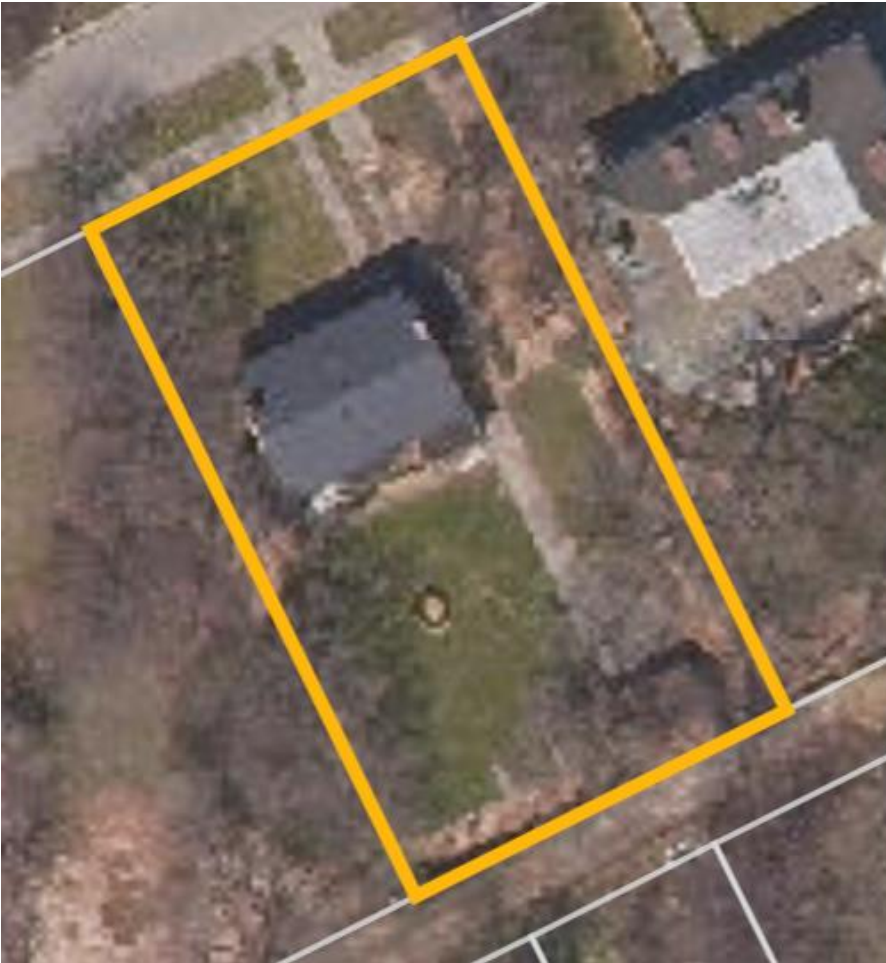
Aerial view from Detroit Parcel Viewer.

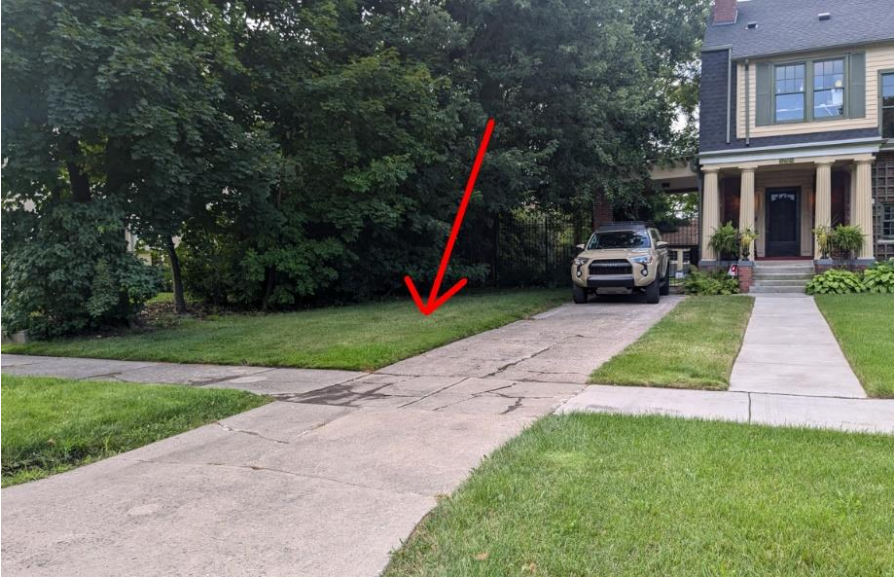
August 2024 staff photo with arrow added to indicate approximate location of proposed pavement.

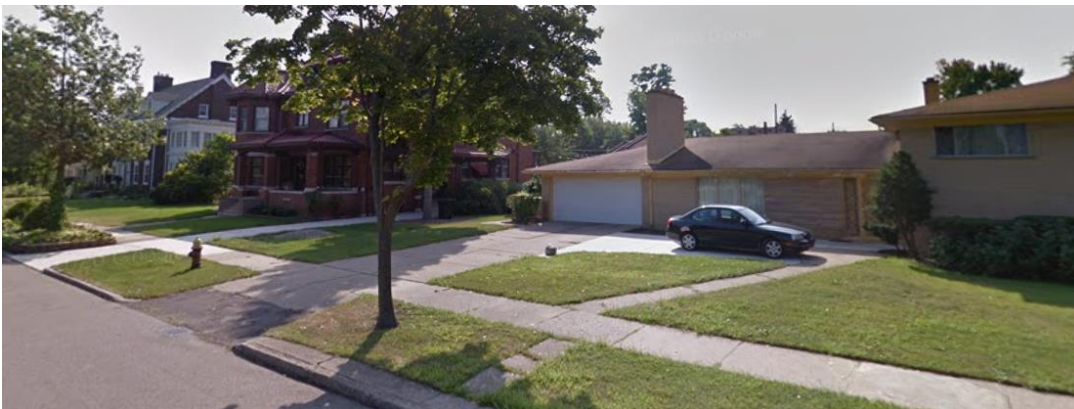
*The 200 block of Arden Park Boulevard, looking east. This view shows the only example in the neighborhood of a paved front yard area, shown being used for improper parking. There is no record of Historic District Commission approval for the expanded pavement. 2013 Google Maps image. **Correction: Another such area is at 621 Arden Park; this work predates the establishment of the historic district.***
