**ADDRESS: 801 EDISON**

**APPLICATION NO: HDC2025-00037**

**HISTORIC DISTRICT: BOSTON-EDISON**

**SCOPE: REPLACE WINDOWS, GUTTERS, AND DOWNSPOUTS**

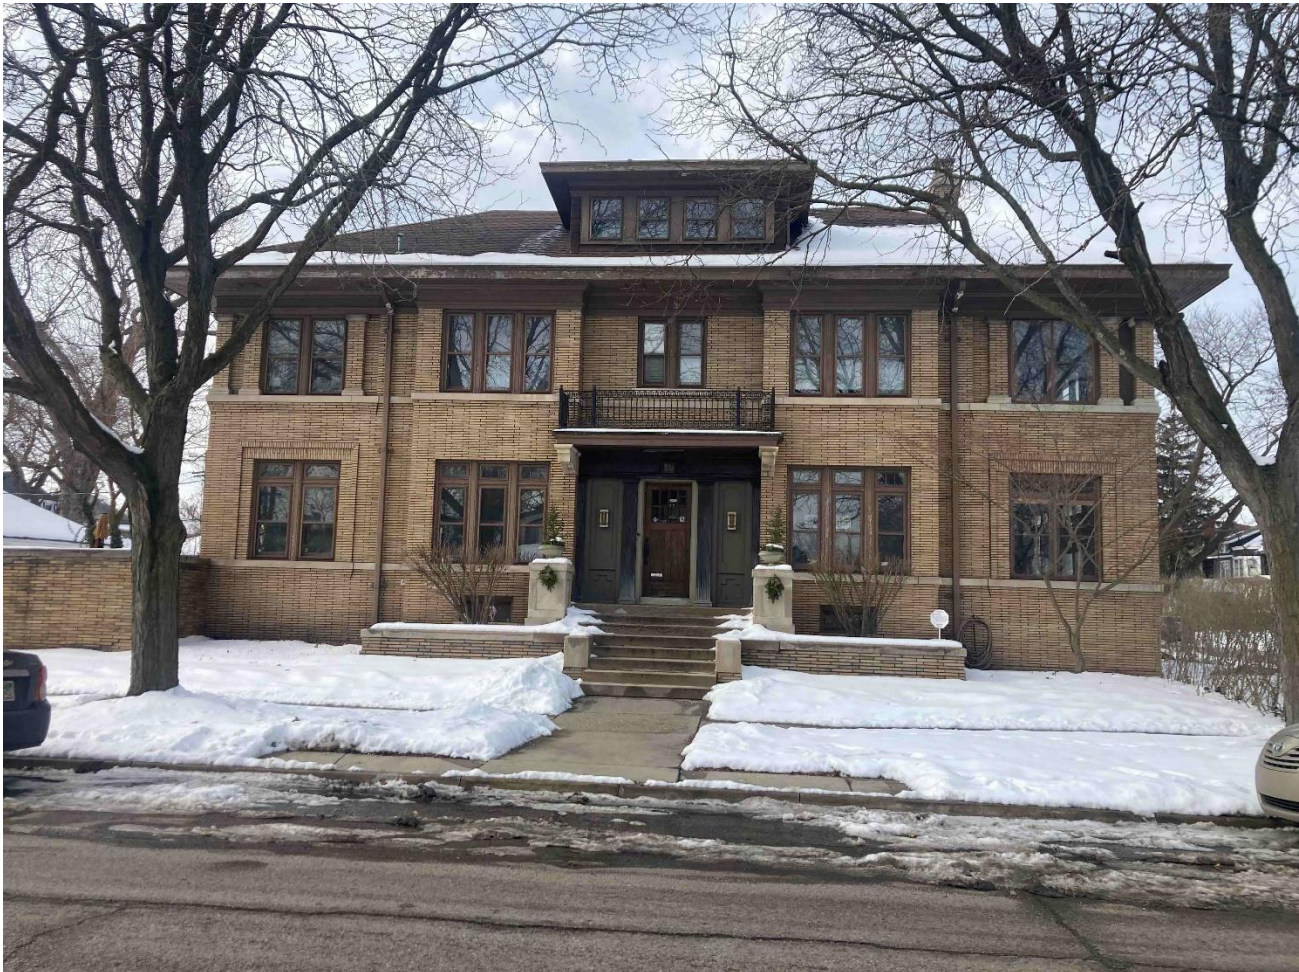
**801 Edison, current conditions. Photo by HDC staff, 2/25/2025.**

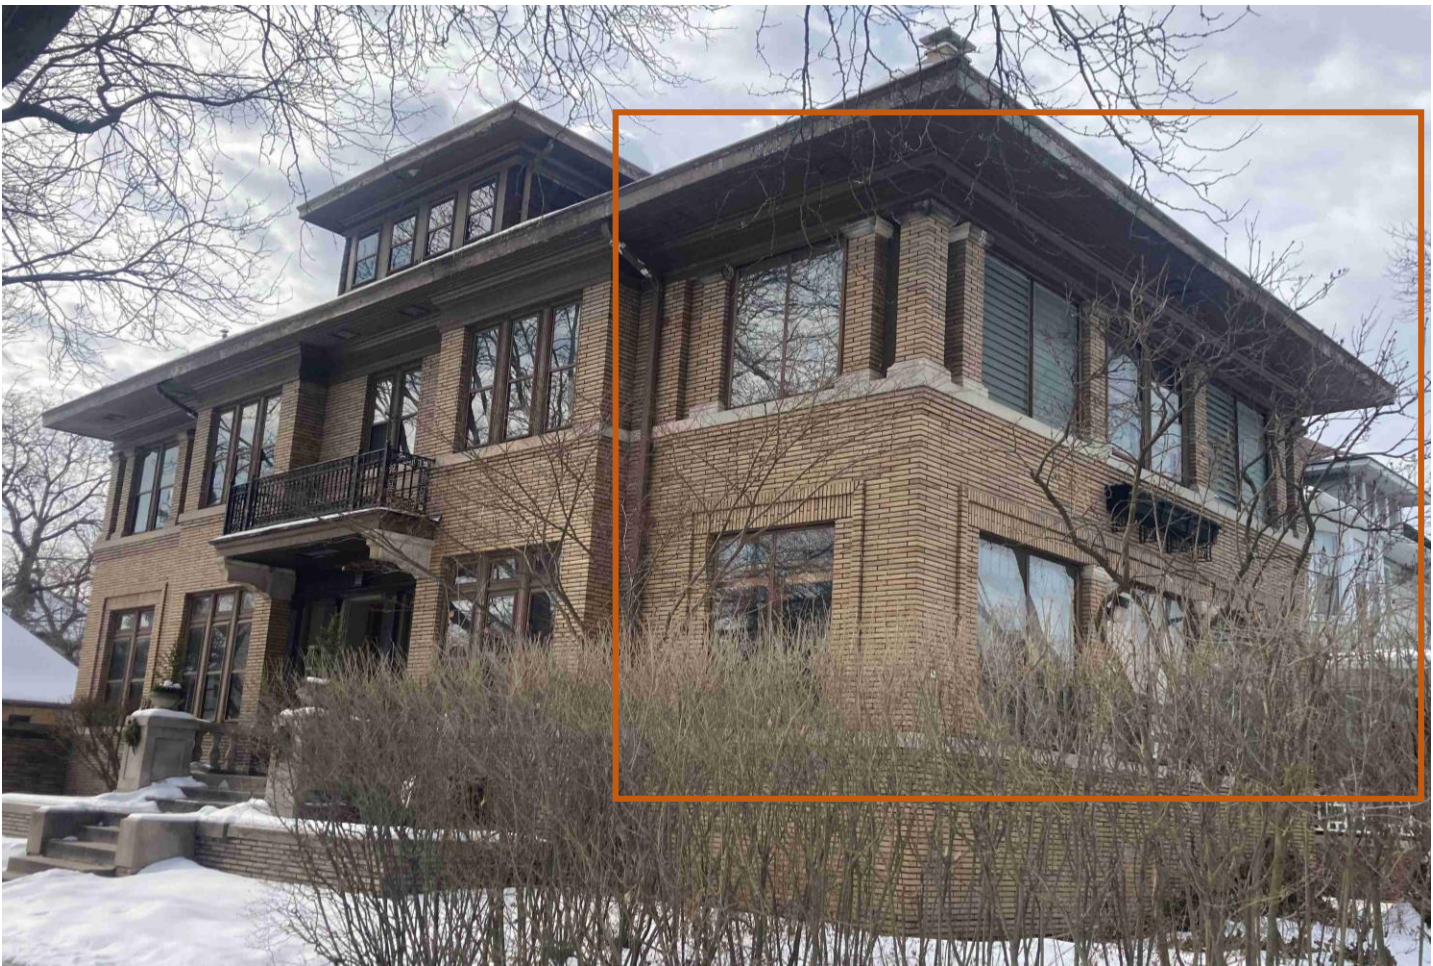
801 Edison, current conditions. Photo by HDC staff, 2/25/2025. North side porch outlined in orange

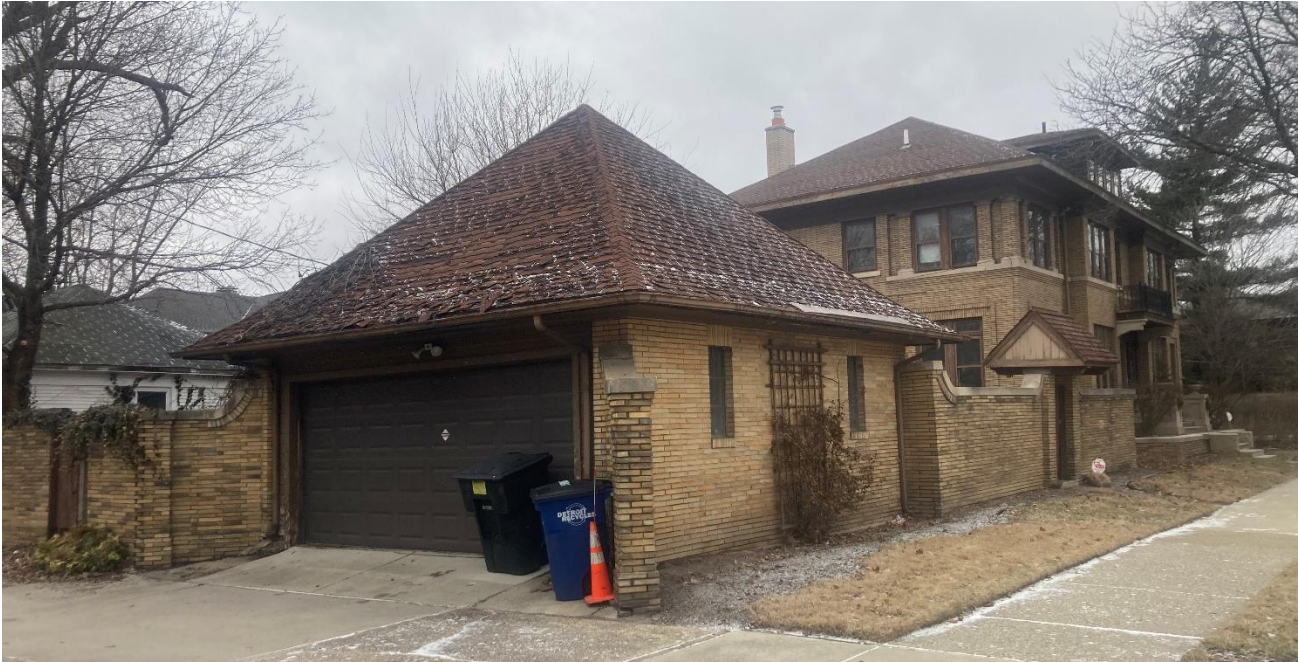
801 Edison garage, current conditions. Photo by HDC staff, 3/6/2025.

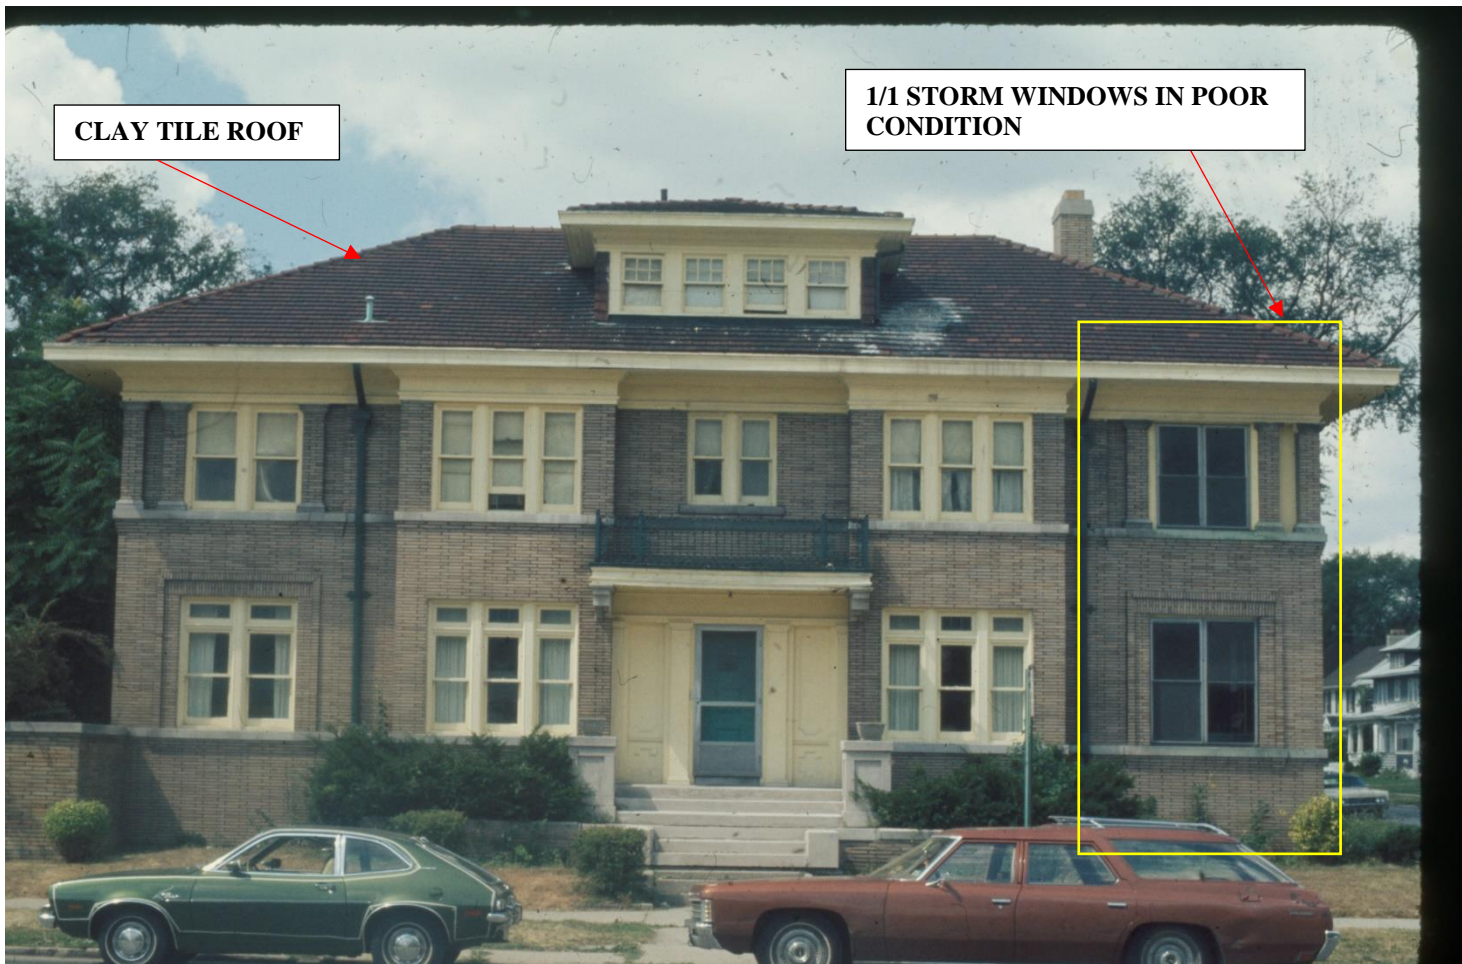
801 Edison, designation photo taken in 1974

- The Boston-Edison historic district was designated in 1974
- See the below photos of the house which date from 1974 and 1980. Note that at the time of the district's designation, the house had a clay tile roof, and the porch windows appeared to be 1/1 storm windows and jalousie windows

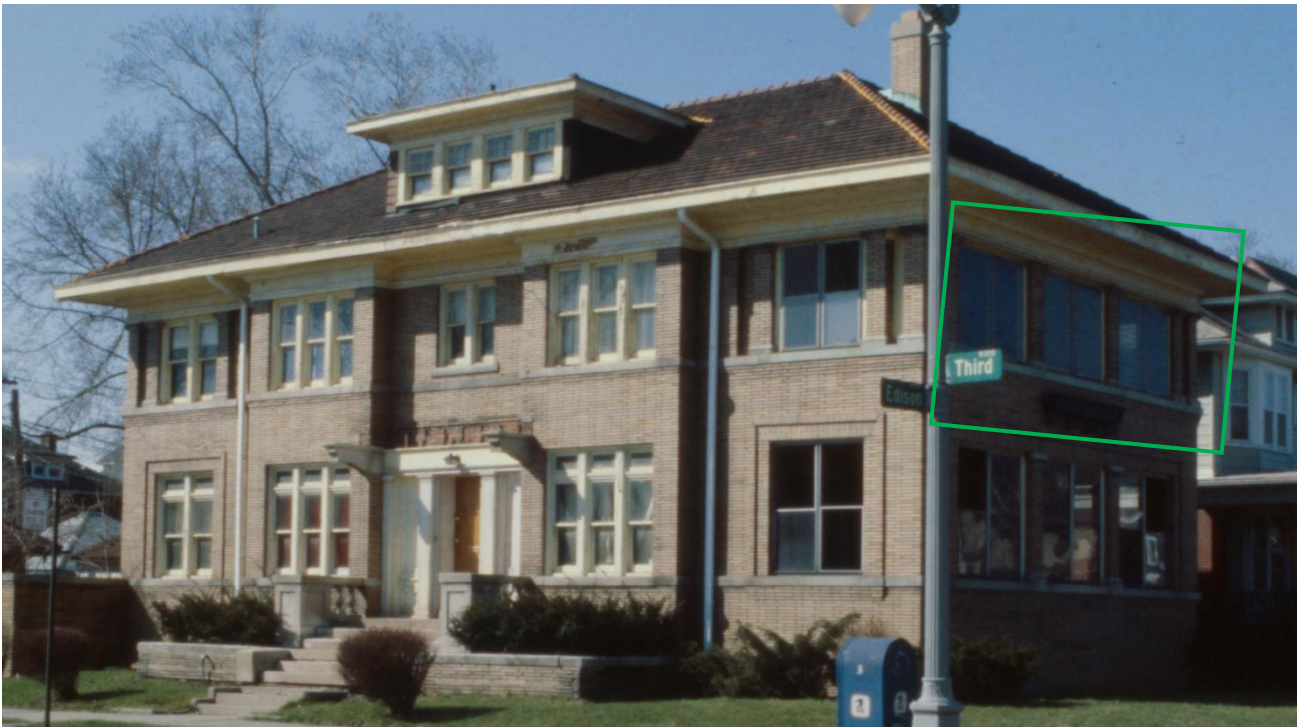
801 Edison, photo taken in 1980. See the side porch wing. The windows at the porch outlined in green are jalousie windows. All other windows at the porch appear to be 1/1 storm windows

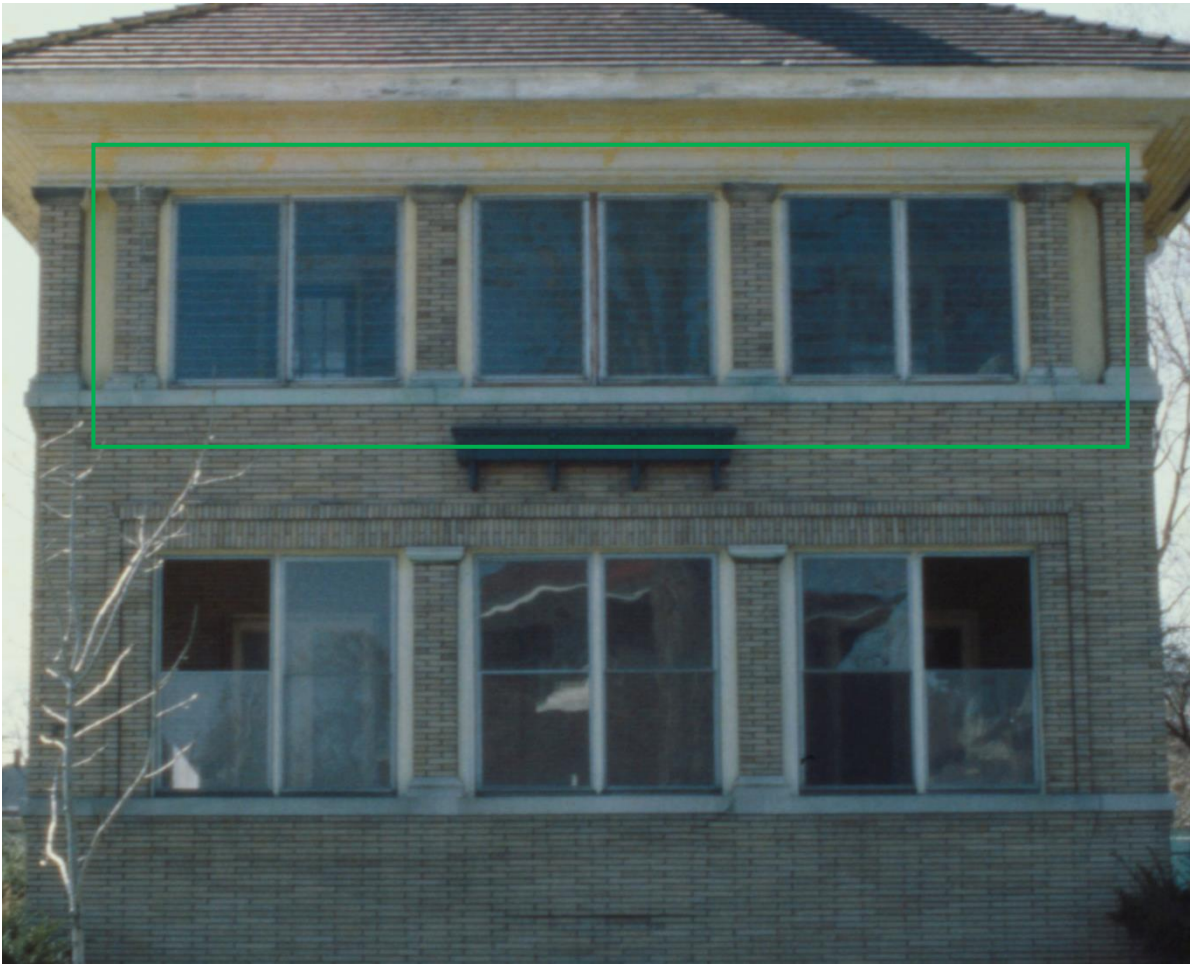
801 Edison, photo taken in 1980. See the side porch wing. The windows at the porch outlined in green are jalousie windows. All other windows at the porch appear to be 1/1 storm windows

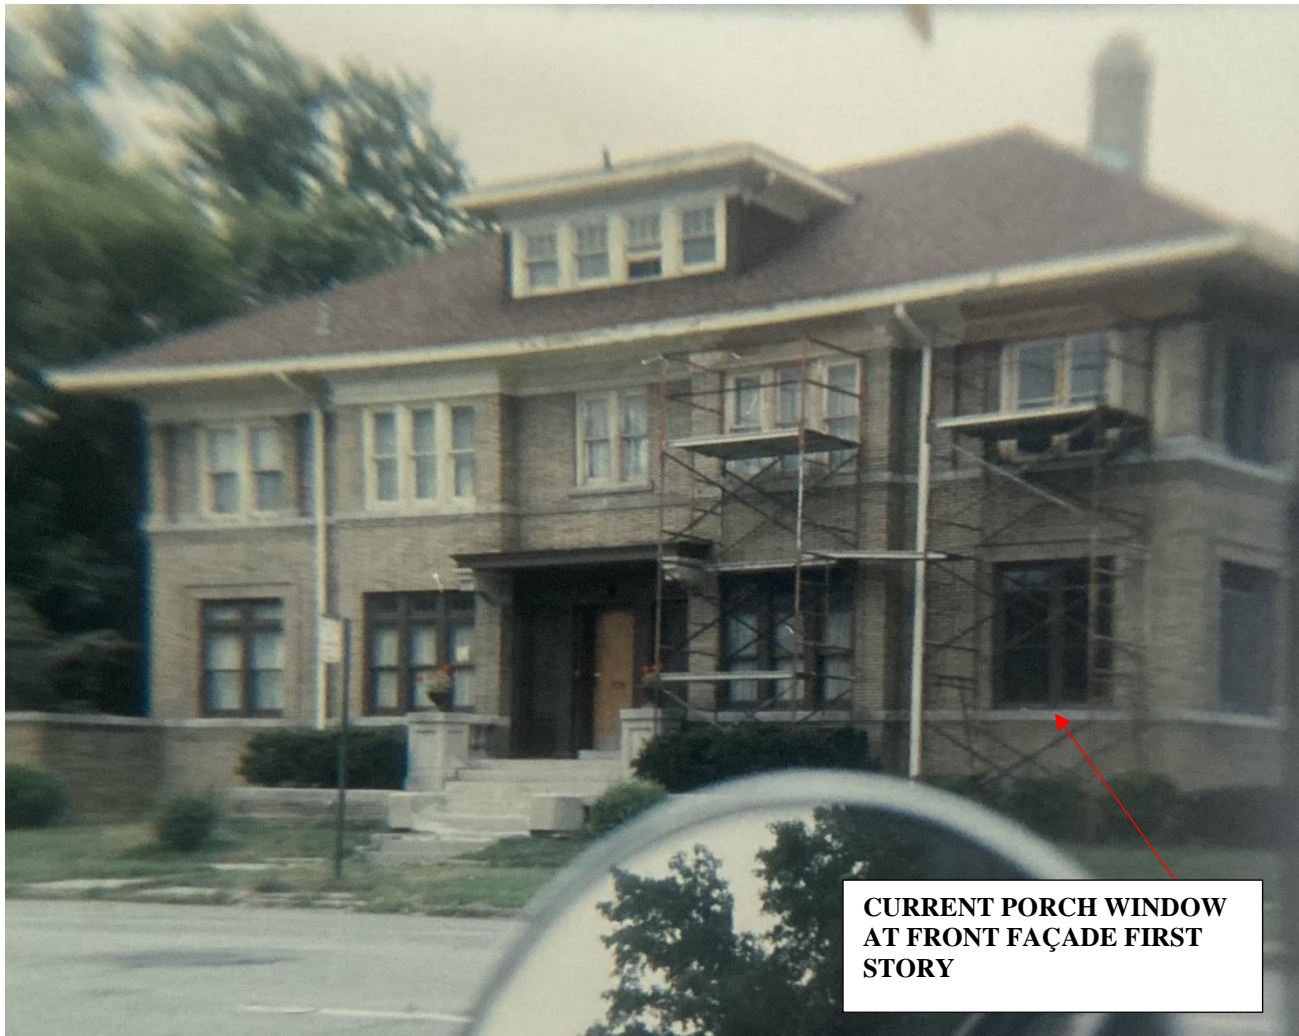
Ca. 1983 photo. Note that the owner was in the process of replacing the side porch windows per the above note. See the below photos to note the window conditions in 1974 and 2025.

- Install new aluminum storm windows
- See the below undated/ca. 1983 photo to note the following:
  - The clay tile roof had been removed and replaced with asphalt shingles per the 1982 COA.

- The window and front door trim were in the process of being painted brown
  - The aluminum storm windows which were approved by the 1982 COA had not yet been installed at the house's main body. Likely, the wood windows had to be painted brown prior to the installation of the storms

- The owner had begun to install the current wood windows at the north side porch. Staff was unable to locate a COA for the replacement of the porch's storm windows. Nevertheless, as noted above, the windows which were present in 1974 and removed ca. 1983 were not distinctive character-defining features of the house, in staff's opinion.

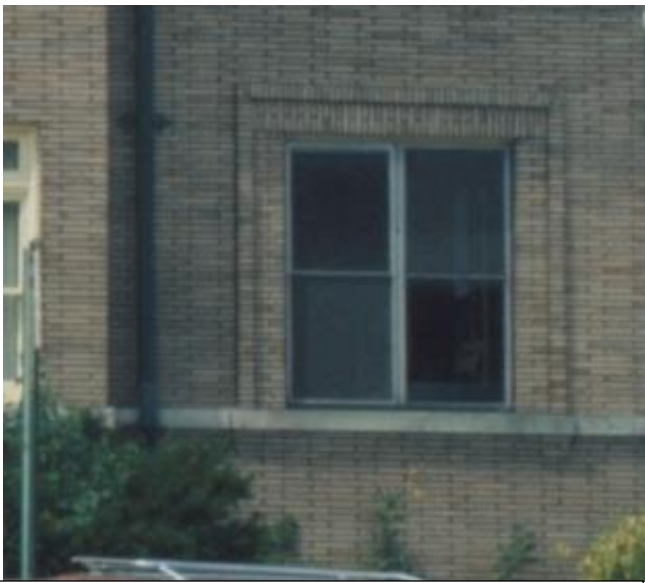
**Above referenced porch window opening at front façade, first story, condition in 1974, prior to ca. 1983 replacement**

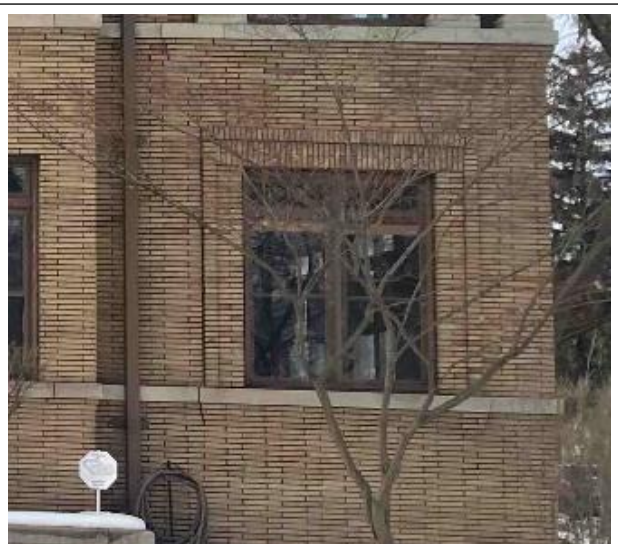
**Above referenced porch window opening at front façade, first story, current condition. This window was installed ca. 1983**

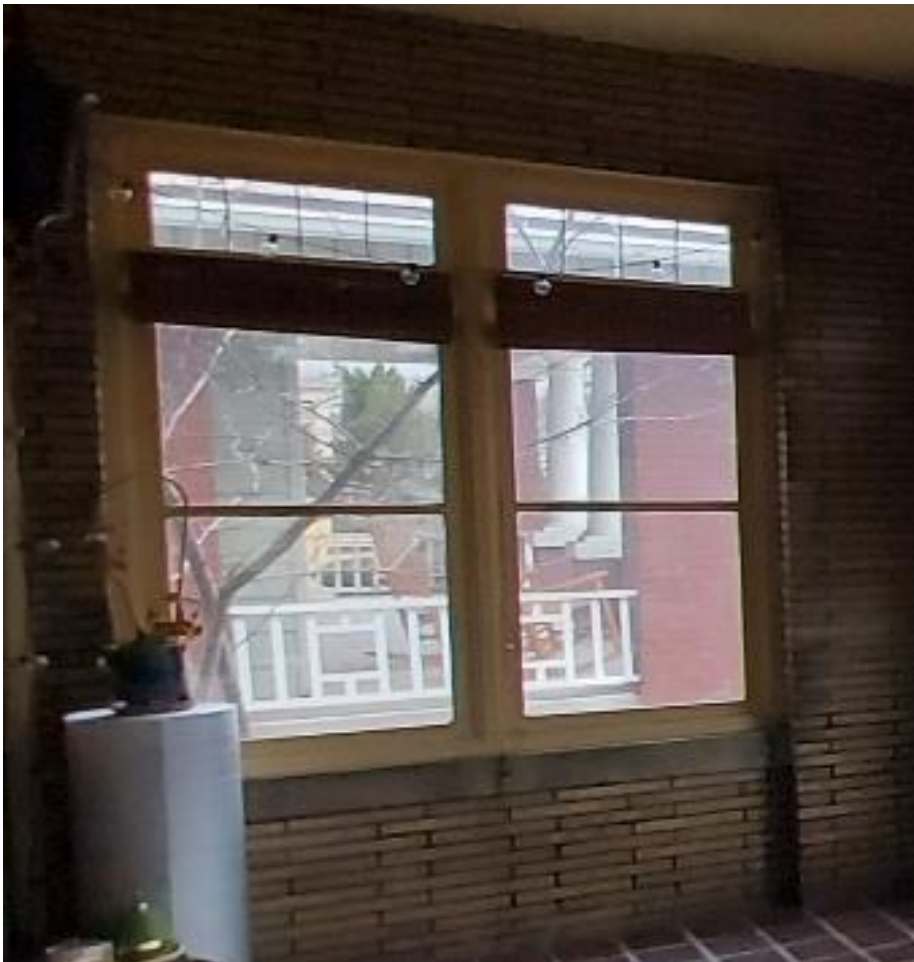
**Window type that is present at the porch, front façade, first story. This window was installed ca. 1983. The window type is a wood 1/1 unit with what appears to be a fixed transom with metal caming**

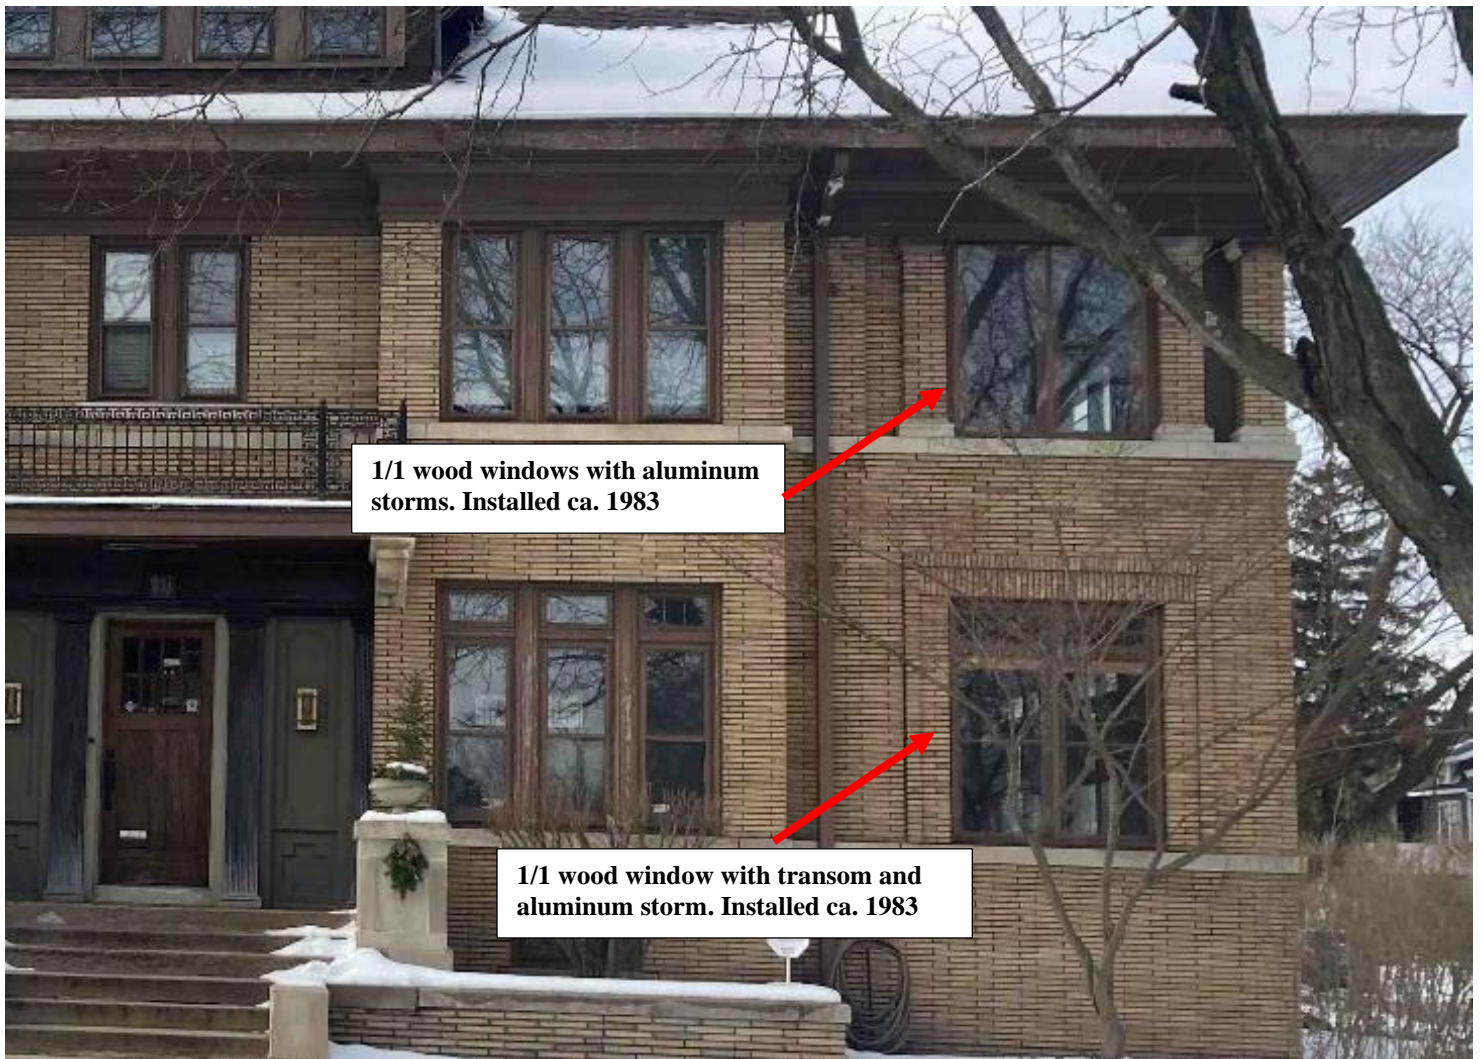
East/front façade, showing windows at porch which are proposed for replacement. Staff photo taken on 2/25/2025

**1/1 wood windows with aluminum storms. Installed ca. 1983**

- See the below photos of the windows at the side two-story porch. A review of HDC records indicated that the current porch windows were likely installed in 1983. Note that the windows at the first story are 1/1 wood units and jalousie units. Each window at the first story is topped with a fixed transom with metal casing, consistent with the original wood windows at the house's main body, first floor. The porch's second story windows are 1/1 wood units and jalousie windows without transoms, which is consistent with the original wood windows at the house's main body, second floor. Aluminum storm windows, also added ca. 1983, are present at all of the porch windows with the exception of two jalousie windows at the porch's south façade, second story. Staff was unable to locate a COA for the existing wood porch windows. However, as noted above, the porch windows which were present in 1974/at the time of the district's designation which were replaced by the current windows were not original to the building's construction and were not character defining. Their removal in 1983 was therefore appropriate. However, staff would have recommended that any new windows proposed for installation at the side porch be simple 1/1 wood units with minimal casing/trim of a simple profile and clear/transparent, non-reflective glass as the openings at the porch would have originally been open/unenclosed. Staff therefore would have recommended against any proposal that the new windows include a transom.

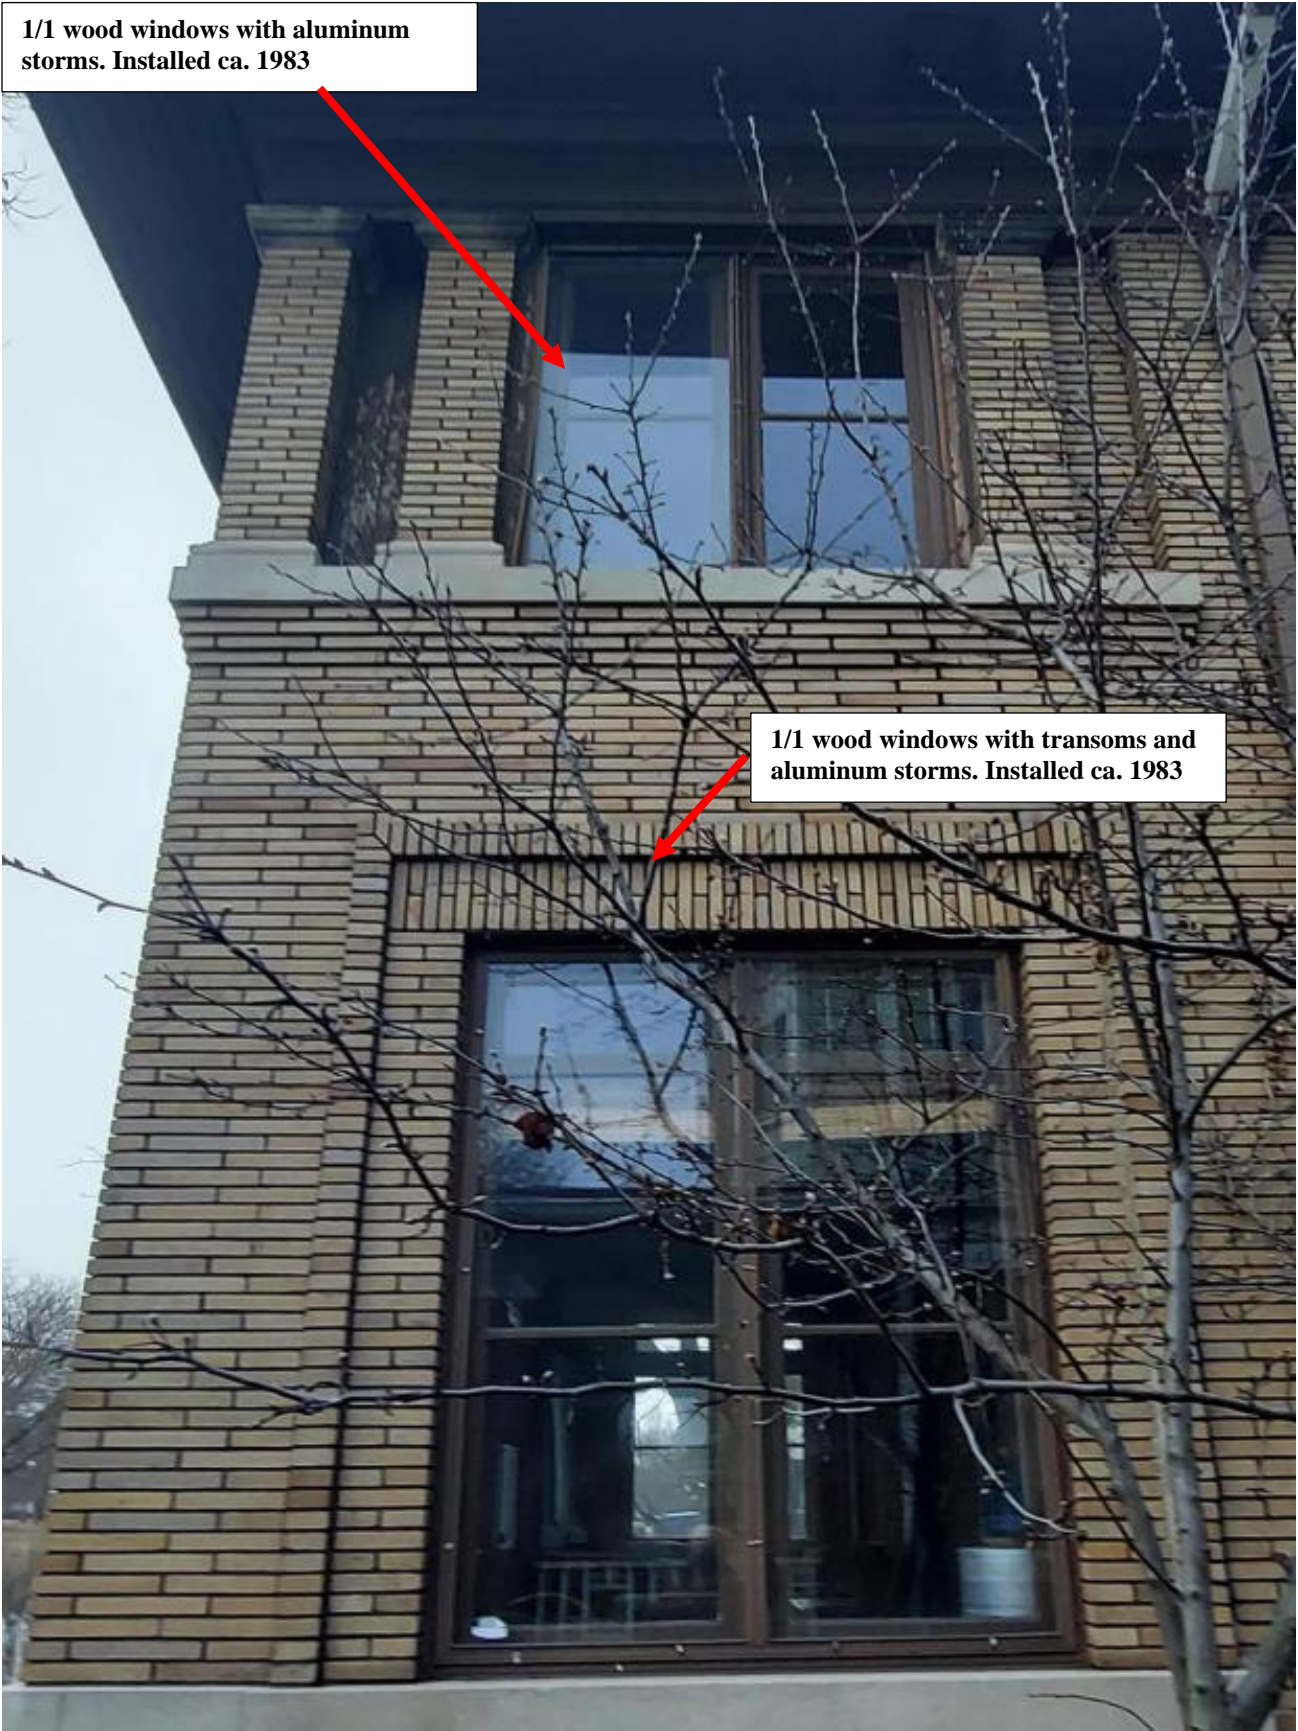
**1/1 wood windows with transoms and aluminum storms. Installed ca. 1983**

**West façade of porch, showing ca. 1983 window proposed for replacement. Photo by applicant**

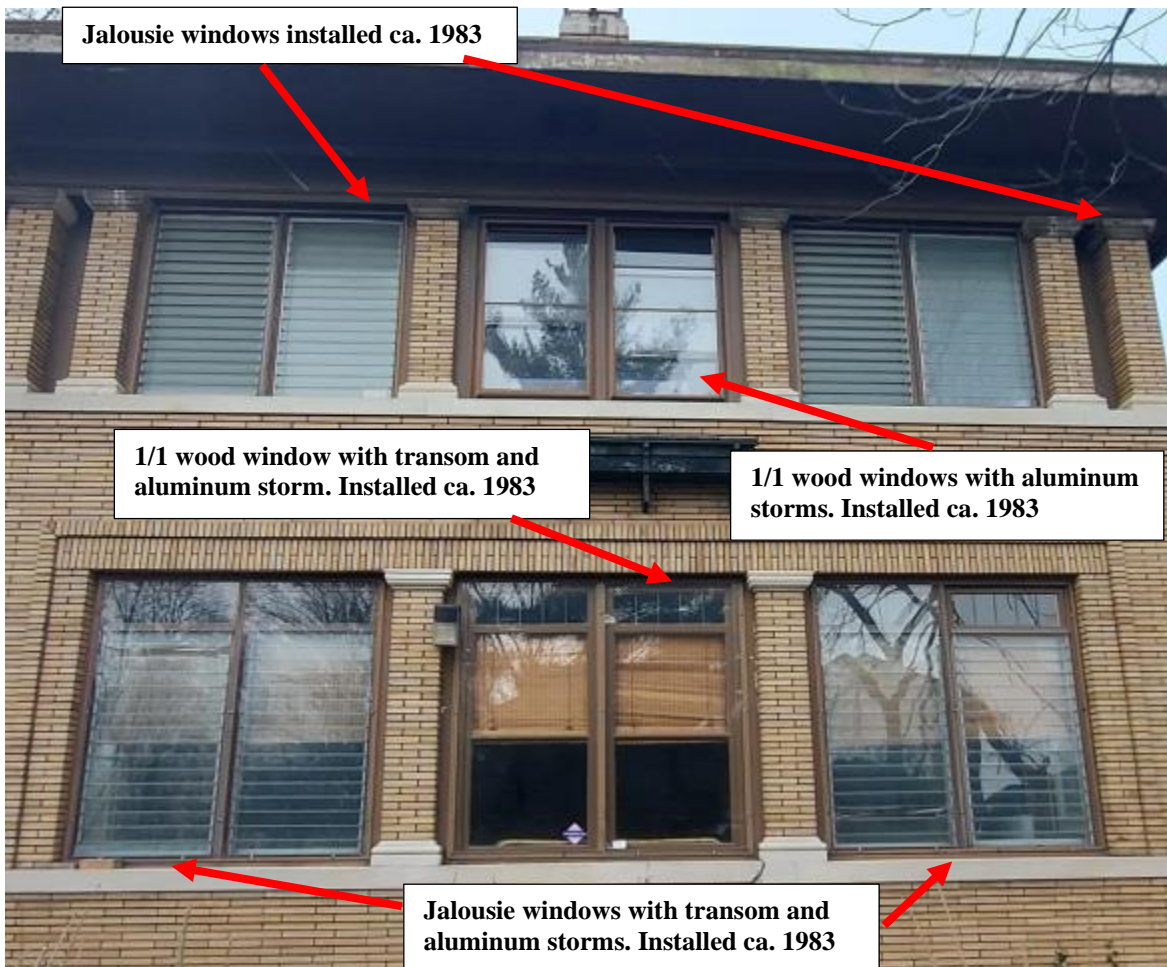
North/side façade, showing windows at porch which are proposed for replacement. Staff photo taken on 2/25/2025

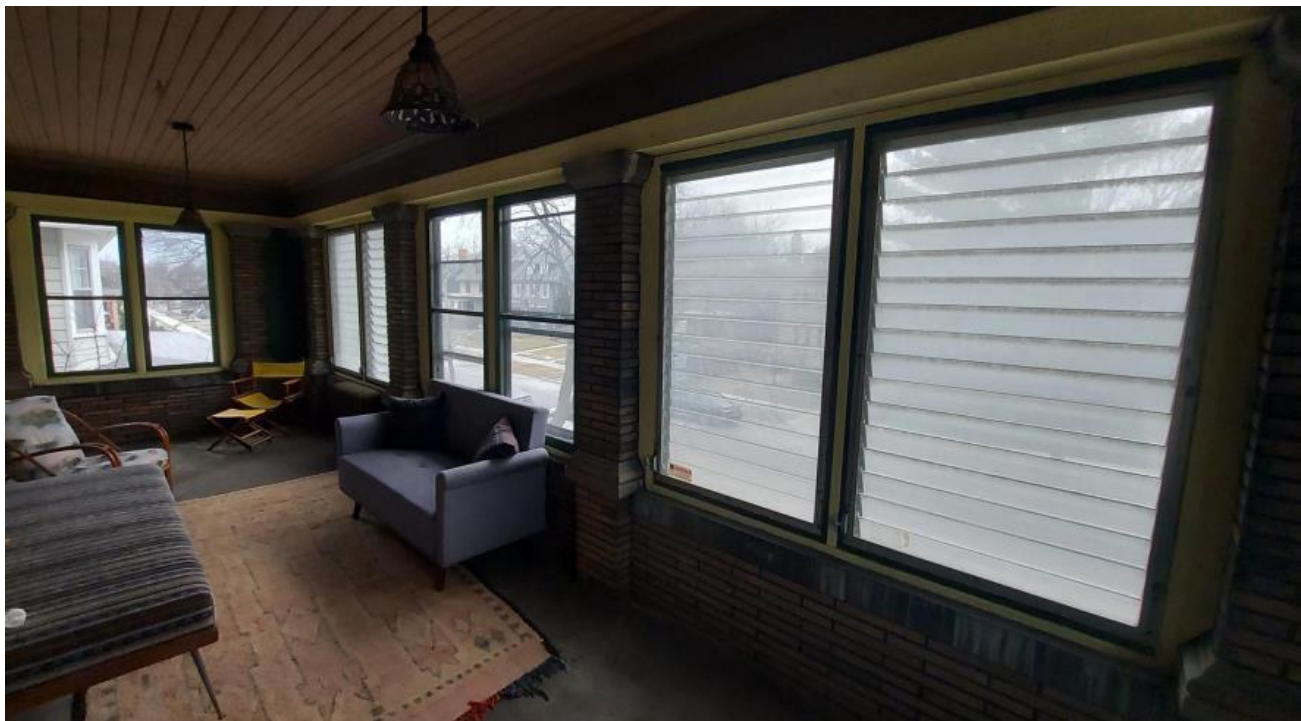
Interior of porch, second story. Facing northwest, showing windows installed ca. 1983. Photo provided by applicant

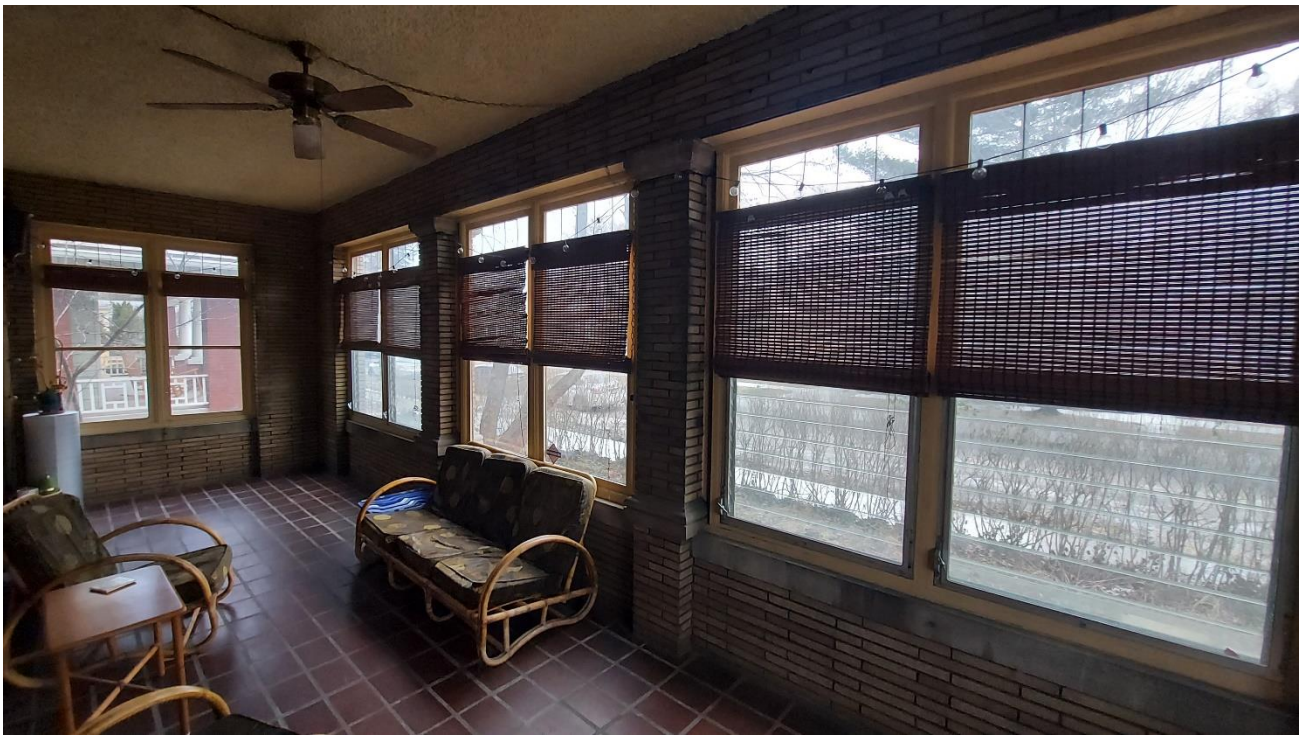
Interior of porch, first story. Facing northwest, showing windows installed ca. 1983. Photo provided by applicant
