APPROVED BY:	DATE:
CUSTOMER APPROV:	DATE:
DRAWN BY: S.A. FERRISE	
PORCH REPAIR & CONCRETE AS SAME	
JOB NUMBER: TM2003	
SCALE: 1/2" = 1'	
DATE: 13-MAY-2020	
<b>WILSON RESIDENCE</b> <b>14801 PENROD</b> <b>DETROIT, MI 48223</b> <b>313-338-9767</b>

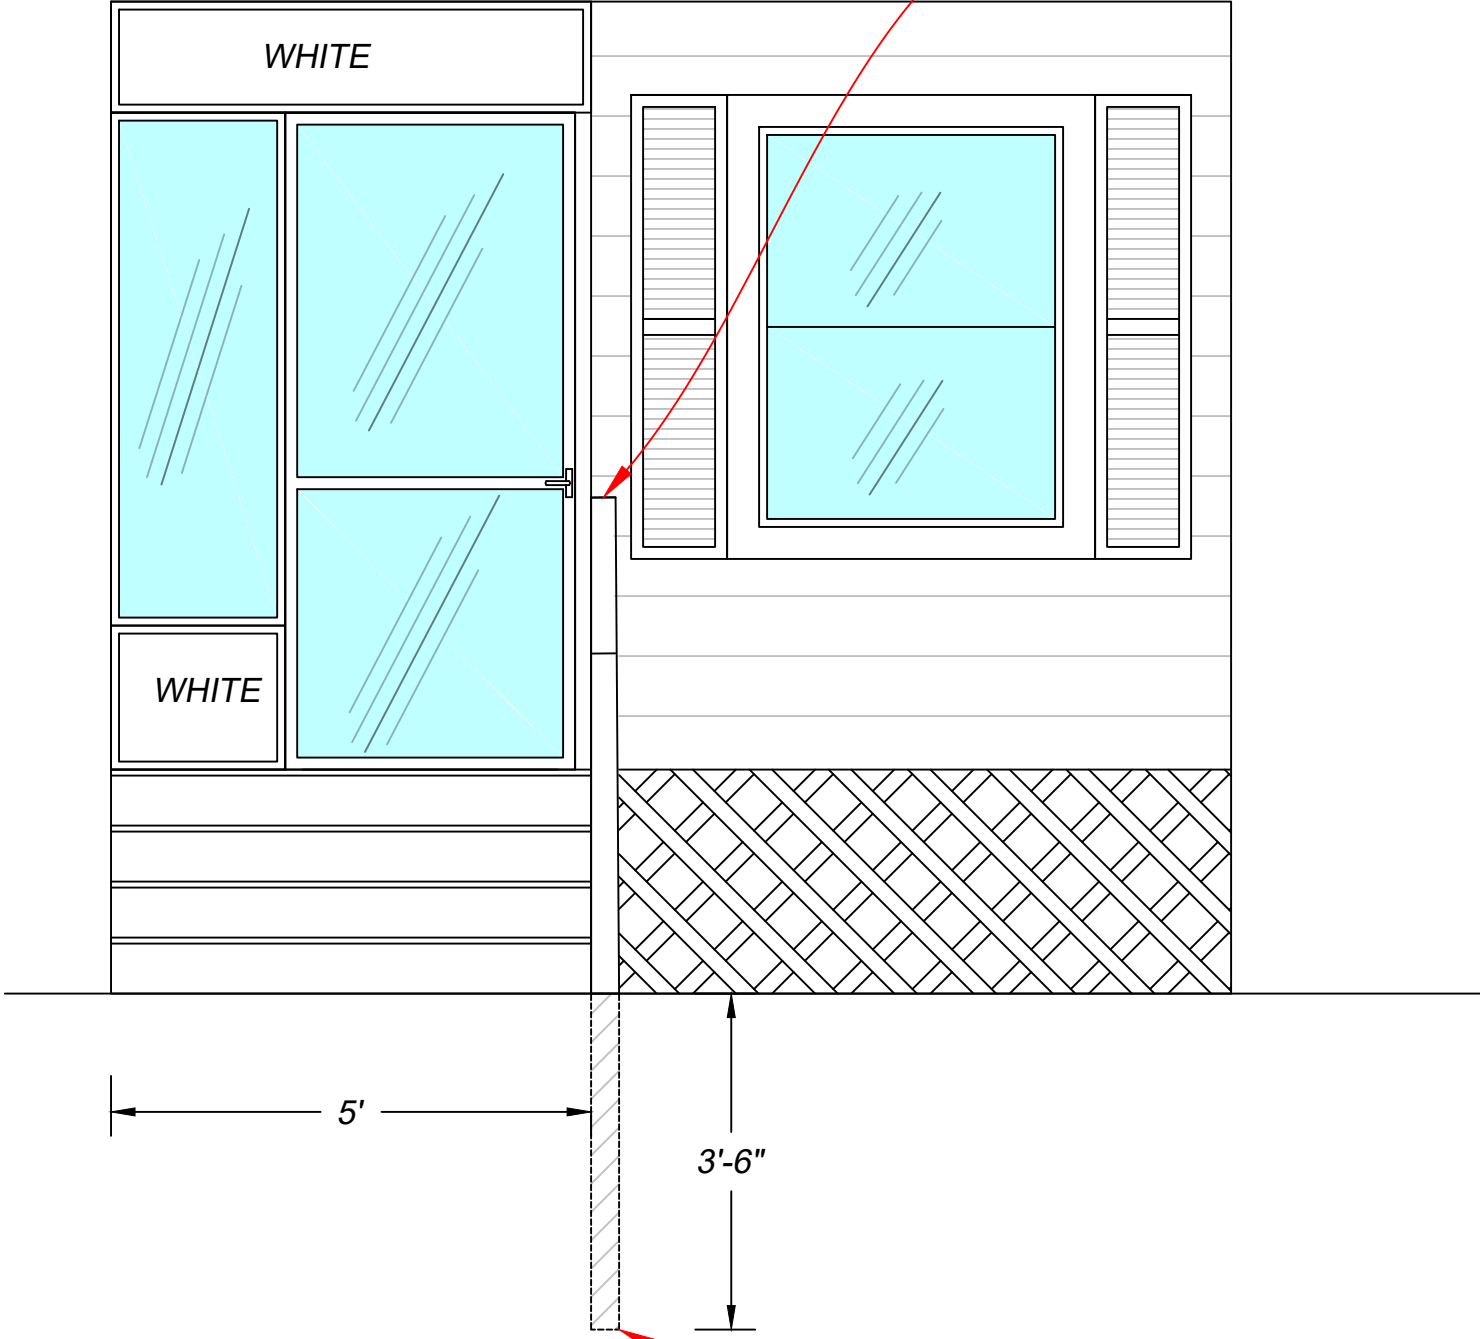
TOP RAIL TO BE ANCHORED TO CORNER OF EXISTING STRUCTURE.

BOTTOM RAIL POST TO BE SET MIN. 42" BELOW GRADE.

MRC R311.7.7  
REQUIRES AT LEAST ONE HANDRAIL  
PROVIDED ON ONE SIDE OF CONTINUOUS  
RUN OF TREADS OR FLIGHT WITH FOUR  
OR MORE RISERS.
