THE RECTORY

1920 ATKINSON ST. Detroit, Michigan 48206

Iannuzzi Studio PLLC 1410 Service St. Suite 202 Detroit, MI 48207

SHEET TITLE:
DEMO PLANS

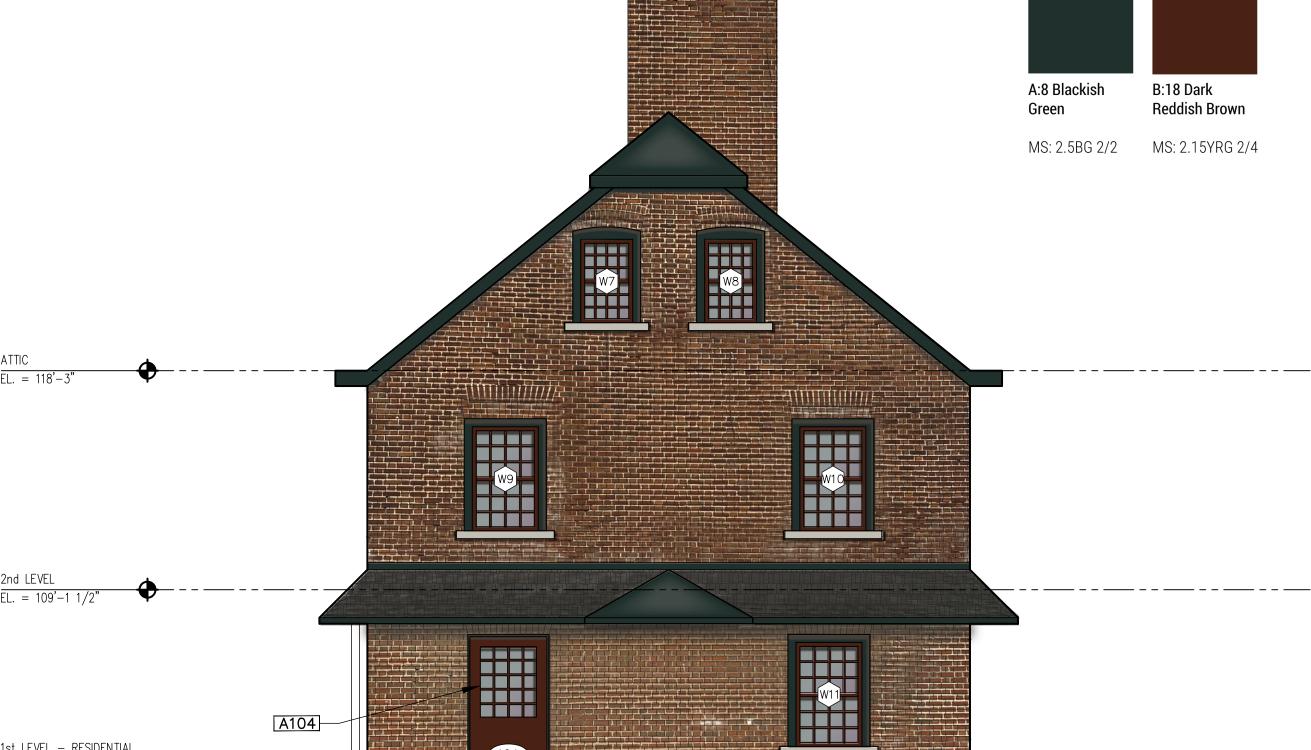
3 South Elevation
A2.0 1/4" = 1'-0"

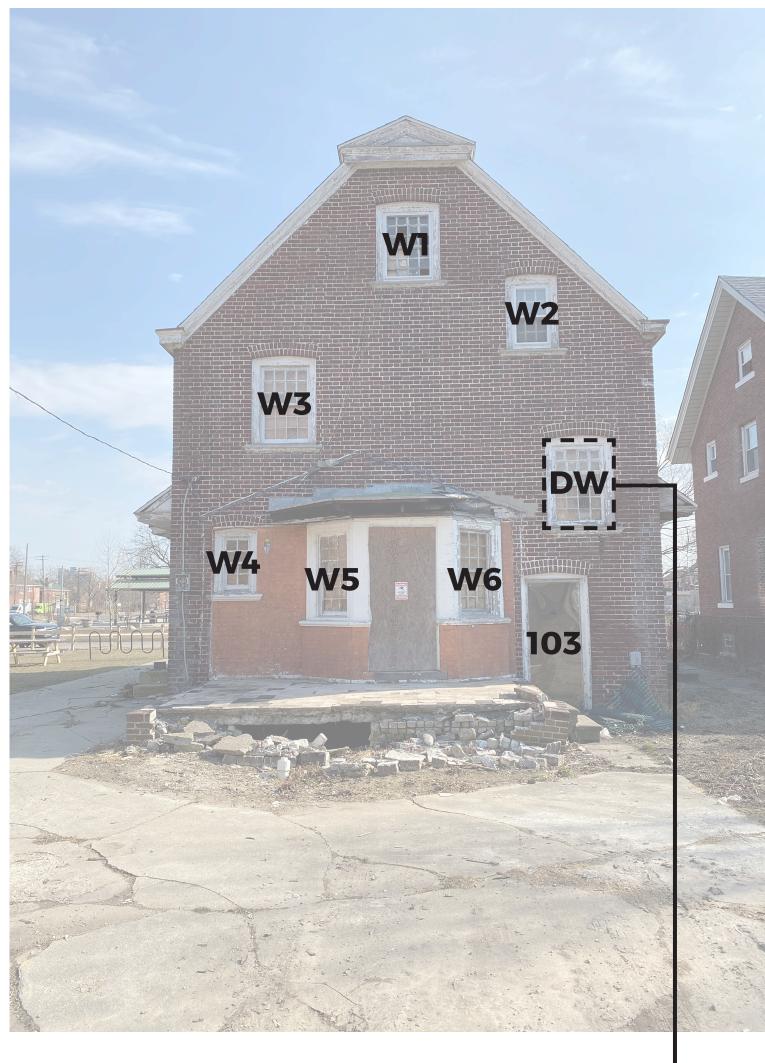
NORTH ELEVATION

REMOVING WINDOW TO
MOVE DOOR 103 UP FOR
NEW PATIO - SEE
ELEVATIONS AND PLANS

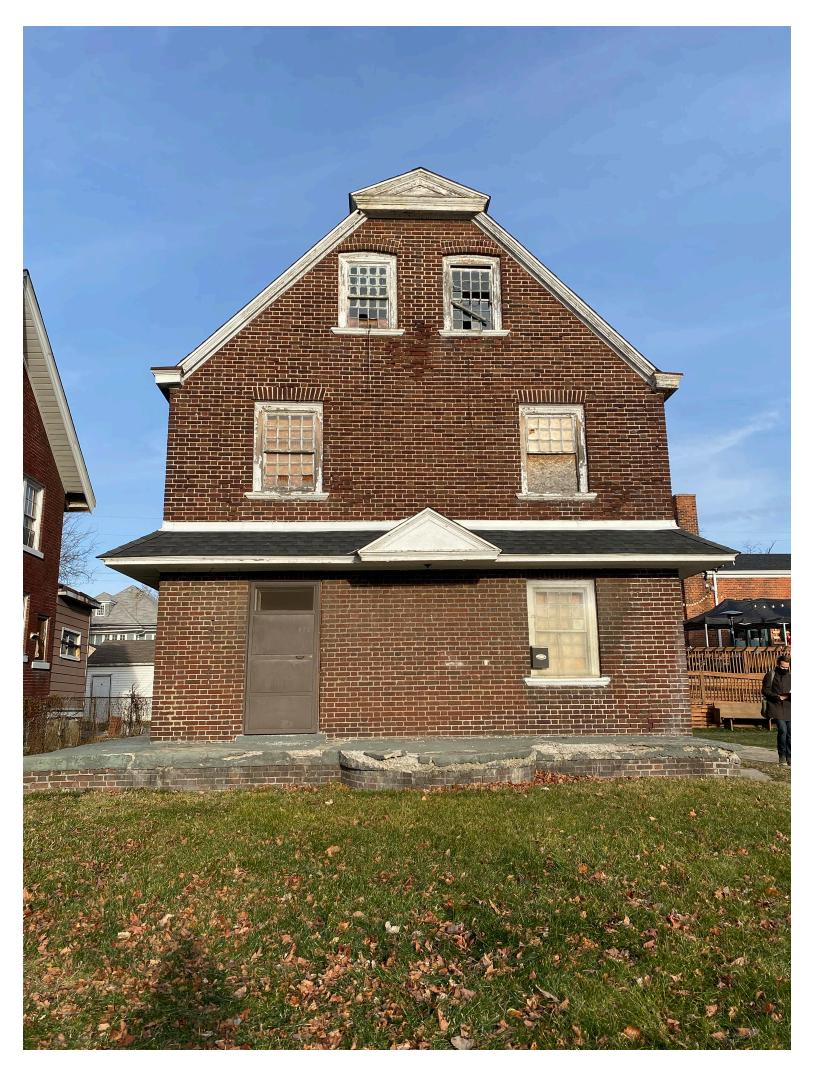
SOUTH ELEVATION

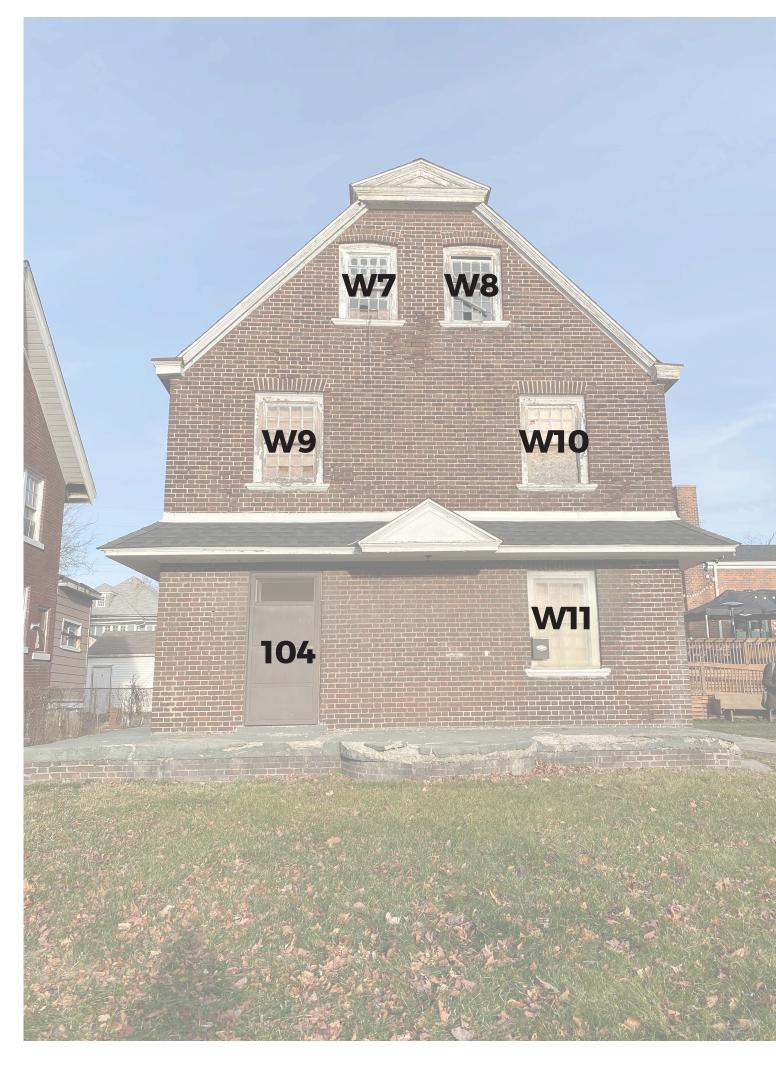
SOUTH ELEVATION

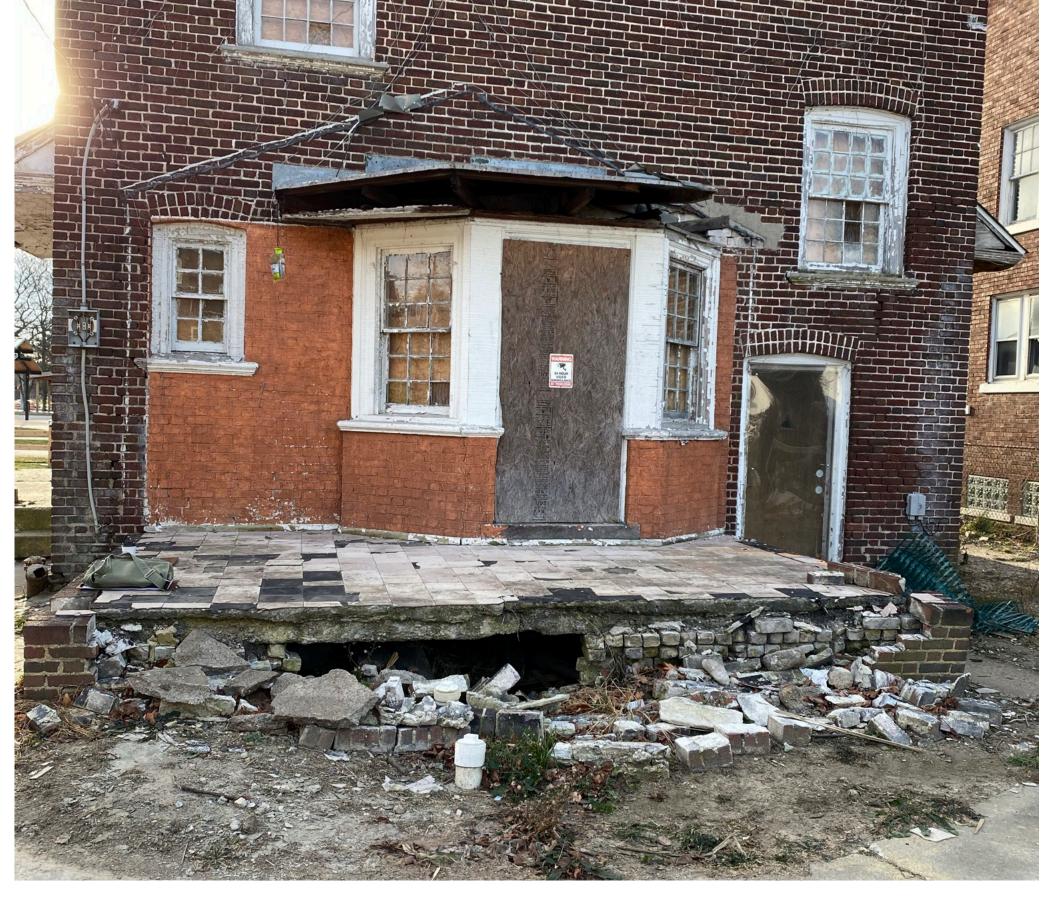
PORCHES

SALVAGE BRICK FROM CRUMBLED BACK PORCH TO USE IN FRONT PORCH AND OR WINDOW CLOSURE (D108)

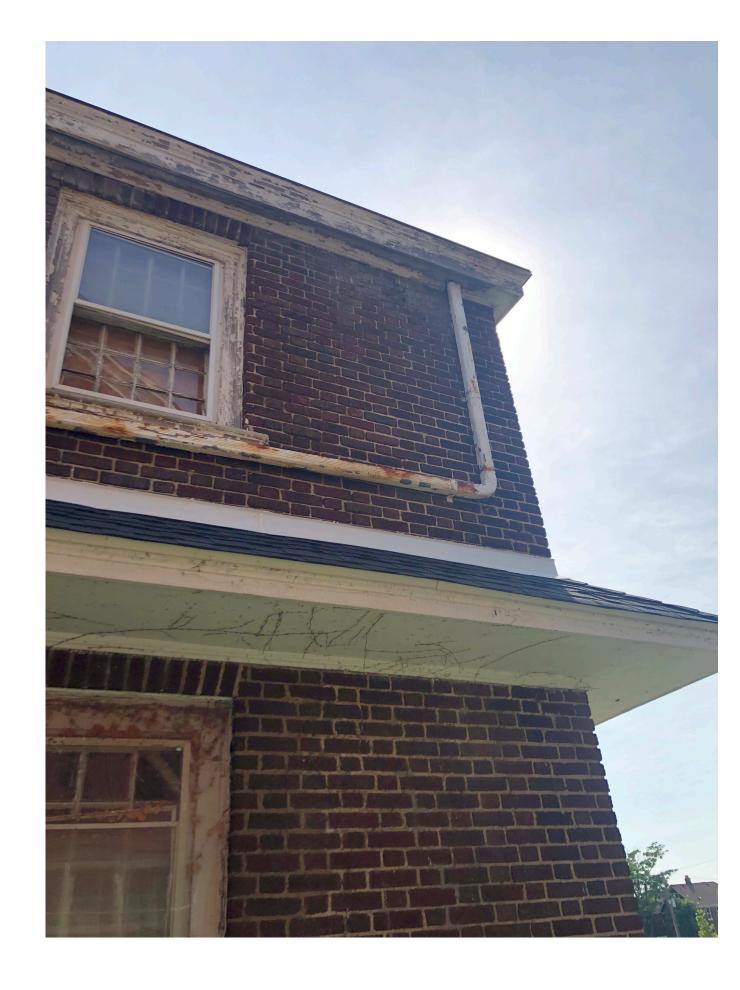
GUTTERS

COLOR OF GUTTERS TO BE A:8 BLACKISH GREEN PER HDC'S DESIGN GUIDELINES

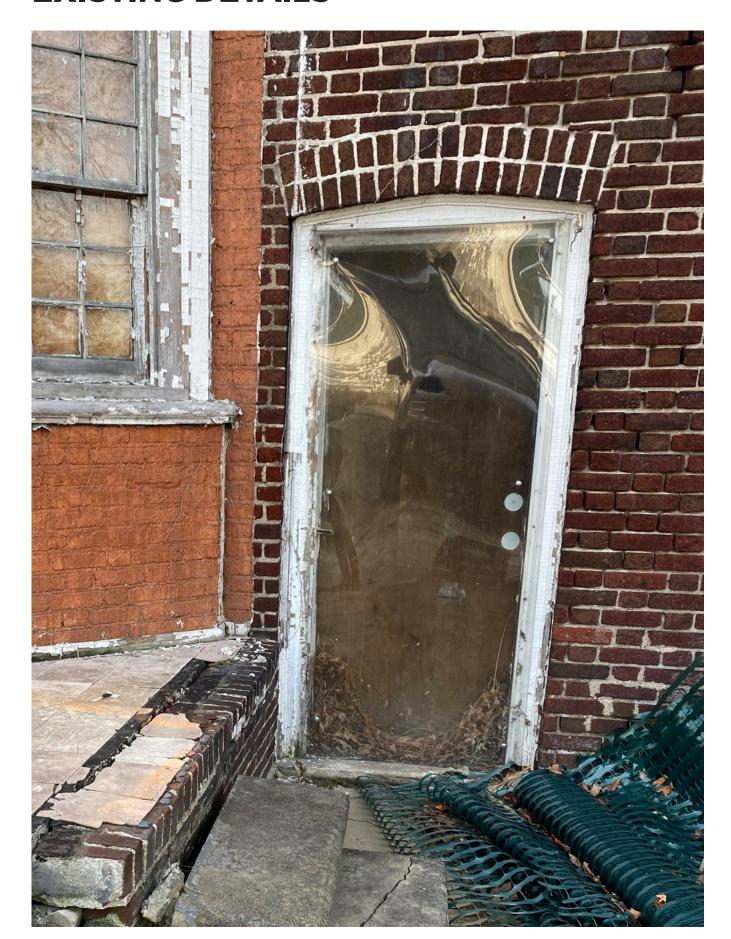
DOOR A - NEW DOOR SILL HEIGHT AND DOOR (103) FOR RESIDENTIAL TENANTS - SEE DOOR SCHEDULE FOR DETAILS

EXISTING MATERIAL: WOOD

THE DOOR WOOD TRIMS ARE ROTTED AND NEED TO BE REPLACED AS WELL. BECAUSE THE FIRST FLOOR WILL BE A COMMERCIAL SPACE, ALL EXISTING DOORS ARE NOT TO CODE AND MUST SWING OUT. NEW DOORS WILL MIMIC ADJACENT WINDOW DESIGN.

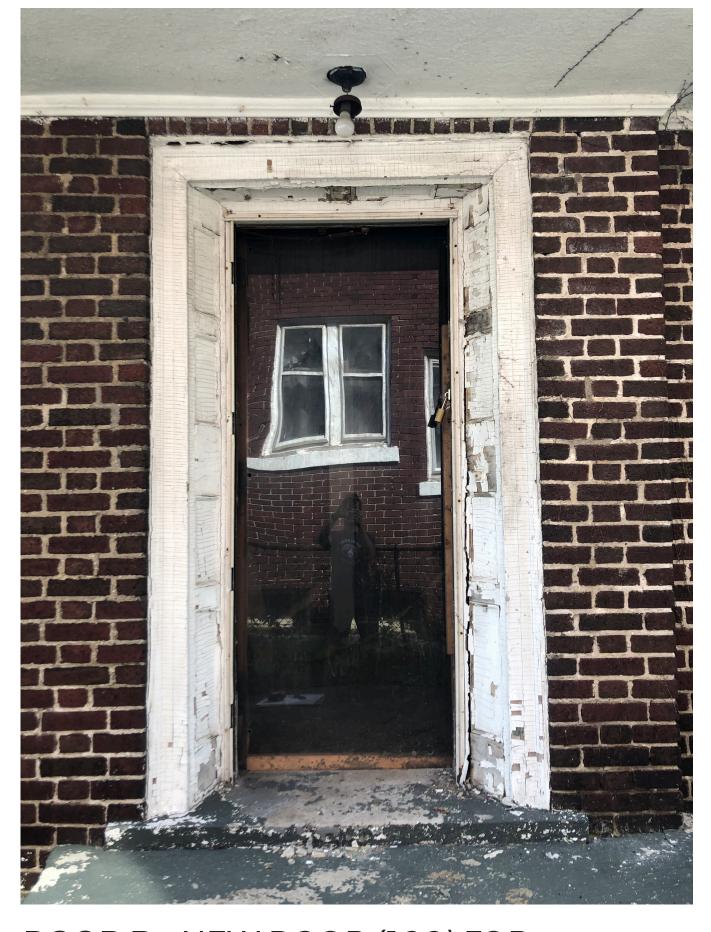
DOOR B - NEW DOOR (102) FOR SECONDARY ENTRANCE TO RESTAURANT - SEE DOOR SCHEDULE FOR DETAILS

EXISTING MATERIAL: WOOD; CURRENT DOOR IS MISSING AND IS HELD BY AN ACRYLIC PIECE

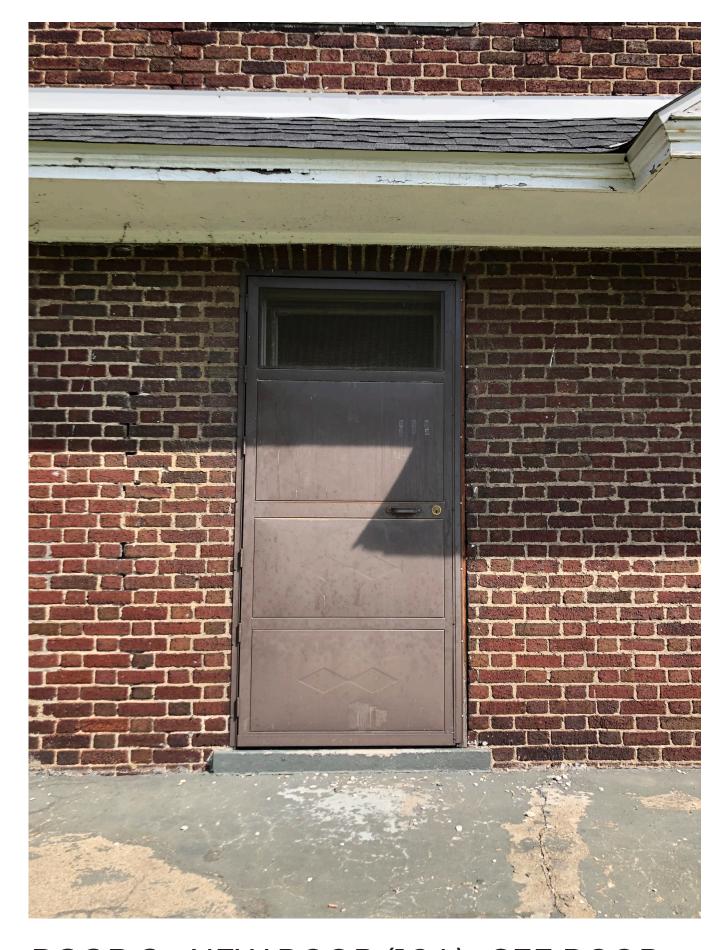
DOOR C - NEW DOOR (104) - SEE DOOR SCHEDULE FOR DETAILS

EXISTING MATERIAL: METAL

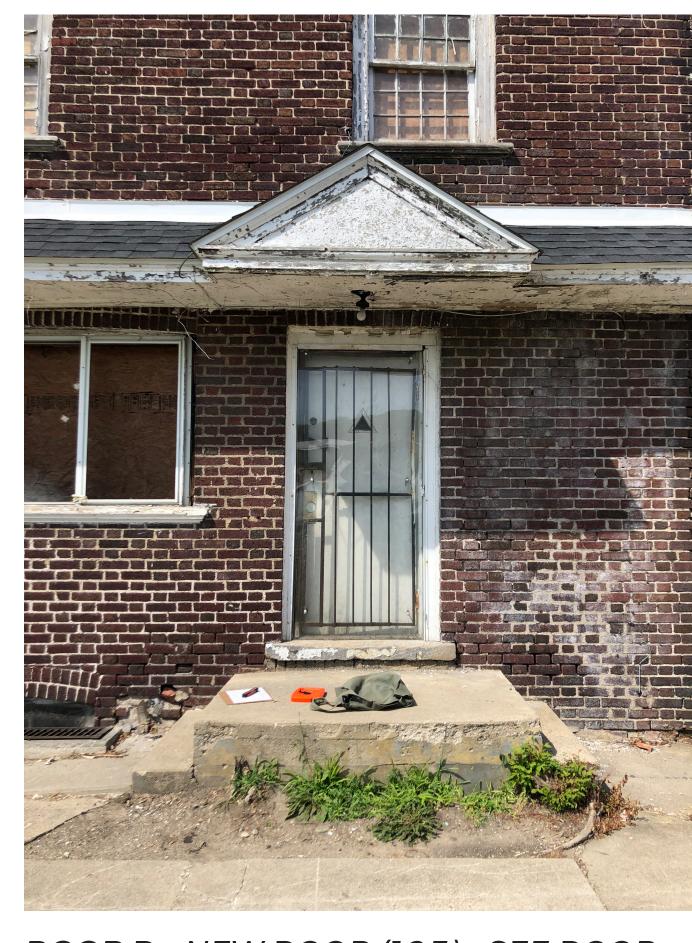
DOOR D - NEW DOOR (105) - SEE DOOR SCHEDULE FOR DETAILS

EXISTING MATERIAL: WOOD
