**Environmental Assessment
Determinations and Compliance Findings
for HUD-assisted Projects
24 CFR Part 58**

Project Name: Meyers-Senior-Center

MEYERS SENIOR APARTMENTS II

Asbestos-Containing Materials Inspection
Meyers Senior Apartments
17370-17400 Meyers Road
Detroit, Michigan 48235

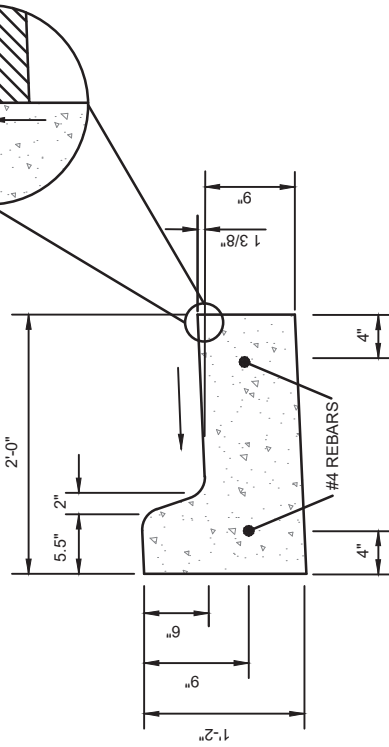
CONCRETE CURB & GUTTER

REVERSE

STANDARD

- NOTE:
1. USE MDOT 35P CONCRETE UNLESS OTHERWISE NOTED.
 2. REFER TO PLANS FOR LOCATIONS OF STANDARD AND REVERSE CURB.
 3. CONTRACTOR SHALL SMOOTHLY TRANSITION BETWEEN STANDARD AND REVERSE CURB.

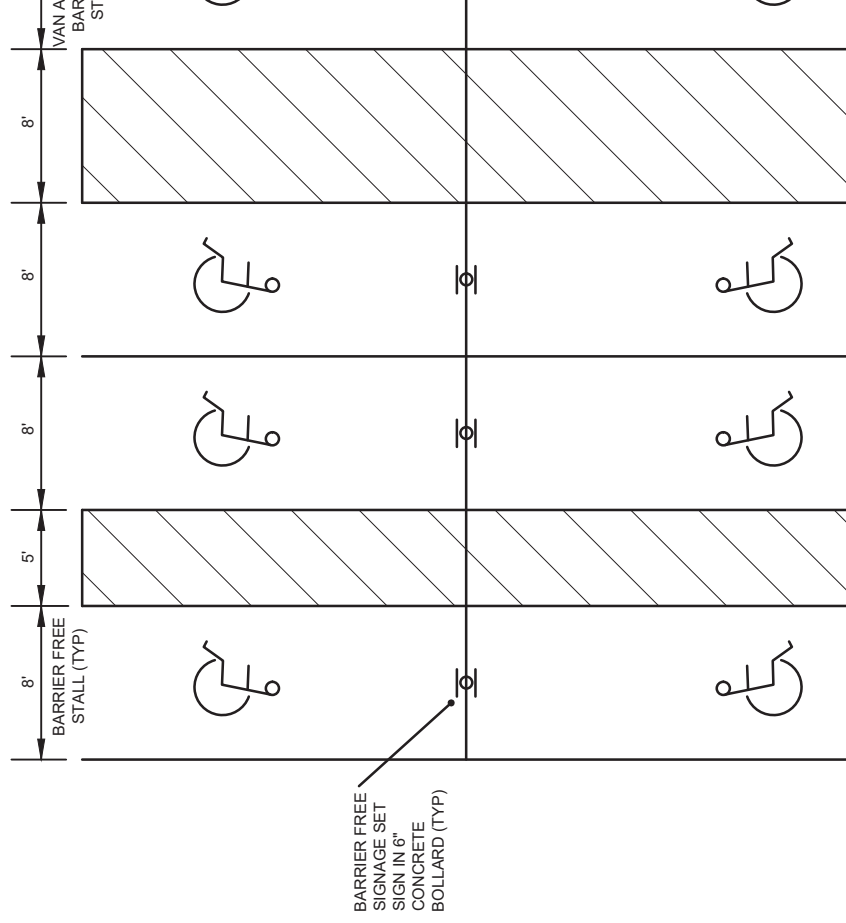
NOTE:

1. PAINT SHALL BE LIFE LINE YELLOW LY-1 FOR STANDARD SPACES.
2. PAINT SHALL BE B-1052 FOR BARRIER FREE SPACES.
3. ALL STRIPING SHALL BE FOUR INCHES (4") IN WIDTH PAINTED HIGHWAY YELLOW OR BLUE SUPPLEMENTAL SPECS.
4. ALL STRIPING SHALL BE APPLIED IN TWO (2) COATS.

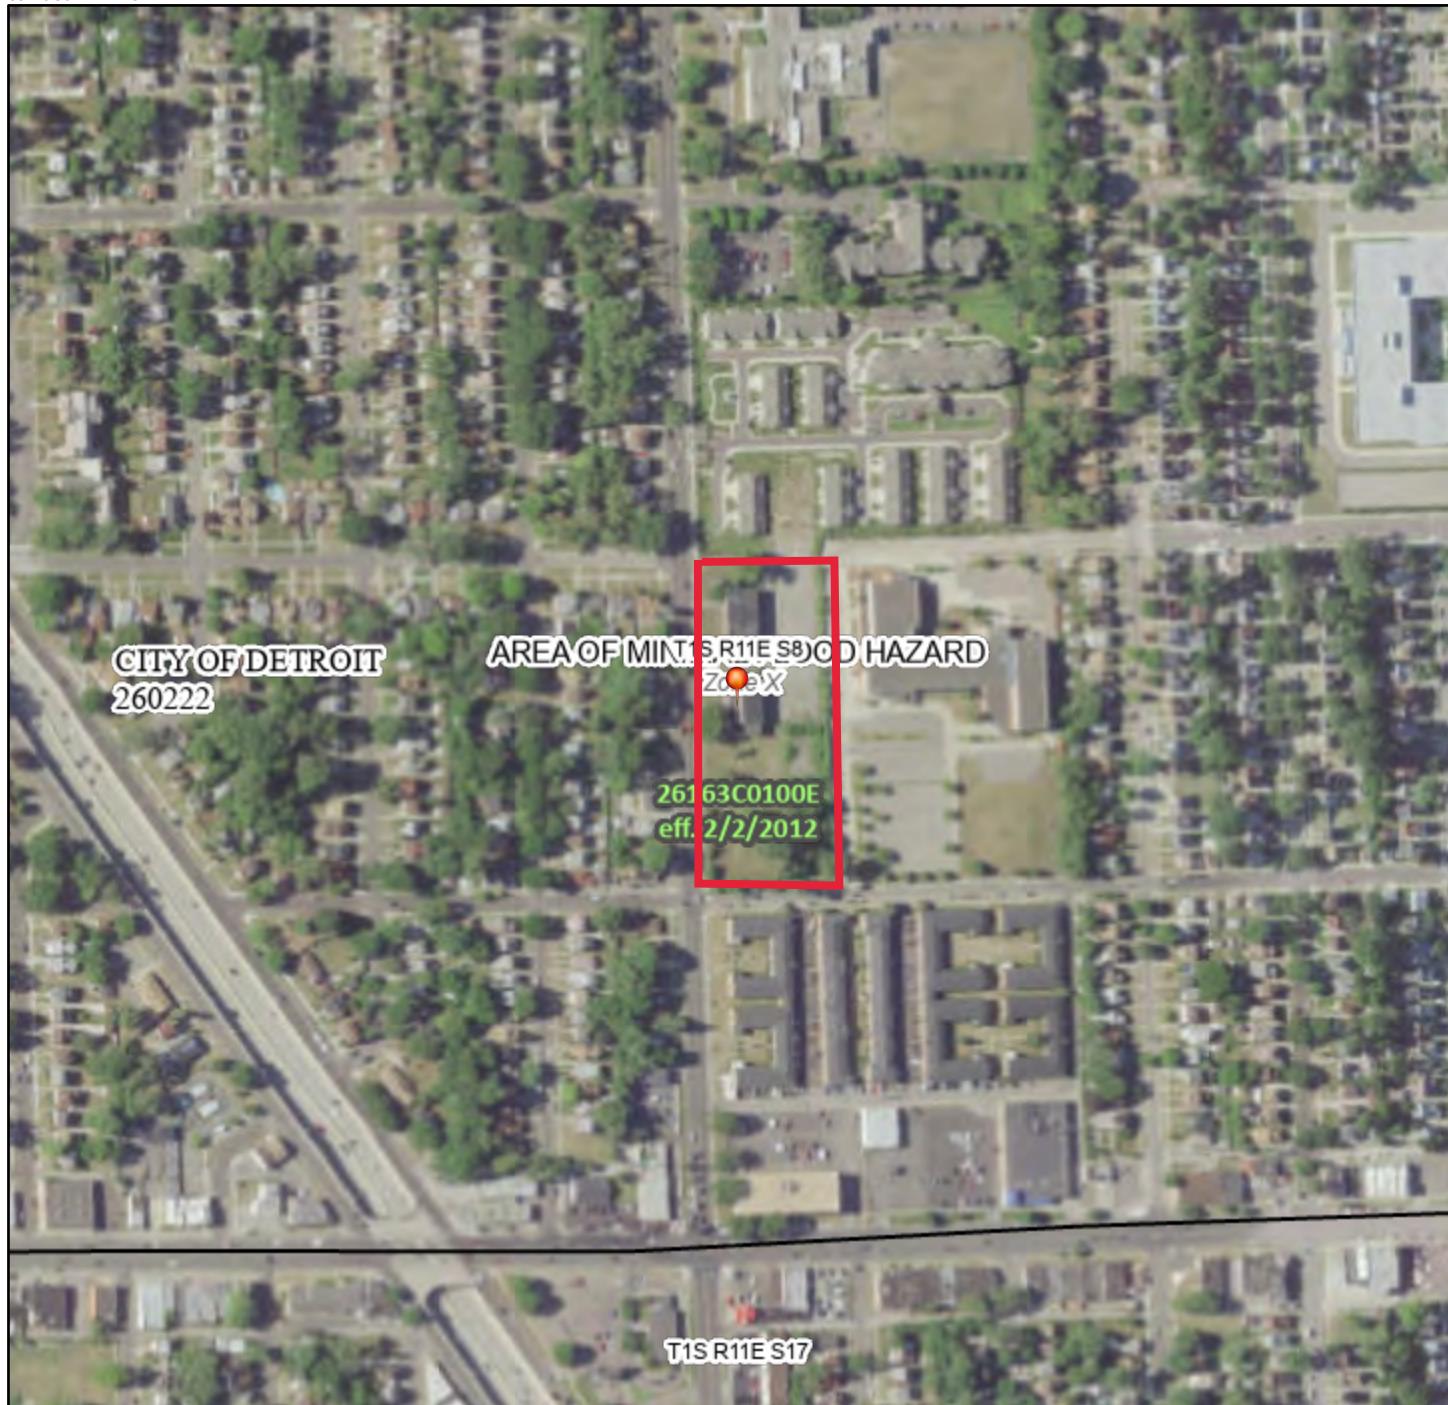
National Flood Hazard Layer FIRMette

The flood hazard information is derived directly from the authoritative NFHL web services provided by FEMA. This map was exported on 9/3/2021 at 2:02 PM and does not reflect changes or amendments subsequent to this date and time. The NFHL and effective information may change or become superseded by new data over time.

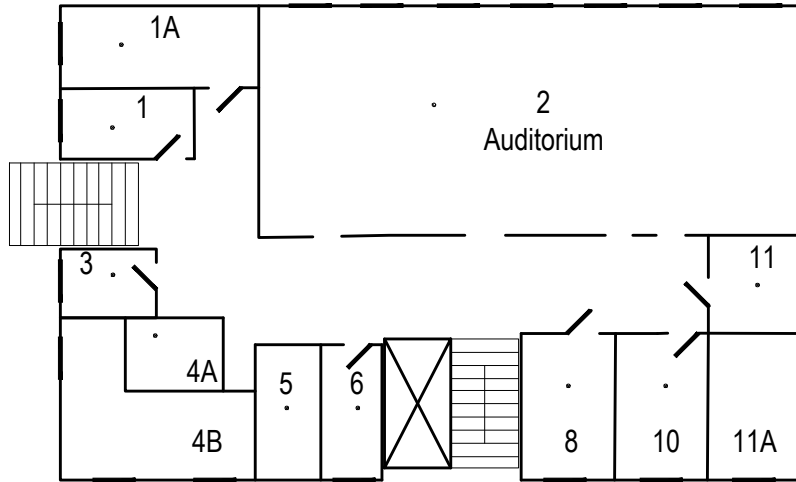
White Hall
 Second Floor
 17400

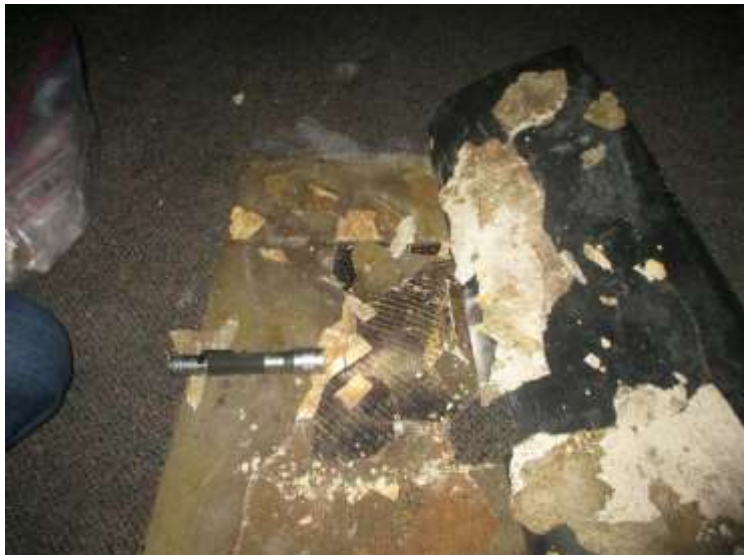
Photo 2. A view of the asbestos-containing floor tile beneath carpet

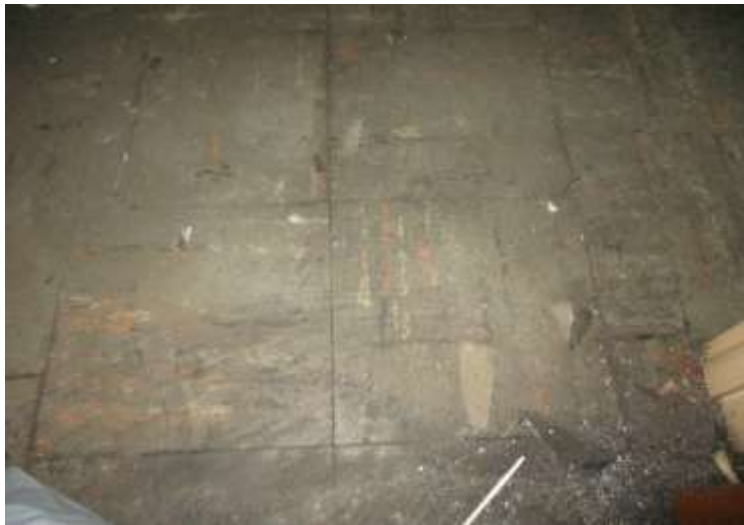
Photo 3. A view of the asbestos-containing 9"x9" floor tile

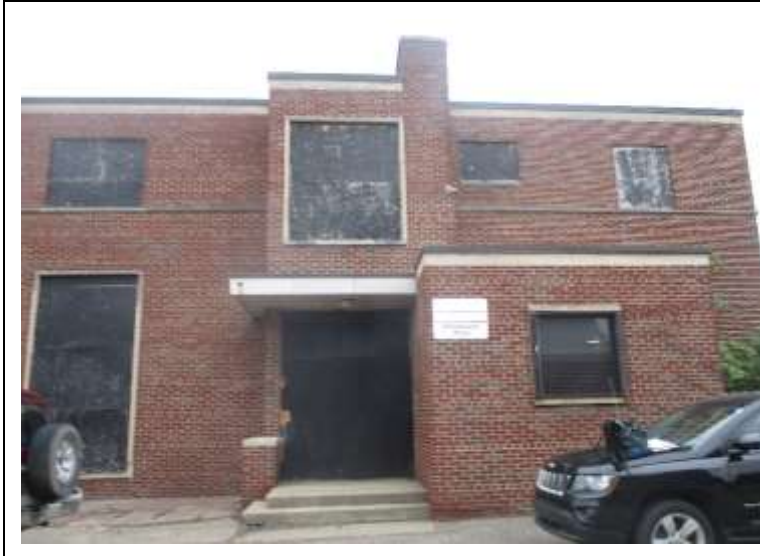
Photo 4. A view of the asbestos-containing caulk on overhang

Sample Information	Asbestos Type/Percent	Non-Asbestos Material
Lab ID #: 96256 - 64 Cust. #: 30A Material: Caulk-Grey Location: Overhang Appearance: grey,fibrous,homogenous Layer: 1 of 1	Asbestos Present: YES Chrysotile - 5%	Other - 95%
Lab ID #: 96256 - 65 Cust. #: 30B Material: Caulk-Grey Location: Overhang Appearance: Layer: of	Asbestos Present: NOT ANALYZED	
Lab ID #: 96256 - 66 Cust. #: 19C Material: Textured Wall-White Location: Appearance: white,nonfibrous,homogenous Layer: 1 of 1	Asbestos Present: NO No Asbestos Observed	Cellulose - 1% Other - 99%

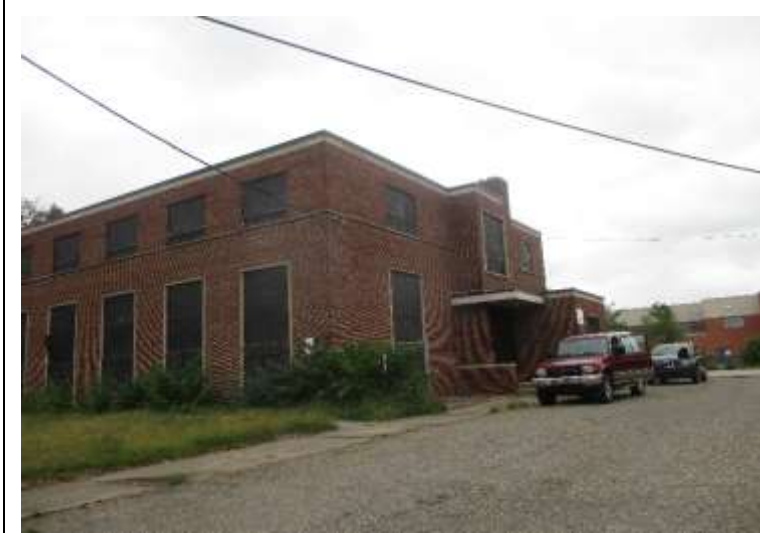
Photo 5. A view of the asbestos-containing caulk on overhang

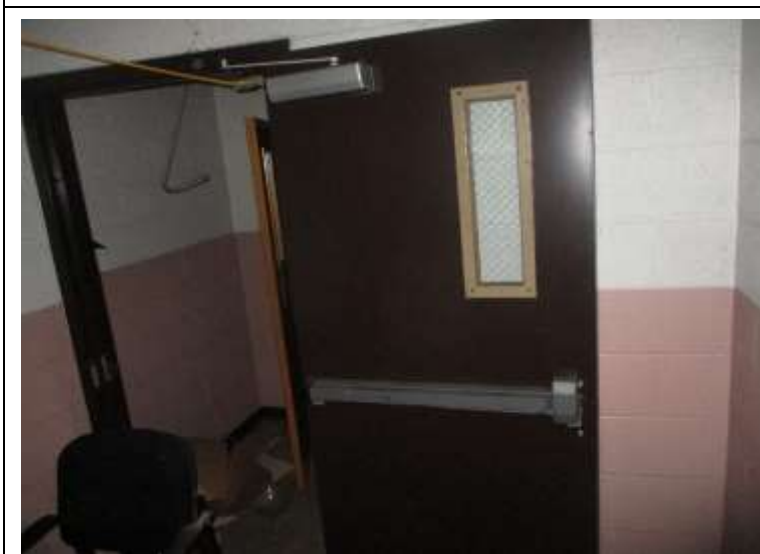
Photo 6. A view of presumed asbestos-containing fire doors

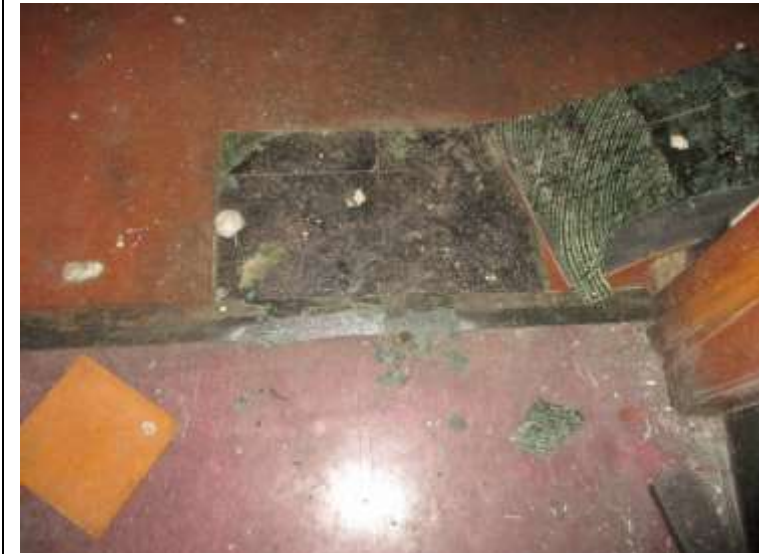
Photo 10. A view of the asbestos-containing 9"x9" green floor tile beneath carpet

Sample Information	Asbestos Type/Percent	Non-Asbestos Material
Lab ID #: 96256 - 28 Cust. #: 12A Material: 9x9 FT-Green w/Orange & White Streaks Location: Room B10 Appearance: grey,fibrous,homogenous Layer: 1 of 2	Asbestos Present: YES Chrysotile - 10%	Other - 90%
Lab ID #: 96256 - 28a Cust. #: 12A Material: Mastic Location: Room B10 Appearance: black,nonfibrous,homogenous Layer: 2 of 2	Asbestos Present: NO No Asbestos Observed	Other - 100%
Lab ID #: 96256 - 29 Cust. #: 12B Material: 9x9 FT-Green w/Orange & White Streaks Location: Room B6 Appearance: Layer: 1 of 2	Asbestos Present: NOT ANALYZED

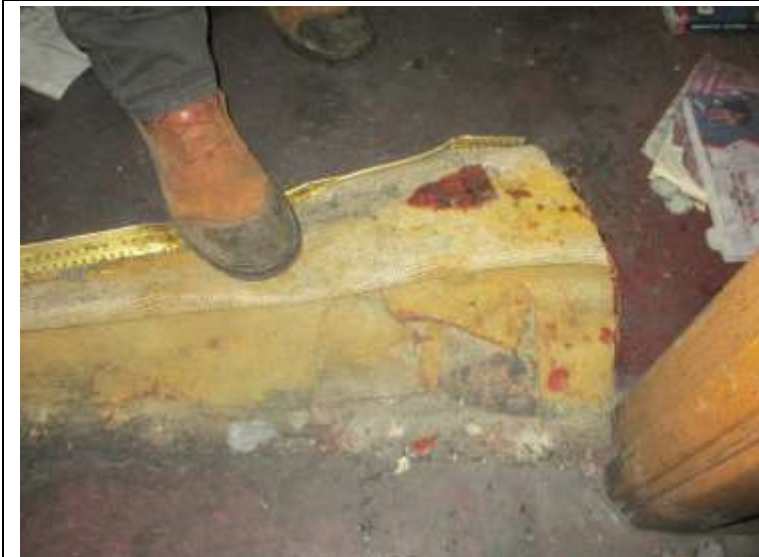
Photo 11. A view of the asbestos-containing 9"x9" red floor tile beneath carpet+

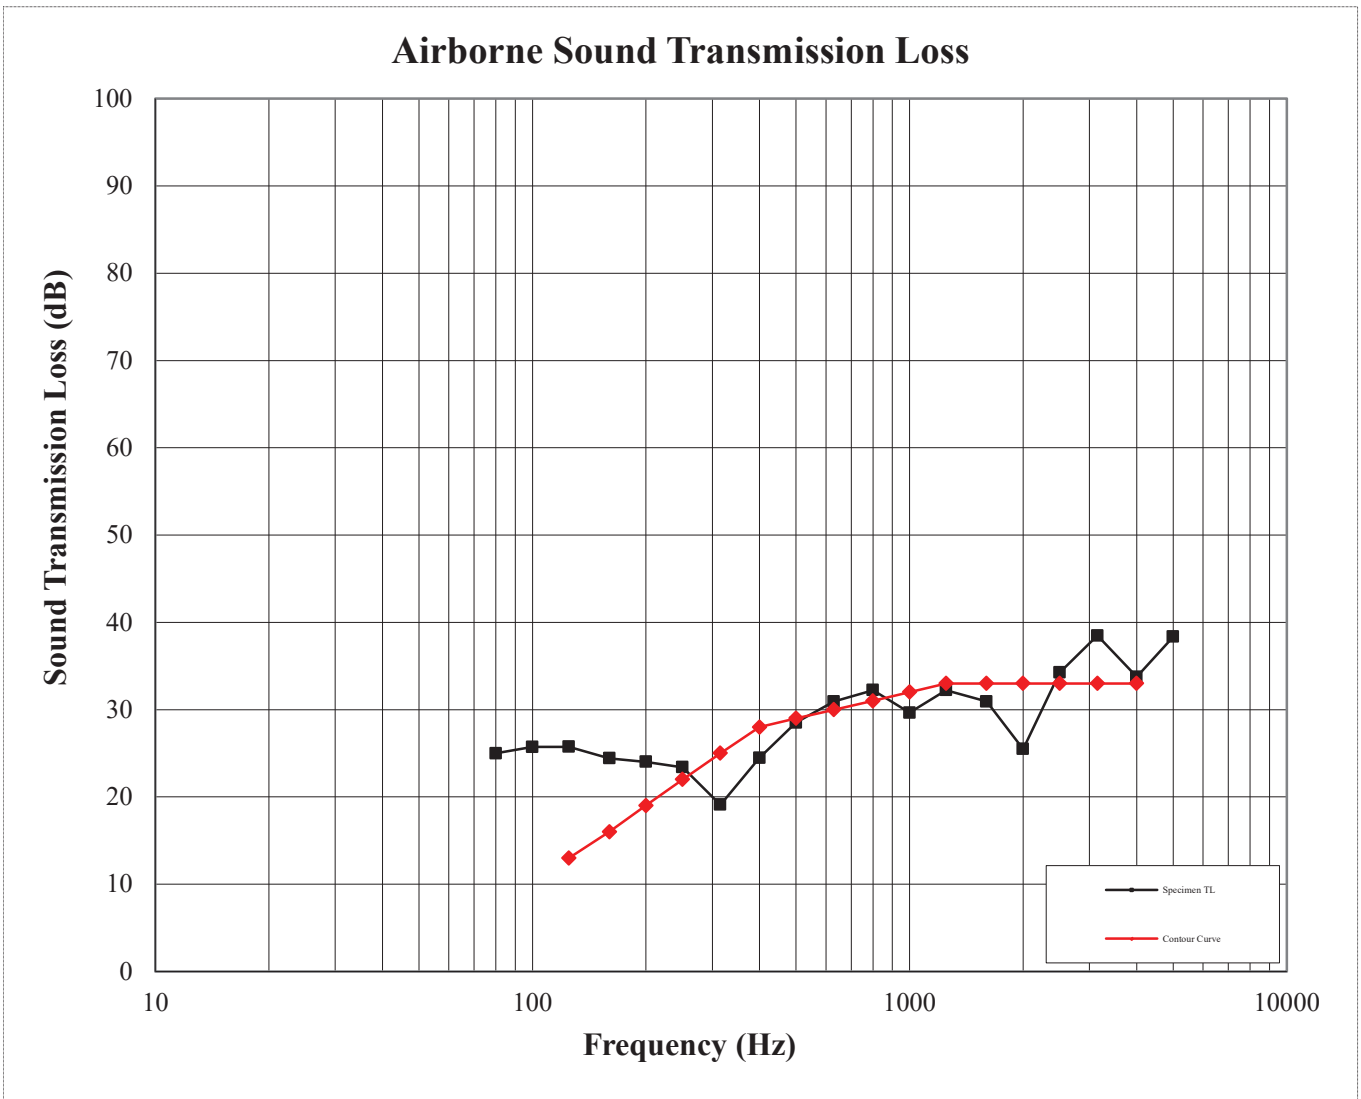
AIRBORNE SOUND TRANSMISSION LOSS ASTM E 90

Test Date	04/21/15					
Data File No.	E6297.01B1					
Client	Therma-Tru Corporation					
Description	Series/Model: 3/0 x 6/8 Fiber-Classic/Smooth-Star full lite flush glazed, side-hinged single door system with 5/8" IG (1/8" tempered, 3/8" air space, 1/8" tempered), sealed with duct tape on both sides (inoperable)					
Specimen Area	1.99 m ²	Receive Temp.	22.6 °C		Source Temp.	22.1 °C
Technician	Daniel P. Platts	Receive Humidity	49%		Source Humidity	48%

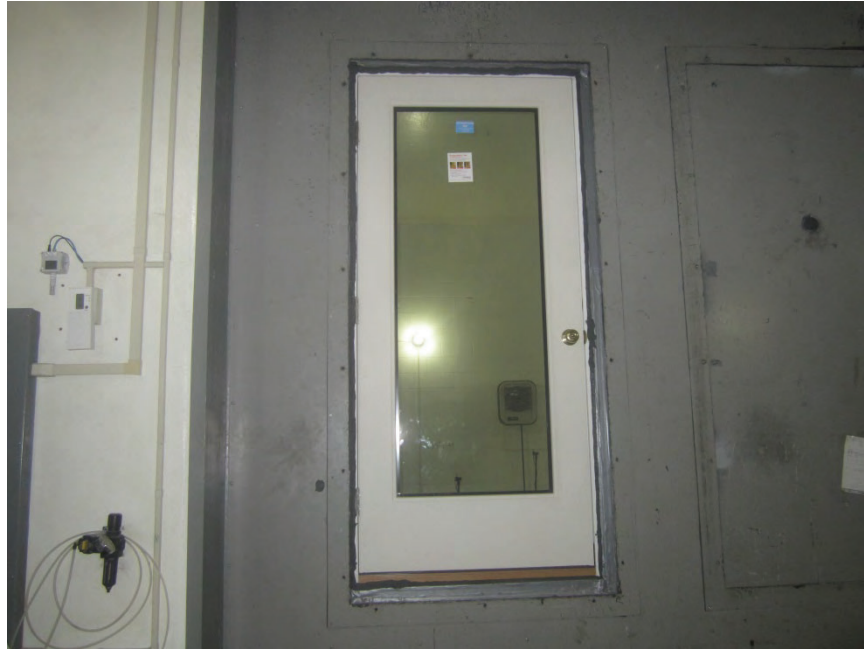
Receive Room View of Installed Specimen

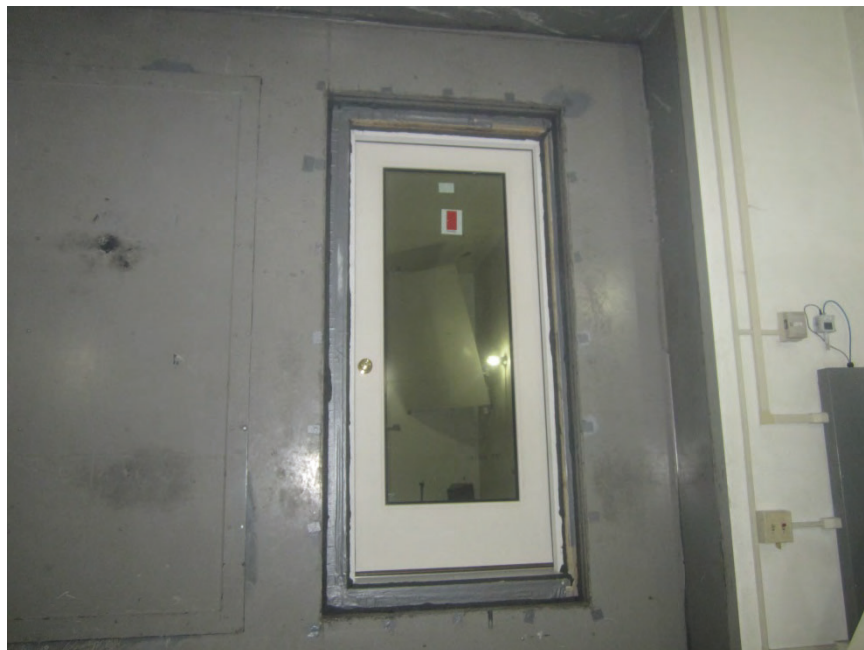
Source Room View of Installed Specimen

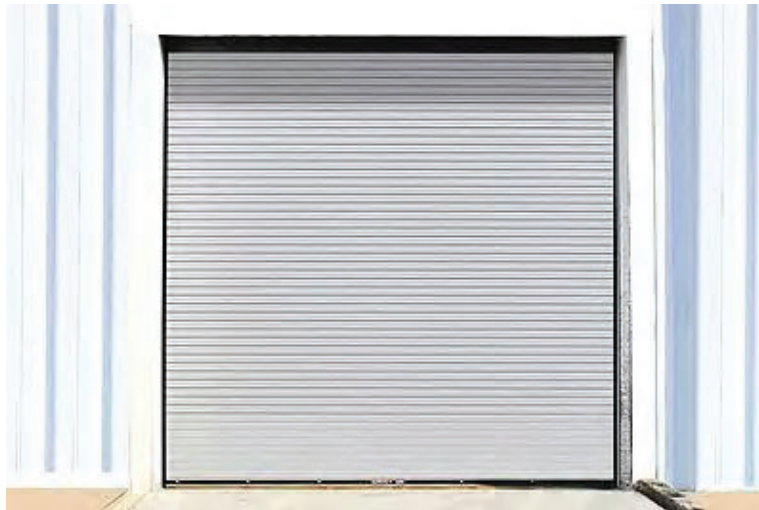
Rolling Steel Doors - Stormtite™ AP Model 627

Our **rolling steel doors** (also known as roll-up steel doors, roll-up overhead doors, coiling doors, and folding garage doors) are designed for durability, serviceability, and good looks. Each of our rolling service doors is computer-designed to your specifications, then solidly constructed to promote easy installation, trouble-free operation, and long life.

The **Stormtite™ AP Model 627** is engineered to supply advanced performance in industrial and general commercial applications where thermal performance, climate control, and security are primary concerns.
