**Environmental Assessment
Determinations and Compliance Findings
for HUD-assisted Projects
24 CFR Part 58**

Project Name: Meyers-Senior-Center

MEYERS SENIOR APARTMENTS II

Asbestos-Containing Materials Inspection
Meyers Senior Apartments
17370-17400 Meyers Road
Detroit, Michigan 48235

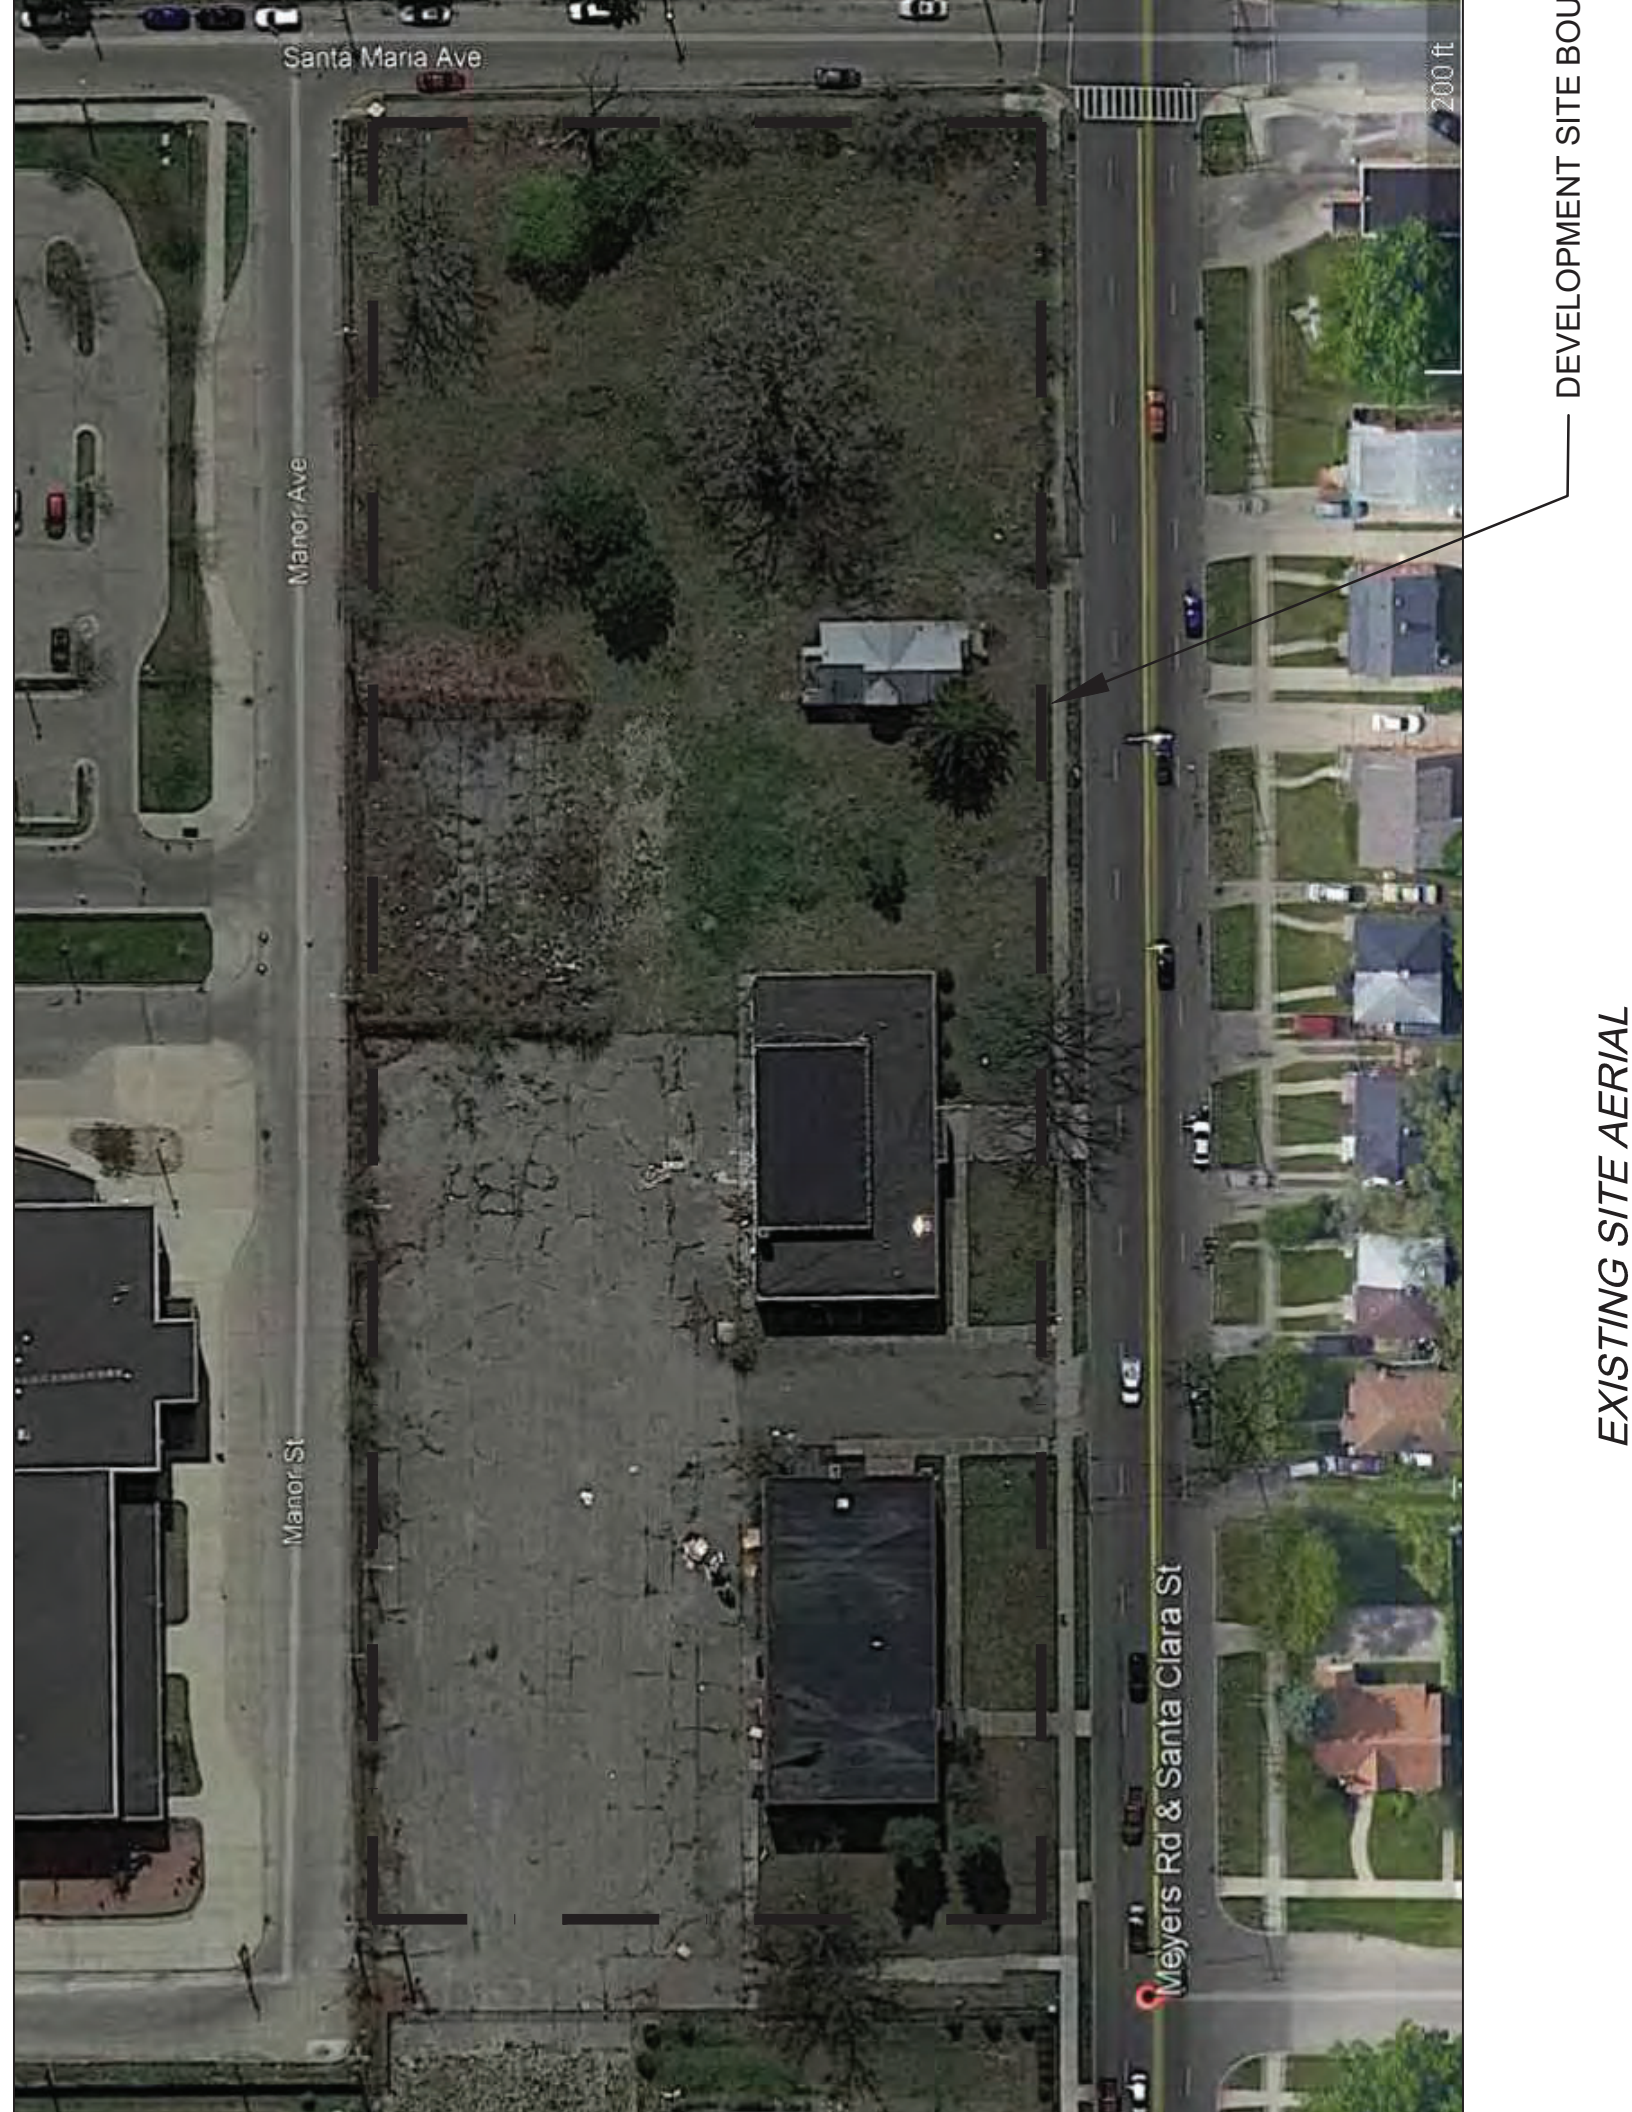
1. A site plan package including Existing Conditions, Soil and Sediment Control Plan, Demolition Plan, Site Plan, Grading Plan, Utility Plan, and Site Details.
2. A letter dated May 3, 2021 from Jayda Philson, City of Detroit Zoning Manager, noting Site Plan approval, dimensional variance approval, variance extension, and future lot split acknowledgement.

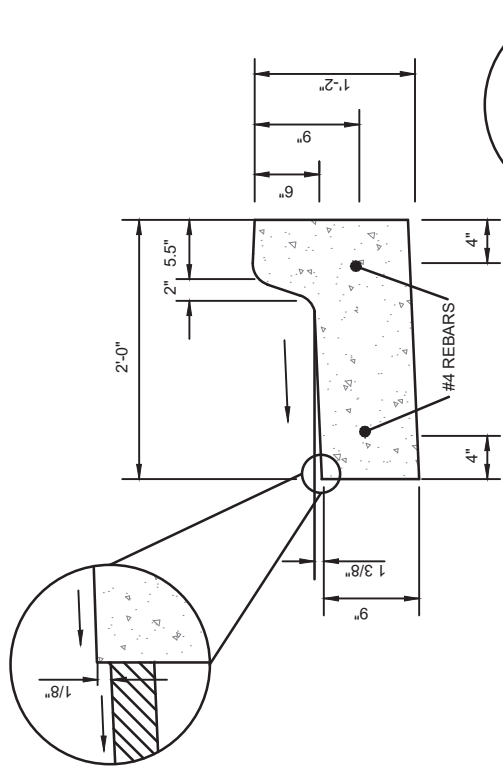
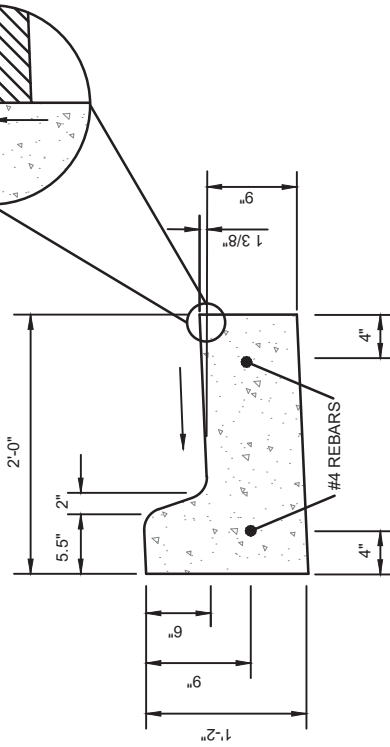
CONCRETE CURB & GUTTER

- NOTE:
1. USE MDOT 35P CONCRETE UNLESS OTHERWISE NOTED.
 2. REFER TO PLANS FOR LOCATIONS OF STANDARD AND REVERSE CURB.
 3. CONTRACTOR SHALL SMOOTHLY TRANSITION BETWEEN STANDARD AND REVERSE CURB.

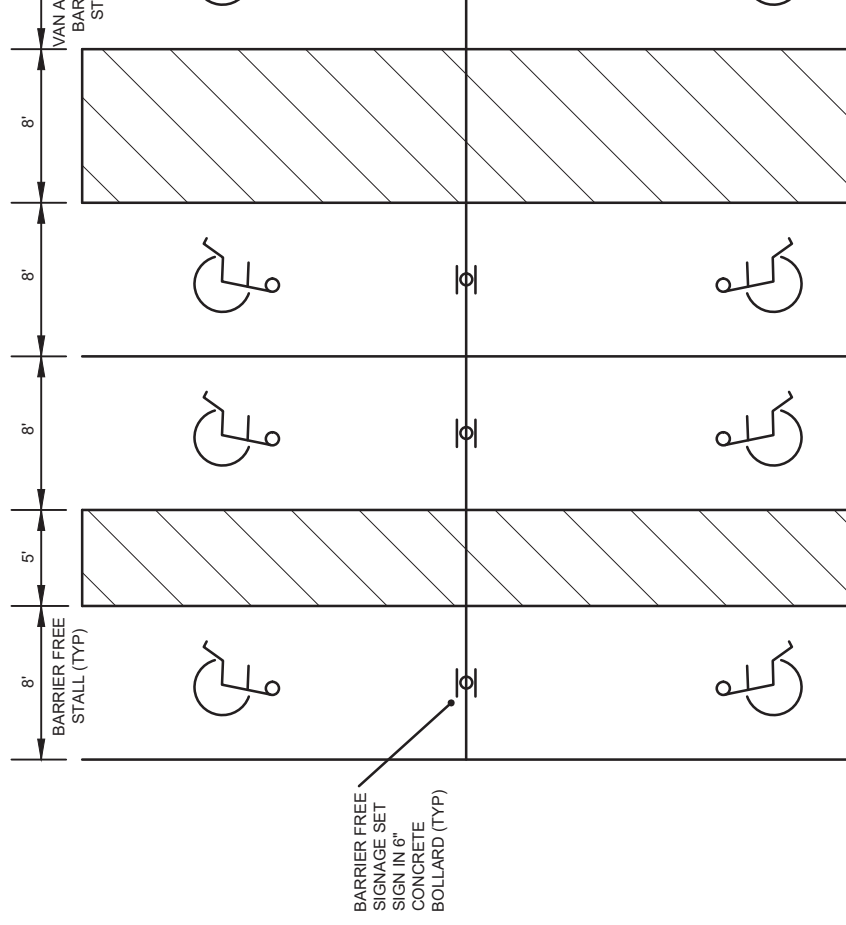
1. PAINT SHALL BE LIFE LINE YELLOW LY-1 FOR STANDARD SPACES.
2. PAINT SHALL BE B-1052 FOR BARRIER FREE SPACES.
3. ALL STRIPING SHALL BE FOUR INCHES (4") IN WIDTH PAINTED HIGHWAY YELLOW OR BLUE SUPPLEMENTAL SPECS.
4. ALL STRIPING SHALL BE APPLIED IN TWO (2) COATS.

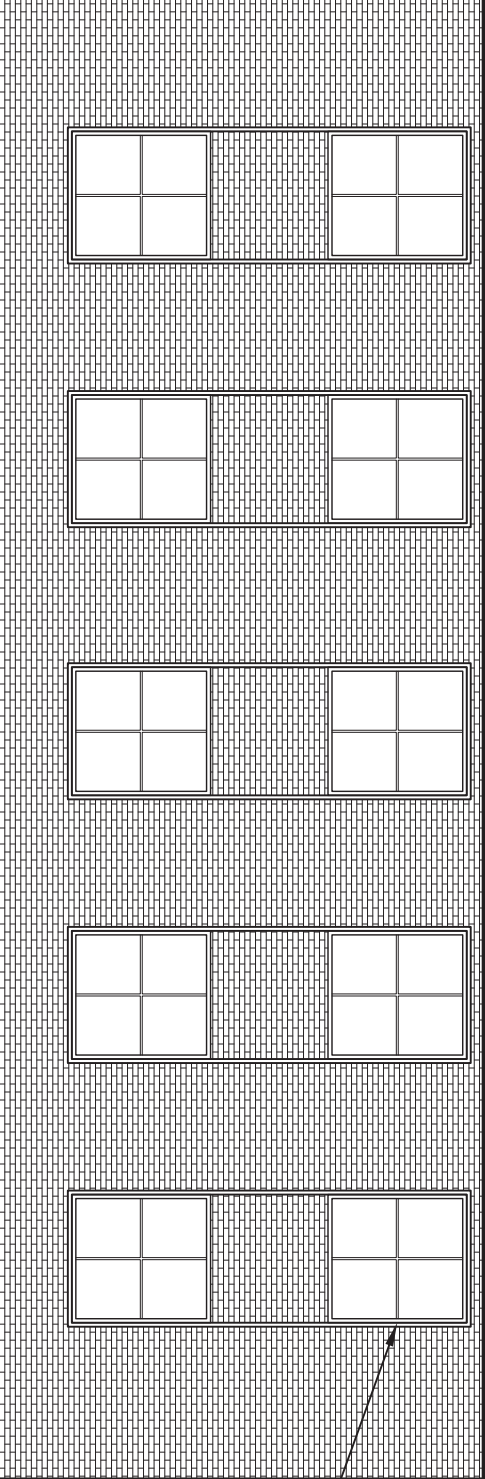
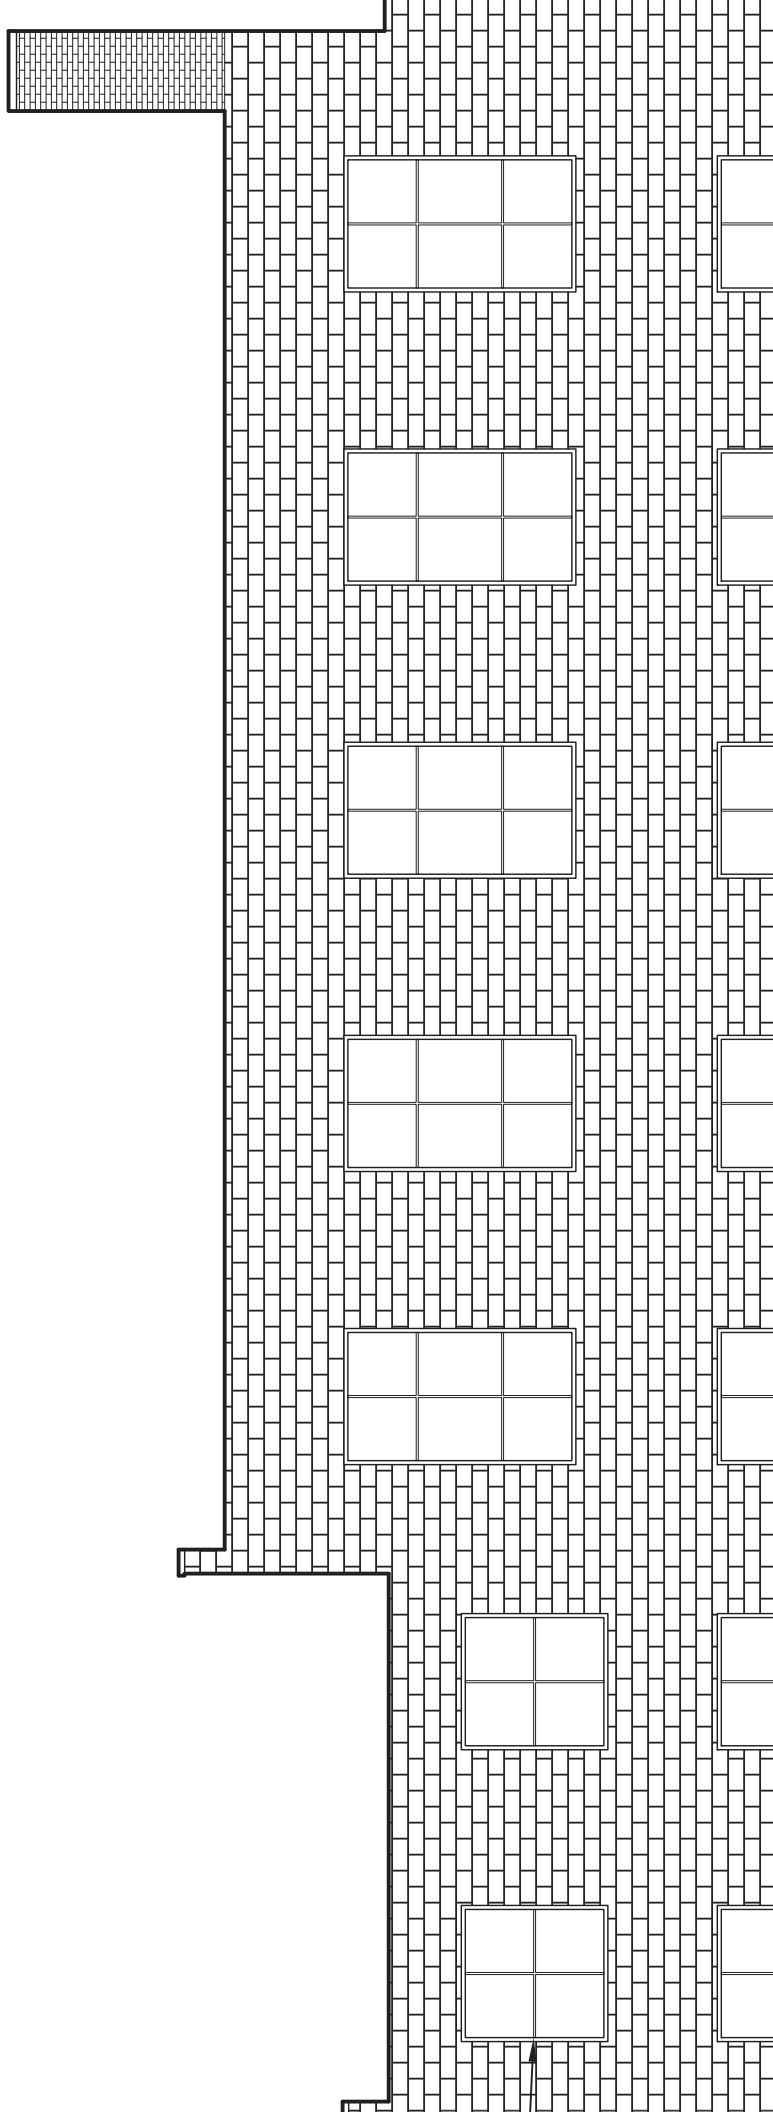
SOUTH ELEVATION - BUILDING 'B'

NEW CASEMENT STYLE WINDOWS,
TO MEET RESIDENTIAL EGRESS AND
SAFETY STANDARDS

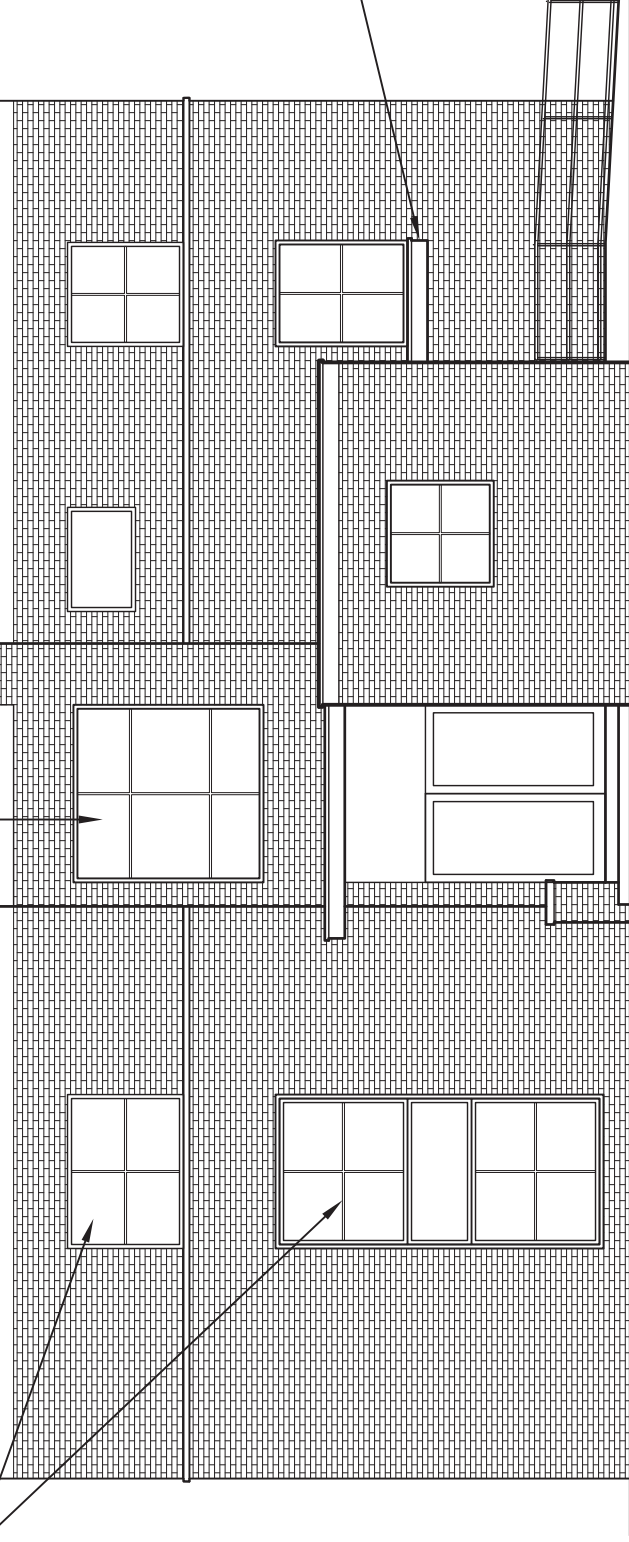
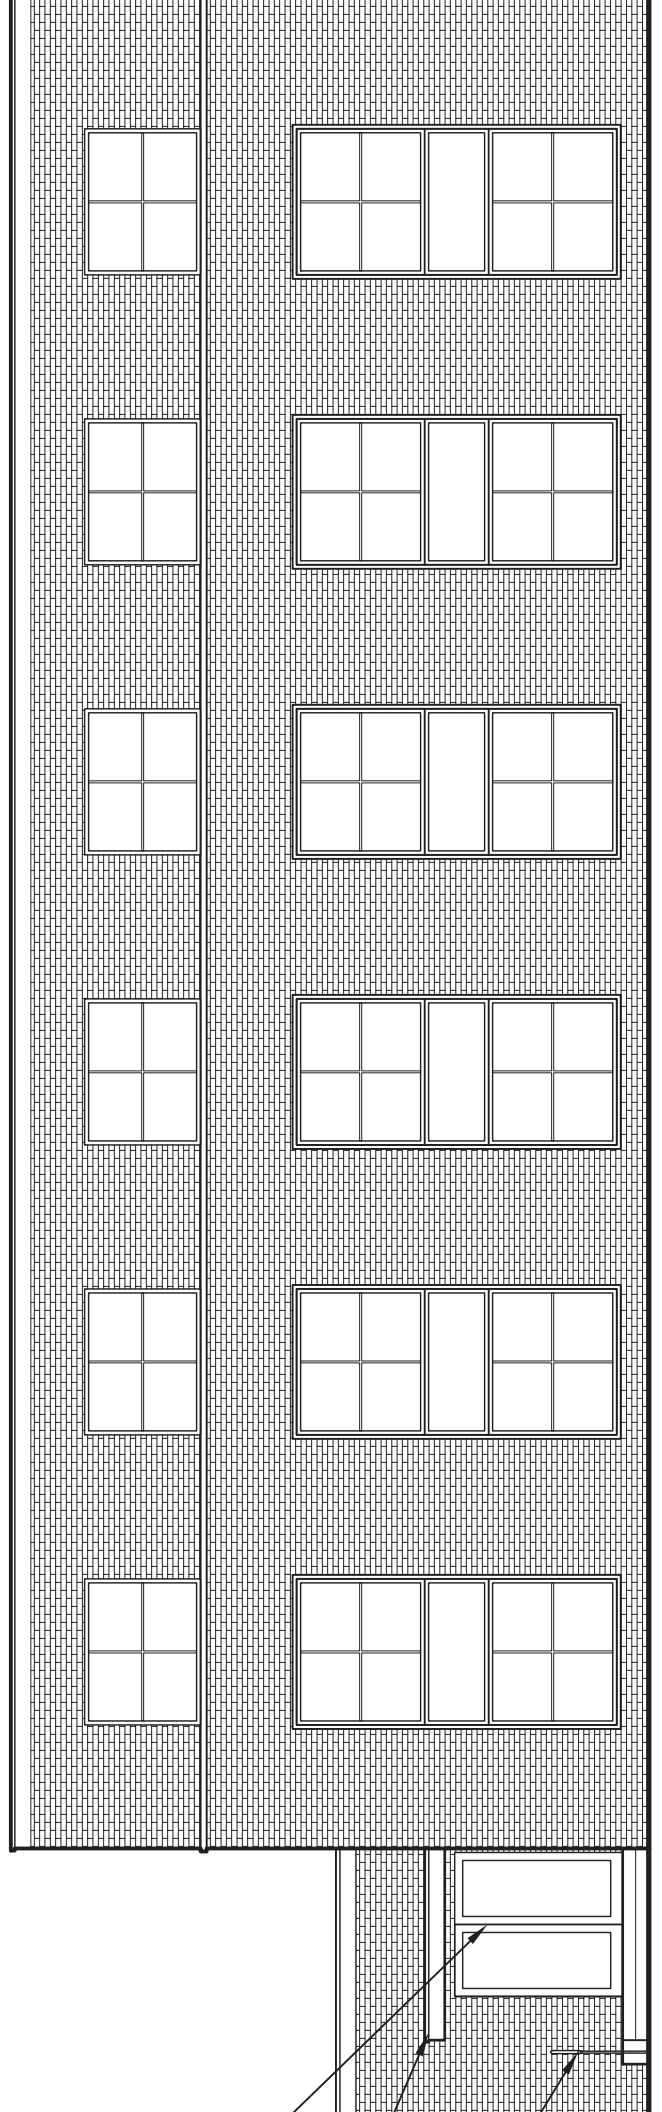
SOUTH ELEVATION - BUILDING 'A'

TO MEET RESIDENTIAL EGRESS AND SAFETY STANDARDS

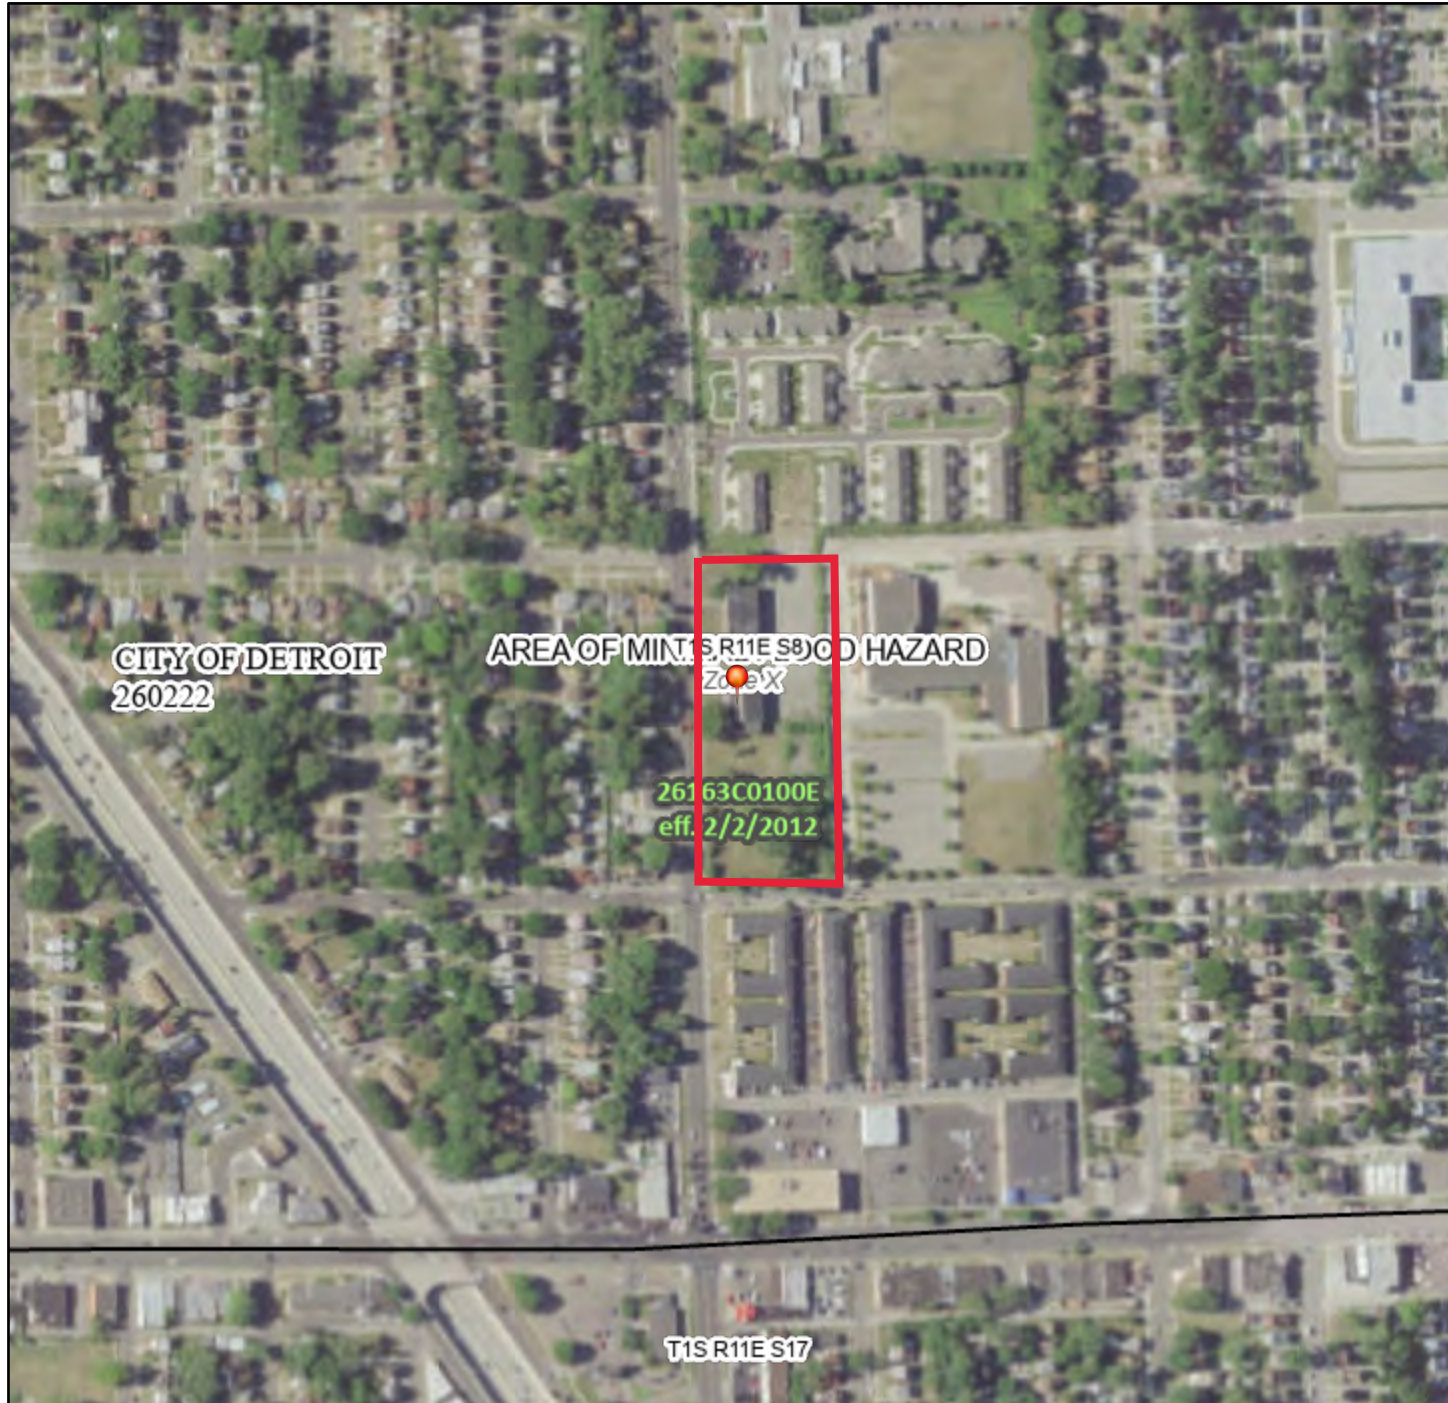
National Flood Hazard Layer FIRMette

The flood hazard information is derived directly from the authoritative NFHL web services provided by FEMA. This map was exported on **9/3/2021 at 2:02 PM** and does not reflect changes or amendments subsequent to this date and time. The NFHL and effective information may change or become superseded by new data over time.

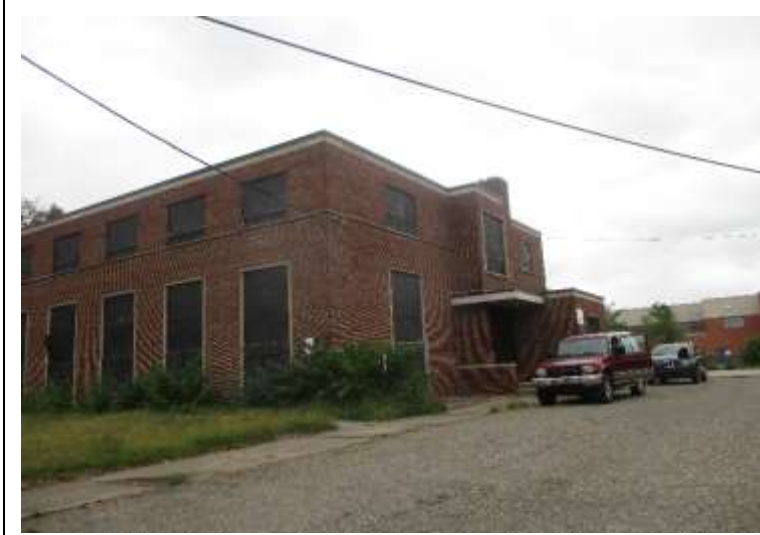
Photo 5. A view of the asbestos-containing caulk on overhang

Sample Information	Asbestos Type/Percent	Non-Asbestos Material
Lab ID #: 96256 - 64 Cust. #: 30A Material: Caulk-Grey Location: Overhang Appearance: grey,fibrous,homogenous Layer: 1 of 1	Asbestos Present: YES Chrysotile - 5%	Other - 95%
Lab ID #: 96256 - 65 Cust. #: 30B Material: Caulk-Grey Location: Overhang Appearance: Layer: of	Asbestos Present: NOT ANALYZED	
Lab ID #: 96256 - 66 Cust. #: 19C Material: Textured Wall-White Location: Appearance: white,nonfibrous,homogenous Layer: 1 of 1	Asbestos Present: NO No Asbestos Observed	Cellulose - 1% Other - 99%

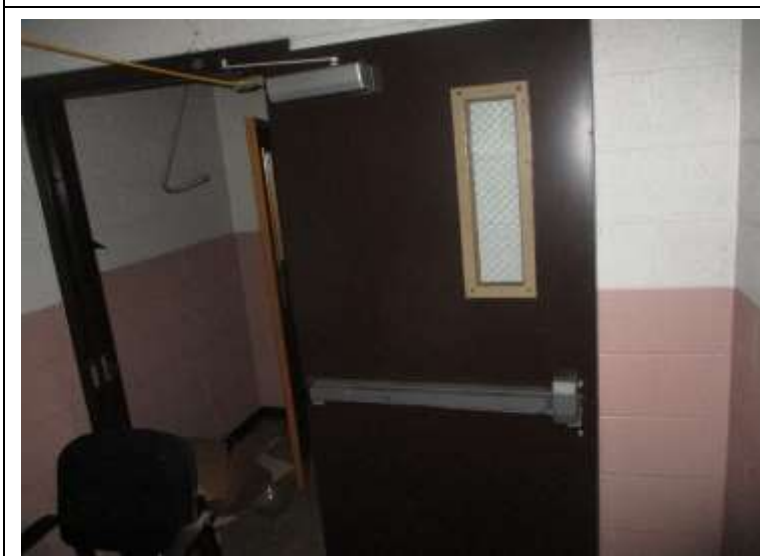
Photo 6. A view of presumed asbestos-containing fire doors

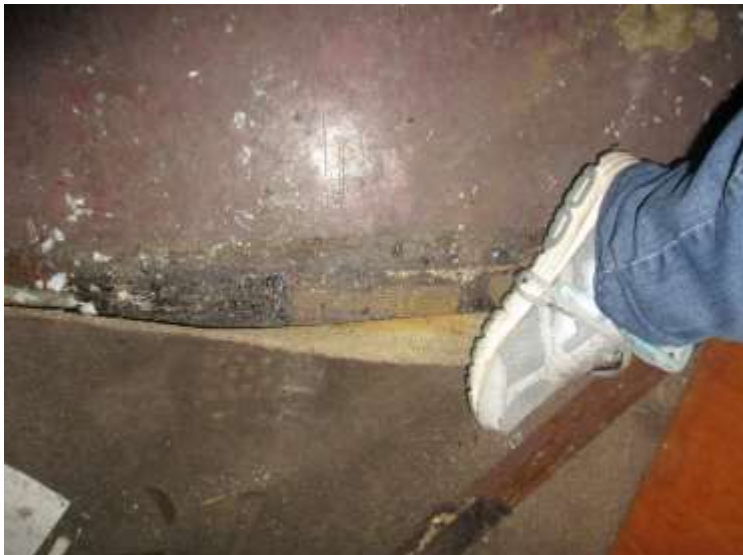
Photo 8. A view of the asbestos-containing 9"x9" floor tile beneath carpet

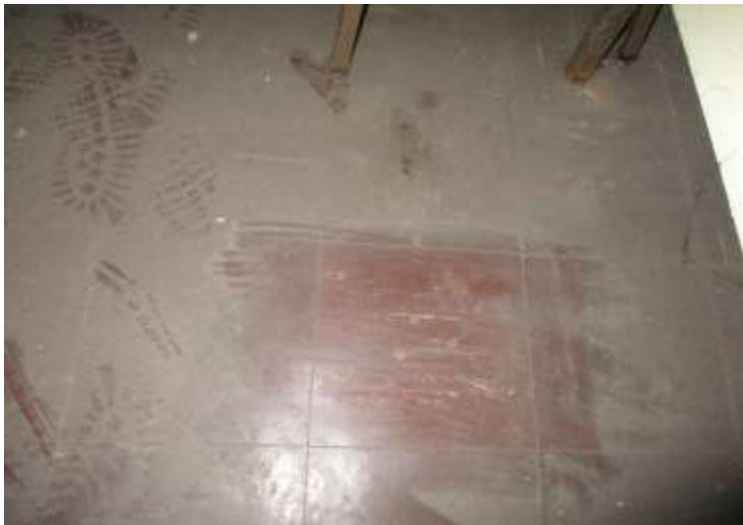
Photo 9. A view of the asbestos-containing 9"x9" floor tile

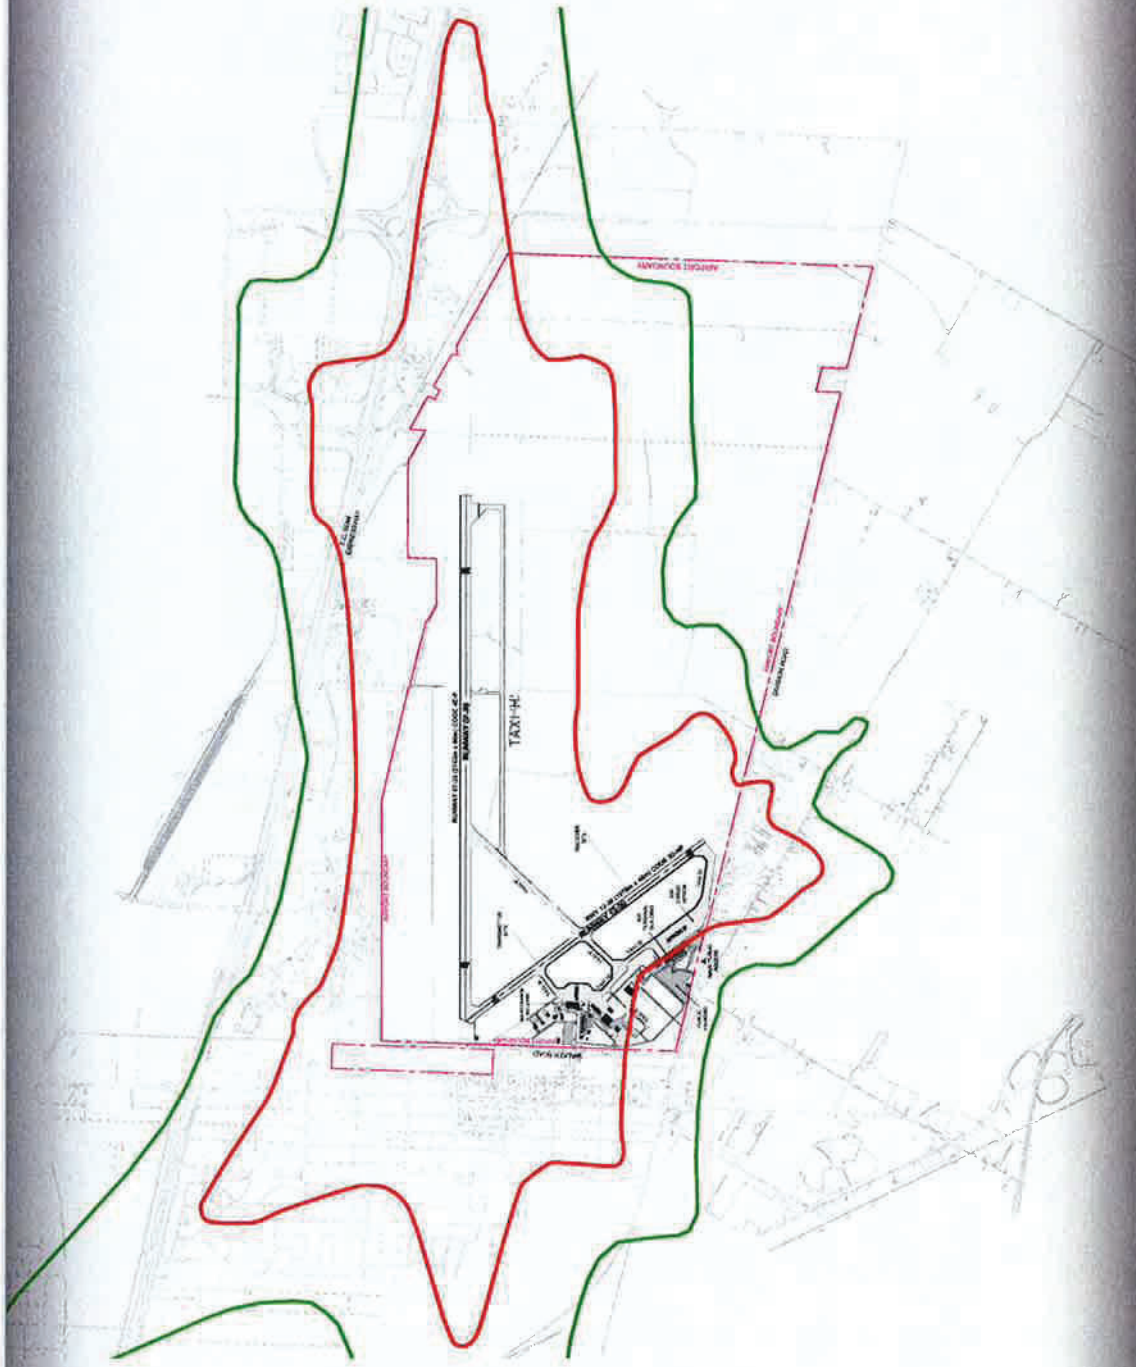
**WINDSOR AIRPORT
MASTER PLAN**

**FIGURE 3-4 - AIRPORT NOISE
EXPOSURE FORECAST CONTOURS**

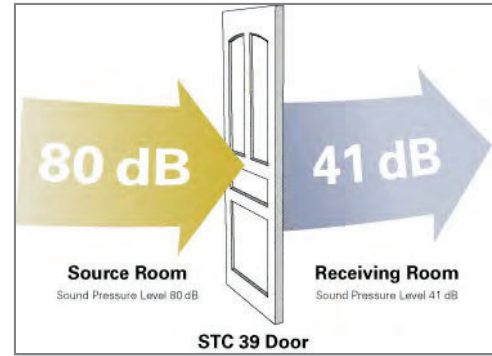
See image using STC 39 as a sample -->

These values are fitted to a curve in a method defined by the ASTM E413 Classification Standard for Rating Sound Insulation. The higher the STC value, the better the rating and the better the performance.

STC Rating	Performance	Description
50-60	Excellent	Loud sounds heard faintly or not at all
40-50	Very Good	Loud speech heard faintly
35-40	Good	Loud speech heard but hardly intelligible
30-35	Fair	Loud speech understood fairly well
25-30	Poor	Normal speech understood easily and distinctly
20-25	Very Poor	Low speech audible

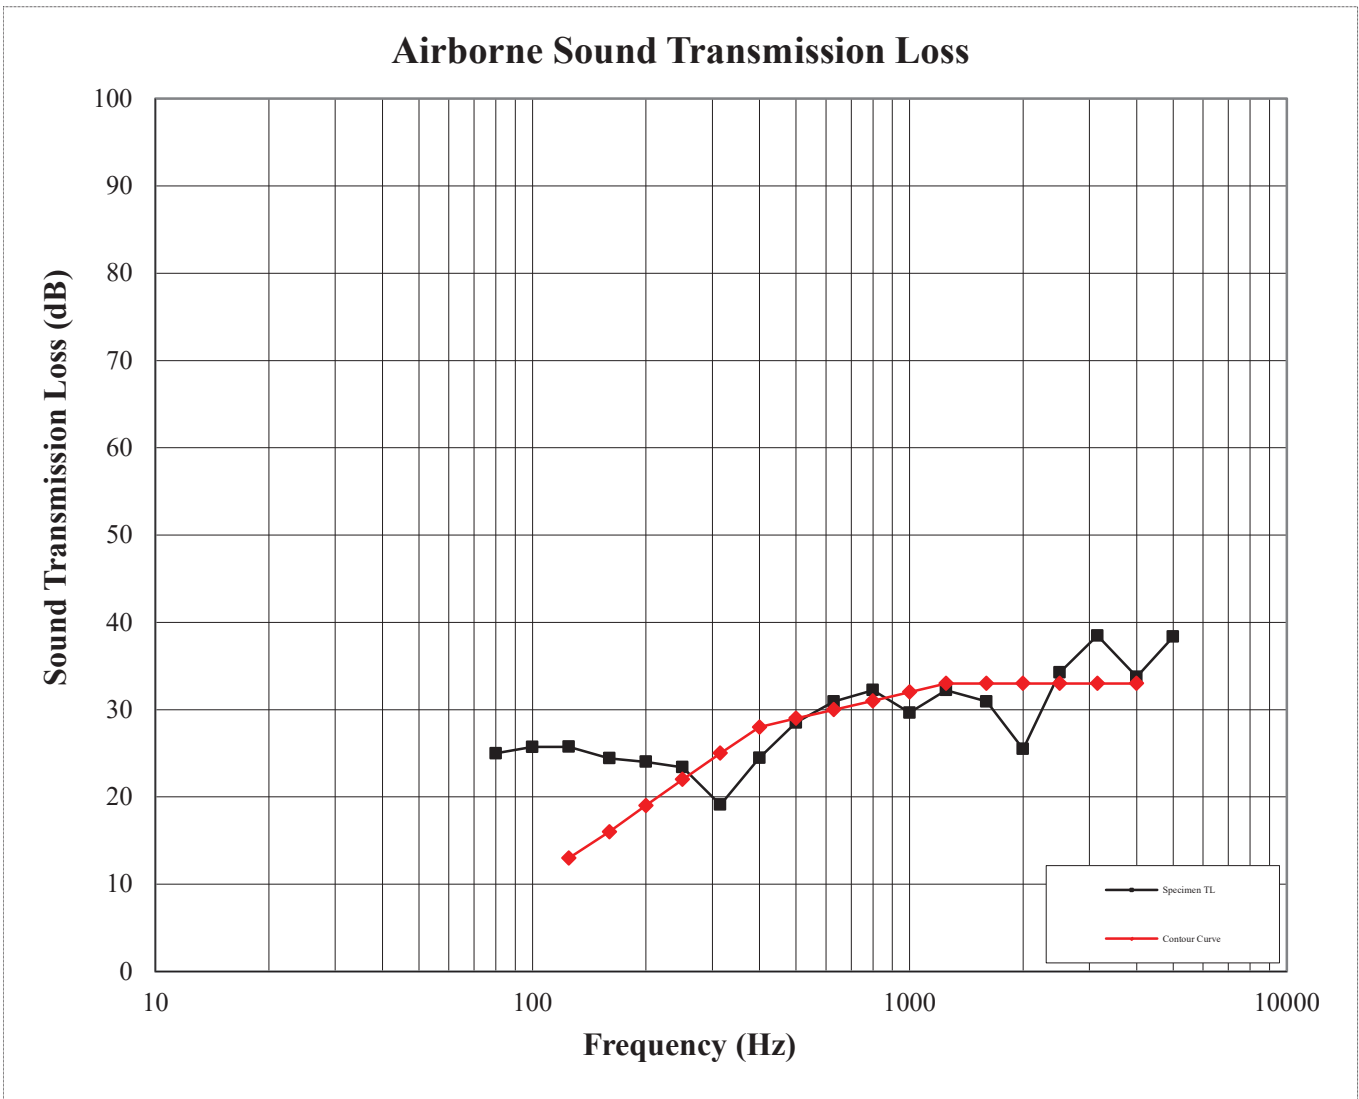
AIRBORNE SOUND TRANSMISSION LOSS
ASTM E 90

Test Date	04/21/15					
Data File No.	E6297.01B1					
Client	Therma-Tru Corporation					
Description	Series/Model: 3/0 x 6/8 Fiber-Classic/Smooth-Star full lite flush glazed, side-hinged single door system with 5/8" IG (1/8" tempered, 3/8" air space, 1/8" tempered), sealed with duct tape on both sides (inoperable)					
Specimen Area	1.99 m ²	Receive Temp.	22.6 °C		Source Temp.	22.1 °C
Technician	Daniel P. Platts	Receive Humidity	49%		Source Humidity	48%

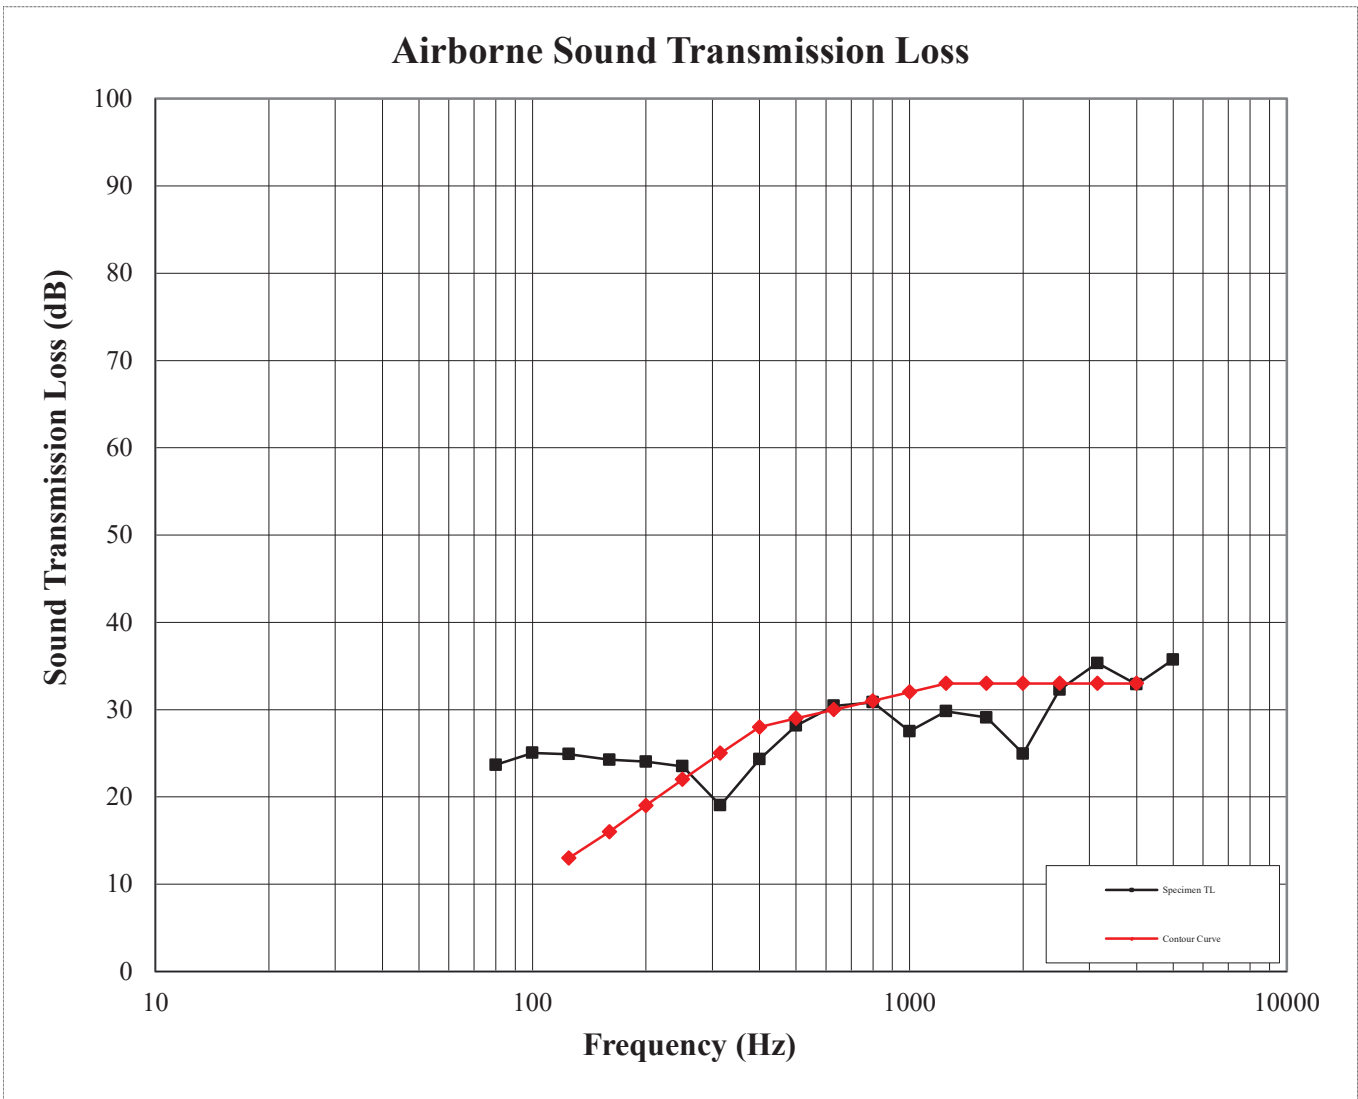
AIRBORNE SOUND TRANSMISSION LOSS
ASTM E 90

Test Date	04/21/15					
Data File No.	E6297.01B					
Client	Therma-Tru Corporation					
Description	Series/Model: 3/0 x 6/8 Fiber-Classic/Smooth-Star, full lite flush glazed, side-hinged single door system with 5/8" IG (1/8" tempered, 3/8" air space, 1/8" tempered) (operable)					
Specimen Area	1.99 m ²	Receive Temp.	22.6 °C		Source Temp.	22.1 °C
Technician	Daniel P. Platts	Receive Humidity	49%		Source Humidity	48%

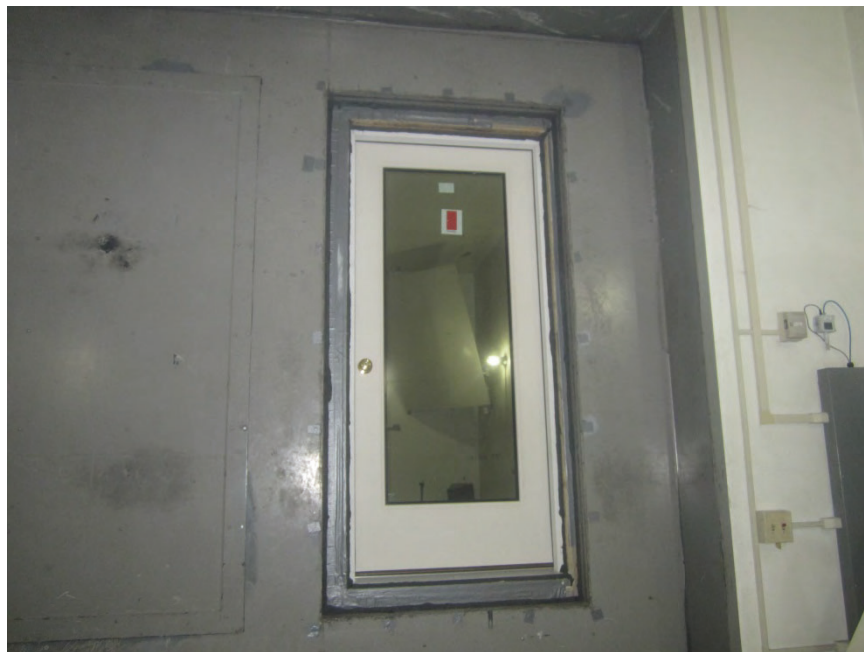
Source Room View of Installed Specimen
