STAFF REPORT 5-8-2019 MEETING  
APPLICATION NUMBER 19-6181  
ADDRESS: 2081 VERMONT  
HISTORIC DISTRICT: CORKTOWN  
APPLICANT: JIM KORF  
DATE OF STAFF VISIT: 5-2-2019

Erected ca. 1900, the dwelling at 2081 Vermont is a 1 1/2-story, wood-frame shotgun-plan dwelling. The home features a front-gabled roof which is covered with asphalt shingles. An historic brick chimney tops the roof. Exterior walls are covered with aluminum siding at the front/east and south/side elevations. The original lapped wood siding is visible at the rear and north elevations. A small portion of the original siding can be viewed at the front elevation as several sections of the aluminum siding have fallen off. The original brick foundation wall is visible at the rear elevation and the rear 1/2 of the side elevations. A wood skirting is at the front elevation and wraps around the front 1/2 of the side elevations. A concrete block foundation is located to the rear of the building. The front porch features a flat roof, turned wood supports/columns, and a wood deck and stairs. The porch roof intersects with a projecting flat-roof, three-window bay. Original 2/2 wood windows (with associated wood trim) remain at t

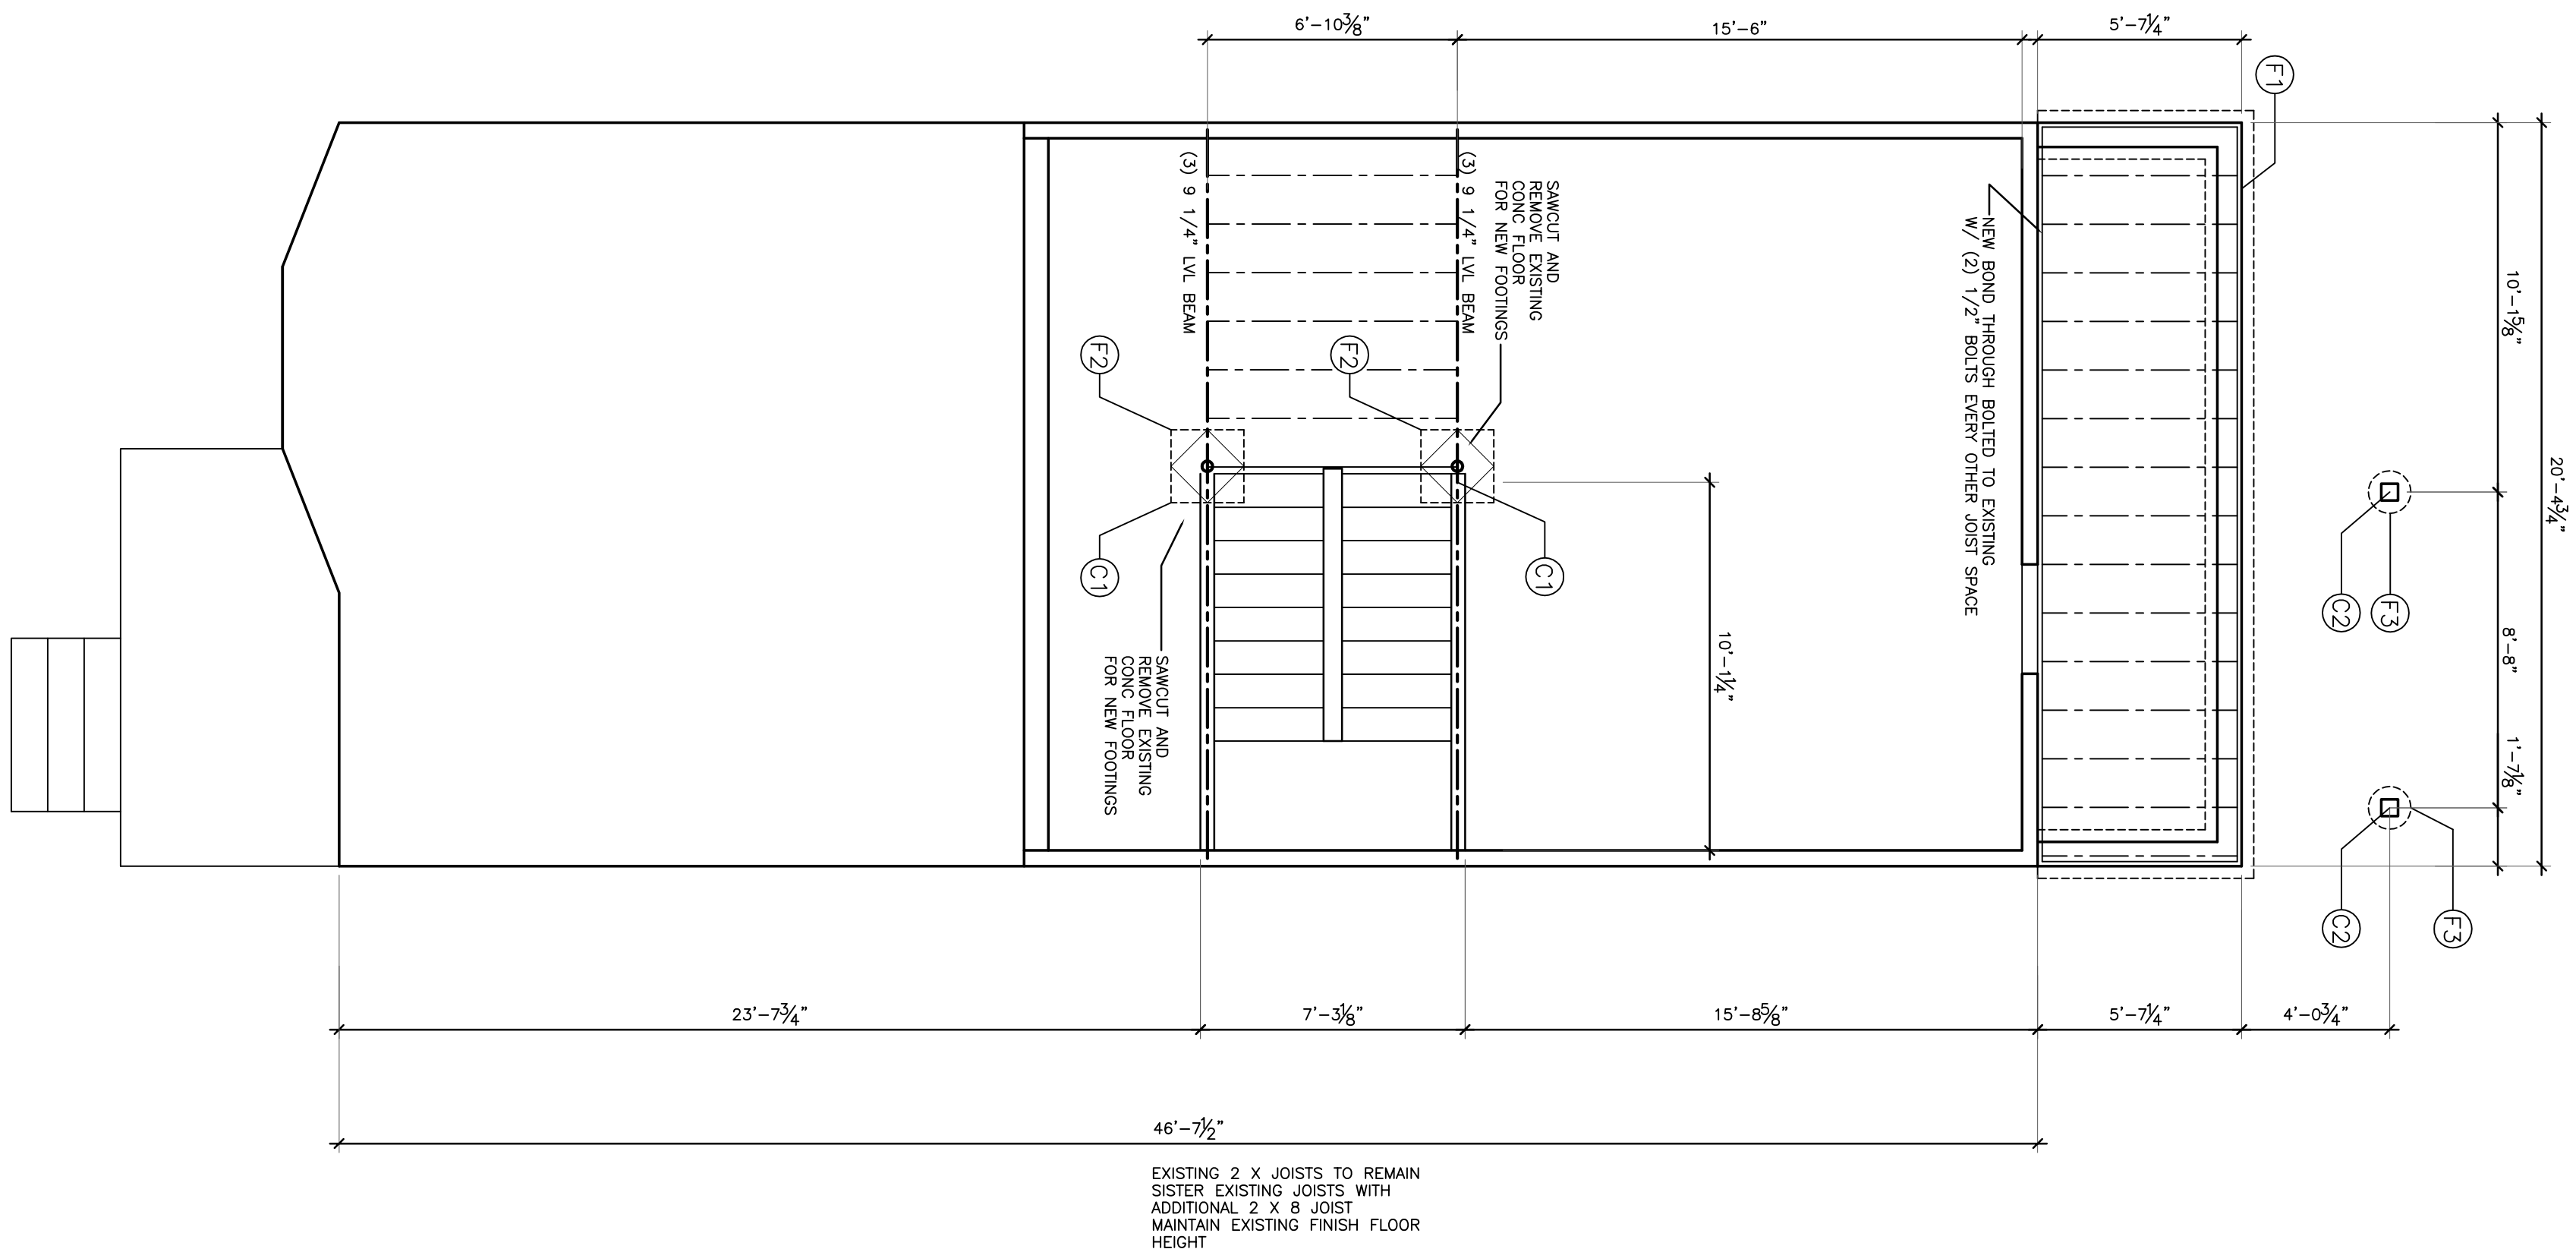
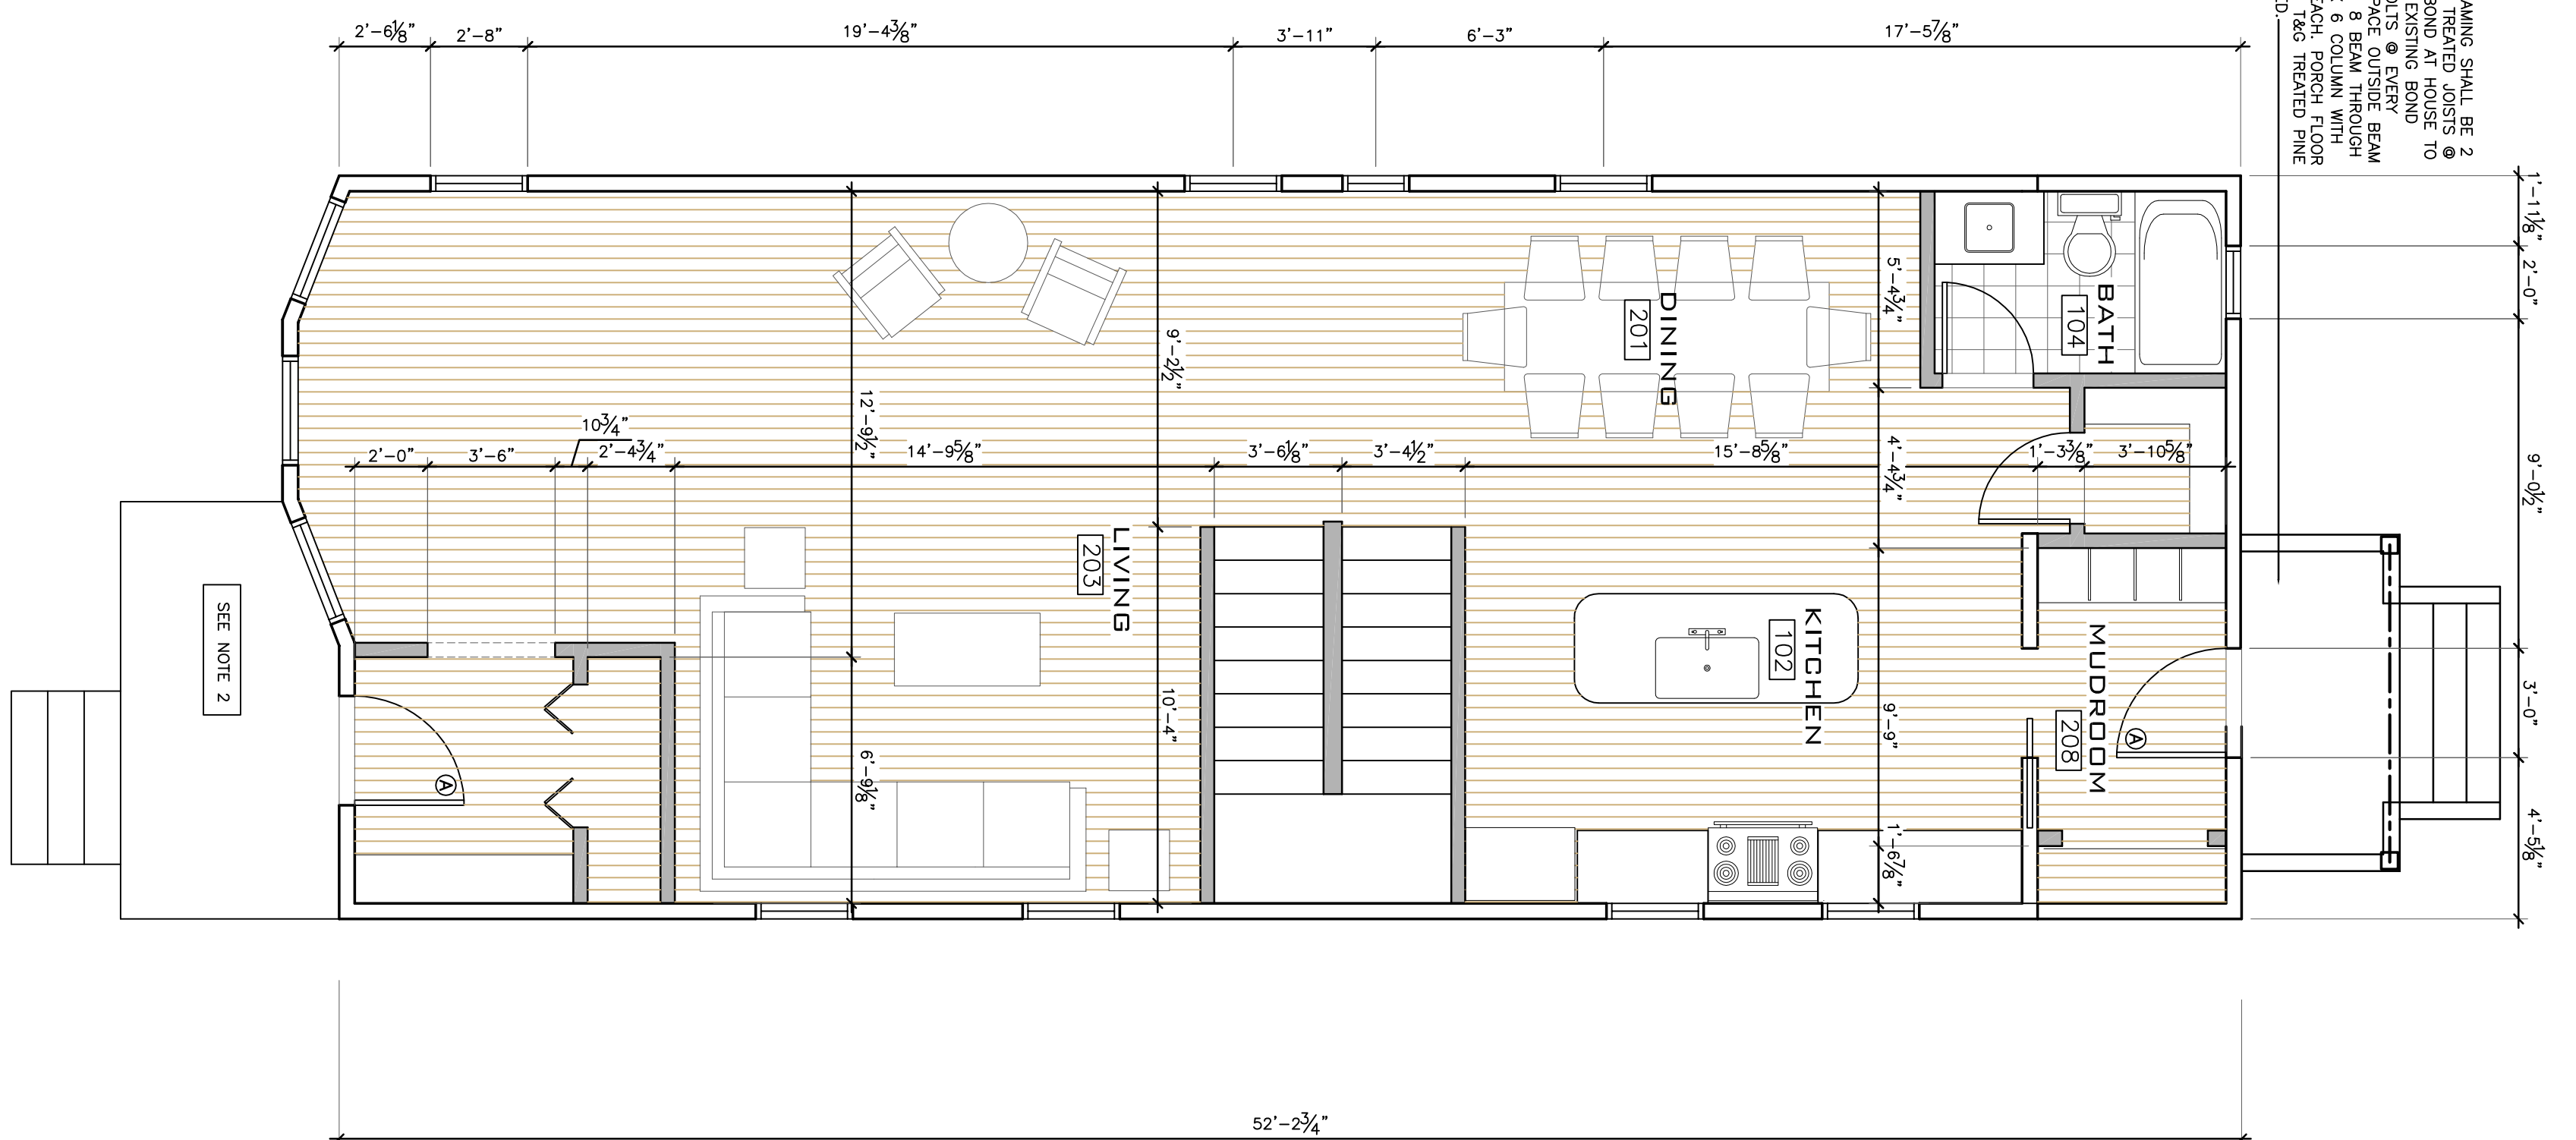
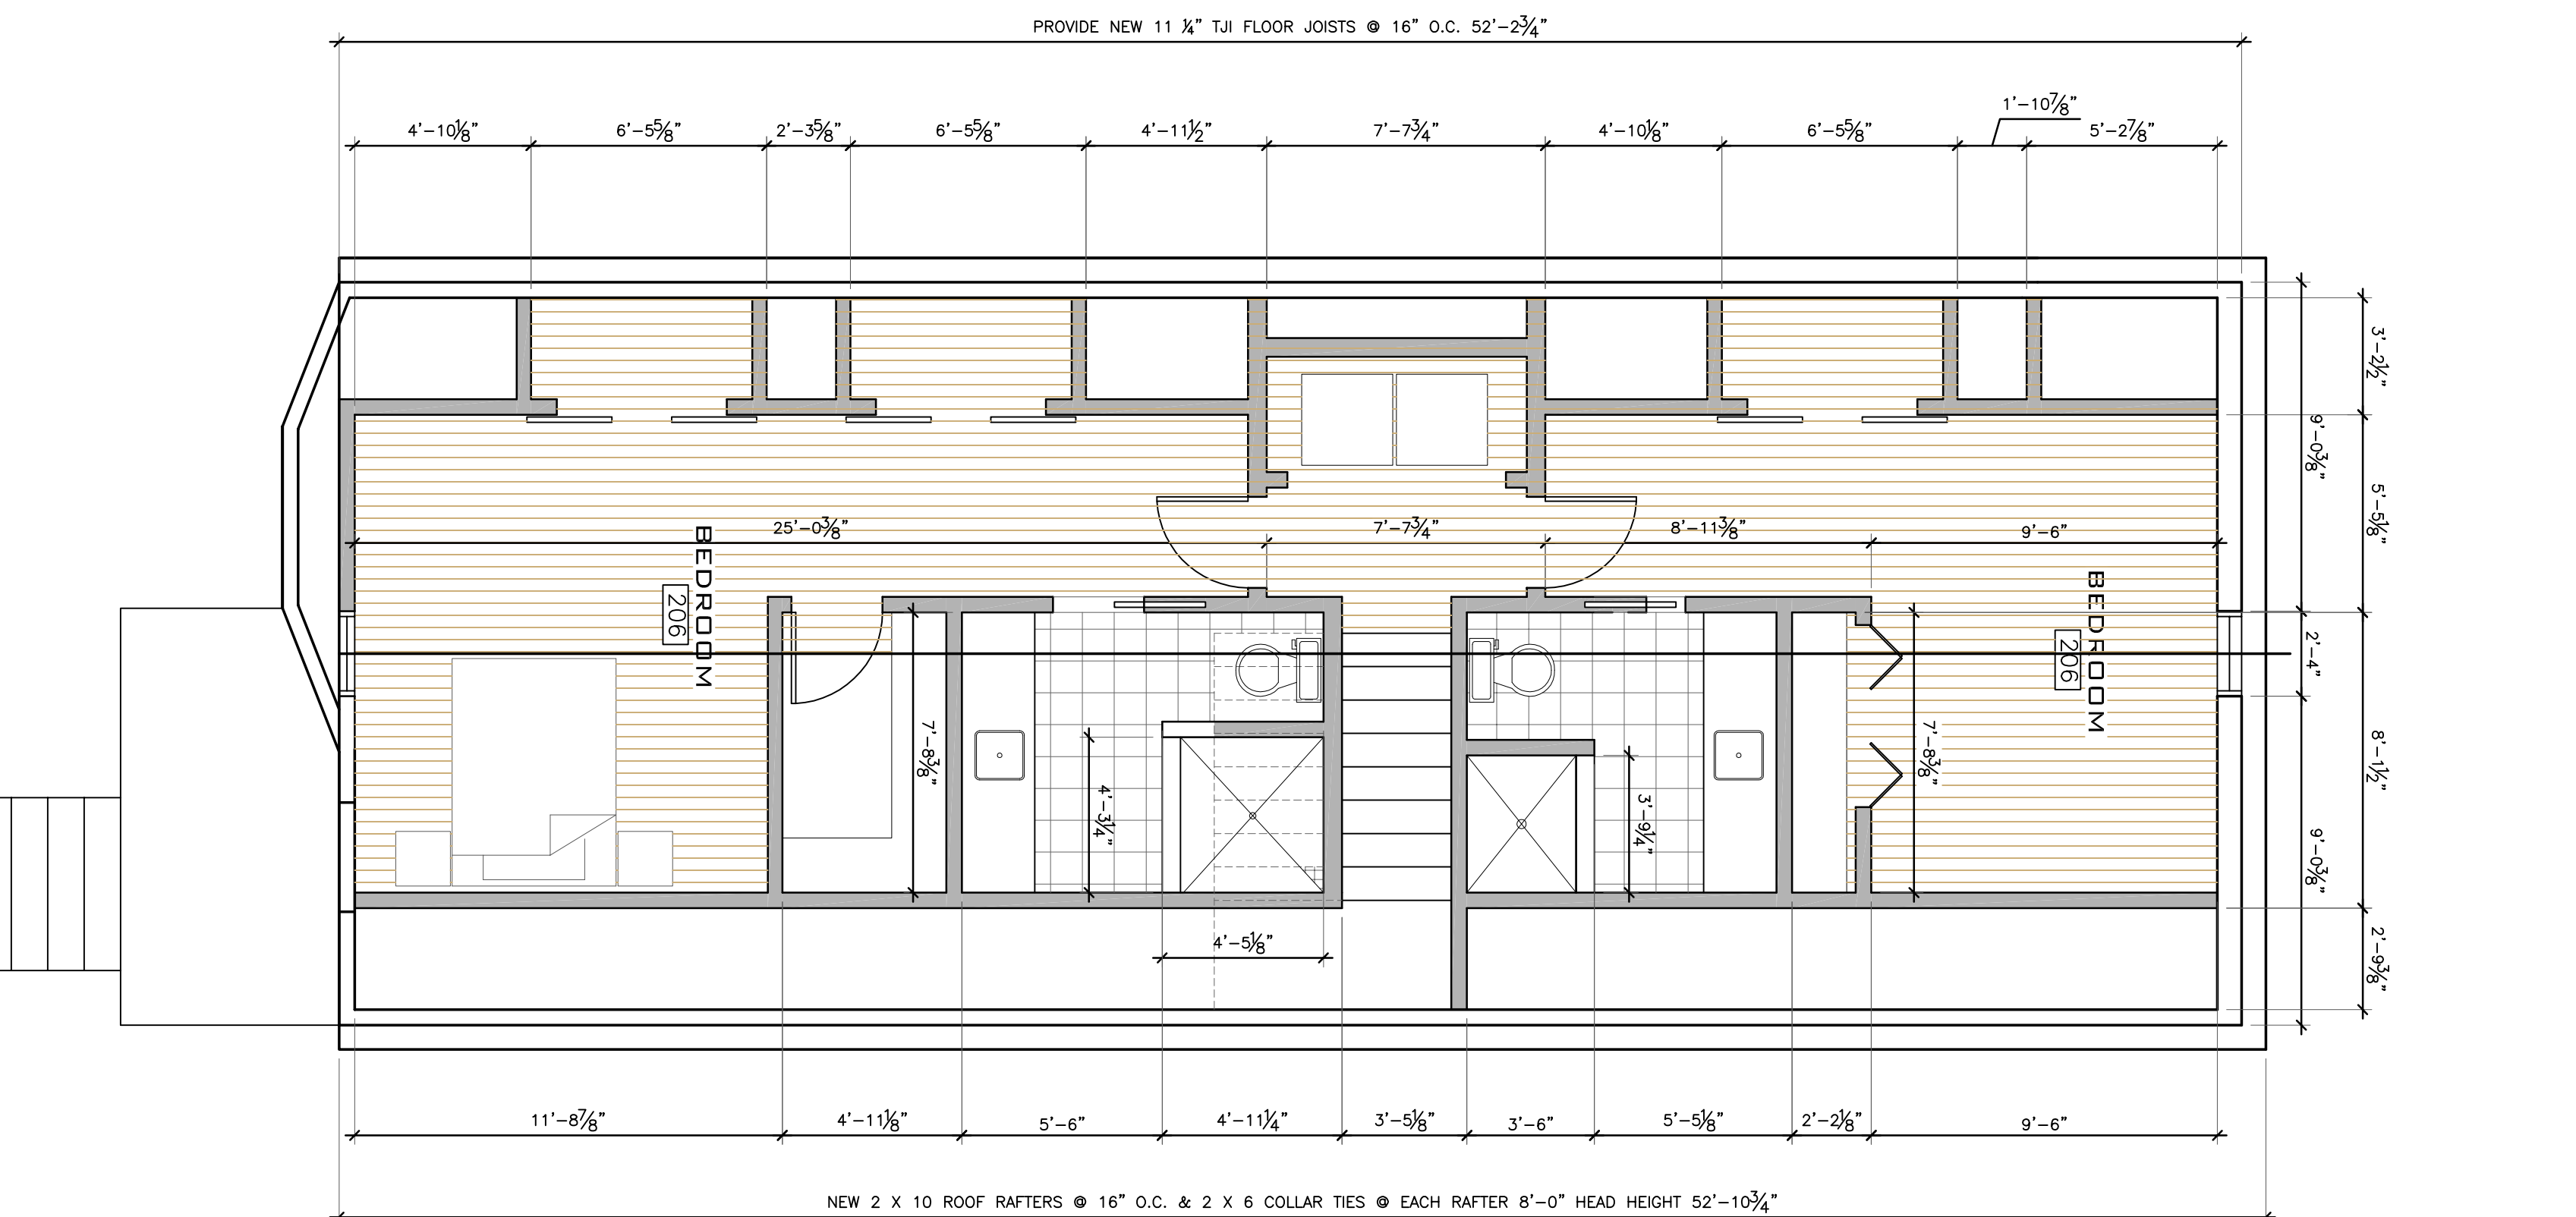
# FOUNDATION PLAN

FOUNDATION NOTES		FOUNDATION SCHEDULE		COLUMN SCHEDULE		FRAMING NOTES		STRUCTURAL NOTES		DOOR SCHEDULE			
1. THE CONTRACTOR SHALL CONFORM THE LOCATION OF ALL SILL, FABRIC AND ALL DRAINAGE TILL @ ALL FOOTING LOCATIONS AS REQUIRED.		F1 8" CONCRETE BLOCK FOUNDATION WALL. PROVIDE #3 BARS, GROUTED FOUNDATION WALLS BEAR ON 16" X 12" REINFORCED CONCRETE BEAM. FROST DEPTH, BEARING ON UNDISTURBED SOIL.		C1 3 1/2" ADJUSTABLE STEEL COLUMN		1. FOUNDATION WALLS AT HOUSE, PROVIDE R-13 RIGID INSULATION ON ALL INSIDE SURFACES. EXTERIOR FINISH TO BE VERTICALLY INSULATED. EXTERIOR SHEATHING IS 1/2" OSB. WITH 1/4" POLYURETHANE INTERIOR SHEATHING IS 3/4" GYP BD.		1. EACH 2' X 2' (ACTUAL) WALL STUD SHALL BE SISTERED WITH A NEW 2' X 6 WALL STUD, SEE DETAIL.		# DOOR SIZES

3. THE CONTRACTOR SHALL PROVIDE 3/4" ANCHOR BOLTS AT 4'-0" O.C. AT ALL FOUNDATION WALLS AND SHEAR WALL LOCATIONS.		F3 14" REINFORCED CONCRETE SOUTERLE TYPE FOOTING @ 42" MIN DEPTH				3. NEW ROOF: PRE-ENGINEERED TRUSSES AND BATTERS AS SHOWN WITH HERRING CLIPS PER CODE. 1/2" OSB SHEATHING WITH CLIPS PER CODE. PROVIDE CLOSED CELL POLYURETHANE INSULATION BETWEEN ALL PARTERS.		3. THE GC SHALL ASSURE THAT AT LEAST 12 EXISTING 1ST FLOOR JOISTS WILL REMAIN A FULL REPLACEMENT WITH NEW JOISTS.		FRAMES

5. THE CONTRACTOR SHALL PROVIDE ALL FOUNDATION WALL BEAM POCKETS AS REQUIRED. SEE FIRST FLOOR FRAMING PLAN.								5. NEW PORCH STRUCTURE IS PRESSURE TREATED LUMBER. ALL JOISTS BE HANGERS INTO BEAM. NEW PORCH FLOORS ARE 3/4" X 4" T&G. PRESSURE TREATED TO MATCH EXISTING.		HARDWARE TYPE

4. There is an existing foundation and floor structure on the west side of the building, shown in pictures. A portion of the foundation will be replaced (5'-7 ¼" x the width of the building), and the addition rebuilt in that area only. The owner has chosen to rebuild only a portion of the existing addition in order to preserve open space in the backyard.

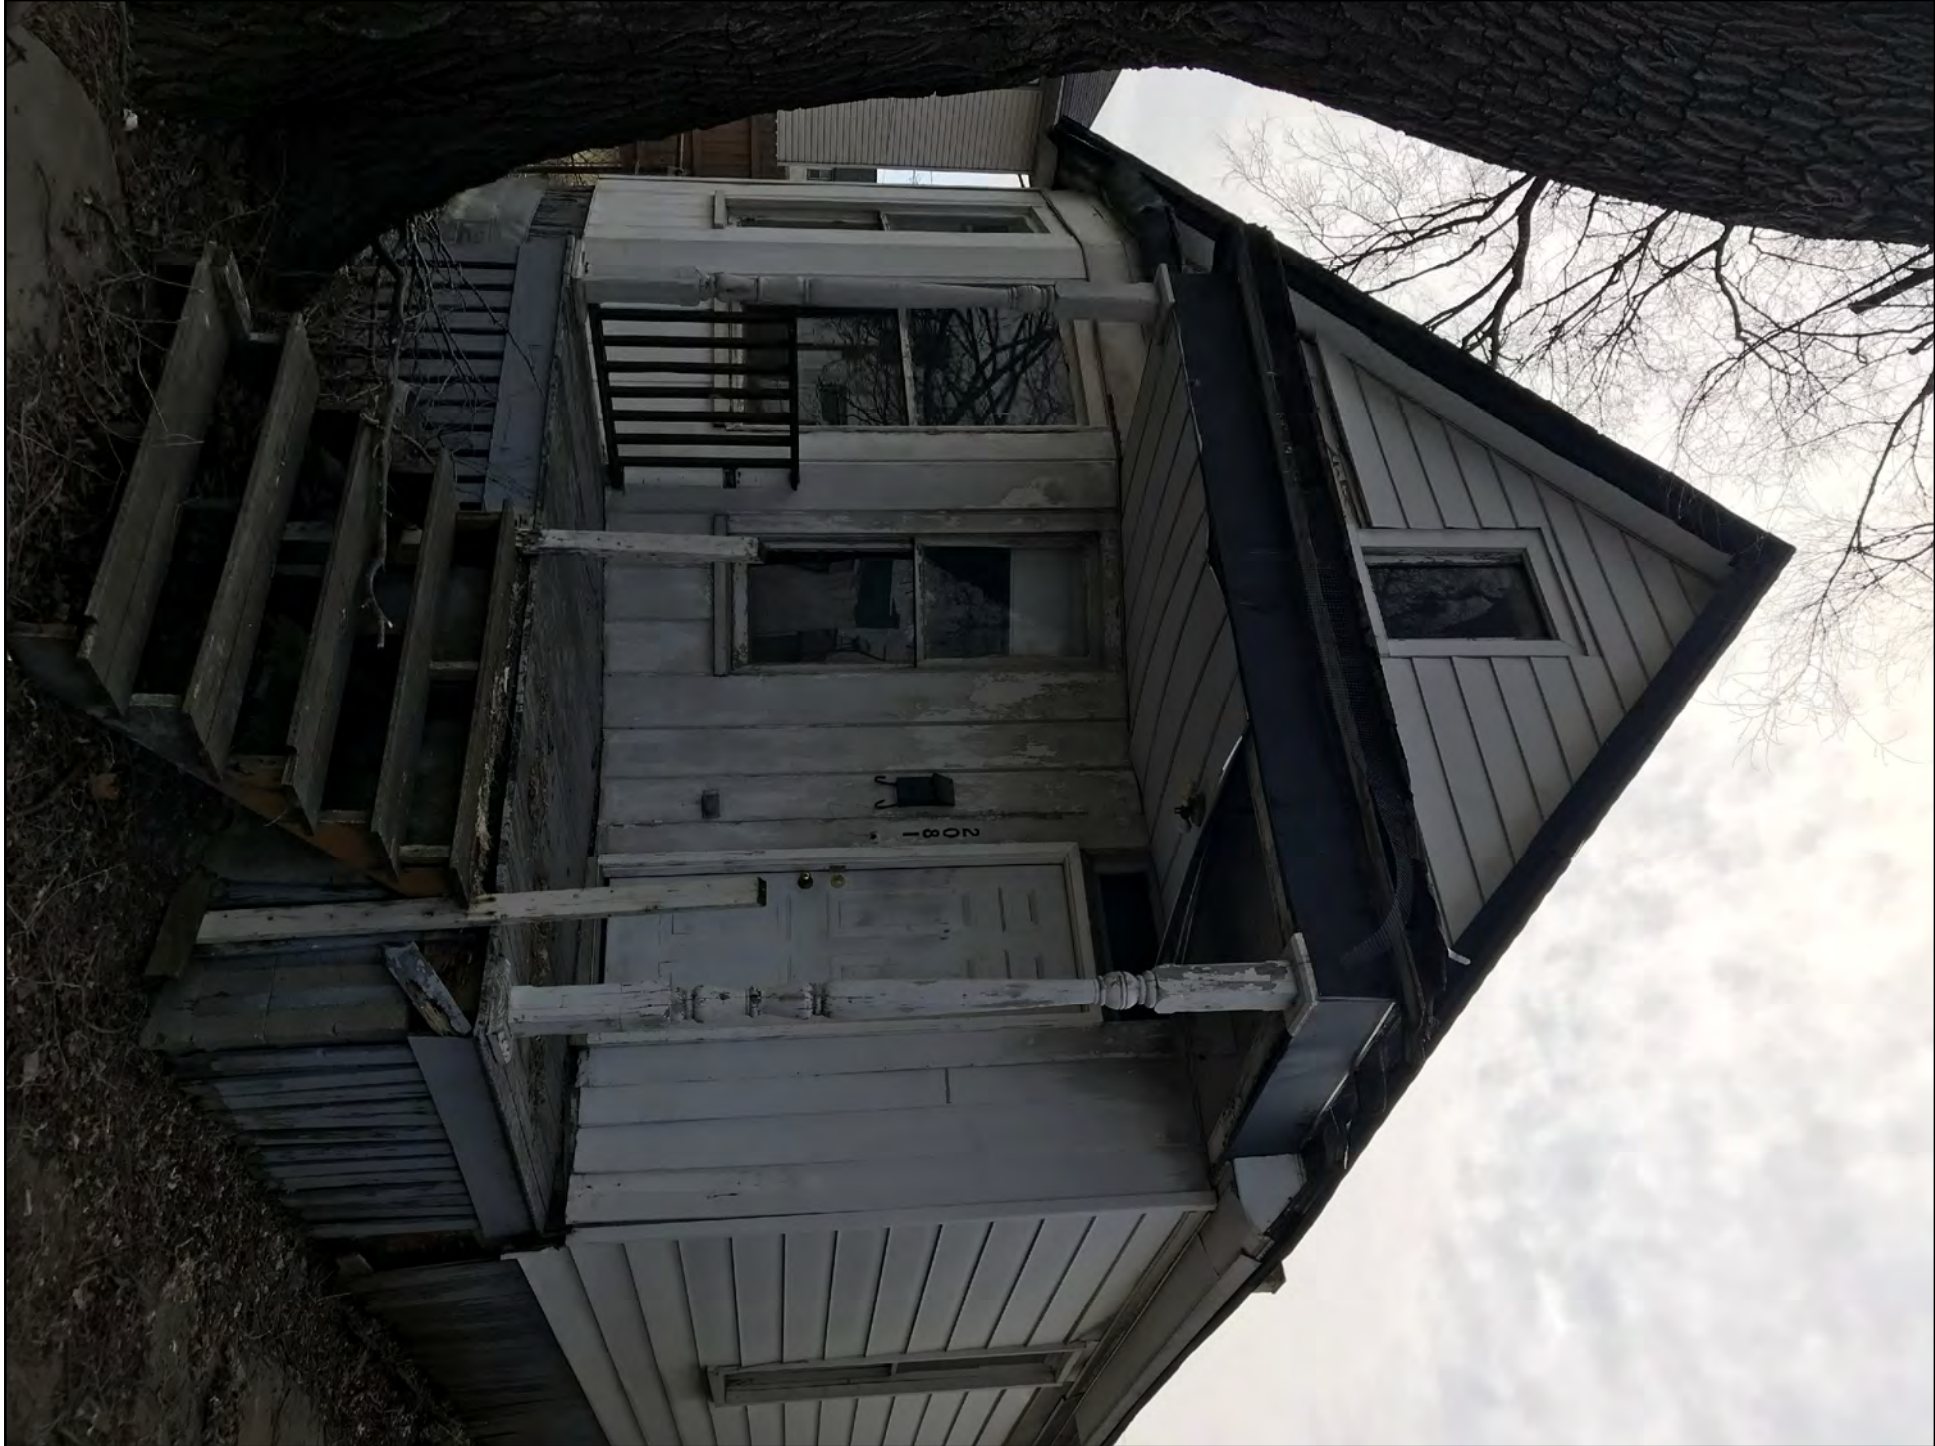
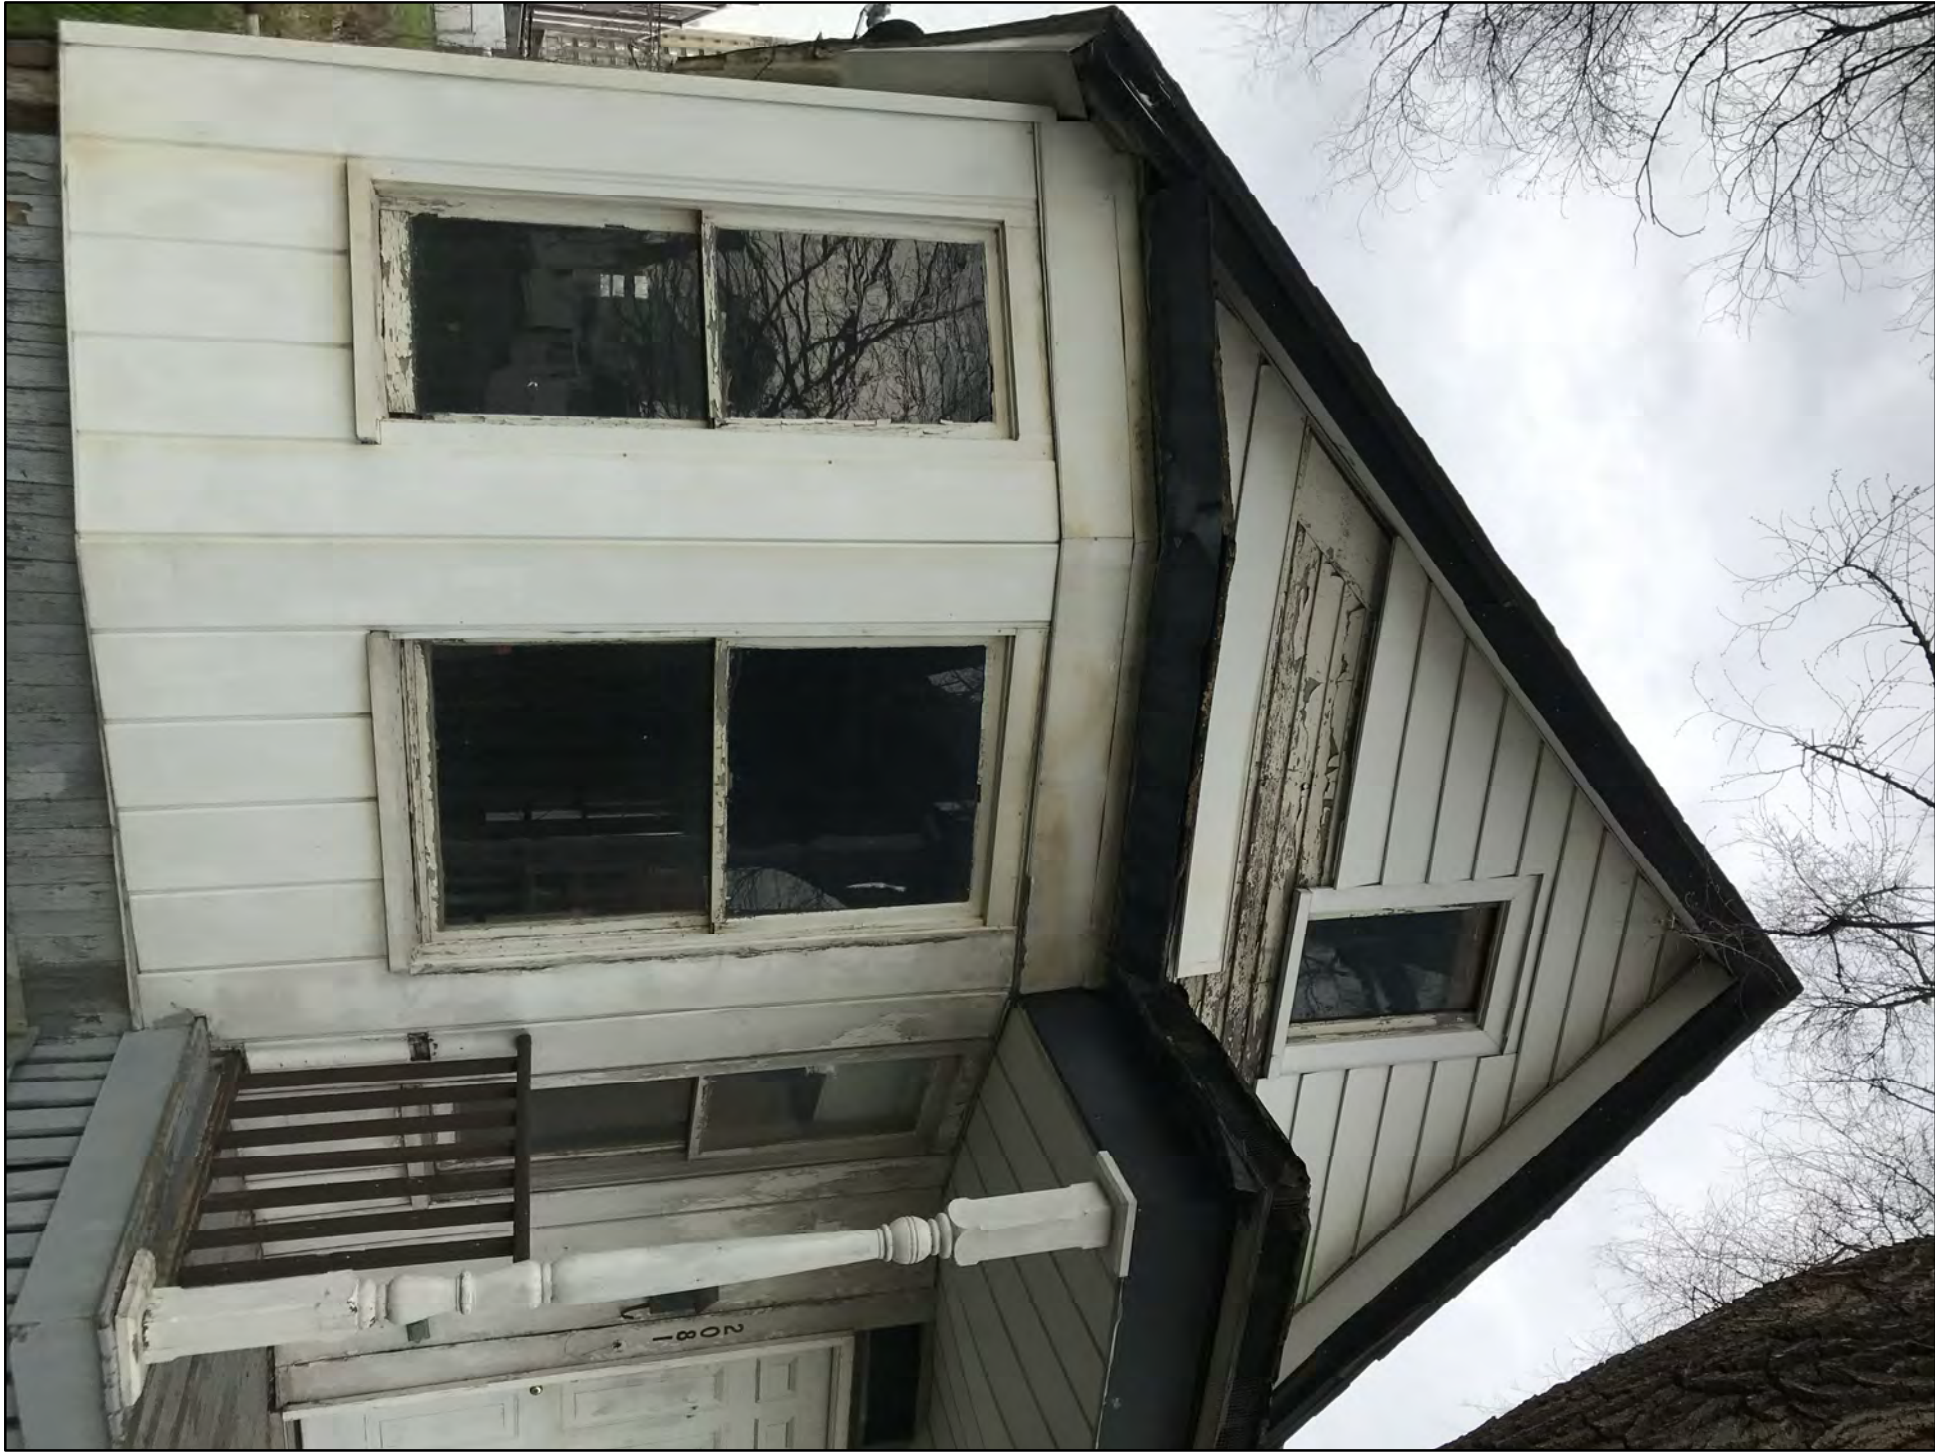
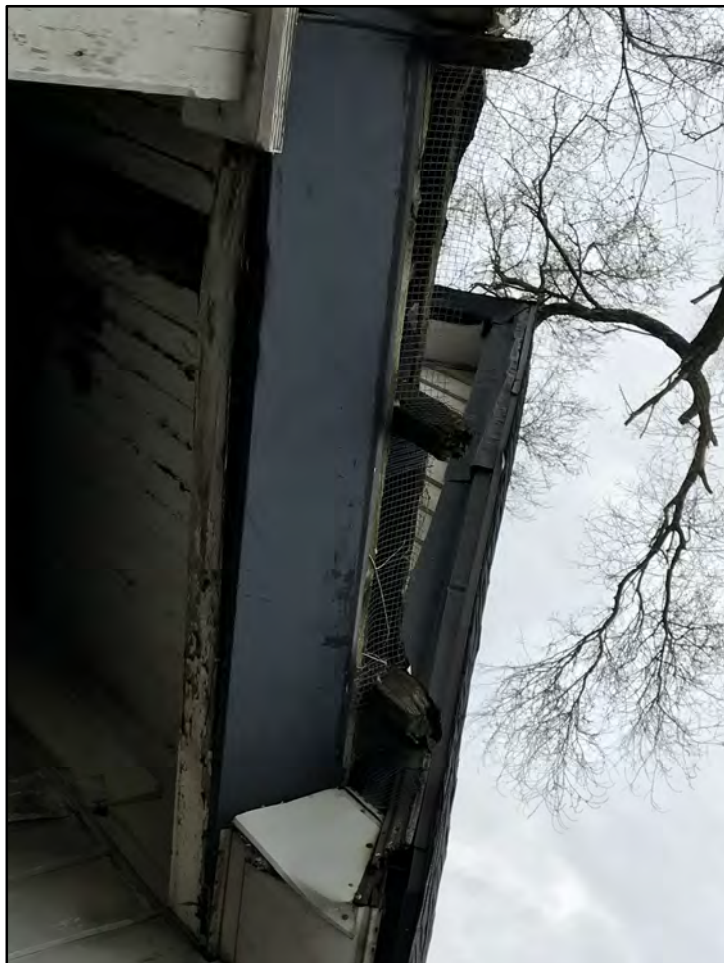
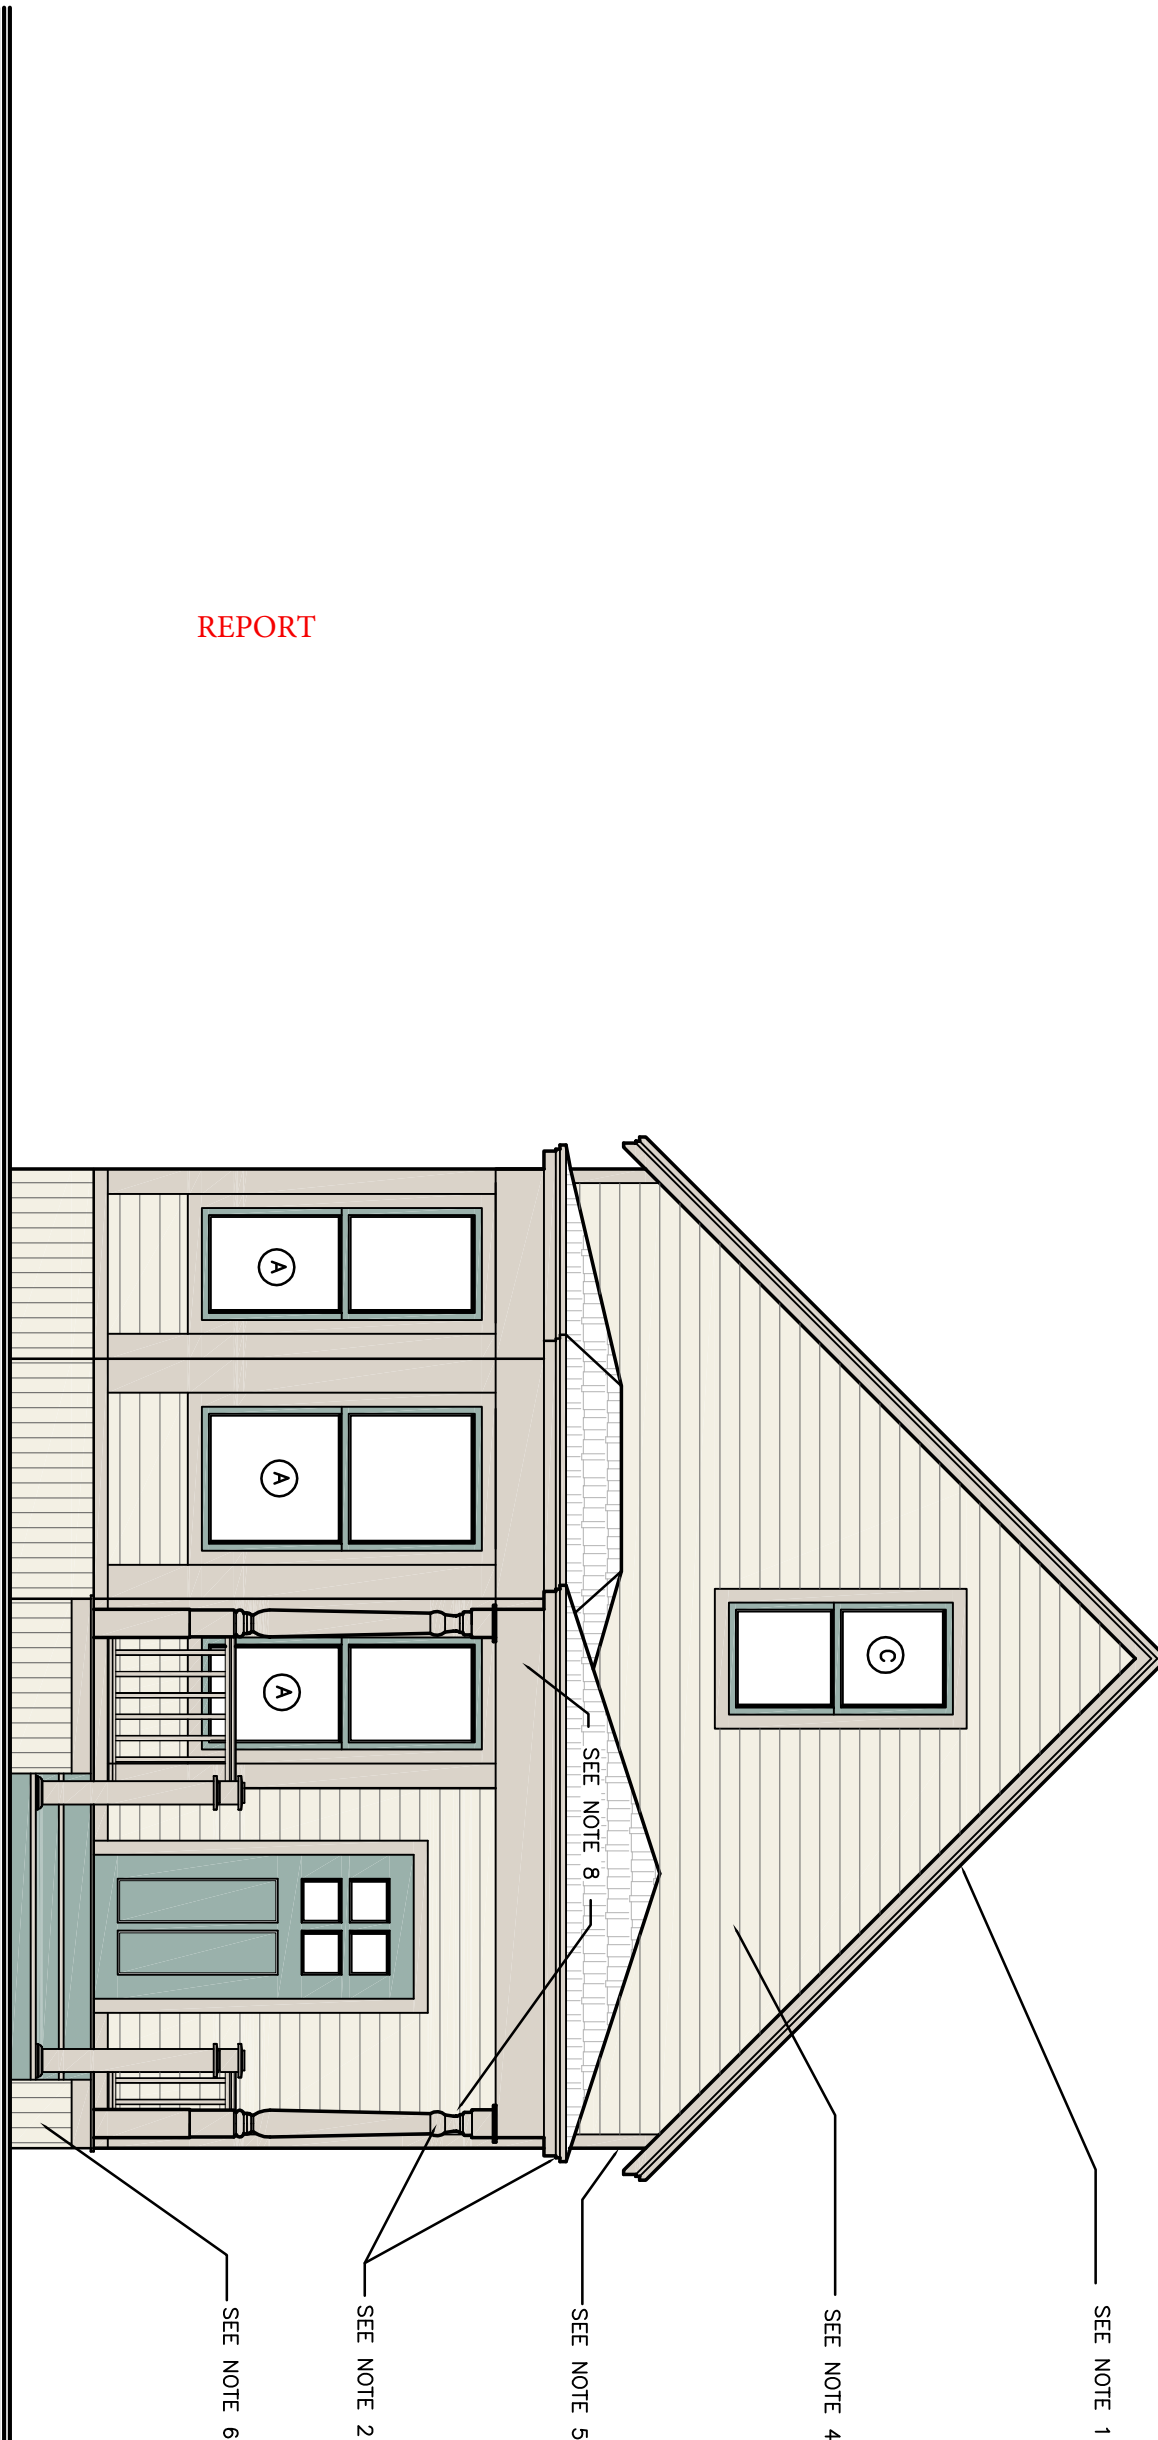
EAST ELEVATION  
1/4" = 1'-0"

2. EXISTING DECORATIVE ELEMENTS AND COLUMNS ARE TO BE RETAINED, REPAIRED AND REPAINTED, WHEREVER POSSIBLE. IN THE EVENT THAT SOME PORTION OF THE EXISTING MATERIAL CANNOT BE FEASIBLY REPAIRED, NEW MATERIAL SHALL MATCH THE EXISTING AS CLOSELY AS POSSIBLE. THE GC IS TO CONFIRM ANY REPLACEMENT MATERIALS WITH THE ARCHITECT PRIOR TO ORDERING OR INSTALLING MATERIAL.

3. ALL WINDOWS WILL BE REPLACED AND SHALL BE: BE PETLA -- ARCHITECT SERIES DOUBLE HUNG WOOD WINDOWS WITH PRE PAIRED WOOD EXTERIOR FRAMES AND WOOD INTERIOR FRAMES. THE GC SHALL SUBMIT A FINAL WINDOW SCHEDULE PROVIDED BY HIS WINDOW PROVIDER TO THE ARCHITECT FOR FINAL APPROVAL. EXTERIOR WINDOW TRIM SHALL BE 1" X 4" PAINTED WOOD TO MATCH EXISTING WINDOW TRIMS.

5. EXISTING CORNER TRIMS ARE TO BE 1" X 4" TO MATCH EXISTING. PAINTED.
6. EXISTING VERTICAL 1" X 4" SHIRT IS TO BE REMOVED AND REPLACED WITH NEW PRESSURE TREATED 1" X 4" BOARDS TO MATCH EXISTING.

7. East elevation –
  - a. Existing porch floor to be removed, floor joists replaced as required, and new 4" tongue and groove wood porch floor to be installed to match existing.

- b. Existing decorative porch columns are to be repaired and painted.
  - c. All wood fascias at porch roof perimeter to be repaired and painted, unless extent of degradation requires replacement. If replacement is required, new fascias are to match existing.

- d. The extent of the structural damage to the porch roof is unknown until further demolition is complete. The low slop hip roof over the existing porch and bay window will be built identically to the original construction.

- e. The existing 1 x 4 porch ceiling is visible beneath the existing aluminum ceiling. Existing 1 x 3 tongue and groove materials will be repaired and repainted if possible. If the extent of the degradation is such that the ceiling material cannot be repaired, new material will match the original 1 x 4 ceiling.

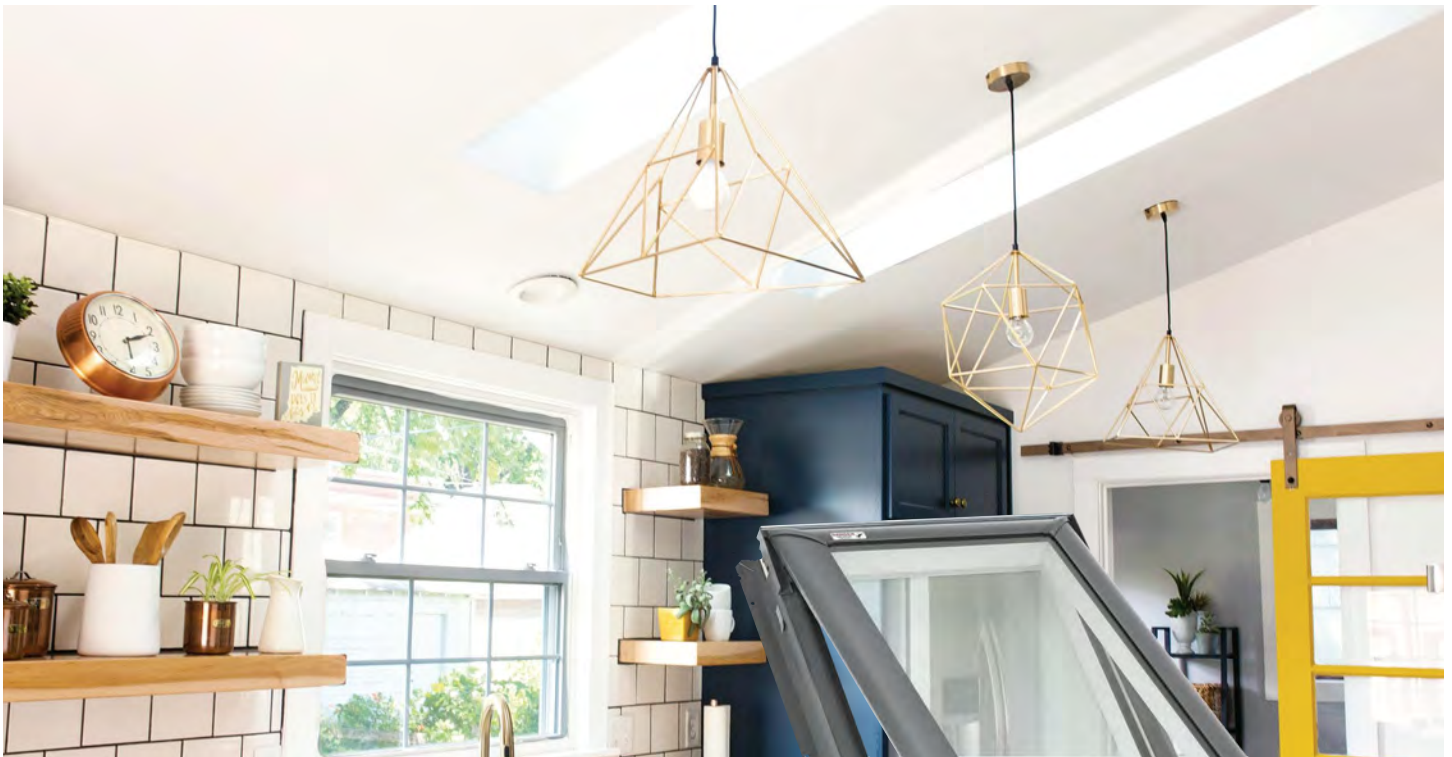
## Electric "Fresh Air" Skylight VSE Model

As the ideal daylighting solution for your home, the VELUX Electric "Fresh Air" Skylights bring in abundant natural light and with the touch of a button, open to let fresh air in too. Your home can be brighter and feel more fresh with the combined power of light and air from your skylight.

- A pre-installed concealed motor and control system lets you easily open and close with remote.
- Fitted with a rain sensor, your skylight will automatically close at the first signs of rain.
- Compatible with VELUX ACTIVE with NETATMO: your home's climate control and monitoring system. *See page 11*
- Clean, Quiet & Safe glass is standard on all VSE models. *See page 13*

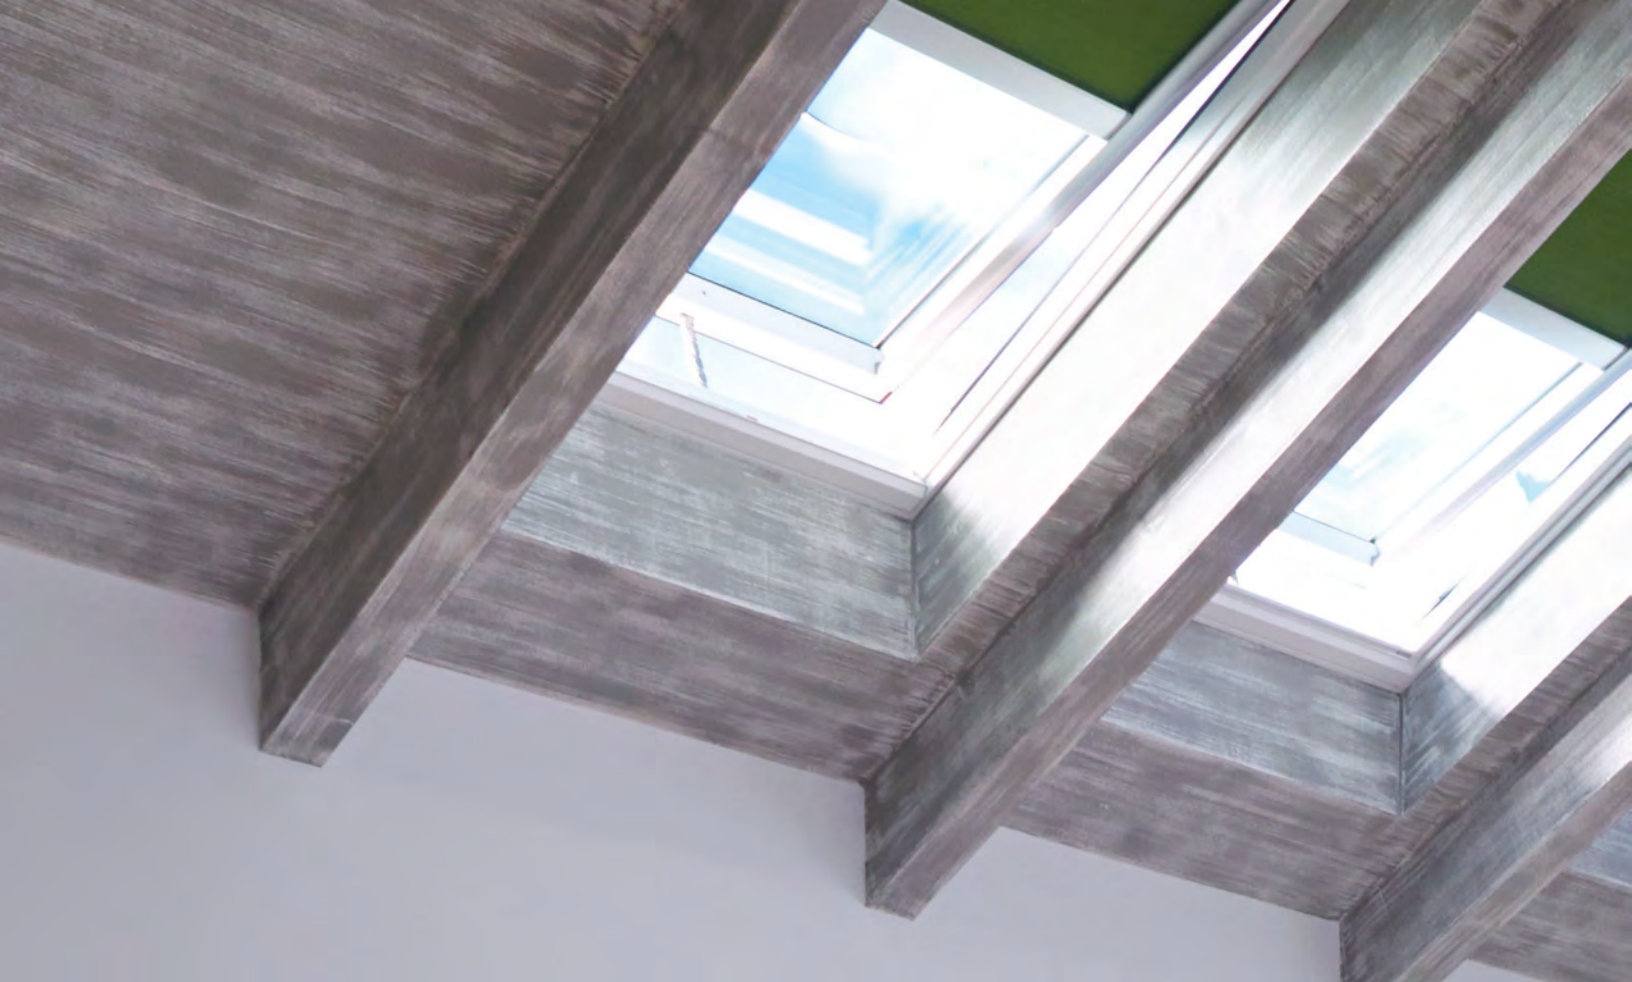
## 3 Layers of Protection

At VELUX, we've developed three layers of water protection to safeguard your house against damaging leaks. Our No Leak Skylight carries a 10-year installation warranty plus 20 years on glass, 10 years on product, and 5 years on blinds and controls.

- 1 Pre-attached Seal**  
Pre-attached deck seal provides a tight seal for leak-proof installation.
- 2 Adhesive Underlayment**  
Adhesive underlayment for secondary water protection against the harshest weather conditions.
- 3 Engineered Flashing**  
Engineered flashing for easy installation and primary water protection.
