STAFF REPORT 7-10-2019 MEETING
APPLICATION NUMBER: 19-6321
ADDRESS: 110 SPROAT
HISTORIC DISTRICT: EDDYSTONE HOTEL
APPLICANT: BRIAN REBAIN
DATE OF STAFF VISIT: 7/8/2019

Kraemer Design Group (KDG) is writing to submit information to the Detroit Historic District Commission (HDC), on behalf of Eddystone Renaissance, LLC regarding the proposed rehabilitation of the Eddystone Hotel located at 110 Sprout. The proposed exterior work at the Eddystone Hotel will include exterior masonry cleaning and restoration; new storefronts; new exterior doors; new historic replica replacement windows; new signage in keeping in character with the historic signage; new façade lighting; cleaning and repair of the iron flagpoles; new roofing, reconstruction of the mechanical penthouse, and new rooftop mechanical equipment.

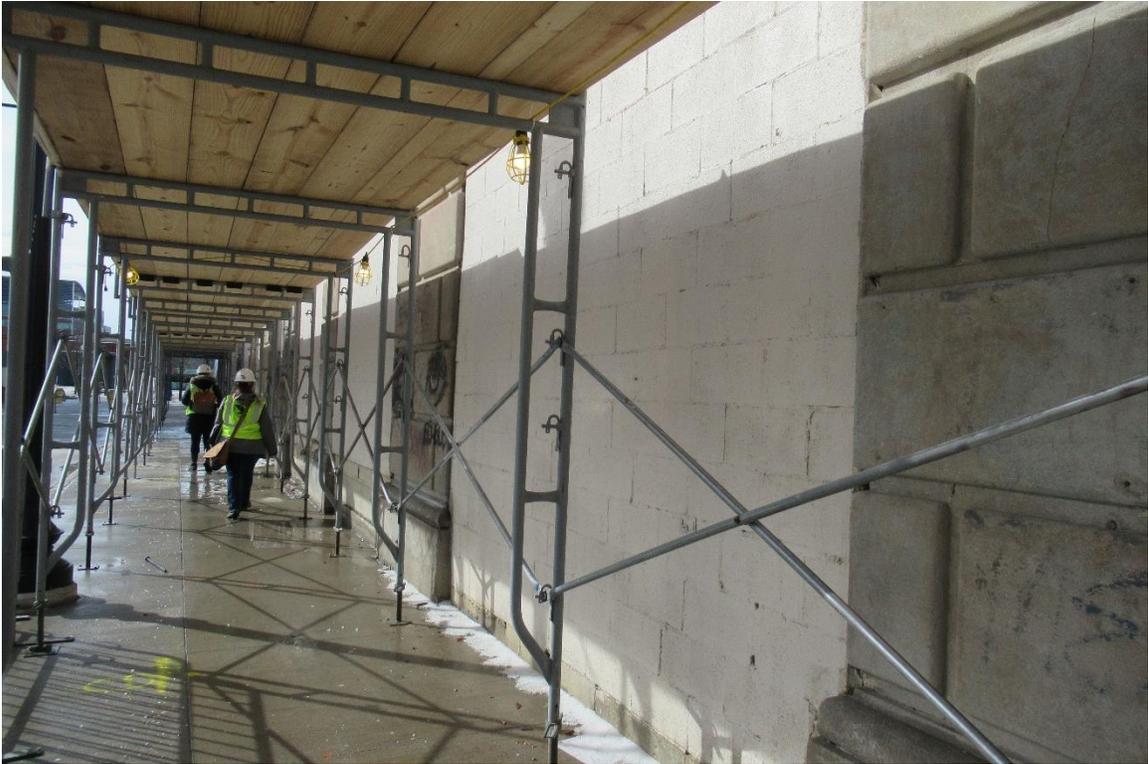
Figure #X: Exterior, storefronts with CMU infill, looking northwest. 2/14/19

There are currently no storefront systems in the building as all historic materials have long since been removed and the openings have been boarded or bricked over. Historically there were storefront systems on the Sproat Street and Park Avenue facades. All non-original storefront materials will be removed, and they will be replaced with a new storefront system designed to complement the historic character of the building without appearing falsely historic. Historic photos and limited physical evidence will be used to guide the design process. The storefronts will be aluminum framed with clear insulated glazing. The muntin pattern is based upon a historic photograph which is included here for reference. The sightlines will be approximately 2 1/2". Please see drawings for storefront elevations.

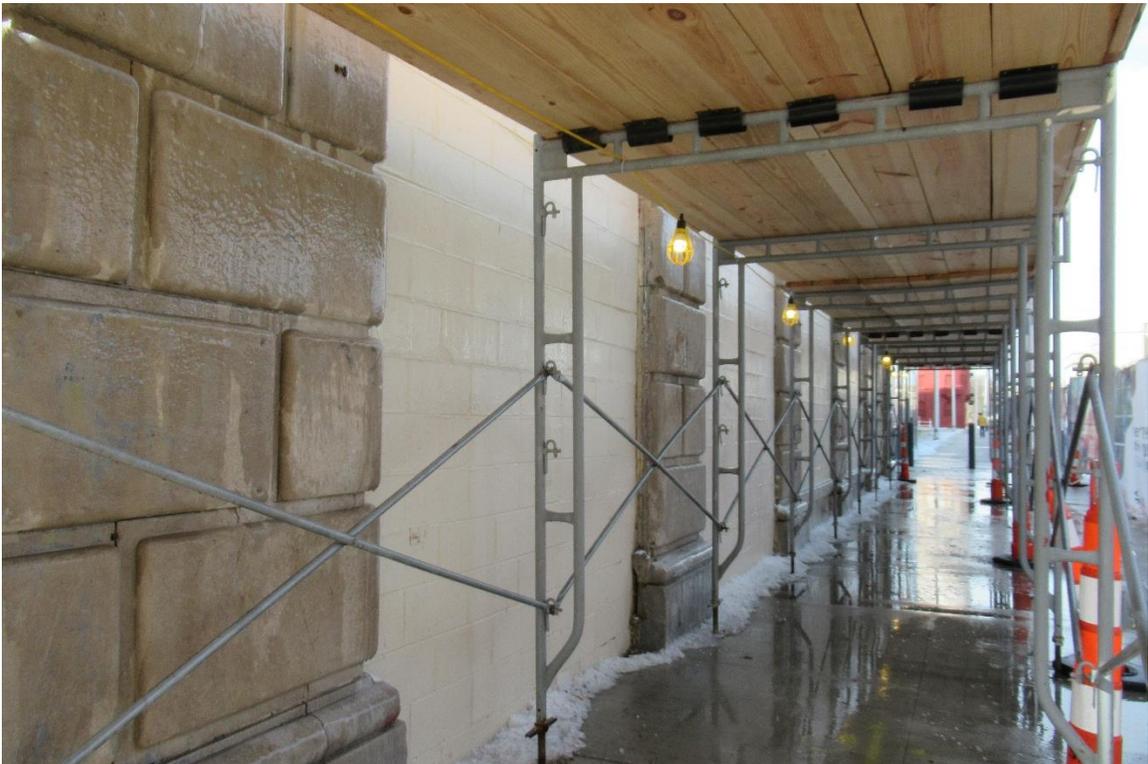
Figure #X: Exterior, storefronts with CMU infill, looking north. 2/14/19

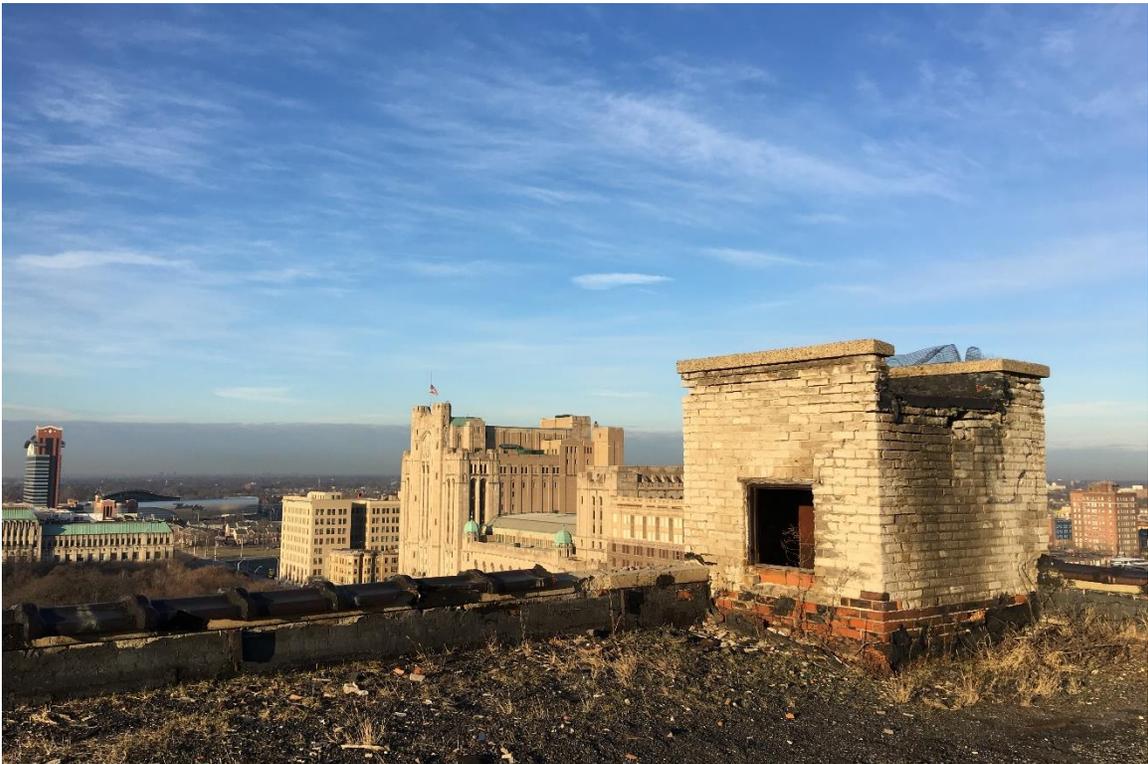
Figure #X: Exterior, chimney on roof, looking northwest. 12/5/18

The asphalt roofing system is in poor condition and will be replaced with a new EPDM roofing system. The chimney at the northwest corner of the roof will be removed as it is in very poor condition with significant spalling and missing units. The roof structure, parapet, and coping will be infilled at this location to match the historic parapet configuration. The existing penthouse form will be retained; however, the east, south, and west walls will be removed and rebuilt, due to extreme structural degradation, in the same shape and with matching brick veneer as the existing. The north wall of the penthouse is contiguous with the north façade wall and will remain and be repaired as necessary. The existing penthouse roof and structural frame will also be retained.

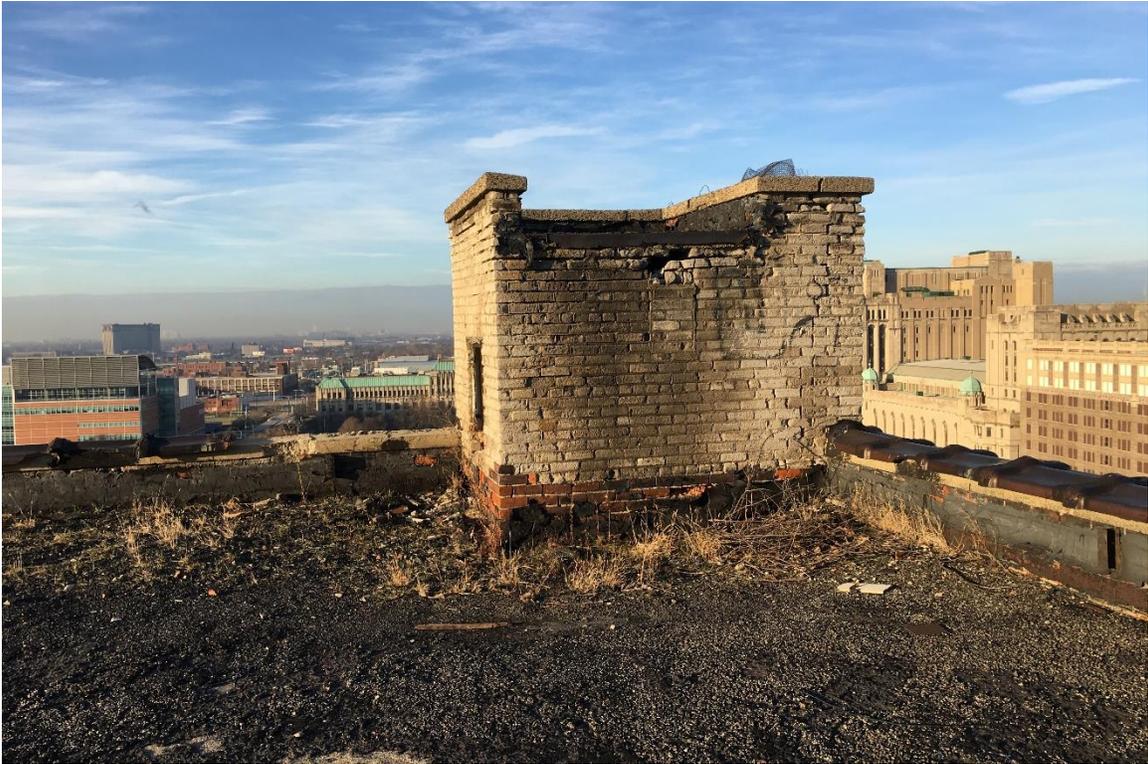
Figure #X: Exterior, chimney, looking northwest. 12/5/18

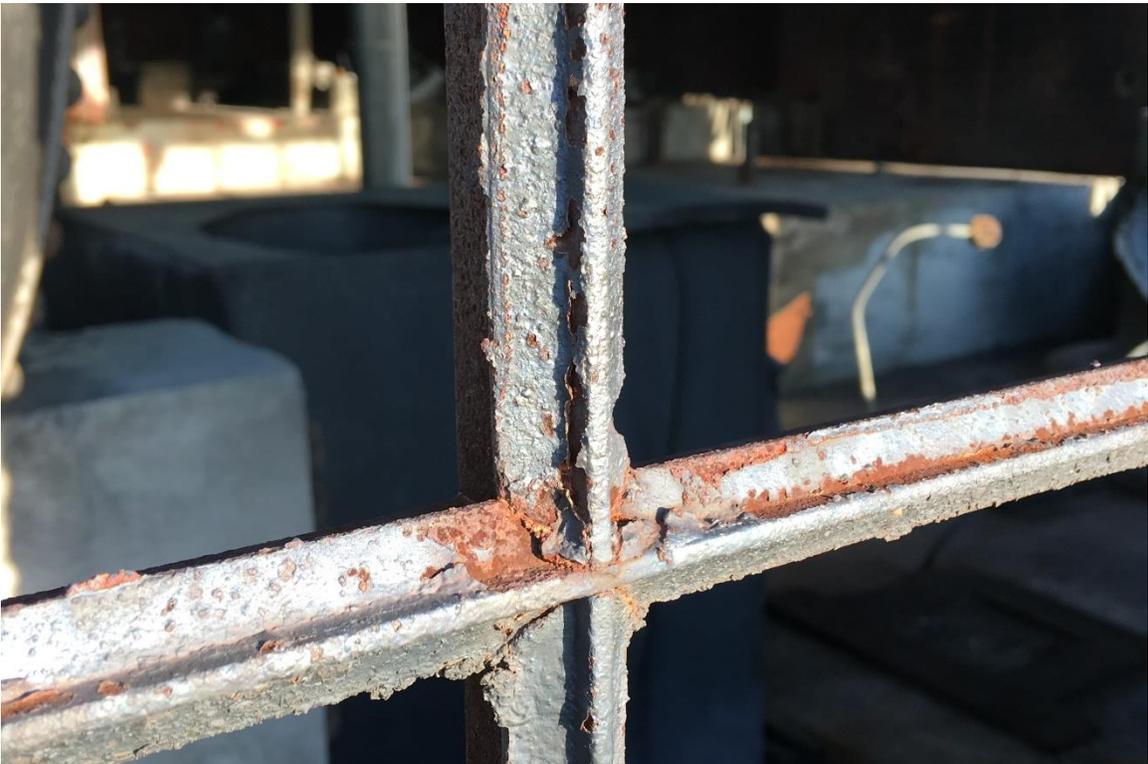
Figure #X: Exterior, penthouse window detail, looking down. 12/5/18

There are no windows in the building although a few small fragments of the window frames and brick mold have been found and salvaged. The salvaged pieces indicate that the original windows were wood, double hung units, and will be used as the basis of design for the new replacement historic replica windows. All windows will be replaced with new aluminum windows to match the original window as closely as possible and will also match the position in the wall and the dimensions of the individual elements including but not limited to muntins, head, sill, panes, jambs, sash, and overall depth. There will be no screens or screen rail additions. Accordingly, these new windows will be compatible with the historic character of the building. The steel frame windows in the penthouse

are in very poor condition and will be removed and infilled while the sill will remain. The infilled brick will be set back 1" to maintain a sense of the historic opening.

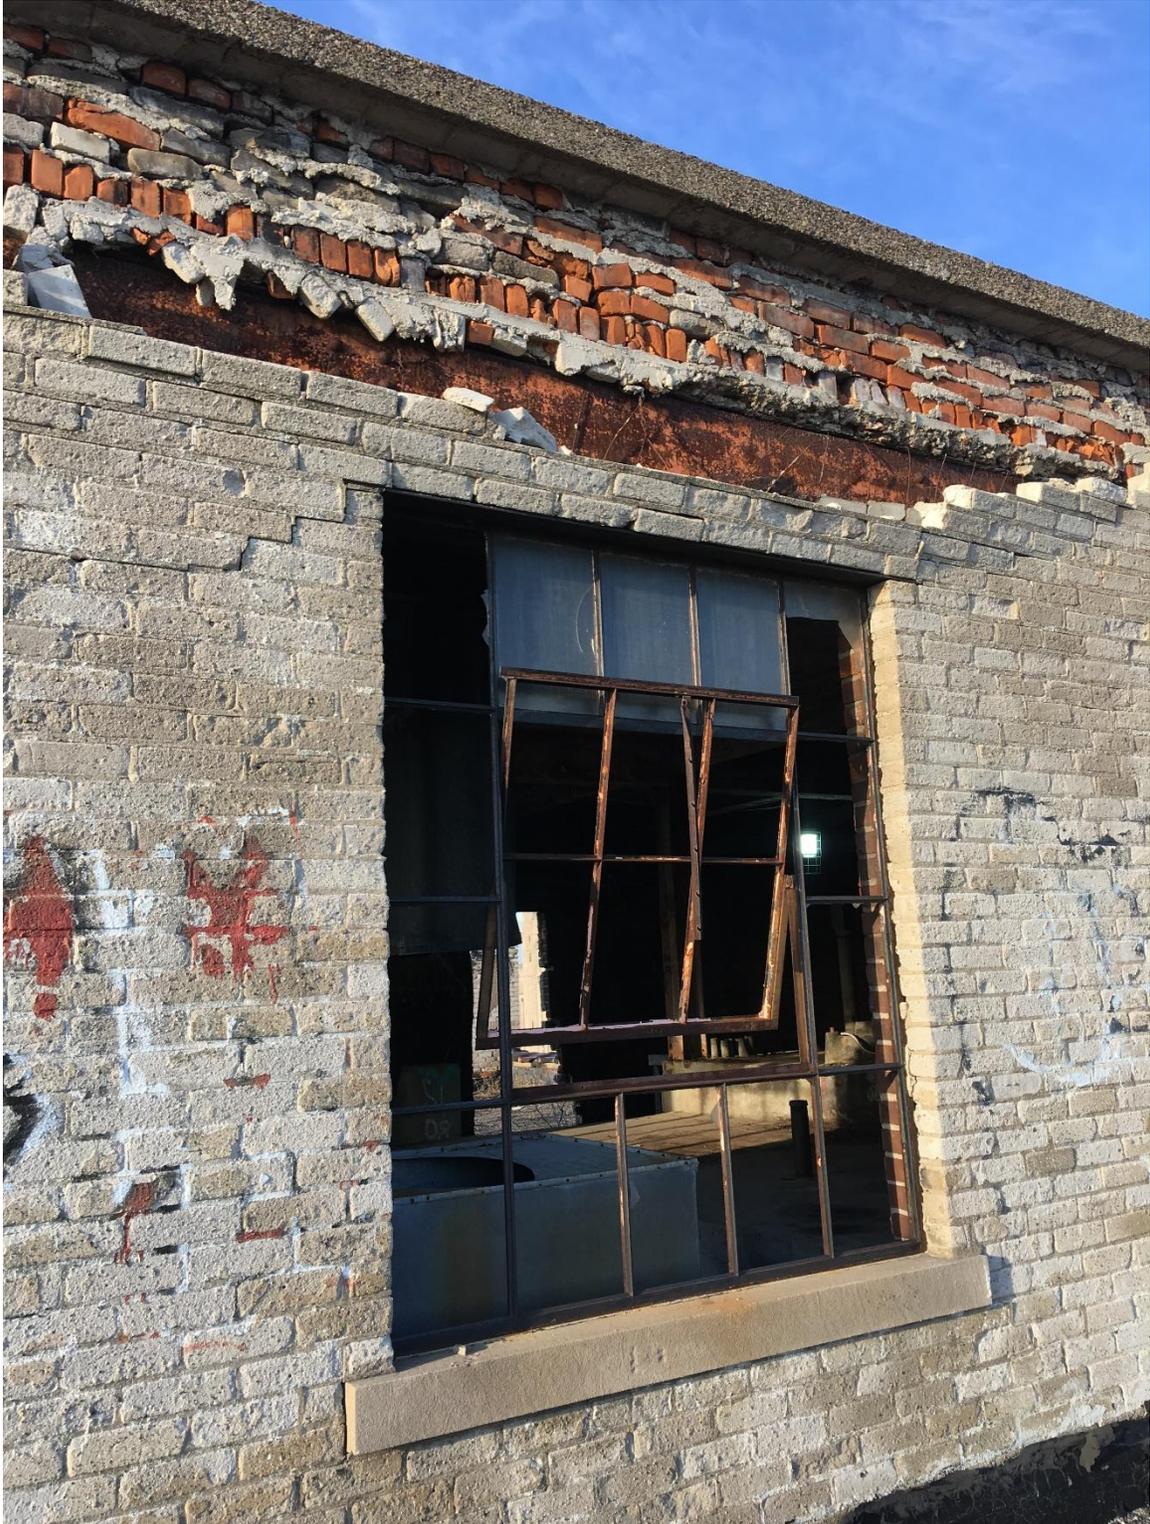
Figure #X: Exterior, penthouse, window and partial wall collapse detail. 12/5/18

The penthouse windows are damaged beyond repair, and, as described below, the masonry wall construction is also proposed to be demolished and replaced in kind for a new mechanical penthouse. As a result, all of the existing windows and door will be removed. The penthouse shall be reconstructed out of new brick masonry to match the existing penthouse enclosure. Window openings will not be recreated, but the historic window openings shall be outlined in the new brick walls by recessing the brick veneer 1" at the historic window opening locations to simulate the original window configuration.

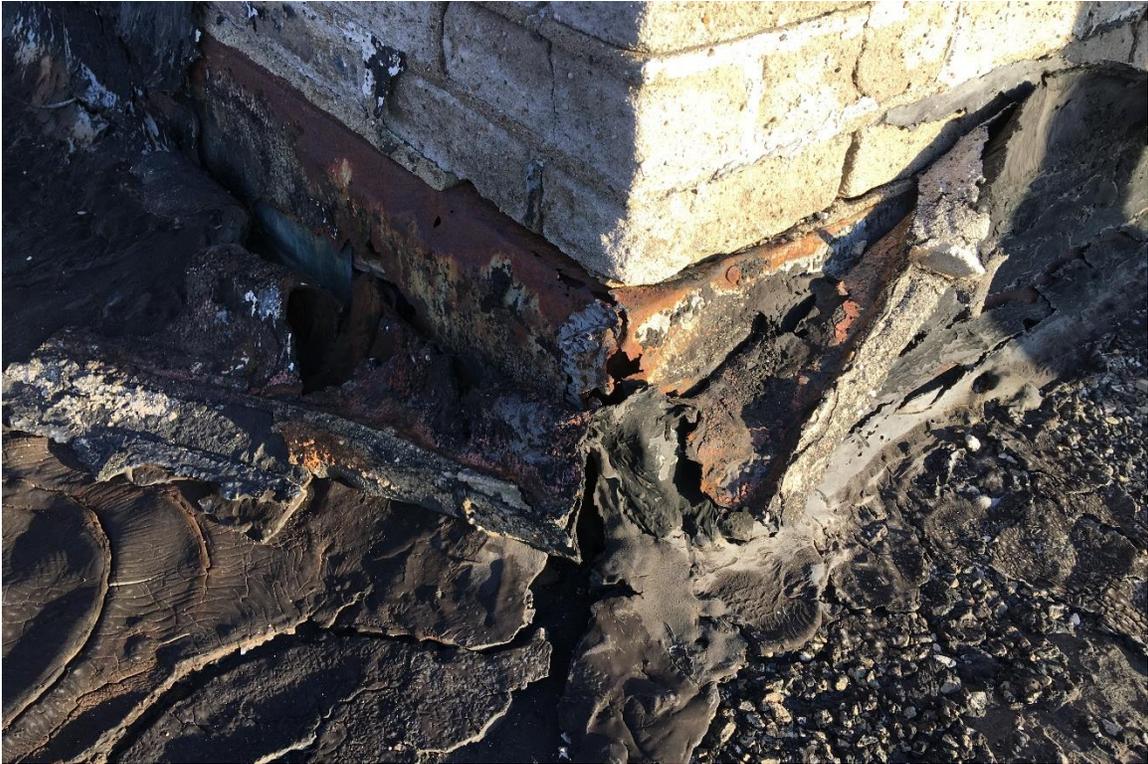
Figure #X: Exterior, roof, detail. 12/5/18

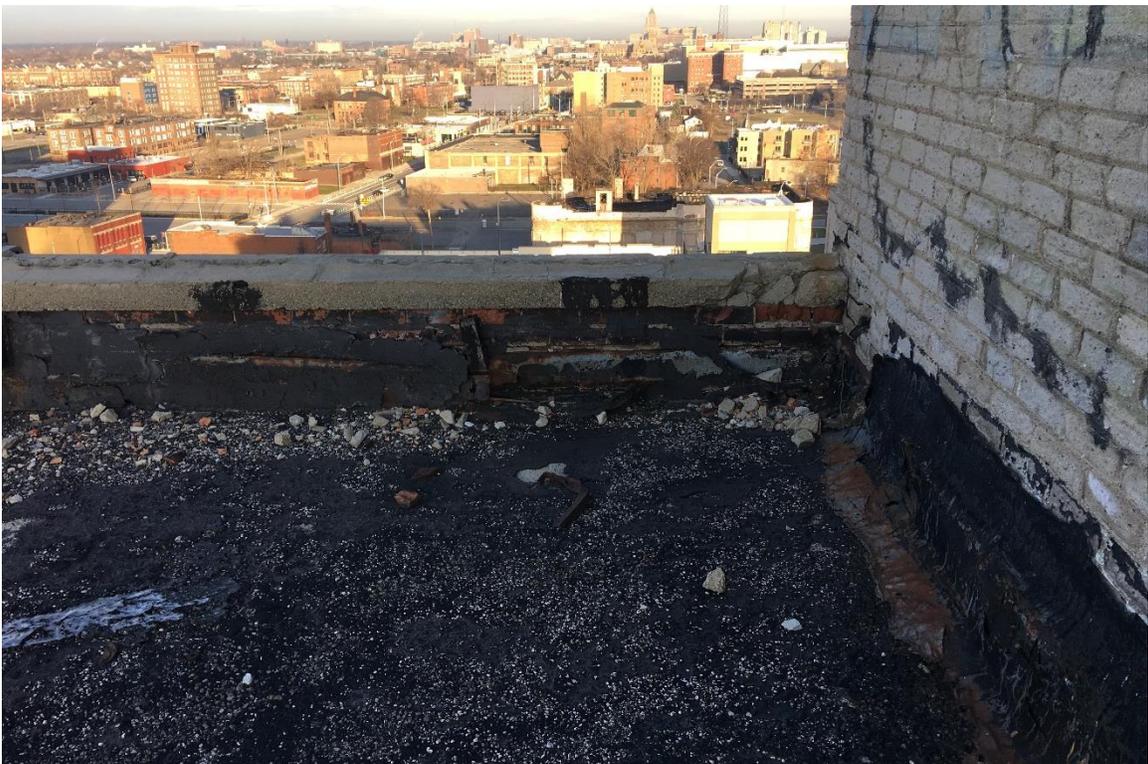
Figure #X: Exterior, roof, detail. 12/5/18

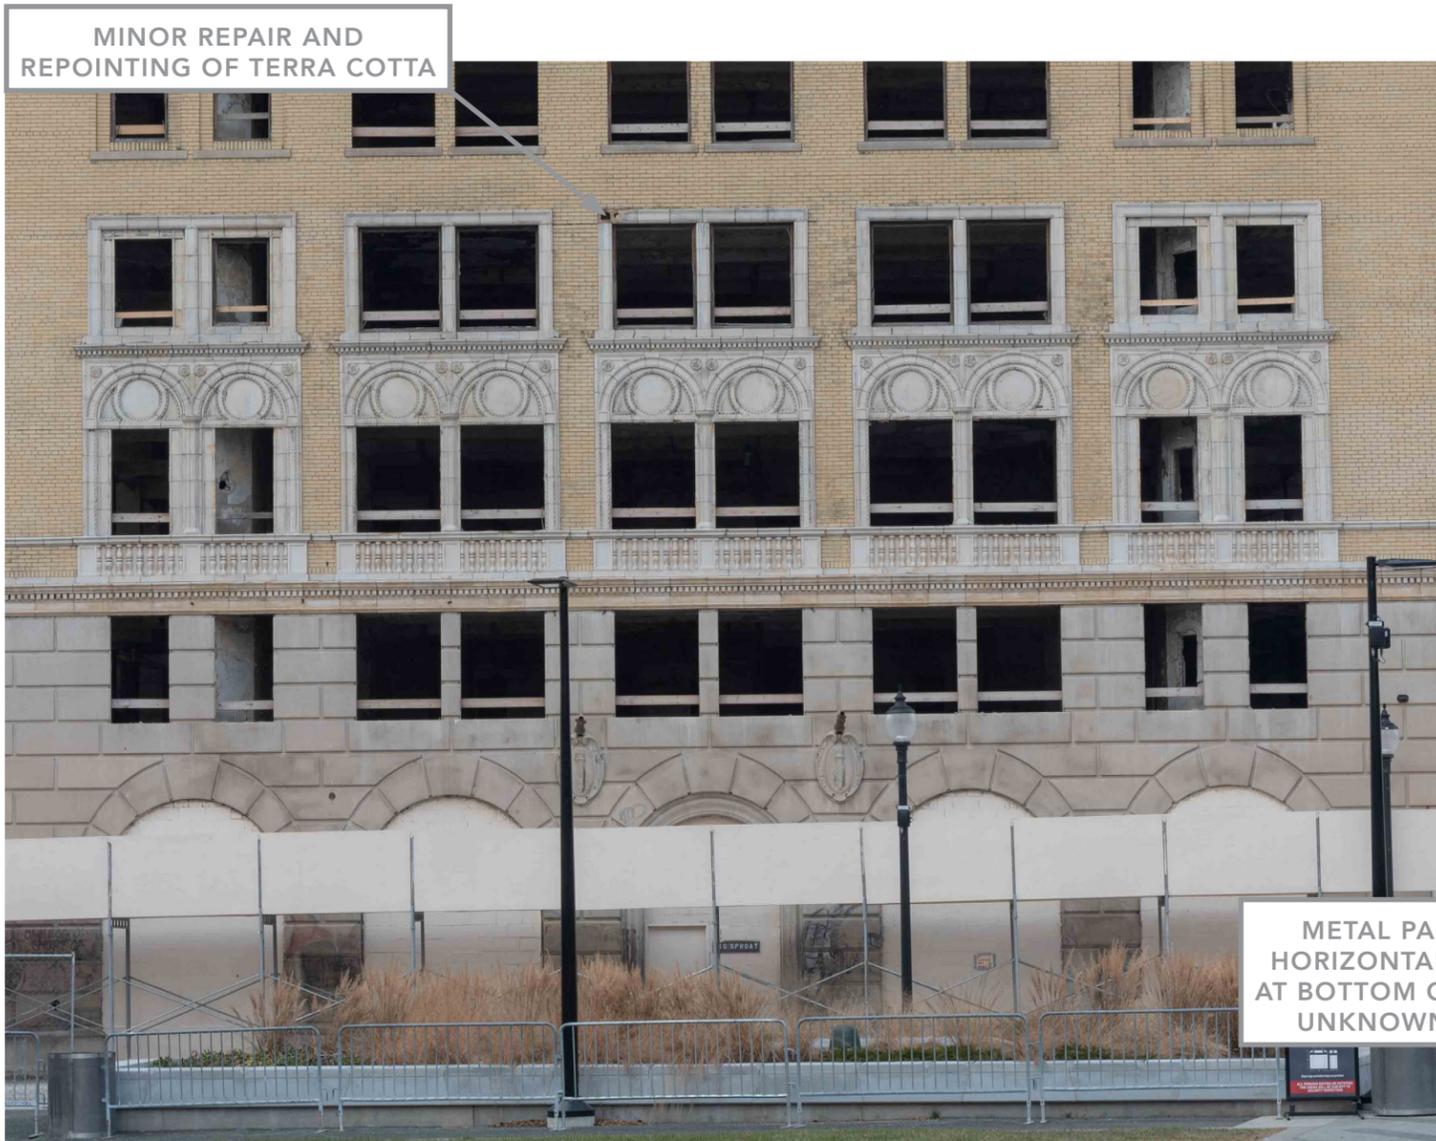
LOWER SOUTH FACADE

ISSUES: Entire missing balustrade on upper south facade allows for repetitive components and more options.
Unknown condition under metal panning at base of balustrade.

RECOMMENDATION: Bid alternate for terra cotta and fiberglass at balustrade. Price and schedule will be considered. Metal panel to be removed and condition ascertained before final decision on underlying repair.

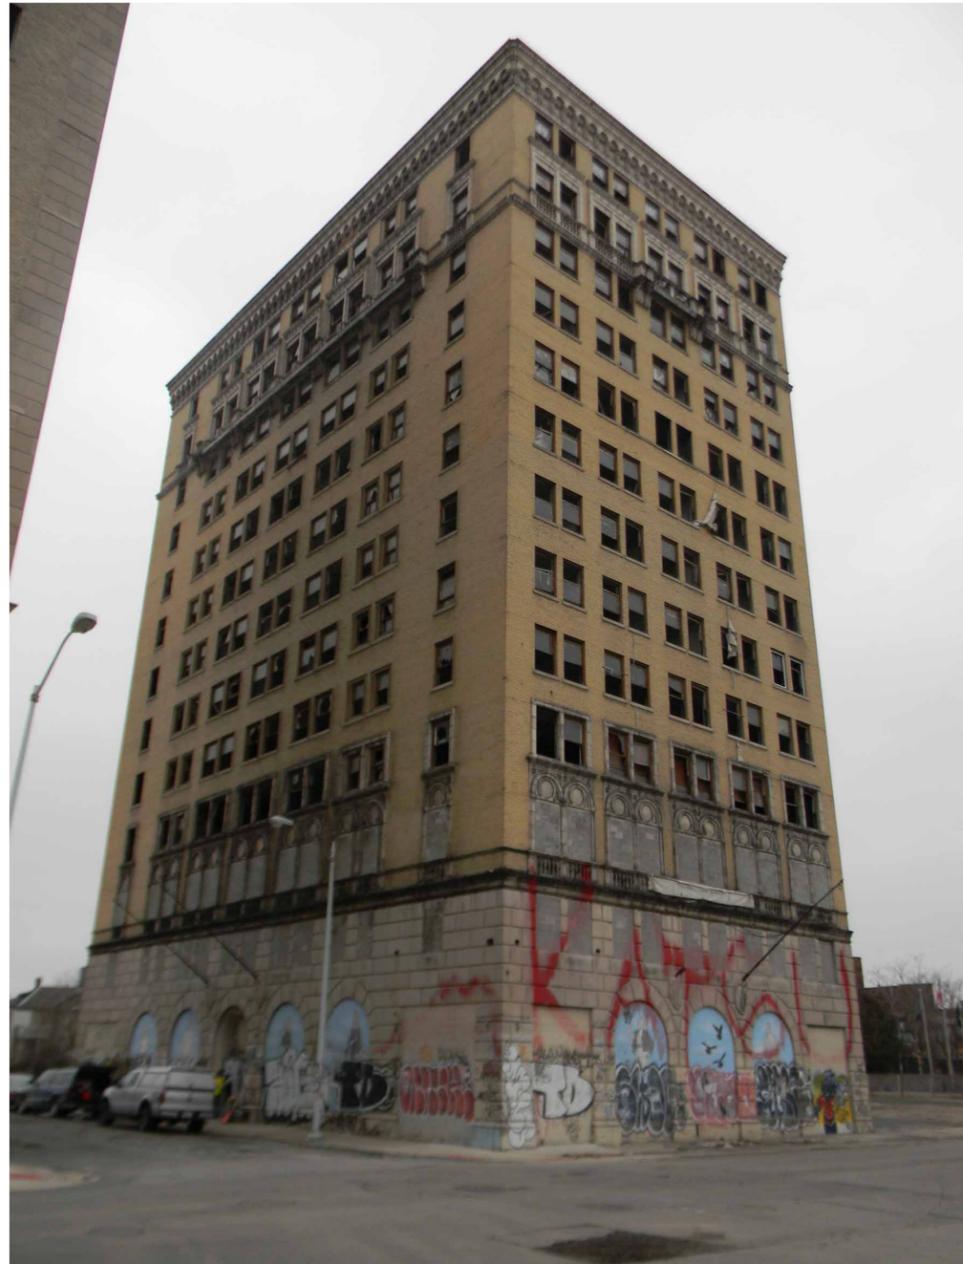
FIRST FLOOR LIMESTONE - BEFORE

ISSUES: The initial limestone cleaning method could not remove entirety of graffiti

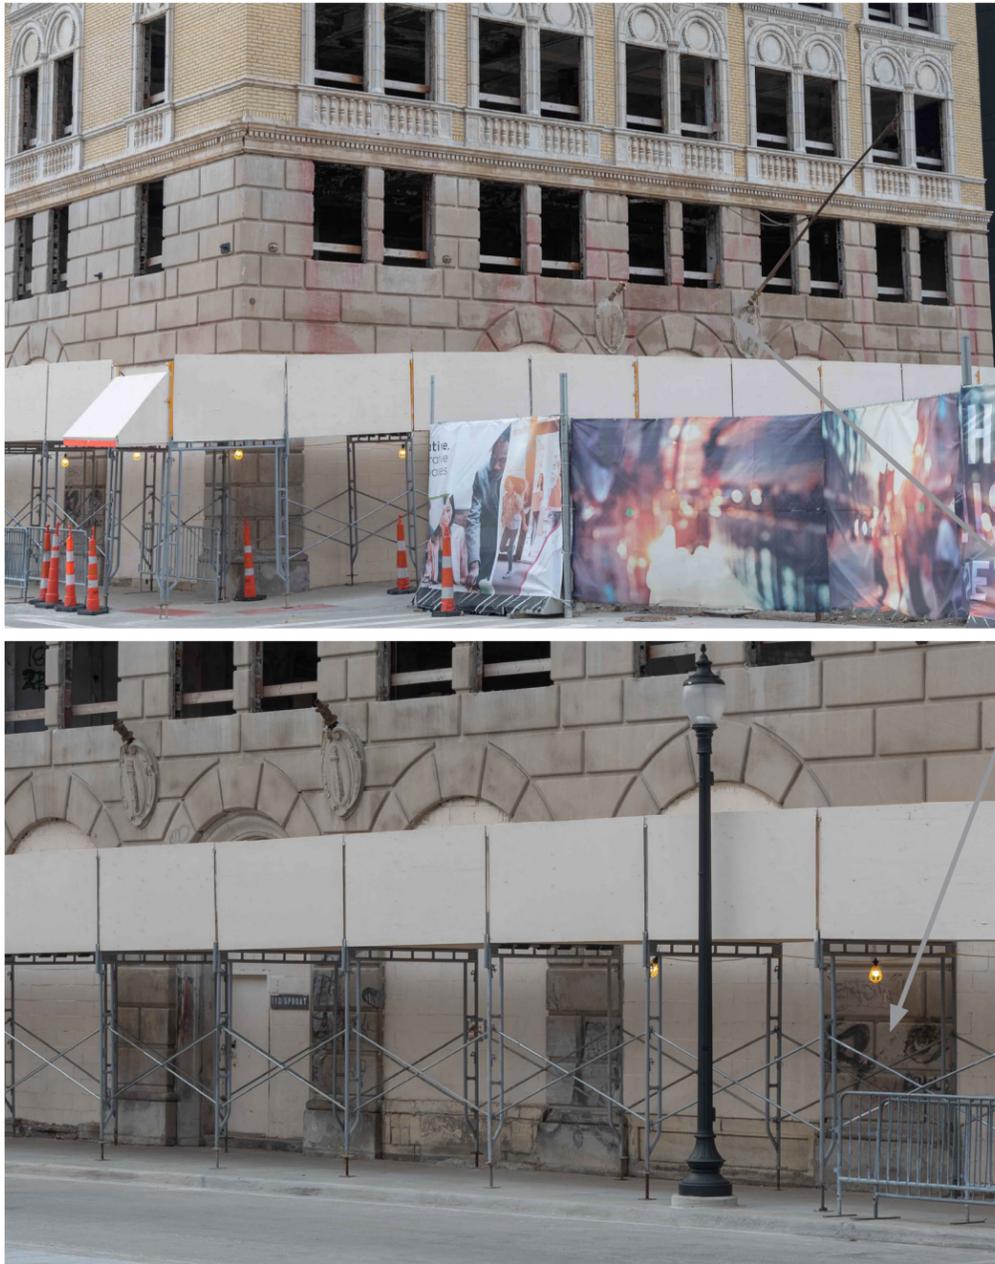
FIRST FLOOR LIMESTONE - CURRENT

RECOMMENDATION: Quintek Corporation's Rotec Vortex Cleaning System

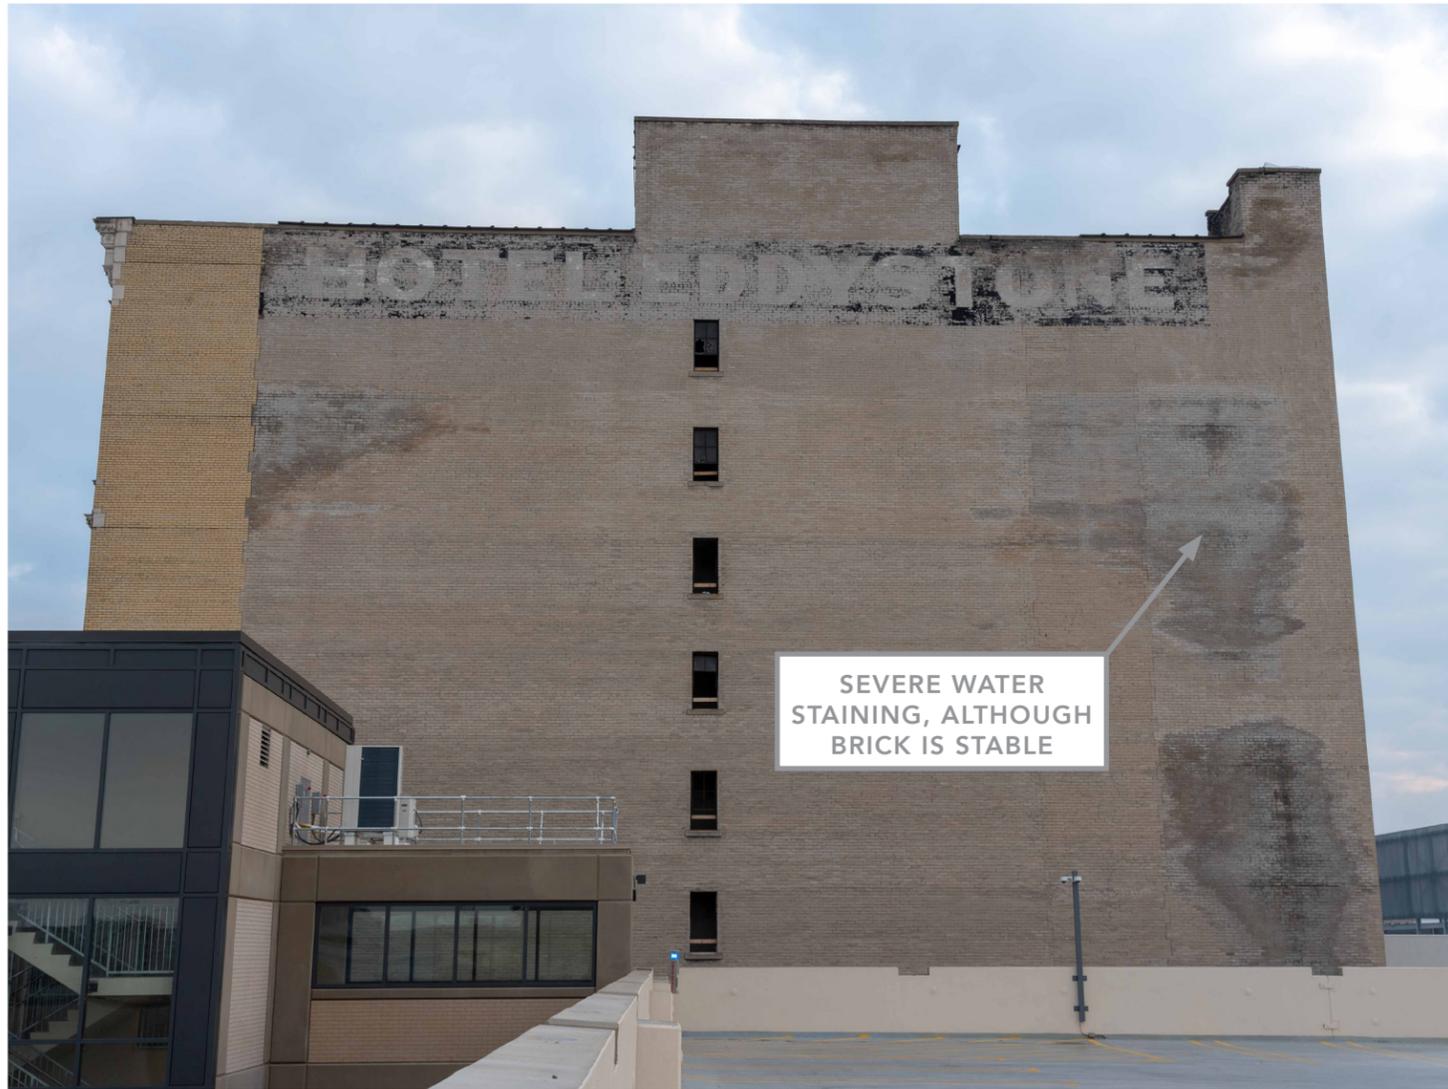
NORTH FACADE

ISSUES: Rear facades utilize a unique “concrete brick” that shows more wear than typical clay brick, and is highly difficult to match. Surface of concrete brick is stable, but has worn significantly.

RECOMMENDATION: Concrete brick from penthouse shall be salvaged and re-used on rear facades for infill and repair. Color match clay brick shall be used to reconstruct penthouse.

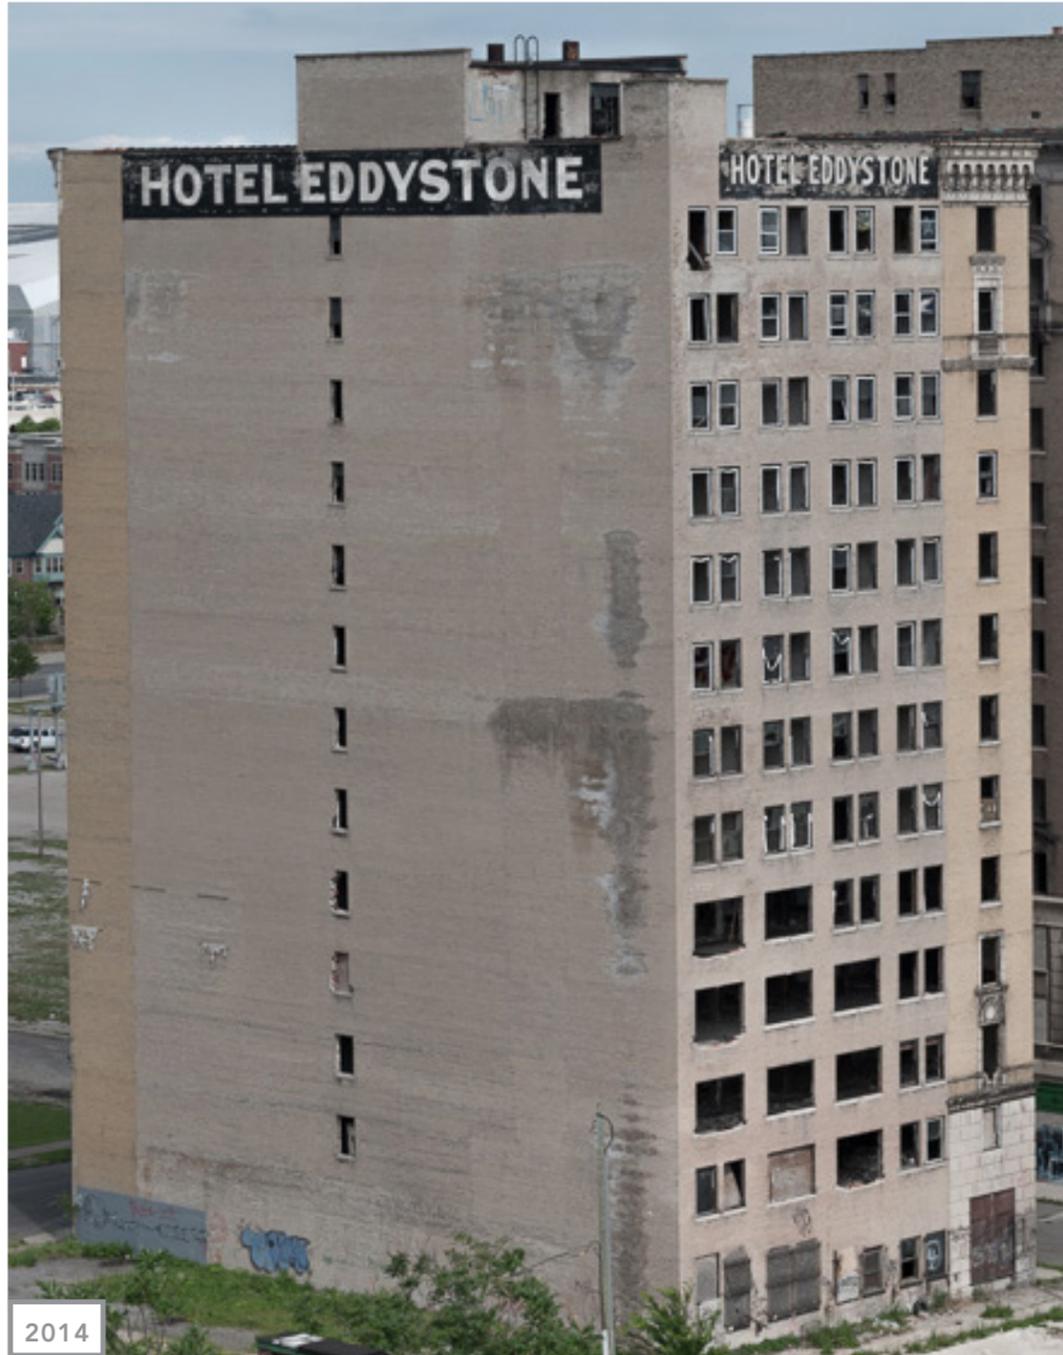
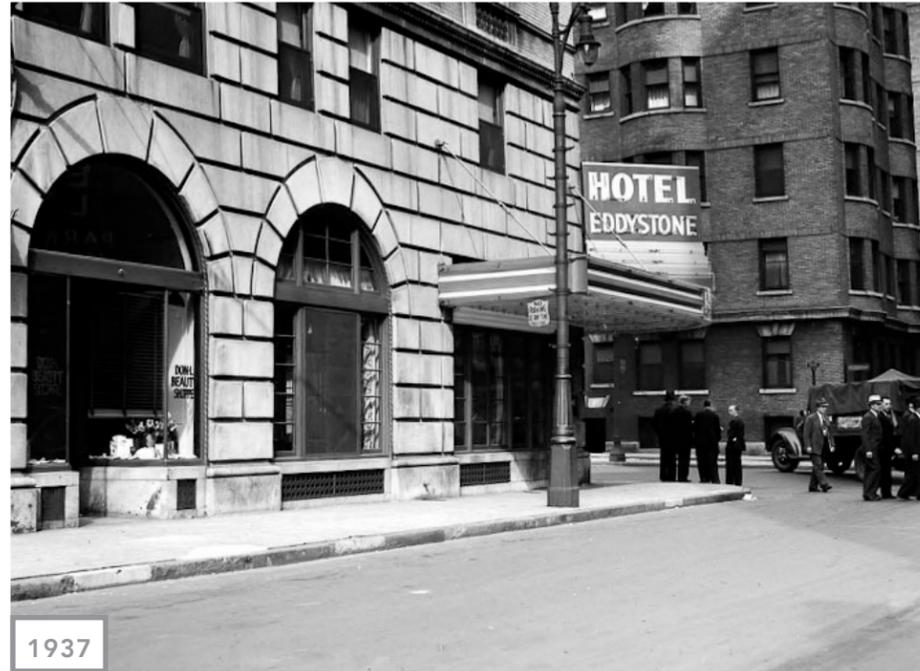
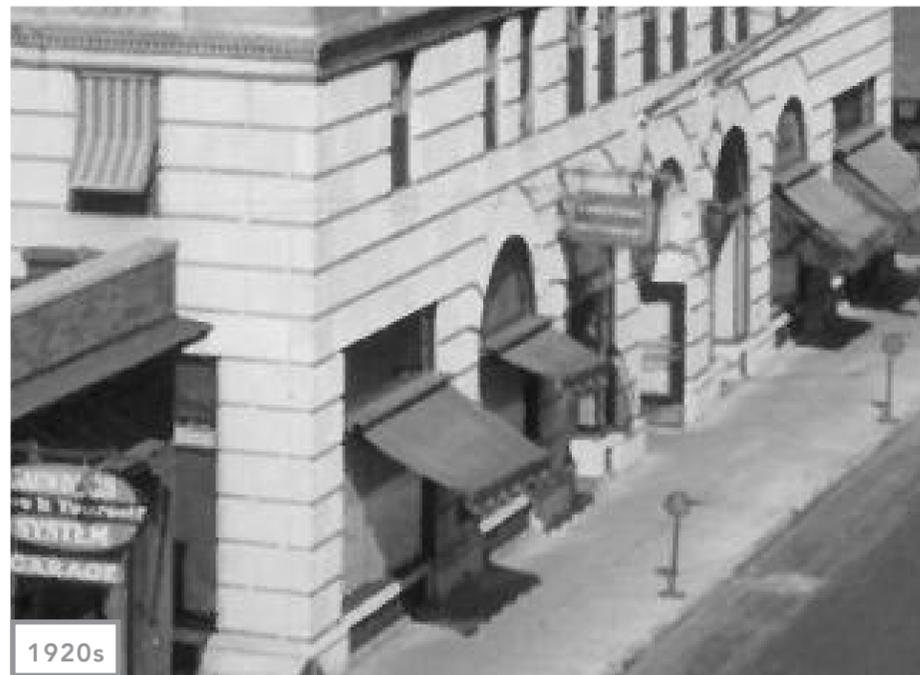
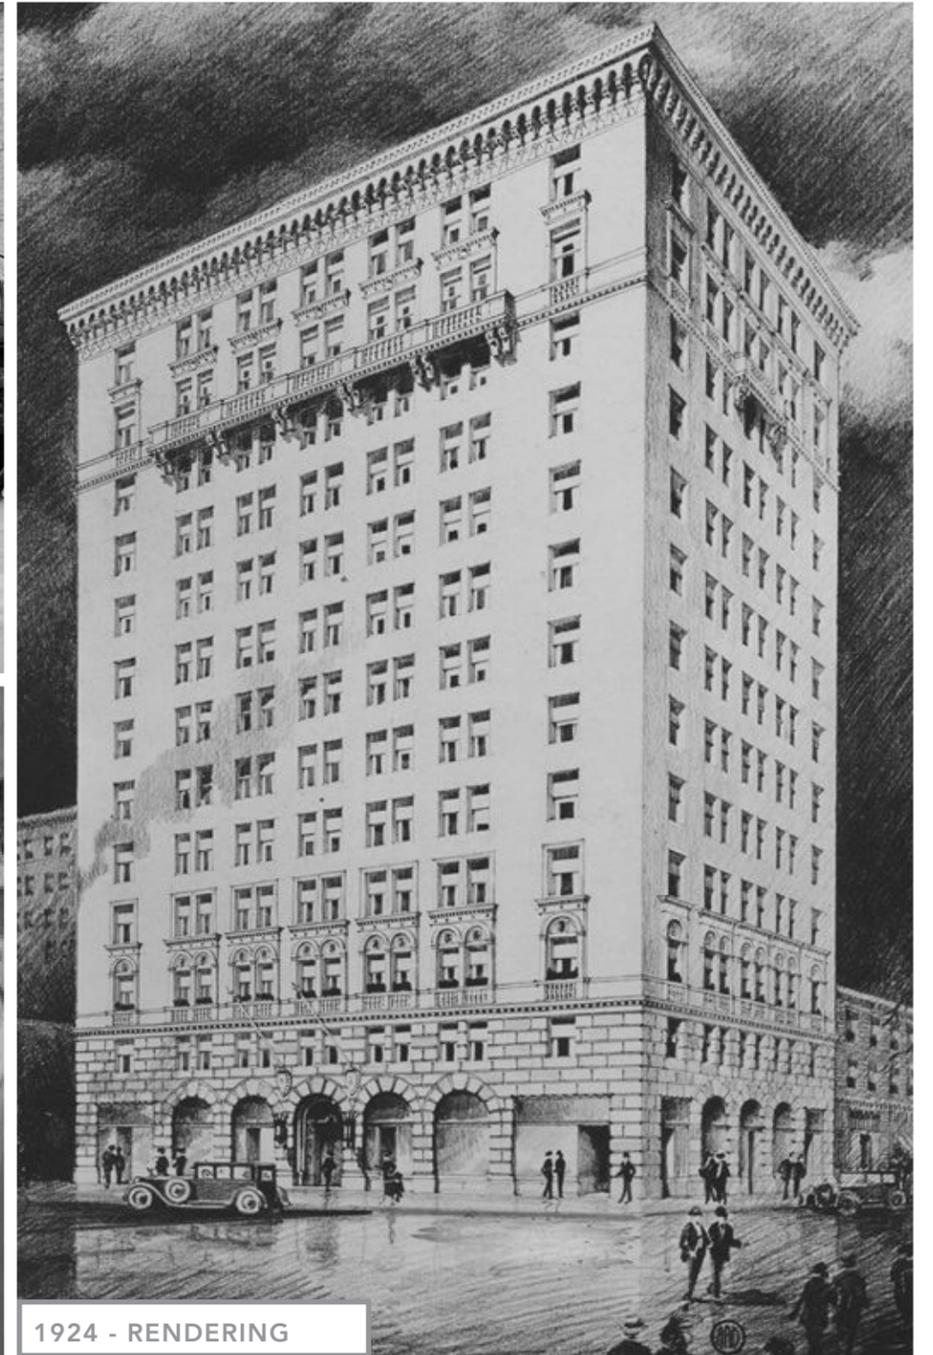
ISSUES: Historic signage was located at: blade sign, painted sign, and hanging sign. See photos.

RECOMMENDATION: Capitalize on historic "ghost" signage for high visibility. Reserve corner blade sign only for signature tenant. Two smaller signs on east and south facade proposed.

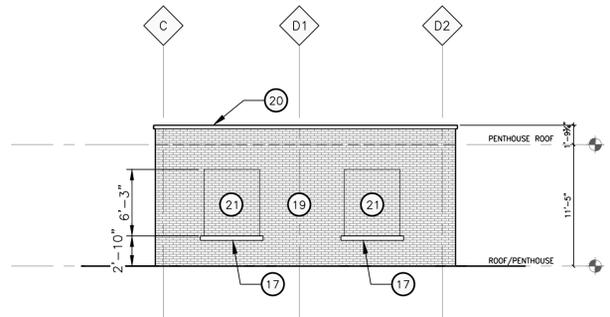
1 SOUTH PENTHOUSE ELEVATION
 A205 SCALE: 1/8" = 1'-0"
 REFERENCE LOCATIONS: A105

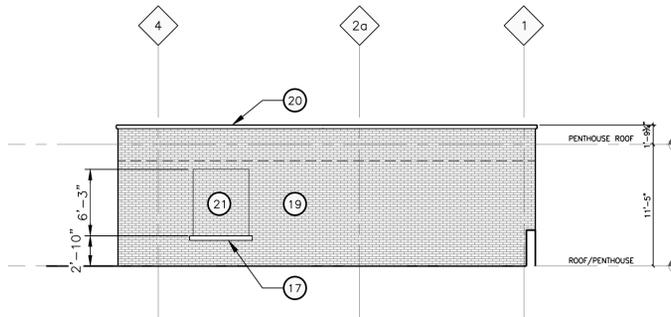
2 EAST PENTHOUSE ELEVATION
 A205 SCALE: 1/8" = 1'-0"
 REFERENCE LOCATIONS: A105

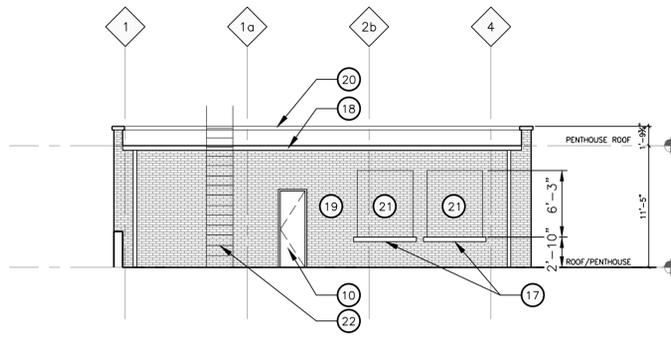
3 WEST PENTHOUSE ELEVATION
 A205 SCALE: 1/8" = 1'-0"
 REFERENCE LOCATIONS: A105

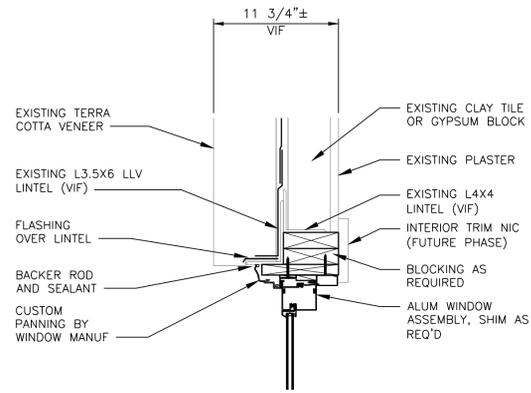
7
A612 **TYPICAL TERRA COTTA HEAD DETAIL**
SCALE: 1 1/2" = 1'-0"
REFERENCE LOCATIONS: A611

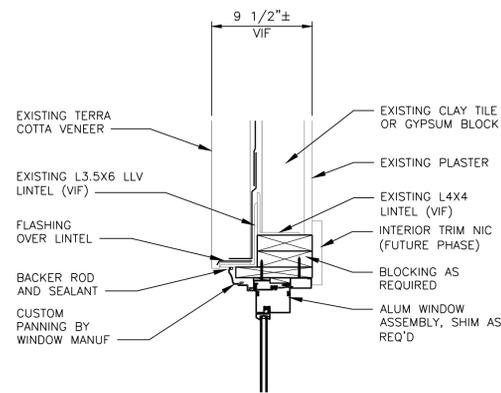
4
A612 **TYPICAL TERRA COTTA HEAD DETAIL**
SCALE: 1 1/2" = 1'-0"
REFERENCE LOCATIONS: A611

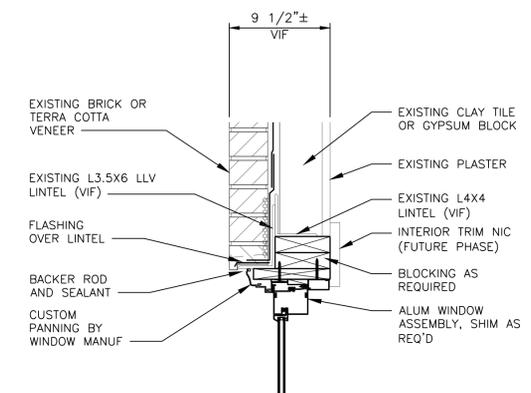
1
A612 **TYPICAL BRICK HEAD DETAIL**
SCALE: 1 1/2" = 1'-0"
REFERENCE LOCATIONS: A611

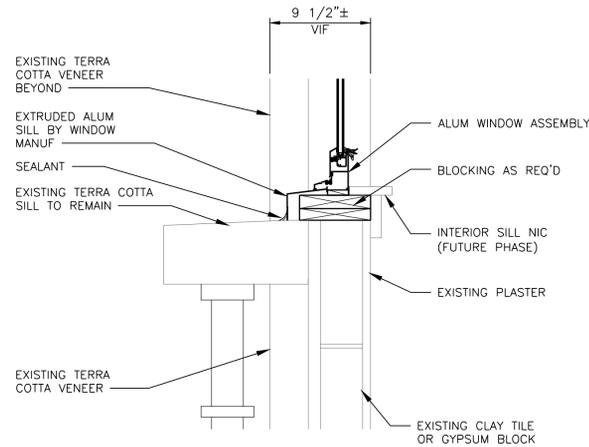
11
A612 **TYPICAL BALUSTRADE SILL DETAIL**
SCALE: 1 1/2" = 1'-0"
REFERENCE LOCATIONS: A611

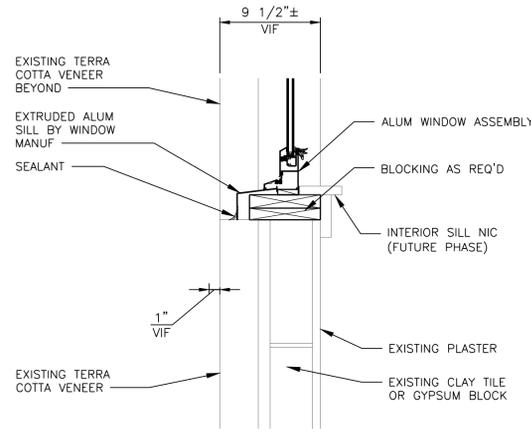
8
A612 **TYPICAL LIMESTONE SILL DETAIL**
SCALE: 1 1/2" = 1'-0"
REFERENCE LOCATIONS: A611

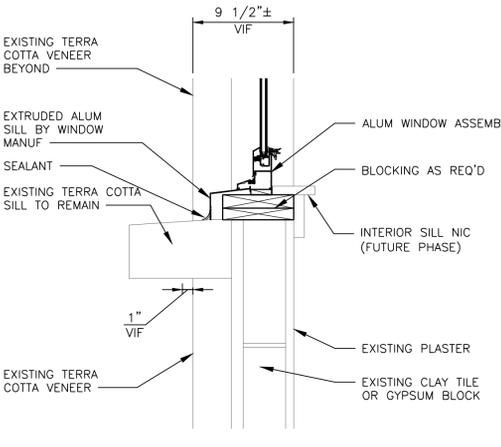
5
A612 **TYPICAL TERRA COTTA SILL DETAIL**
SCALE: 1 1/2" = 1'-0"
REFERENCE LOCATIONS: A611

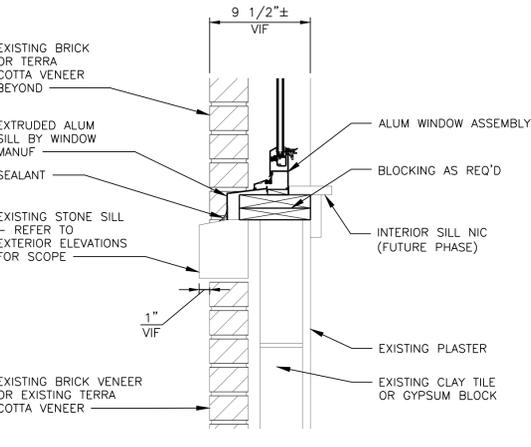
2
A612 **TYPICAL STONE SILL DETAIL**
SCALE: 1 1/2" = 1'-0"
REFERENCE LOCATIONS: A611

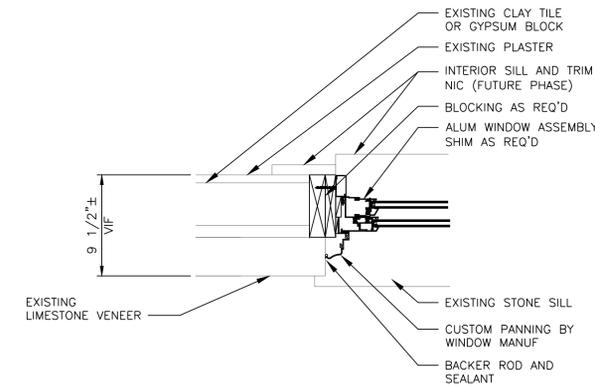
9
A612 **TYPICAL LIMESTONE JAMB DETAIL**
SCALE: 1 1/2" = 1'-0"
REFERENCE LOCATIONS: A611

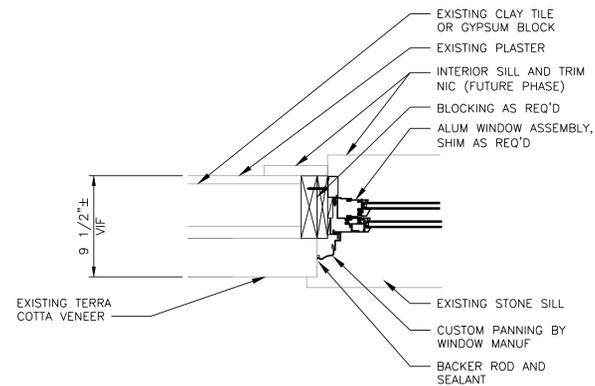
6
A612 **TYPICAL TERRA COTTA JAMB DETAIL**
SCALE: 1 1/2" = 1'-0"
REFERENCE LOCATIONS: A611

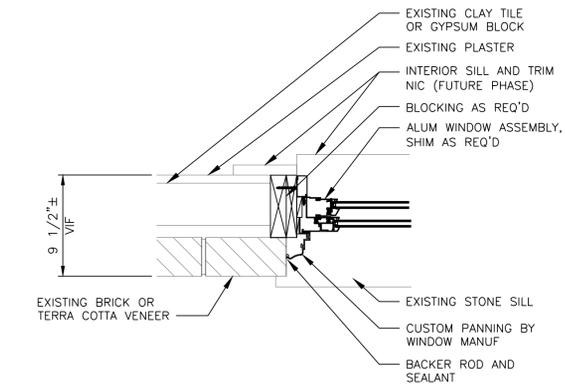
3
A612 **TYPICAL BRICK JAMB DETAIL**
SCALE: 1 1/2" = 1'-0"
REFERENCE LOCATIONS: A611
