**STAFF REPORT 05-13-2020 REGULAR MEETING****PREPARED BY: A. PHILLIPS****APPLICATION NUMBER: 20-6718****ADDRESS: 729 SEWARD AVENUE****HISTORIC DISTRICT: NEW CENTER AREA****APPLICANT: ANDREW JORDAN, LEWAND BUILDING COMPANIES****PROPERTY OWNER: TARA YENGLIN, 700 SEWARD DETROIT LLC****DATE OF COMPLETE APPLICATION: 04-22-2020****STAFF SITE VISIT: N/A****SCOPE: GENERAL REHABILITATION OF BUILDING INCLUDING WINDOW REPLACEMENT****EXISTING CONDITIONS**

With the current proposal, the applicant is seeking the Commission's approval **to perform a general rehabilitation of the building including the replacement of all existing wood windows, trim, and brick mold with new vinyl window units and trim per the attached drawings and application.** Included in the proposal are the following scope items:

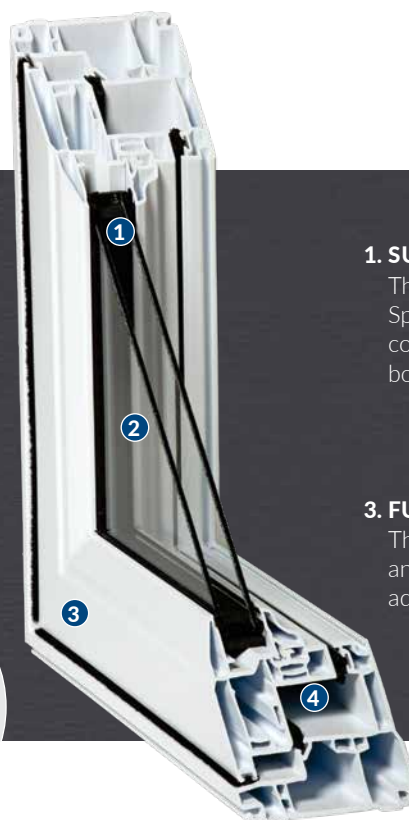
### OPTIONAL TRIPLE PANE

The addition of a third glass pane provides a secondary chamber for optimal insulation and comfort. For unparalleled performance and superior energy efficiency, ask for North Star's optional triple pane windows.

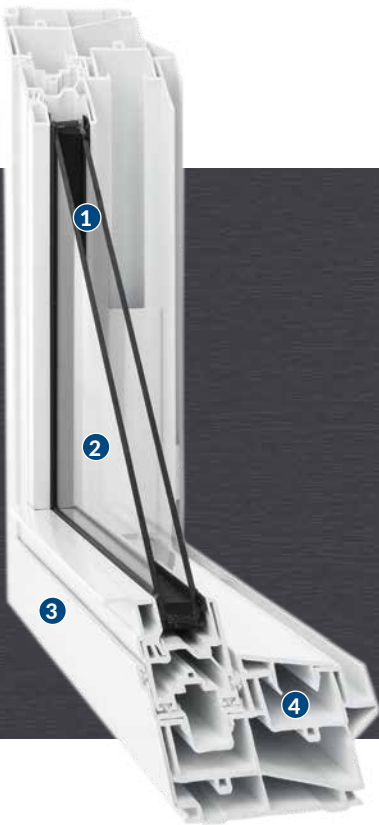
**INTERLOCK**  
*Interlocking meeting rail design adds strength and durability while keeping out air and water.*

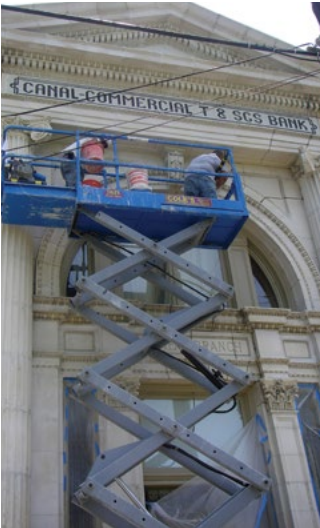
[1] An alkaline-based product is appropriate to use to clean historic marble because it will not damage the marble, which is acid sensitive.

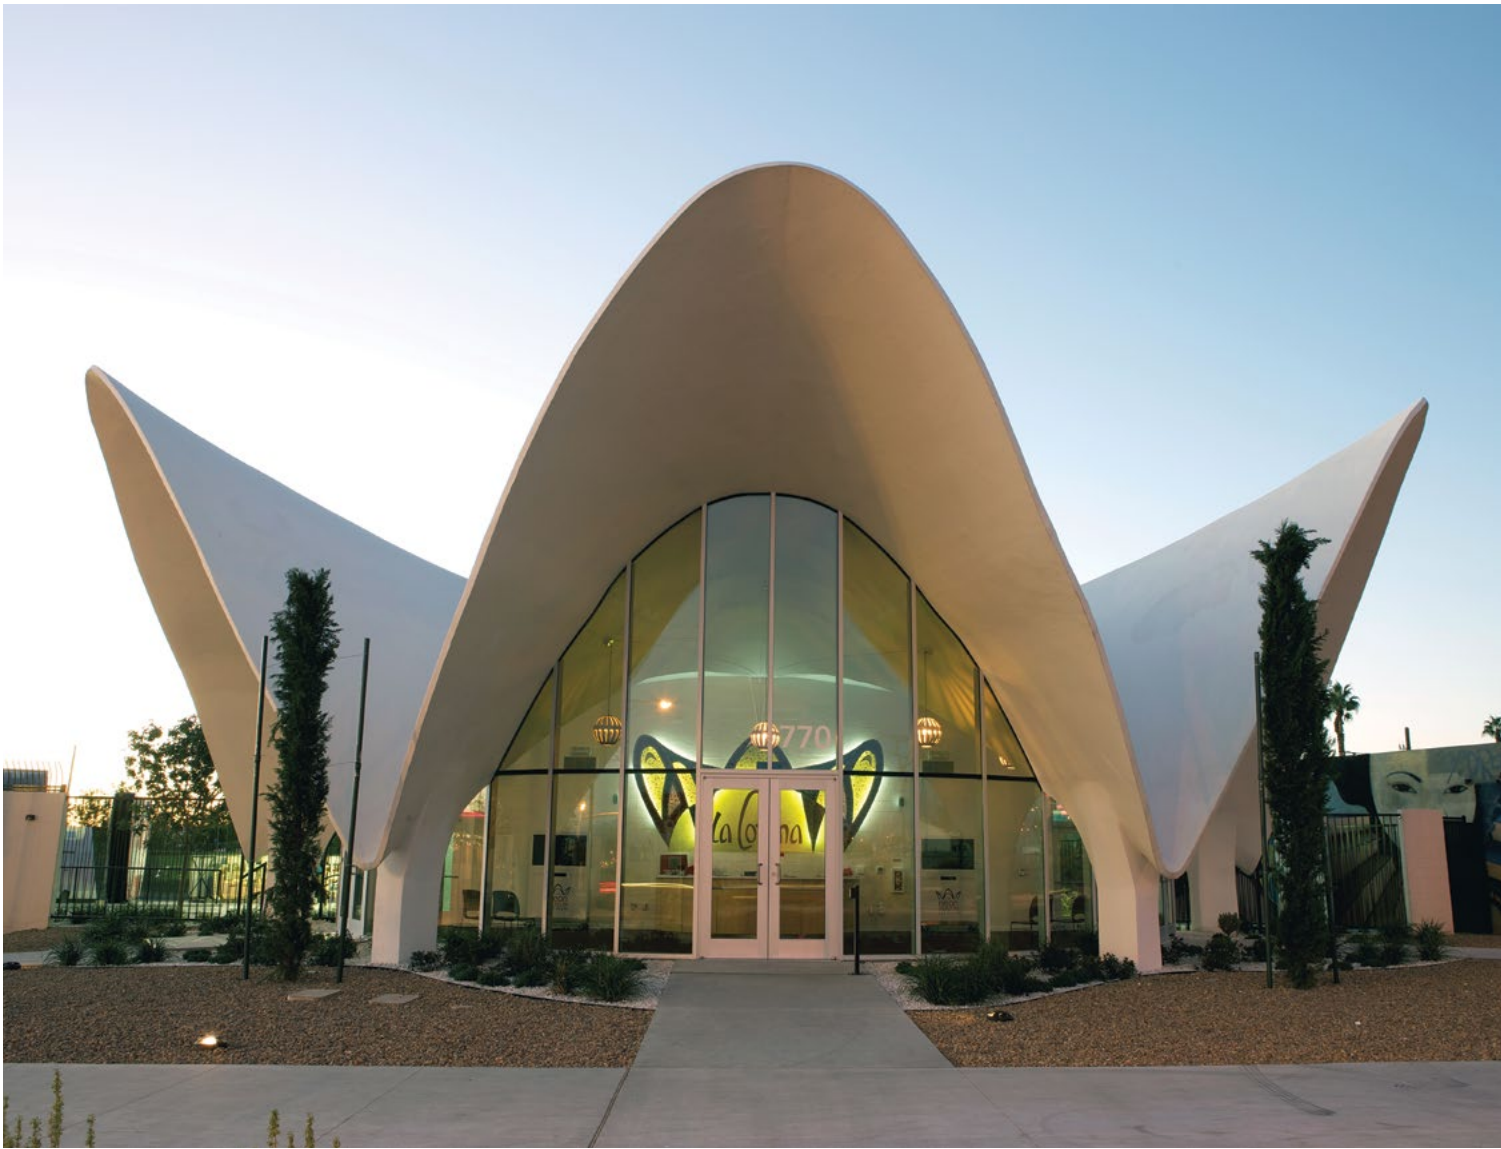
[2] Mid-century modern building technology made possible the form of this parabola-shaped structure and its thin concrete shell construction. Built in 1961 as the lobby of the La Concha Motel in Las Vegas, it was designed by Paul Revere Williams, one of the first prominent African-American architects. It was moved to a new location and rehabilitated to serve as the Neon Museum, and is often cited as an example of Google architecture. *Credit: Photographed with permission at The Neon Museum, Las Vegas, Nevada.*

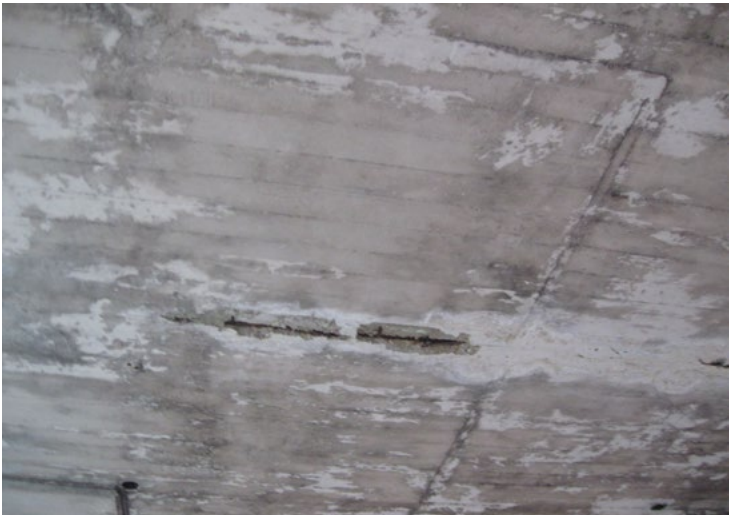
[5] Rebars in the reinforced concrete ceiling have rusted, causing the concrete to spall. The rebars must be cleaned of rust before the concrete can be patched.

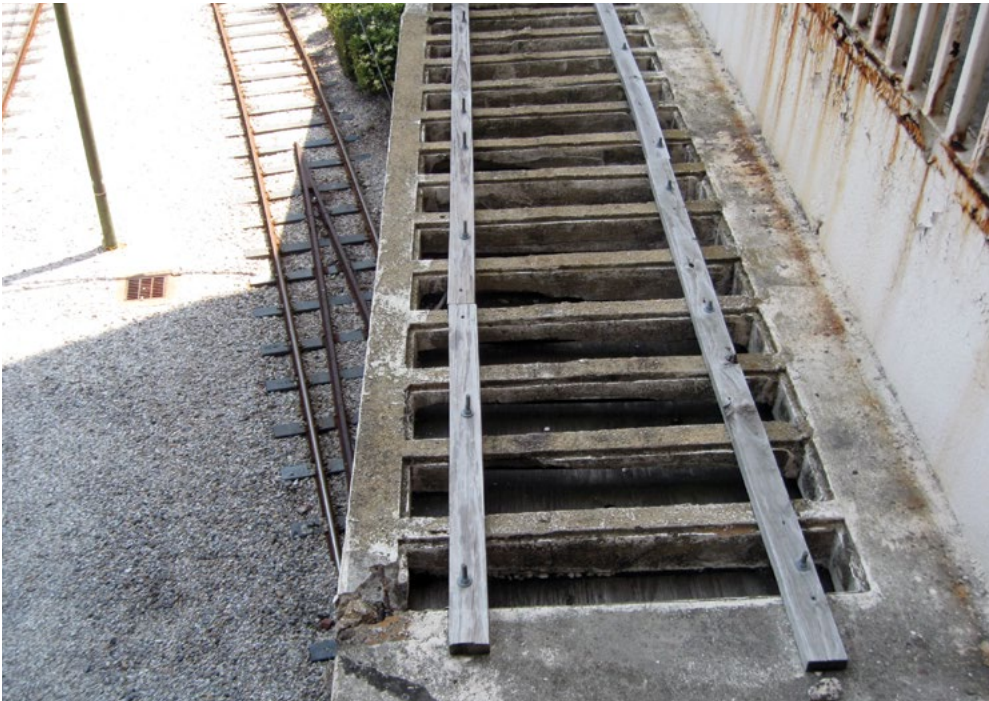
[6] Some areas of the concrete brise soleil screen on this building constructed in 1967 are badly deteriorated. If the screen cannot be repaired, it may be replaced in kind or with a composite substitute material with the same appearance as the concrete.

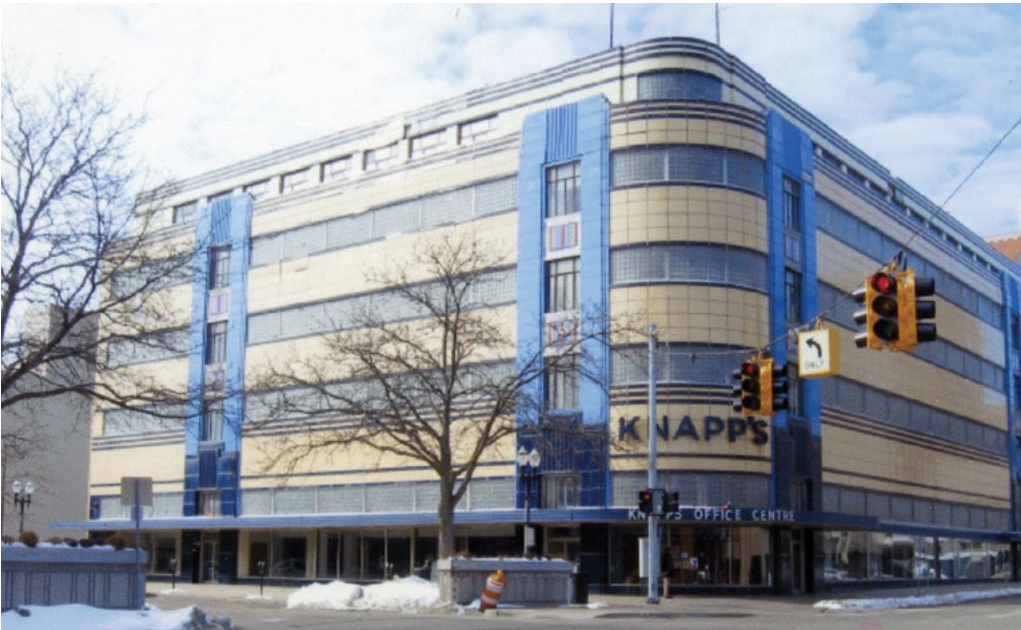
[7] (a) J.W. Knapp's Department Store, built 1937-38, in Lansing, MI, was constructed with a proprietary material named "Maul Macotta" made of enameled steel and cast-in-place concrete panels. Prior to its rehabilitation, a building inspection revealed that, due to a flaw in the original design and construction, the material was deteriorated beyond repair. The architects for the rehabilitation project devised a replacement system (b) consisting of enameled aluminum panels that matched the original colors (c). Photos and drawing (a-b): Quinn Evans Architects; Photo (c): James Haefner Photography.

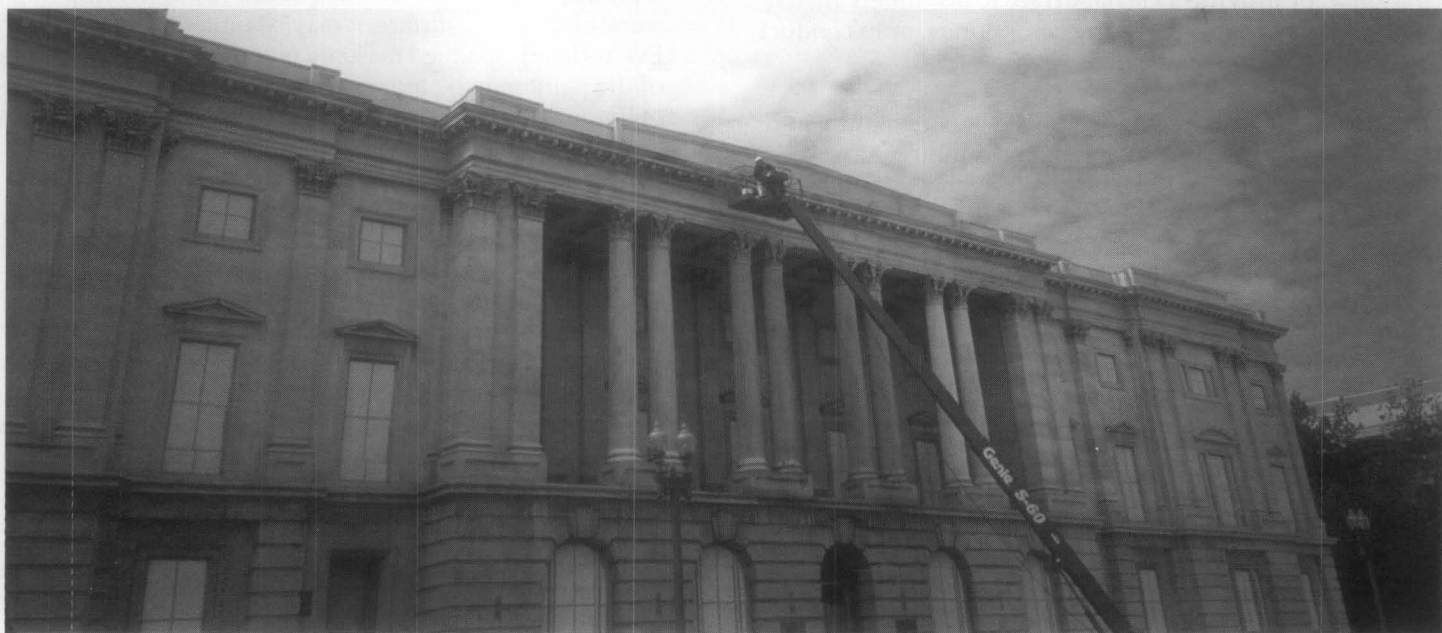
Figure 1. Low-to medium-pressure steam (hot-pressurized water washing), is being used to clean the exterior of the U.S. Tariff Commission Building, the first marble building constructed in Washington, D.C., in 1839. This method was selected by an architectural conservator as the "gentlest means possible" to clean the marble. Steam can soften heavy soiling deposits such as those on the cornice and column capitals, and facilitate easy removal. Note how these deposits have been removed from the right side of the cornice which has already been cleaned.

The Brief is intended to help develop sensitivity to the qualities of historic masonry that makes it so special, and to assist historic building owners and property managers in working cooperatively with architects, architectural conservators and contractors (Fig. 1). Although specifically intended for historic buildings, the information is applicable to all masonry buildings. This publication updates and expands *Preservation Brief 1: The Cleaning and Waterproof Coating of Masonry Buildings*. The Brief is not meant to be a cleaning manual or a guide for preparing specifications. Rather, it provides general information to raise awareness of the many factors involved in selecting cleaning and water-repellent treatments for historic masonry buildings.

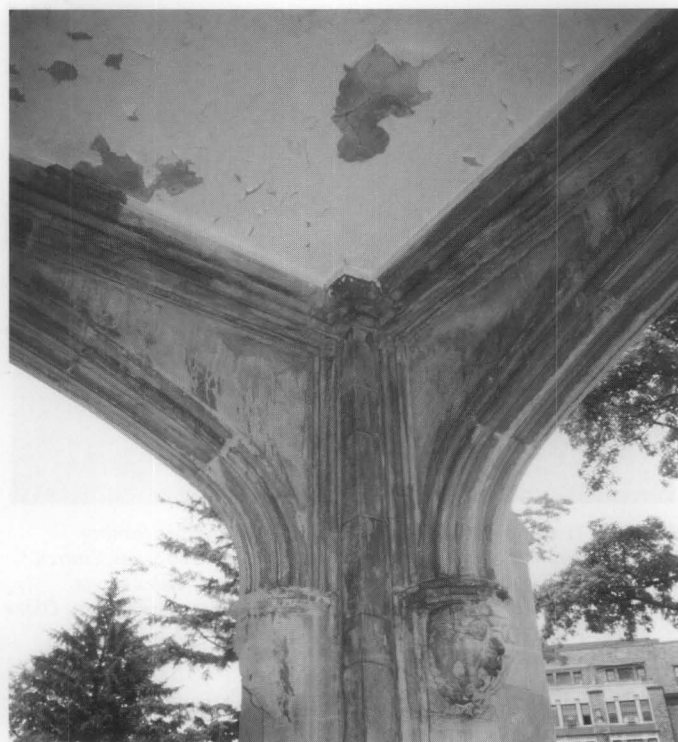
Figure 5. Repeated water washing did not remove the staining inside this limestone porte cochere. Upon closer examination, it was determined to be a water-repellent coating that had been applied many years earlier. An alkaline cleaner may be effective in removing it.

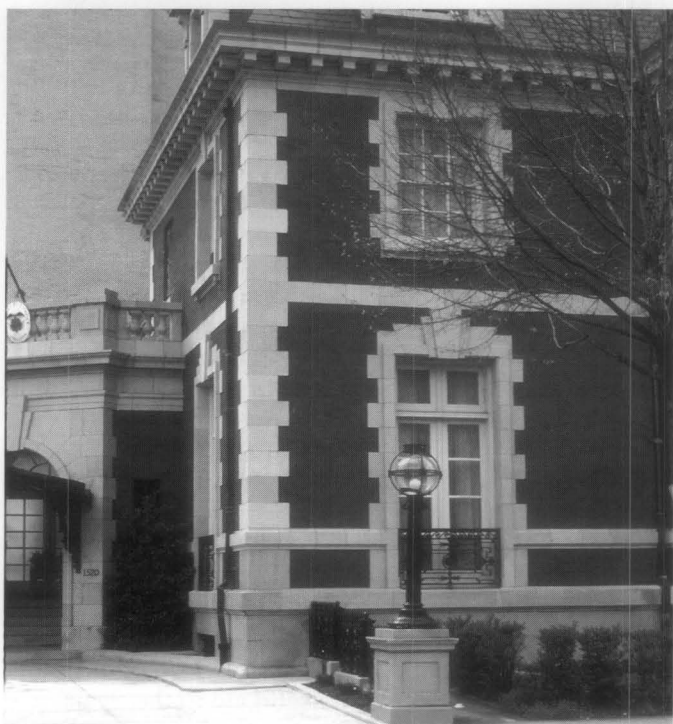
Figure 4. The foundation of this brick building is limestone, but the decorative trim above is architectural terra cotta intended to simulate stone.

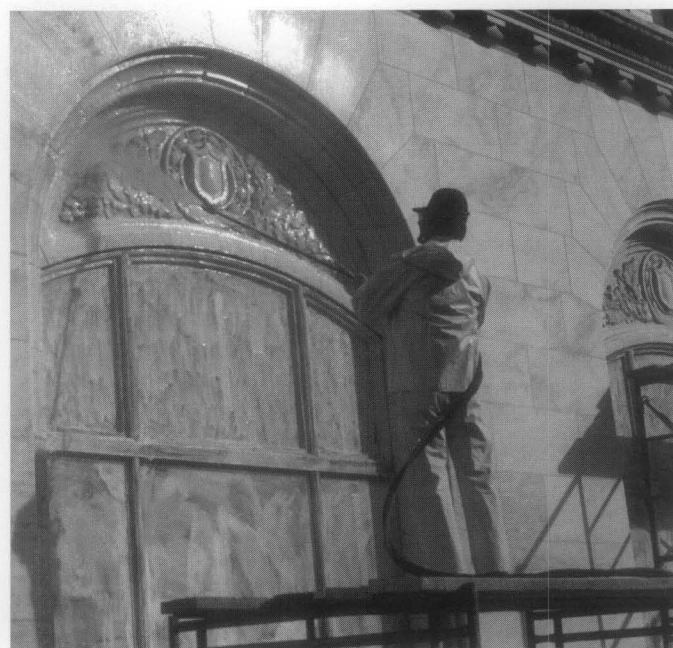
Figure 7. Glazed architectural terra cotta often may be cleaned successfully with a low-pressure water wash and hand scrubbing supplemented, if necessary, with a non-ionic detergent. Photo: National Park Service Files.

**Water Washing.** Washing with low-pressure or medium-pressure water is probably one of the most commonly used methods for removing dirt or other pollutant soiling from historic masonry buildings (Fig. 7). Starting with a very low pressure (100 psi or below), even using a garden hose, and progressing as needed to slightly higher pressure—generally no higher than 300-400 psi—is always the recommended way to begin. Scrubbing with natural bristle or synthetic bristle brushes—never metal which can abrade the surface and leave metal particles that can stain the masonry—can help in cleaning areas of the masonry that are especially dirty.

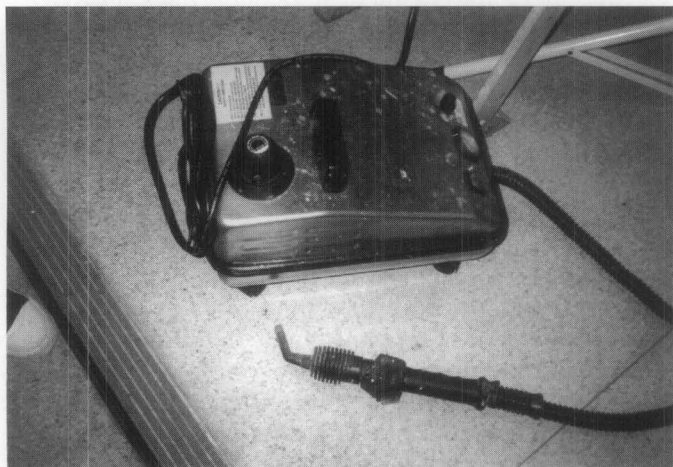
Figure 9. (Left) This small steam cleaner—the size of a vacuum cleaner—offers a very controlled and gentle means of cleaning limited, or hard-to-reach areas or carved stone details. (Right) It is particularly useful for interiors where it is important to keep moisture to a minimum, such as inside the Washington Monument, Washington, D.C., where it was used to clean the commemorative stones. Photos: Audrey T. Tepper.

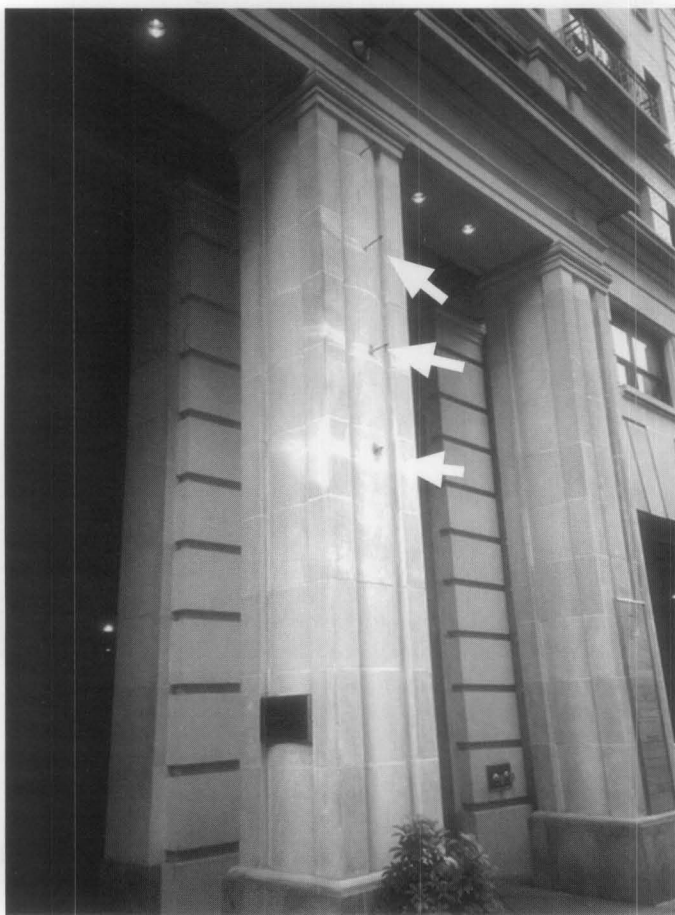
Figure 10. High-pressure water washing too close to the surface has abraded and, consequently, marred the limestone on this early-20th century building.

Most essential of all, it is important to be aware that using water at too high a pressure, a practice common to "power washing" and "water blasting", is very abrasive and can easily etch marble and other soft stones, as well as some types of brick (Figs. 10-11). In addition, the distance of the nozzle from the masonry surface and the type of nozzle, as well as gallons per minute (gpm), are also important variables in a water cleaning process that can have a significant impact on the outcome of the project. This is why it is imperative that the cleaning be closely monitored to ensure that the cleaning operators do not raise the pressure or bring the nozzle too close to the masonry in an effort to "speed up" the process. The appearance of grains of stone or sand in the cleaning effluent on the ground is an indication that the water pressure may be too high.

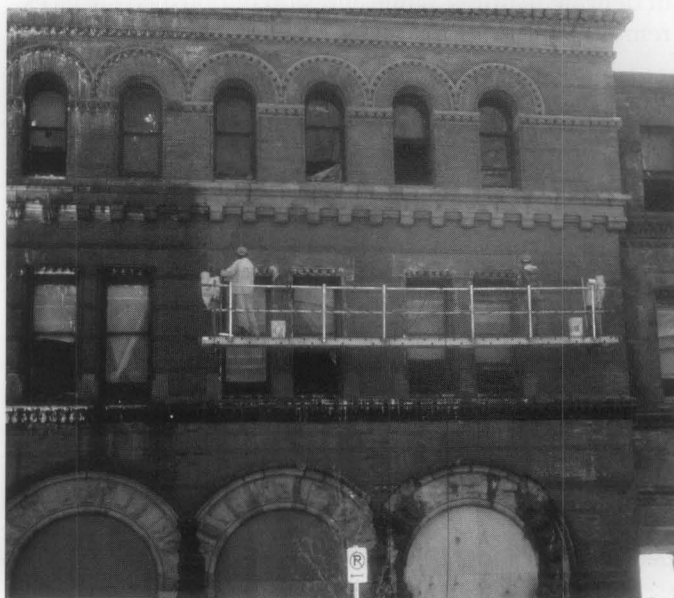
Figure 12. A mild acidic cleaning agent is being used to clean this heavily soiled brick and granite building. Additional applications of the cleaner and hand-scrubbing, and even poulticing, may be necessary to remove the dark stains on the granite arches below. Photo: Sharon C. Park, FAIA.

**Acidic Cleaners.** Acid-based cleaning products may be used on **non-acid sensitive** masonry, which generally includes: granite, most sandstones, slate, unglazed brick and unglazed architectural terra cotta, cast stone and concrete (Fig. 12). Most commercial acidic cleaners are composed primarily of hydrofluoric acid, and often include some phosphoric acid to prevent rust-like stains from developing on the masonry after the cleaning. Acid cleaners are applied to the pre-wet masonry which should be kept wet while the acid is allowed to "work", and then removed with a water wash.

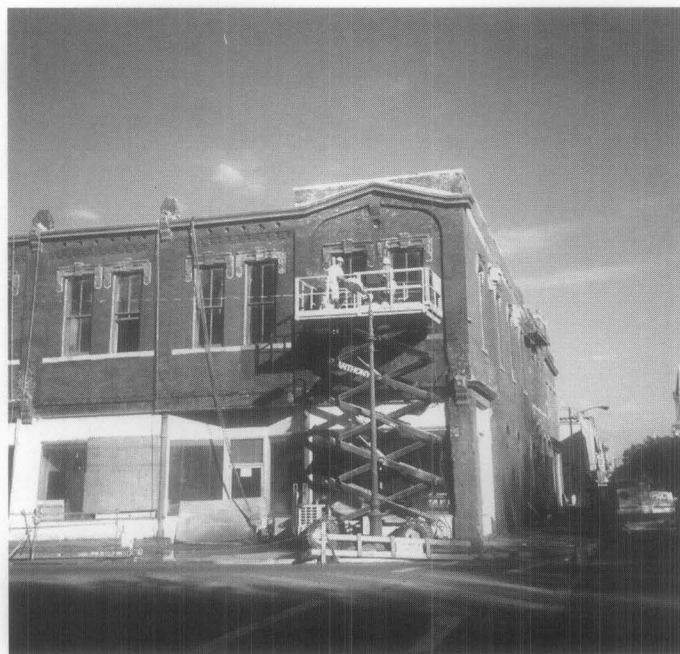
Figure 14. Chemical removal of paint from this brick building has revealed that the cornice and window hoods are metal rather than masonry.

**Other Paint Removers and Cleaners.** Other cleaning compounds that can be used to remove paint and some painted graffiti from historic masonry include paint removers based on N-methyl-2-pyrrolidone (NMP), or on petroleum-based compounds. Removing stains, whether they are industrial (smoke, soot, grease or tar), metallic (iron or copper), or biological (plant and fungal) in origin, depends on carefully matching the type of remover to the type of stain (Fig. 13). Successful removal of stains from historic masonry often requires the application of a number of different removers before the right one is found. The removal of layers of paint from a masonry surface is usually accomplished by applying the remover either by brush, roller or spraying, followed by a thorough water wash (Fig. 14).

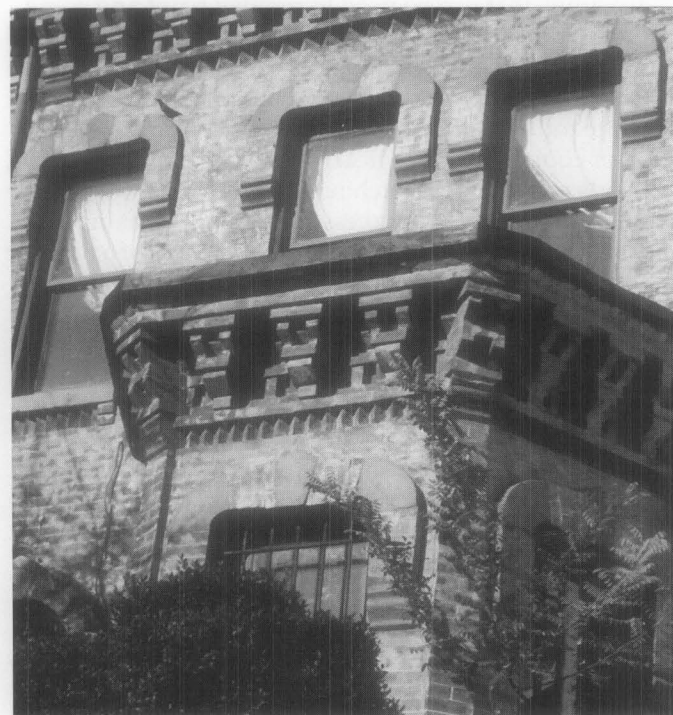
Figure 15. The whitish deposits left on the brick by a chemical paint remover may have resulted from inadequate rinsing or from the chemical being left on the surface too long and may be impossible to remove.

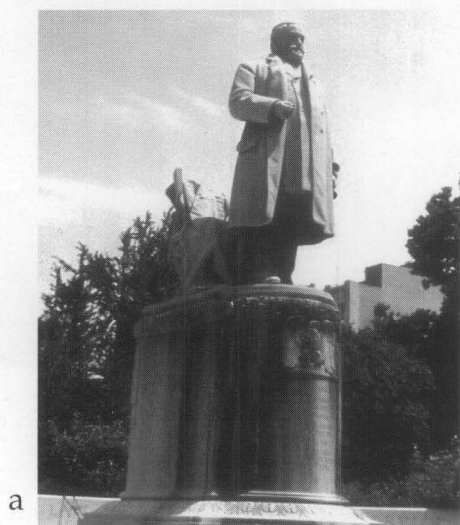
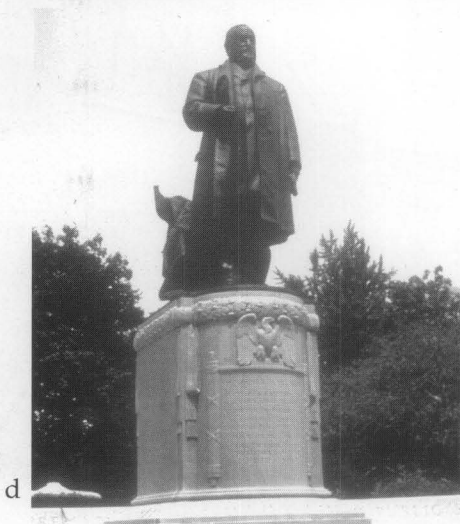
Figure 16. (a) The limestone base was heavily stained by runoff from the bronze statue above. (b) A poultice consisting of copper stain remover and ammonia mixed with fuller's earth was applied to the stone base and covered with plastic sheeting to keep it from drying out too quickly. (c) As the poultice dried, it pulled the stain out of the stone. (d) The poultice residue was removed carefully from the stone surface with wooden scrapers and the stone was rinsed with water. Photos: John Dugger.

Graffiti and stains, which have penetrated into the masonry, often are best removed by using a poultice. A poultice consists of an absorbent material or clay powder (such as kaolin or fuller's earth, or even shredded paper or paper towels), mixed with a liquid (solvent or other remover) to form a paste which is applied to the stain (Figs. 16-17). As it dries, the paste absorbs the staining material so that it is not redeposited on the masonry surface. Some commercial cleaning products and paint removers are specially formulated as a paste or gel that will cling to a vertical surface and remain moist for a longer period of time in order to prolong the action of the chemical on the stain. Pre-mixed poultices are also available as a paste or in powder form needing only the addition of the appropriate liquid. The masonry must be pre-wet before applying an alkaline cleaning agent, but not when using a solvent. Once the stain has been removed, the masonry must be rinsed thoroughly.

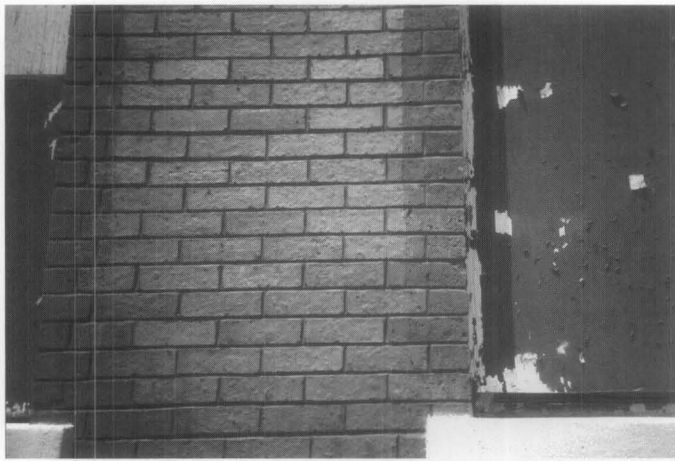
Figure 18. The glazed bricks in the center of the pier were covered by a signboard that protected them from being damaged by the sandblasting which removed the glaze from the surrounding bricks.

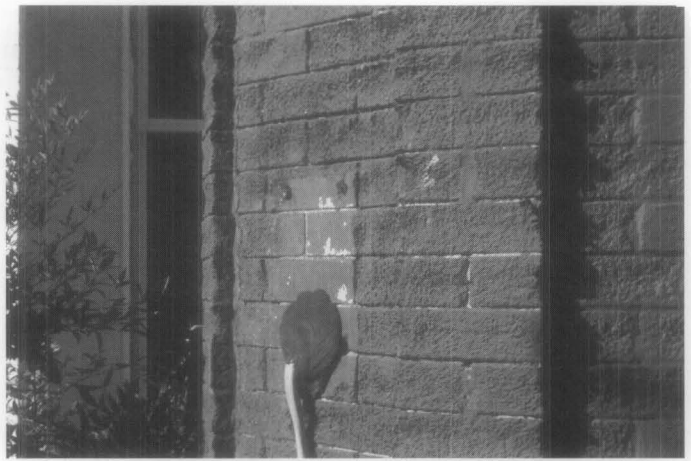
Figure 19. A comparison of undamaged bricks surrounding the electrical conduit with the rest of the brick facade emphasizes the severity of the erosion caused by sandblasting.

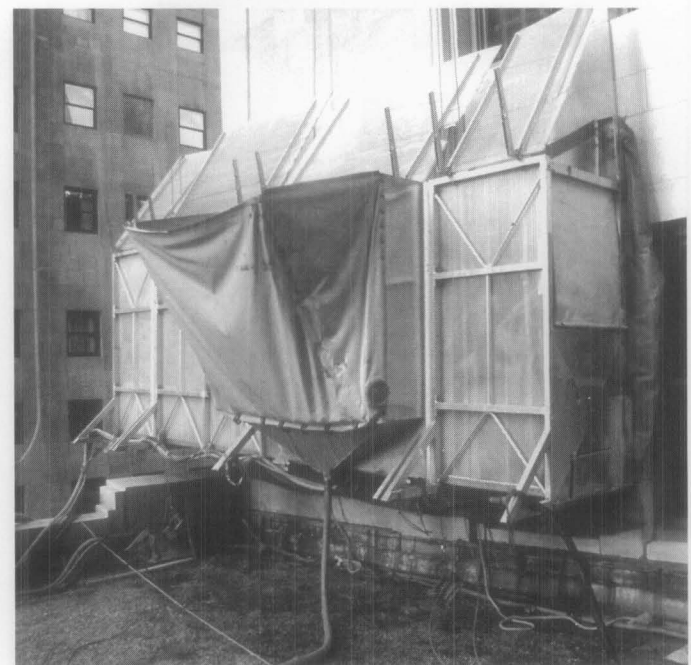
Figure 20. (Left) A comparison of the limestone surface of a 1920s office building before and after “cleaning” with a proprietary abrasive process using fine glass powder clearly shows the effectiveness of this method. But this is an abrasive technique and it has “cleaned” by removing part of the masonry surface with the dirt. Because it is abrasive, it is generally not recommended for large-scale cleaning of historic masonry, although it may be suitable to use in certain, very limited cases under controlled circumstances. (Right) A vacuum chamber where the used glass powder is collected for environmentally safe disposal is a unique feature of this particular process. The specially-trained operators in the chamber wear protective clothing, masks and breathing equipment. Photos: Tom Keohan.

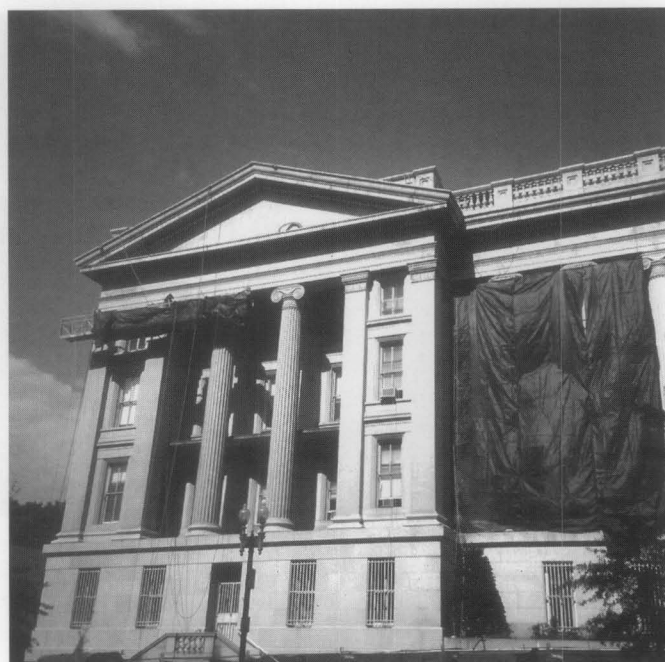
Figure 23. A tarpaulin protects and shields pedestrians from potentially harmful spray while chemical cleaning is underway on the granite exterior of the U.S. Treasury Building, Washington, D.C.

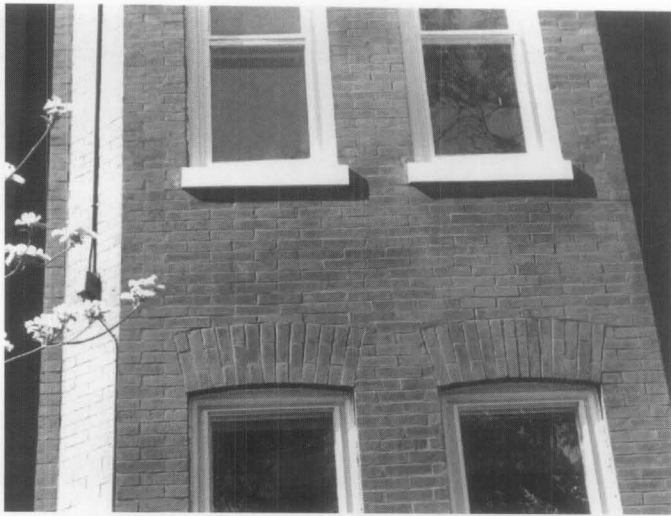
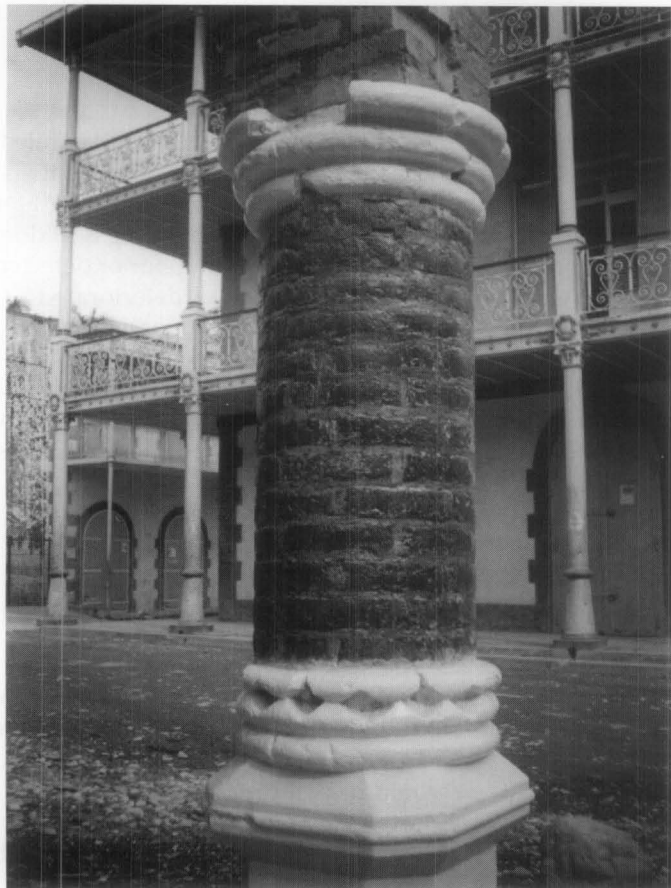
Figure 24. Although the application of a water-repellent coating was probably not needed on either of these buildings, the coating on the brick building (above), is not visible and has not changed the character of the brick. But the coating on the brick column (below), has a high gloss that is incompatible with the historic character of the masonry.

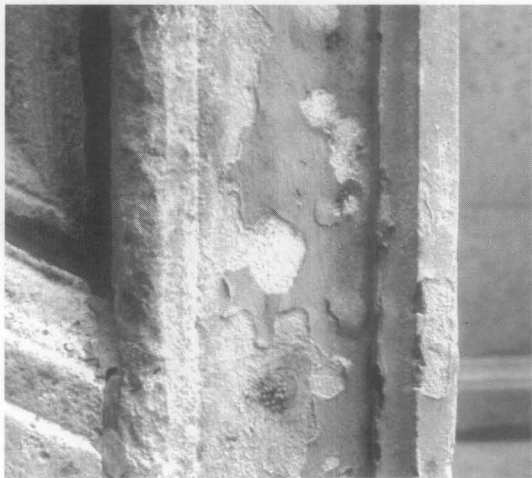
Figure 25. The clear coating applied to this limestone molding has failed and is taking off some of the stone surface as it peels. Photo: Frances Gale.

Some modern water-repellent coatings which contain a binder intended to replace the natural binders in stone that have been lost through weathering and natural erosion are described in product literature as both a water repellent and a consolidant. The fact that newer water-repellent coatings penetrate beneath the masonry surface instead of just forming a layer on top of the surface may indeed convey at least some consolidating properties to certain stones. However, a water-repellent coating cannot be considered a consolidant. In some instances, a water-repellent or "preservative" coating, if applied to already damaged or spalling stone, may form a surface crust which, if it fails, may exacerbate the deterioration by pulling off even more of the stone (Fig. 25).

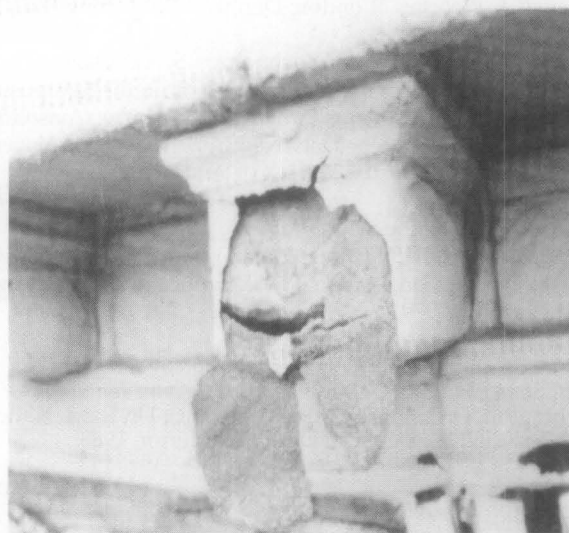
Figure 27. Instead of correcting the roof drainage problems, an elastomeric coating was applied to the already saturated limestone cornice. An elastomeric coating holds moisture in the masonry because it does not "breathe" and does not allow liquid moisture to escape. If the water pressure builds up sufficiently it can cause the coating to break and pop off as shown in this example, often pulling pieces of the masonry with it. Photo: National Park Service Files.

In addition, the water eventually will get out by the path of least resistance. If this path is toward the interior, damage to interior finishes can result; if it is toward the exterior, it can lead to damage to the masonry caused by built-up water pressure (Fig. 27).

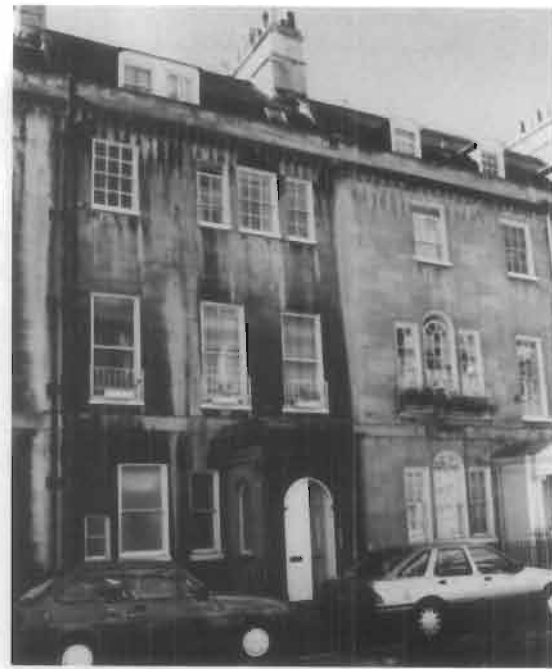
*Figure 2. The building on the left is an obvious candidate for cleaning, as the heavy black crust may be concealing or contributing to deterioration of the stone. Despite its more recent cleaning, the stone facade of the house on the right exhibits the same distinctive, and hard-to-eliminate rainwater wash patterns under the eaves and window sills, as its unwashed neighbor.*

The strongest practical argument in support of masonry cleaning is that it may slow the processes of deterioration and decay. Heavy layers of dirt not only interfere with natural weathering and washing patterns, but also obscure deterioration (figure 2). Cleaning is often necessary to help the architect or building conservator detect problems, and correctly interpret them, in order to take corrective measures, and to prepare a regular maintenance schedule for the building. The cleaning process itself, as well as the close-range view of historic masonry afforded by the scaffolding or other access equipment, also provides an important opportunity to evaluate the condition of the building. Once rid of dirt and pollutant crusts, the condition of the masonry will be more clearly revealed.

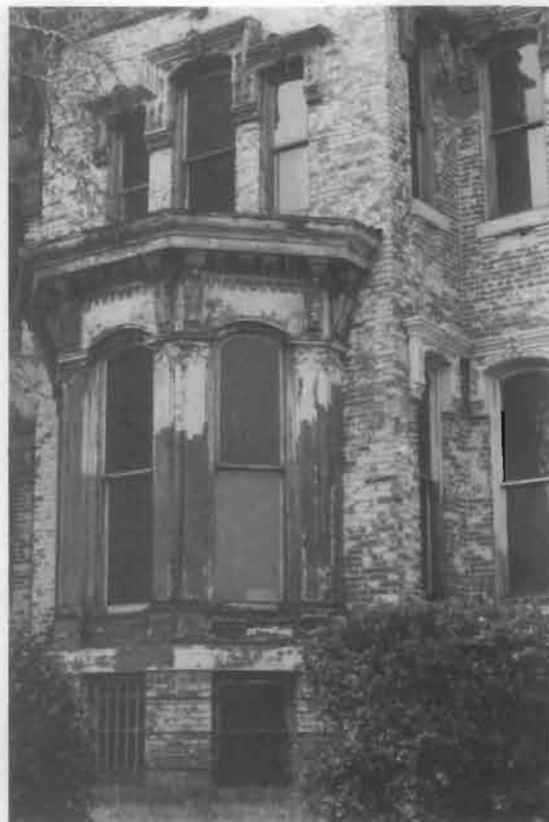
*Figure 3. Know what you are cleaning. If the painted surfaces of the projecting bay window on this once elegant Second Empire brick mansion were still intact, it would not be easy to identify the beltcourse as sandstone, the windows and window frames as wood, and the cornice and all of the window hoods as pressed metal. Cleaning so many different building materials may require a variety of techniques and treatments.*

Indeed, some parts of a building, particularly decorative features, may not be masonry at all (figure 3). Frequently, such features as window hoods, cornices and balustrades may be metal, such as cast iron, galvanized sheet iron or zinc. When painted, they give an intentional appearance of masonry. Some features may have been fabricated of wood, then coated with a sanded paint to give the illusion of sandstone. Thus, the need to correctly identify the type of masonry, or other non-masonry materials on a building cannot be over-emphasized when planning a cleaning project.

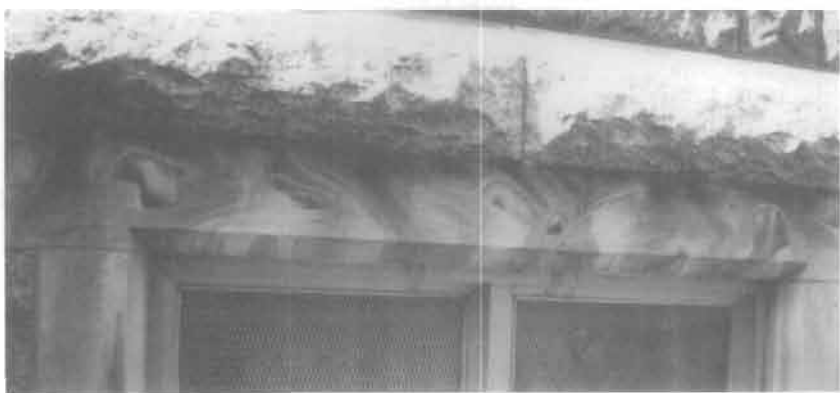
*Figures 4a-4b. Decorative architectural features that project from a wall surface, such as this granite belt course above an intricately-tooled limestone lintel, and this sandstone pinnacle topping a limestone buttress, may shield or protect masonry surfaces beneath them. But they are also responsible for creating unusual “wash” patterns and black crusts that form underneath them, further complicating cleaning projects.*

Dirt or soiling may include disfiguring pollutant or sulfate crusts, which usually build up in sheltered or protected areas not regularly washed by the natural action of rain. It is particularly common under cornices, window sills, or other projecting decorative features (figures 4a - 4b). Some pollutant crusts resulting from a chemical reaction of stone to airborne particulate matter, or particles in which cementing material of the stone has actually incorporated itself, indicate the beginning of dissolution of the stone and incipient decay. Removing these crusts will necessarily involve a loss of a small amount of stone (figure 5). While removal is generally recommended because pollutant crusts hasten stone dissolution, extreme care must nonetheless be exercised to ensure that loss of the stone is minimized.

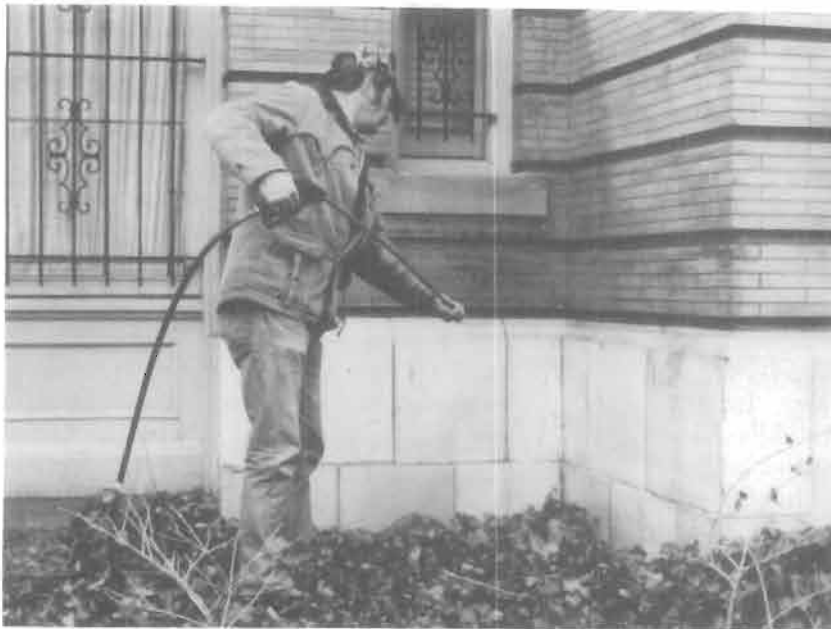
Figure 7. A contractor prepares equipment before testing a low-pressure water wash on a Roman brick and terra cotta building. Photograph: Sharon C. Park, AIA

Because of the wide variety of unforeseeable factors, the cleaning method or methods should always be tested on an inconspicuous area of the building and preferably in more than one location (figure 7). Such tests must be carried out before attempting any large-scale masonry cleaning project. Failure to do so may have disastrous consequences for the outcome of the cleaning as well as the long-term preservation of the historic building material. Testing should be carried out by the consultant or conservation specialist, or by the contractor, under the consul-

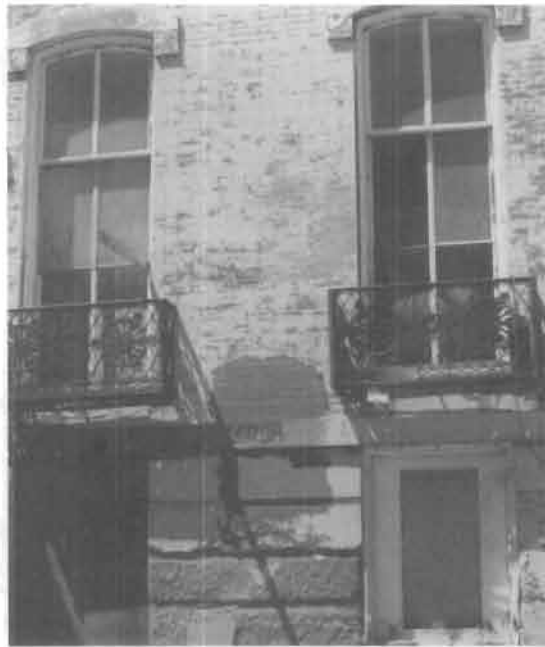
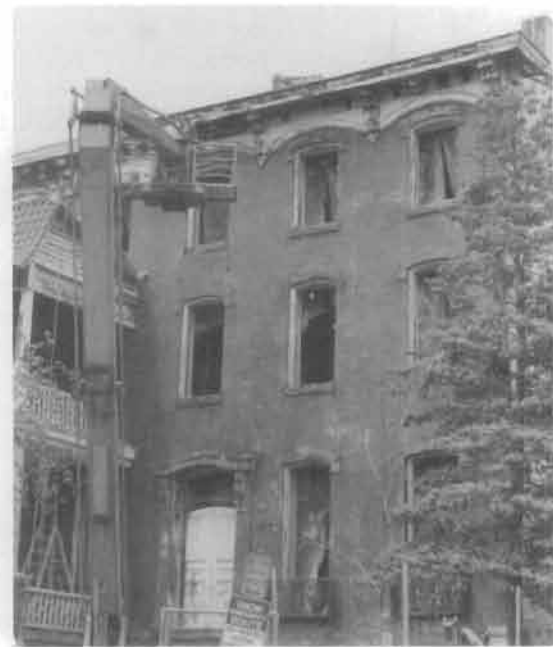
*Figures 10a-10b. This test cleaning patch on brick and sandstone was allowed to weather over a full year, while other aspects of the rehabilitation were carried out. Finally the entire building was cleaned with a proprietary paint remover sprayed-on under low-pressure and then rinsed by workmen from a truck-mounted hydraulic platform lift.*

A test patch should be allowed to weather as long as possible before the cleaning project is begun to give ample opportunity for an accurate evaluation of the results. One year is the preferred amount of time; this allows the patch to be exposed to a complete weathering cycle (figures 10a-10b). If this is not feasible, it is a good idea to

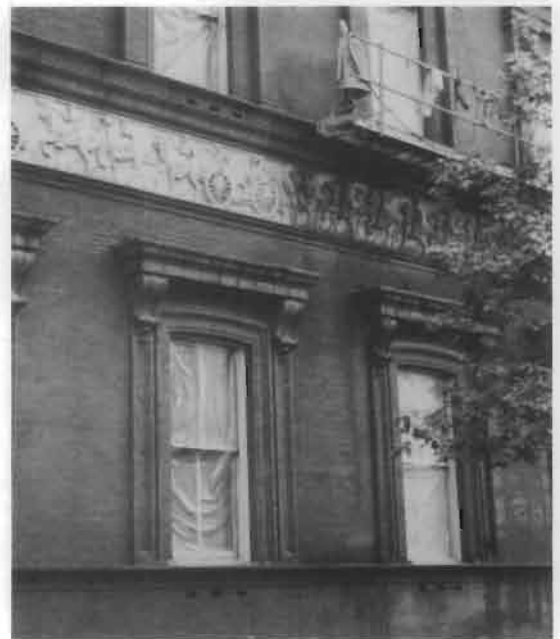
*Figure 11. Removal of 100 years of grime from the brick and terra cotta facade of the Pension Building (now the National Building Museum), Washington, D.C., was accomplished by workmen on a swing stage using a chemical cleaning product. Note the polyethylene covering the windows to prevent damage. Also note the protective clothing for the workmen which hangs on the platform while not in use.*

Many other historic building materials can be damaged by chemical cleaning agents. Glass, glazed brick, and architectural terra cotta will be etched by strong solutions of hydrofluoric acid if not covered adequately. Metal, wood and paint can all be damaged by chemical cleaners, and must be shielded. Such materials can be temporarily protected by plastic sheeting or peelable coatings specifically made for this purpose (figure 11).

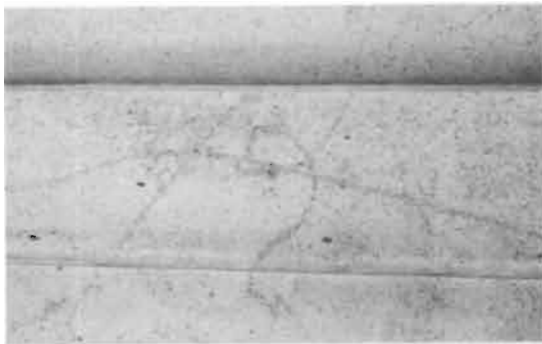
*Figure 12. Water at too high a pressure from a pinpoint nozzle has etched this white Vermont granite. Photograph: David A. Look, AIA*

**Cautions and Precautions.** Despite the fact that water washing methods may be the gentlest of all cleaning methods they are not without hazards. Even these methods can be abrasive. Water pressure should always be kept at the lowest level that will clean the masonry without damage. Too highly pressurized water can etch or otherwise scar masonry, and may penetrate through the masonry walls (figure 12).

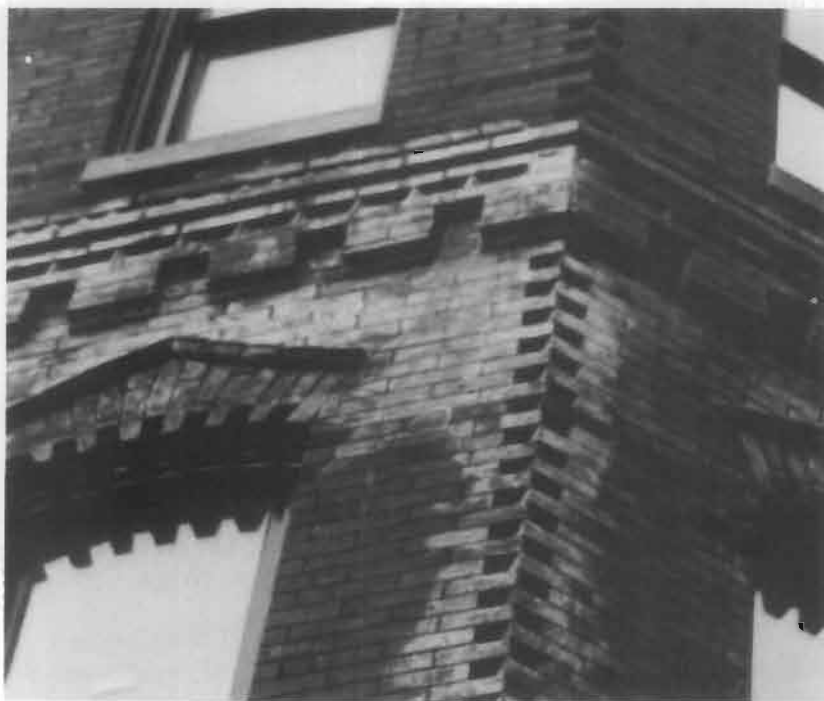
Figure 13. While hydrofluoric acid-based cleaners are often appropriate for cleaning unglazed brick, they may form hard-to-remove whitish silica deposits if left too long on the surface.

**Cautions and Precautions.** Hydrofluoric acid-based cleaners can sometimes leave whitish deposits of silica, or calcium fluoride salts (efflorescence). These deposits are generally not harmful to the masonry but may be disfiguring, especially on darker masonry. Since this efflorescence is soluble in hydrofluoric acid, it can usually be removed by a second chemical treatment, followed immediately by a thorough cold water rinse. It should be noted that hydrofluoric-based cleaners left too long on the masonry may result in a colloidal silica deposit that may be almost impossible to remove (figure 13).

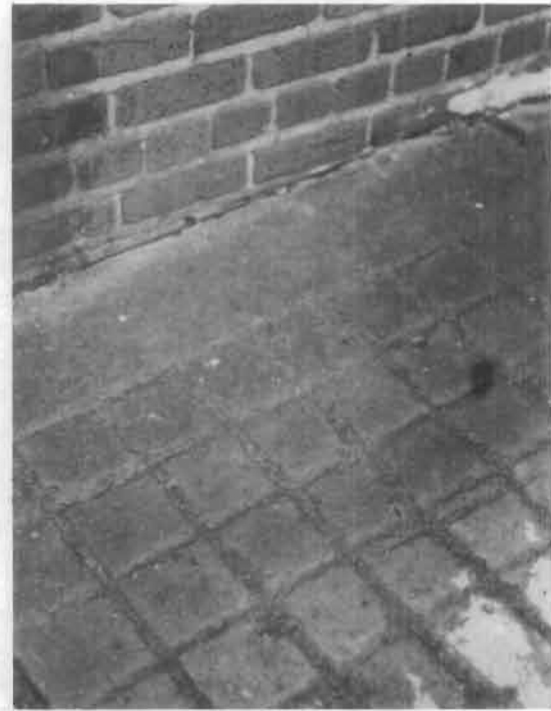
Figure 14. Although the sodium hydroxide-based test cleaning patch on the right side of this wall of common brick appears to have been successfully cleaned, closer inspection reveals that a minute portion of the brick surface has been dissolved and removed by the cleaner. As a result, considerable brick dust can be seen in the cracks of the pavement beneath the wall.

**Cautions and Precautions.** Sodium hydroxide (caustic soda or lye) generally should not be used on older or historic masonry. It is extremely harsh and can cause efflorescence and subflorescence, and may also cause physical abrasion and loss of small amounts of a brick surface (figure 14). Ammonium bifluoride is another alkaline cleaner that is commonly recommended as an "all-purpose" cleaner, but in general, ammonium bifluoride solutions are also not suitable for use on limestones, marbles, calcareous sandstones, or unglazed brick because of the likelihood of
