**STAFF REPORT 05-13-2020 REGULAR MEETING****PREPARED BY: A. PHILLIPS****APPLICATION NUMBER: 20-6718****ADDRESS: 729 SEWARD AVENUE****HISTORIC DISTRICT: NEW CENTER AREA****APPLICANT: ANDREW JORDAN, LEWAND BUILDING COMPANIES****PROPERTY OWNER: TARA YENGLIN, 700 SEWARD DETROIT LLC****DATE OF COMPLETE APPLICATION: 04-22-2020****STAFF SITE VISIT: N/A****SCOPE: GENERAL REHABILITATION OF BUILDING INCLUDING WINDOW REPLACEMENT****EXISTING CONDITIONS**

With the current proposal, the applicant is seeking the Commission's approval **to perform a general rehabilitation of the building including the replacement of all existing wood windows, trim, and brick mold with new vinyl window units and trim per the attached drawings and application.** Included in the proposal are the following scope items:

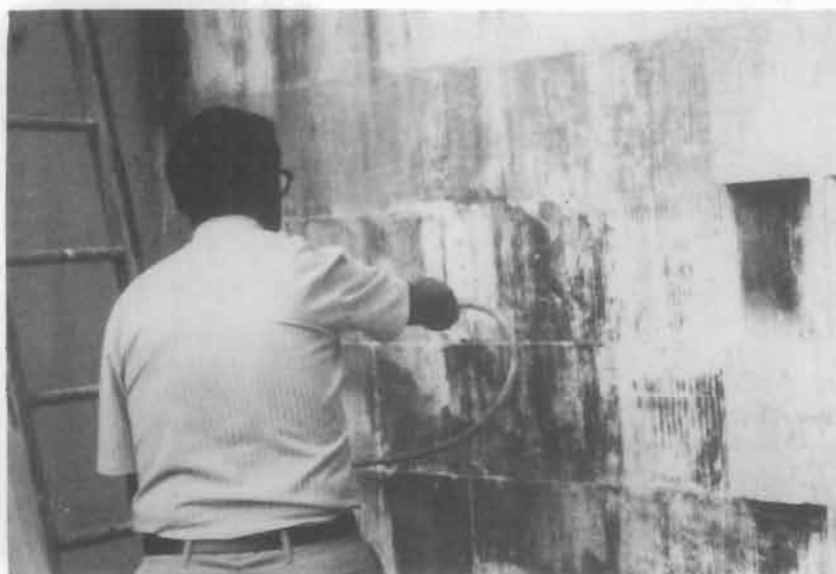
*Figures 15a-15b. If a highly articulated facade is being cleaned it may be necessary to scaffold the building, one elevation at a time. When the monumental task of chemically removing all the paint from the White House was begun, each side was scaffolded in preparation for repainting. Removal of the many layers of paint that had obscured the stone tooling marks for almost a century, without damaging the historic sandstone, required much painstaking hand work.*

generally formulated to remove most types of paint (except cementitious or lime-based paints such as whitewash) from all types of masonry. But it is always preferable to use an alkaline paint remover on acid-sensitive masonry (figures 15a-15b).

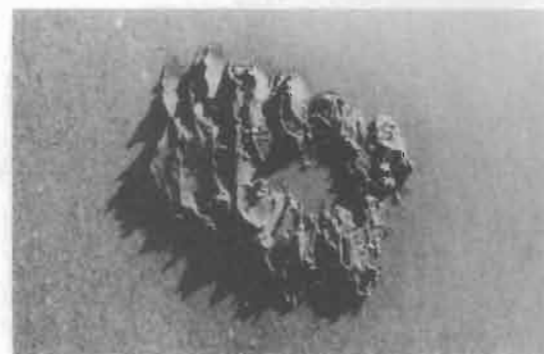
*Figure (c-d) The slight ghost outline remaining was easily removed with the solvent mixture in a poultice composed of attapulgite and Kaolin clays and whiting, and followed by a thorough detergent and water wash. Photographs: Nicholas F. Veloz*

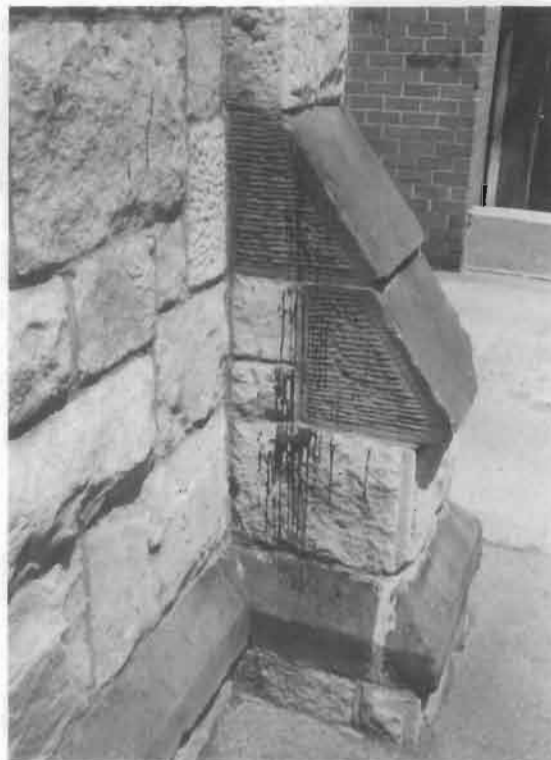
Figure 19. Efficient removal of tar splatters from limestone and sandstone may be facilitated initially by applying dry ice or carbon dioxide, but complete removal will probably require poulticing with an in-organic solvent.

Removal of larger chunks of asphalt or tar accumulations may be facilitated by applying dry ice or spraying with carbon dioxide. The asphalt or tar will be embrittled by the dry ice or carbon dioxide, and after tapping with a small hammer, can usually be removed from the masonry surface by prying it up with a putty knife, (figure 19). This same technique can be used for removing gum, adhesives or other sticky substances. Such techniques, however, should not be used on wet masonry, as they may freeze the moisture in the masonry, and cause cracking or spalling. Organic solvents or bleaches are also effective, sometimes in a poultice, on sticky substances.

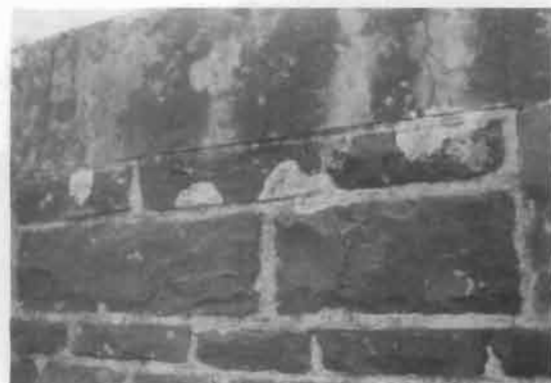
Figure 20. Plant growth such as lichens growing on a protected side of this limestone and granite parapet wall, can be damaging even to a relatively hard stone like granite because lichens secrete oxalic acid. Lichens can usually be removed, after soaking with water by scrubbing with a stiff natural bristle brush.

Lichens and algae can usually be removed with water and a stiff natural bristle brush, after soaking, if necessary (figure 20). Stains caused by plant growth such as mildew (which is a fungus) can sometimes be removed with organic solvents, but are generally best treated with diluted ammonia or bleaches. Hydrogen peroxide can also be effective. Calcium hypochlorite solutions and pastes (the basis of swimming pool chlorine) and Chloramine-T may also be useful in many cases. Chemical removal of the growth itself may sometimes be accomplished with zinc or magnesium fluorosilicate, copper naphthenate, or with a variety of quaternary ammonium salts. Low-to-medium-pressure (100-400 psi) water rinsing can be used to eliminate much of the plant material prior to treatment and stain removal. However, these compounds should be used with caution, as some copper compounds may stain light-colored

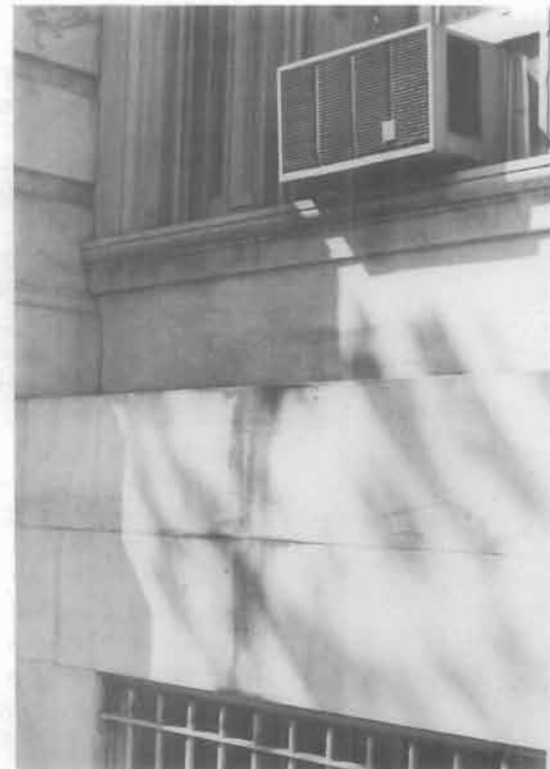
*Figure 22. The discoloration on this white marble is a green-colored algae growth on a shady side of the building and caused by water dripping from the air-conditioner above it.*

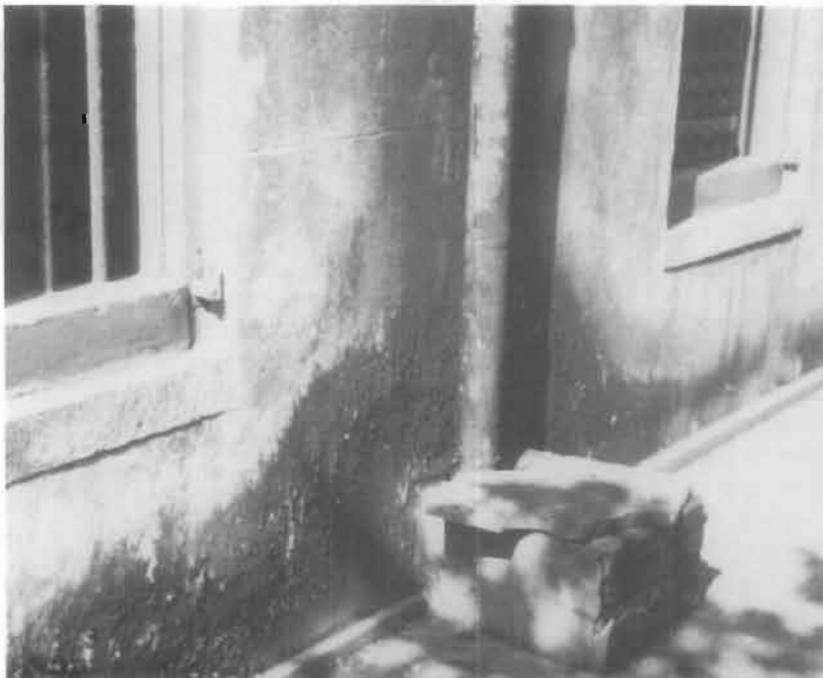
*Figure 23. The moss growing around the downspout and along the base of this stucco building clearly indicates the presence of excess moisture—here due to rising damp as well as a leaky downspout. Photograph: Lee H. Nelson, FAIA*

Most of these forms of plant growth on masonry buildings—algae, moss, lichens and fungi—are a direct result of moisture in the masonry and lack of sunshine. Thus, unless the specific conditions change, i.e., the moisture problem is eliminated, or the masonry is given more exposure to the sun, they will recur continually (figure 22). A leaking downspout or gutter can be repaired, a tree or bush too close to the building can be trimmed or pruned to introduce more sunlight, and even lawn sprinklers can be redirected so they do not repeatedly deposit excessive amounts of water on the same area of a building surface (figure 23).

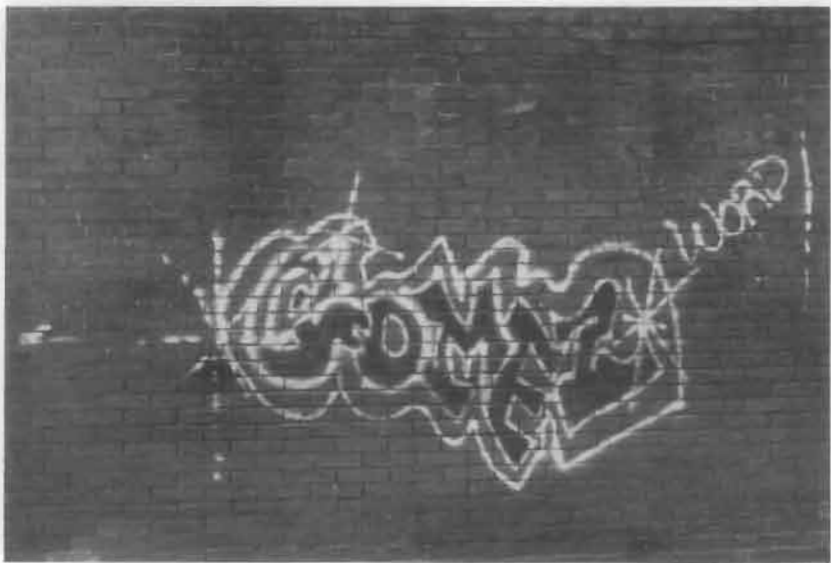
Figure 24. Spray-painted graffiti on this brick wall can be removed with paint remover, and in this case, probably will not require poulticing.

Painted graffiti applied from a spray can or by a felt-tipped marker or lipstick may generally be removed from masonry by a commercial paint remover—either a solvent type of remover such as lacquer thinner or acetone, or a methylene chloride-based remover (figure 24). In some instances, poulticing may not be necessary. If the graffiti has not permeated deeply into the masonry, it may be removed by the paint remover or a solution of trisodium phosphate brushed on with a non-metallic brush. After the paint has softened, as much as possible should be scraped off with a wooden scraper. Then the area should be washed again using a detergent and soapy water, and rinsed thoroughly with water.

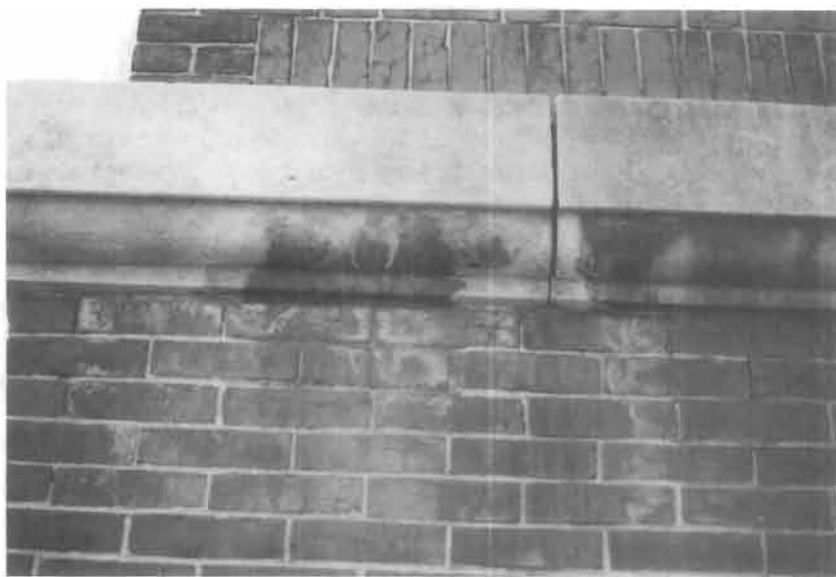
Figure 25. Excess moisture leaching out through the walls has resulted in the formation of white efflorescent salts on the brick and blackish sulfate salts on the limestone water table.

chemical cleaning or repointing if the masonry is not thoroughly rinsed. It may also come from heavy use of de-icing salts, or rain penetrating masonry through deteriorated mortar joints may result in efflorescent patches on an entire facade. Finally, air pollution often results in the formation of thick sulfate (salt) crusts on the underside of moldings and eaves—areas not regularly washed by rainfall (figure 25).

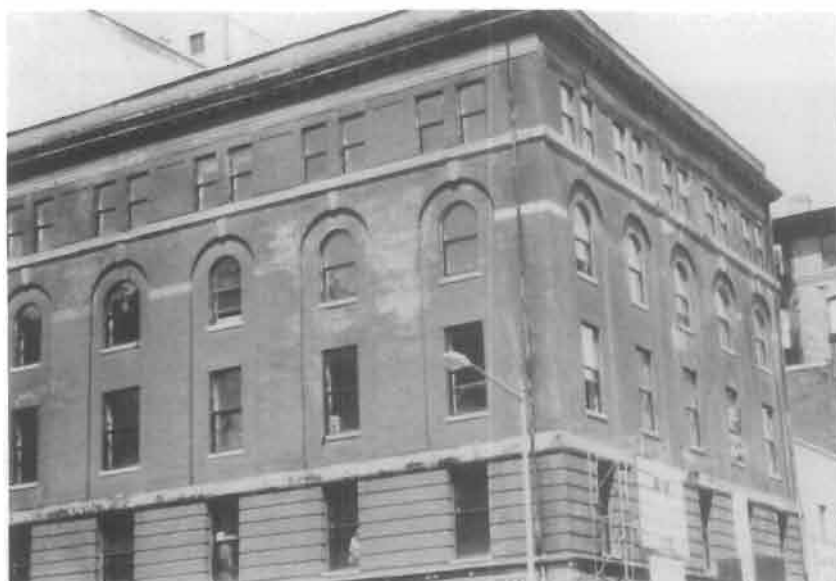
Figure 26. Efflorescent salts appearing on many of the brick piers of this turn-of-the-century building may indicate the existence of clogged interior gutters that, because they no longer function have been supplemented by an exterior rain removal system. Photograph: National Park Service

water soluble salts. Some efflorescence that results from cleaning may eventually disappear through normal rain washing; however, some chemical residue left from the cleaning process can form damaging insoluble salts. Efflorescence resulting from water penetration into the masonry structure will continue to reappear unless the source of the water entry is removed; thus, the first task is to identify the point of entry and stop the water penetration (figure 26).

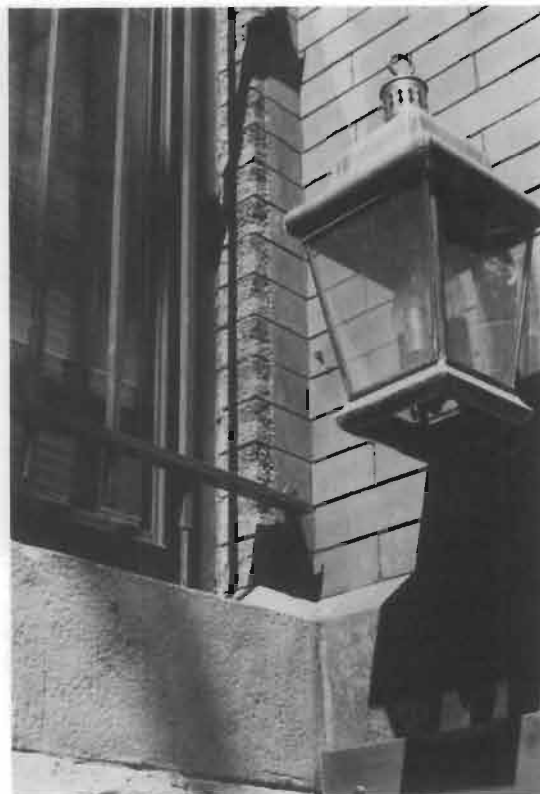
Figure 27. Heavily pitted by sandblasting, this window recess provides a vivid contrast to adjacent un-damaged brick protected from abrasion by a metal signboard.

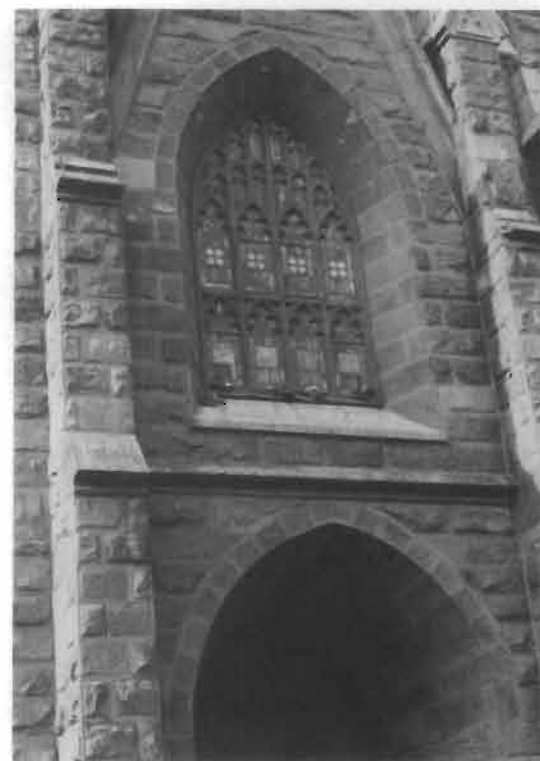
Figure 28. If water, or water and detergent wash, does not remove the pigeon droppings from this sandstone sill and stringcourse below, it may be necessary to use a dilute acidic cleaner containing hydrofluoric acid, providing the sandstone is not calcareous and thus, acid-sensitive.

Removal of small amounts of bird droppings may be accomplished as part of a regular cleaning project with cold water washing, possibly supplemented with detergents and chelating agents such as EDTA (ethylene diamine tetra-acetic acid), or on non-acid sensitive masonry with acidic cleaners, where appropriate. Removal may also be facilitated by brushing with a non-metallic brush and scraping with a wood scraper (figure 28).

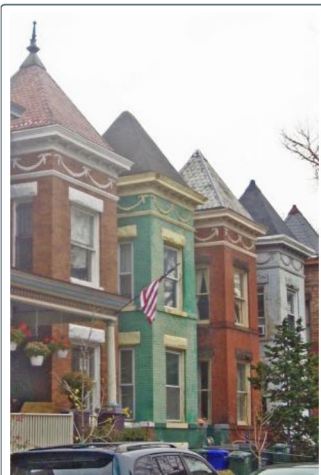
In this row of late-nineteenth century brick rowhouses, the painted brick shows signs of efflorescence (second from left) and flaking (r).
