**SR-2 – ADVISORY STAFF REPORT (04-07-2026)**

**ADDRESS:** 1000 ST. ANNE AND 2635 W LAFAYETTE

**APPLICATION NUMBER:** HDC2026-00107

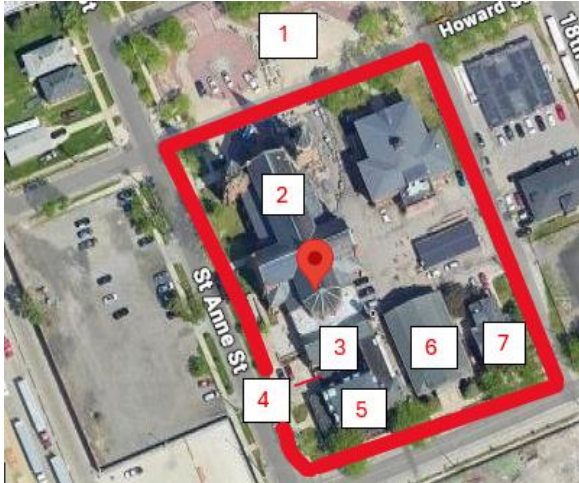
- 1: Plaza in front of the cathedral, outside the historic district/not included in this application's scope
- 2: Basilica/Church & 3: Chapel – Erected in 1886
- 4: Garage – Erected in 1923
- 5: Rectory – Erected in 1886
- 6: Parish Hall – Erected in 1898
- 7: Former Convent/ current Wellness Center – Erected in 1889

Staff-created diagram of buildings and spaces included in the current application. (Source: Google map with staff labels) The red outline indicates the historic district's boundary. The buildings numbered 2-7 are the subject of the current application while the area to the north of the district, numbered 1 is not included in the application's scope.

- The Ste. Anne's Parish Complex is the subject a multi-year, multi-million dollar, campus-wide rehabilitation project, to include work at five buildings within the local historic district boundaries and the non-historic age plaza to the north of/outside of the district boundaries. See the below annotated aerial map which indicates the boundaries of the Ste. Anne's Parish Complex Historic District, the buildings and spaces which are the subject of the current application, and the location of the complex's plaza which is to the north of/outside of the district boundaries

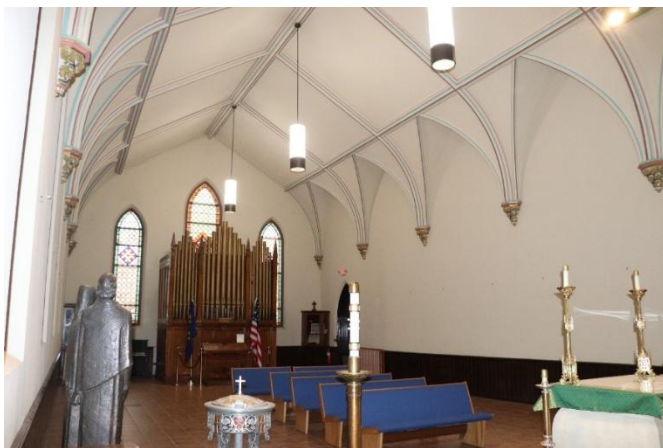
**View of the Chapel’s interior in its current condition, from the east end where the altar is, looking to the west. Note the blank north wall, white ceilings, modest light fixtures, and low wood wainscoting. Photo by staff**

- The application proposes to undertake the following work items within the interior space of the chapel (see below photos and renderings):
  - Paint the white ceiling blue with yellow or gold, similar to the ceiling in the Church but using a darker blue
  - Remove the existing wood wainscoting. New wainscoting takes design cues from the organ enclosure and exterior buttress details would be installed in place of the old wainscoting, and would be taller at the east end, behind the altar.
  - Install new wood trim around existing window and door openings
  - Install new painted panels on the chapel’s north side walls to mirror the actual windows on the south side. Also, install wood trim (matching the trim proposed for the existing north wall doors and window openings) around the new panels
  - Replace existing ceiling lights with new lights similar to those in the Church

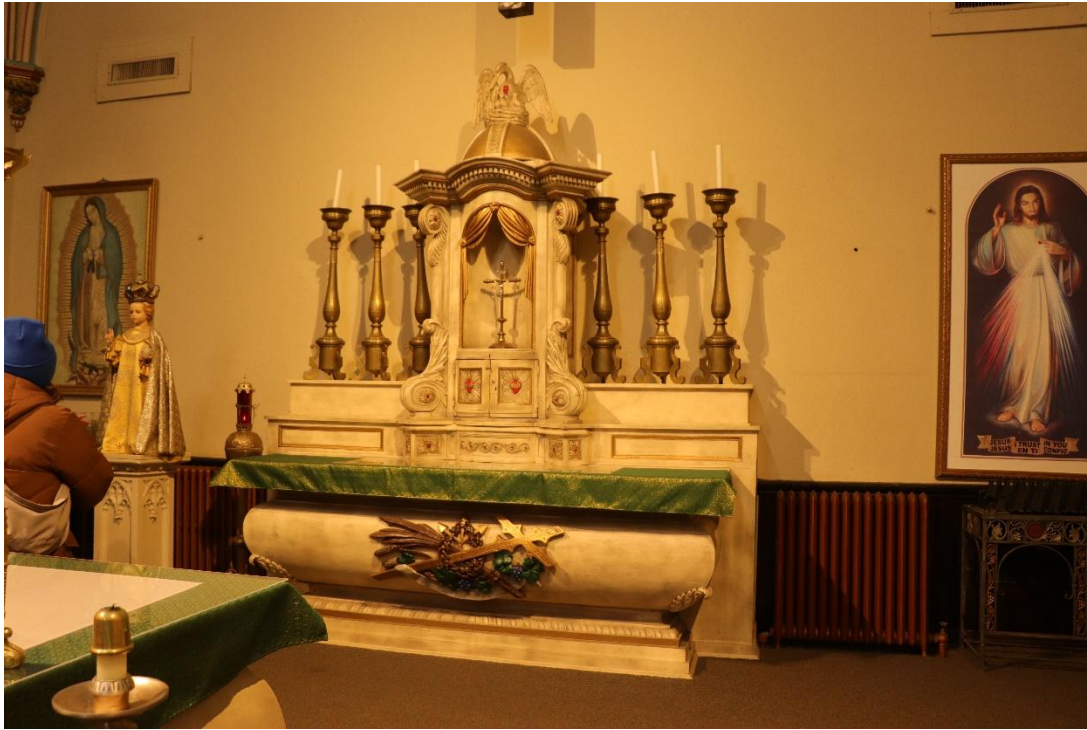
**Historic altar from the 1828 church building and relocated to the current Chapel. Note low wainscoting behind the altar and blank white walls. Photo by staff**

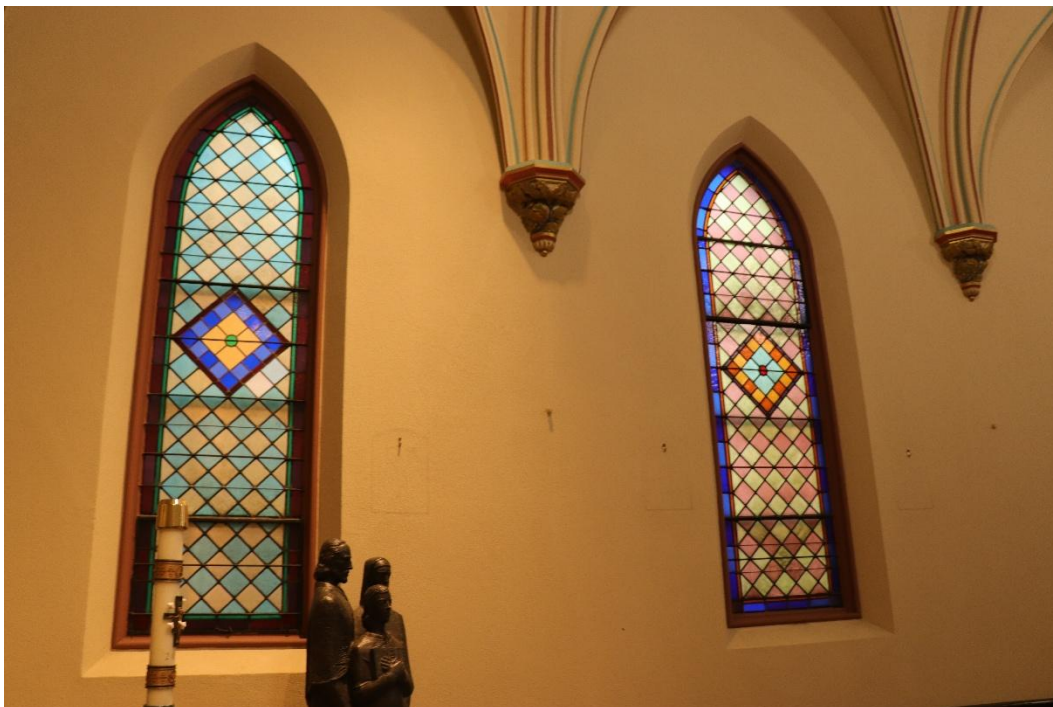
**South wall of the Chapel has pointed-arch windows. The north wall of the Chapel has no windows because it abuts the rest of the Church building to the north. Note lack of trim at wall around window openings. Photo by staff**

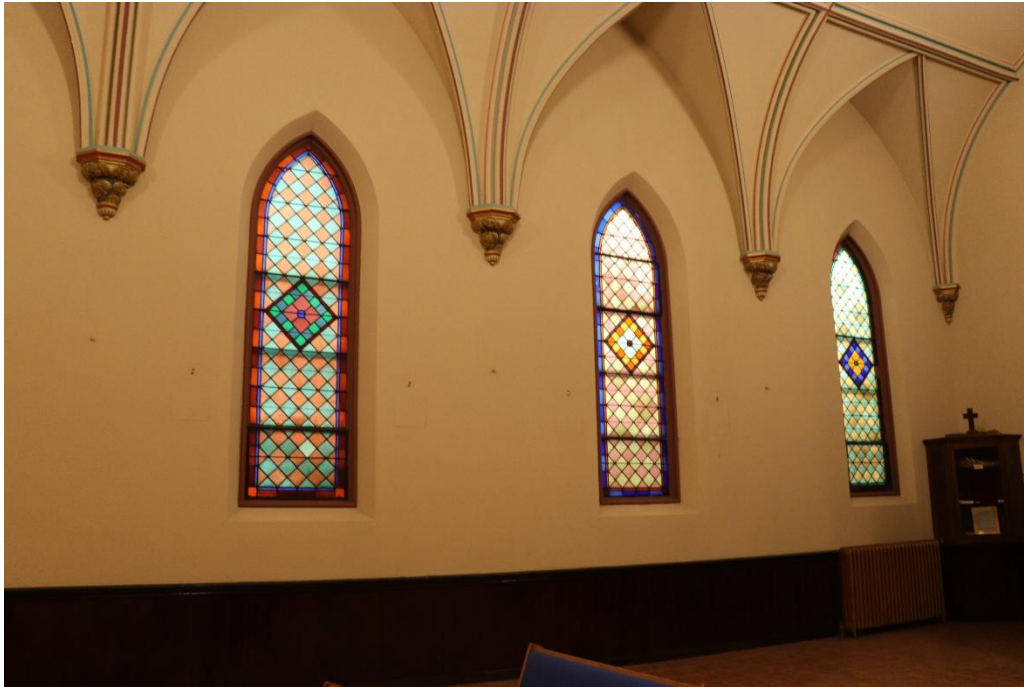
South wall of the Chapel has pointed-arch windows. Note low wood wainscoting and lack of trim at wall around window openings. Photo by staff

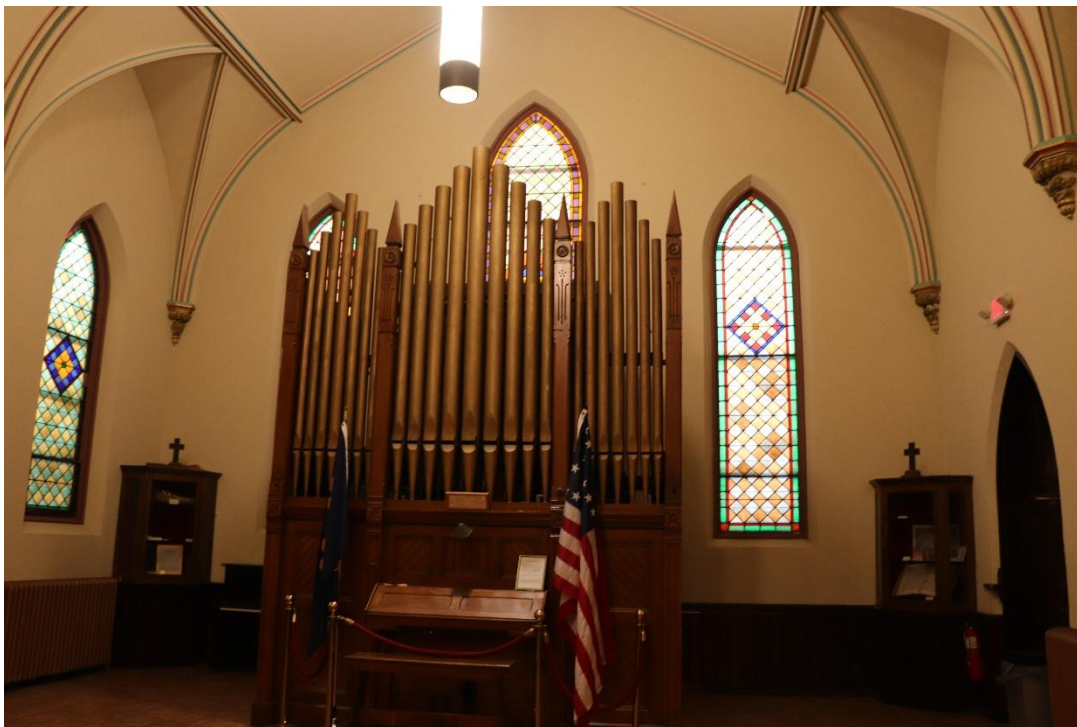
West end of the Chapel with stained glass windows and the organ. Note lack of trim at wall around window openings and low wood wainscoting. Photo by staff

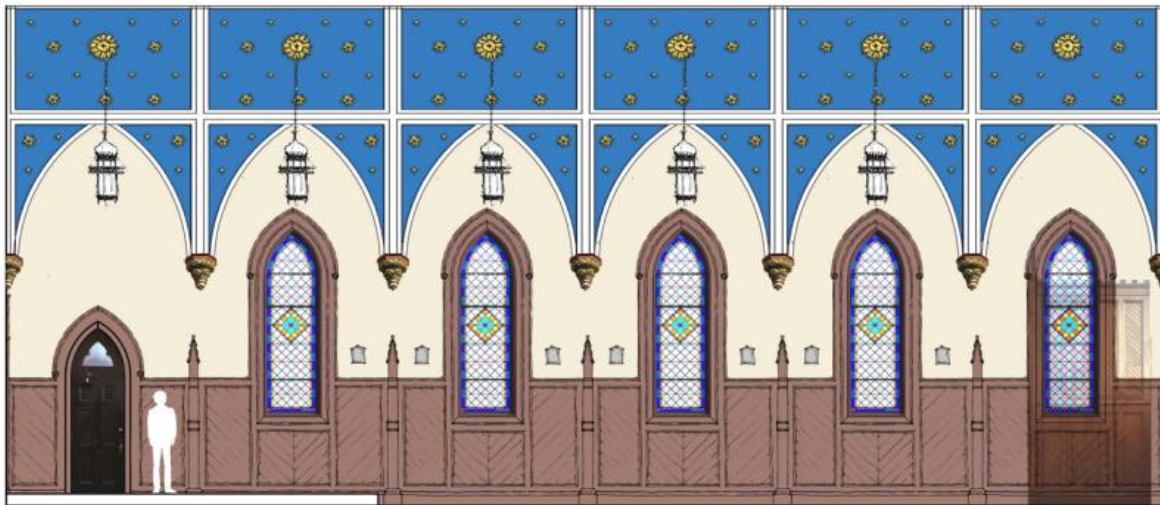
Proposed plan for the Chapel, south wall shown. (From the application materials). Note that the existing wainscoting is proposed to be replaced and new wood trim is proposed for installation around the windows and doors. The ceiling will also be painted, and new elaborate light fixtures will be installed

1. With respect to the chapel wing of the basilica, its current unadorned white walls and ceilings, window and door surrounds, wood wainscoting, and light fixtures are distinctive, character-defining features which should be retained in order to retain its subordination to the church's main interior space and its subdued character. The proposed new elements largely mimic detailing found within the main church's interior, which would disrupt the historic visual relationship between the two spaces. The new elements are conjectural and could also be mistaken as original to the building

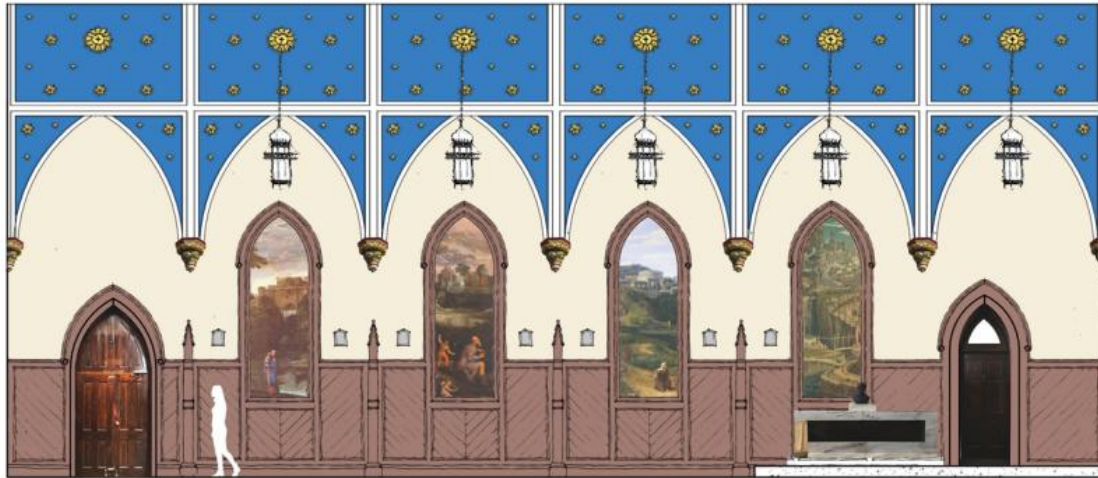
2 North Interior Elevation  
 P4 1/4" = 1'-0" SCALE

Proposed plan for the Chapel’s north wall, showing the painted panels and surrounding trim. The proposed taller and more ornate wainscoting, painted ceilings, and new light fixtures are also shown. (From the application materials)

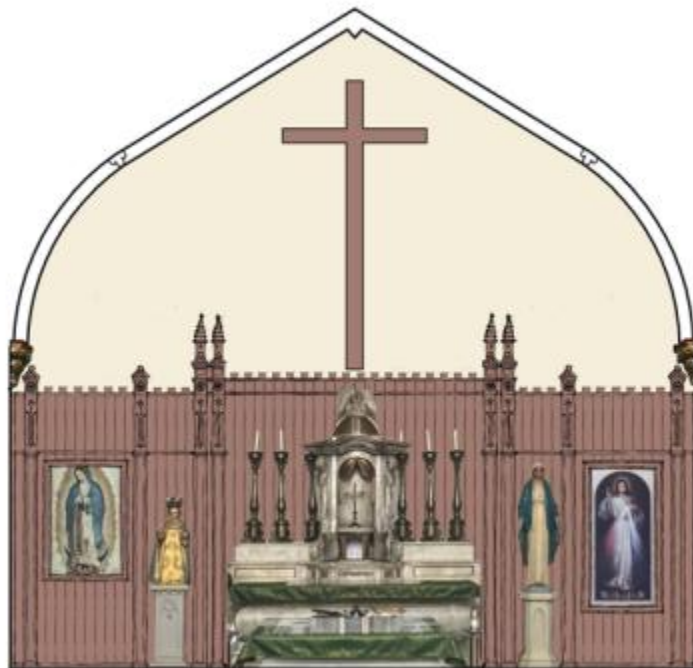
3 East Interior Elevation  
 P4 1/4" = 1'-0" SCALE

Proposed treatment for behind the altar— new taller wainscoting specifically for this area is shown. (From the application materials)

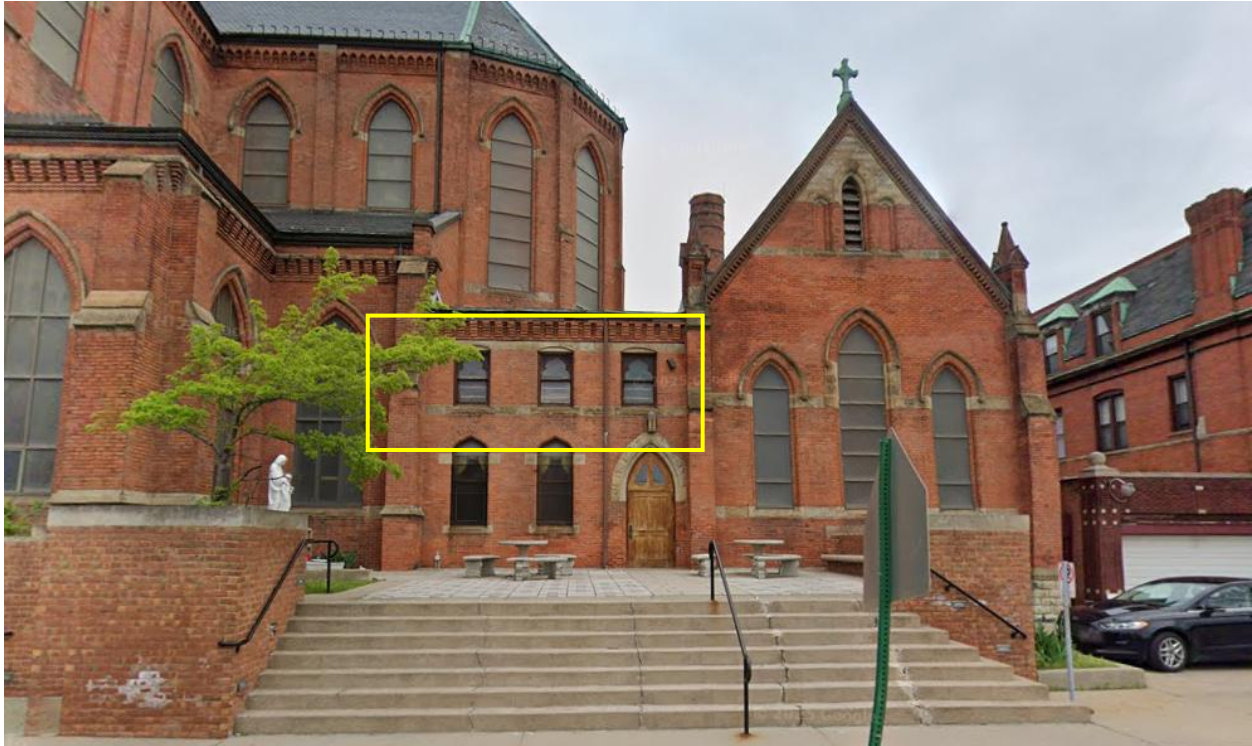
Google Streetview image. Three windows at basilica proposed for replacement, outlined in yellow

- The application proposes to retain and restore all existing historic windows at the basilica building, with the exception of three windows at the second floor, 2-story portion of church (sacristy, see the below image). With respect to these historic windows:

- The application notes that they are wood, display wood tracery, and are visible from public sidewalk/street. The application further states that the windows are in non-repairable condition and is therefore proposing and in-kind replacement. Staff notes that the submission only includes one photos to represent the condition of the three windows proposed for replacement and therefore concludes that the submission does not provide the level of information necessary to demonstrate that the units are deteriorated beyond repair. Also, the application does not provide dimensioned drawings of typical existing conditions at these historic windows and the proposed new units so that staff can ascertain if the replacement windows would adequately match the existing. Staff therefore cannot recommend approval of this scope item.

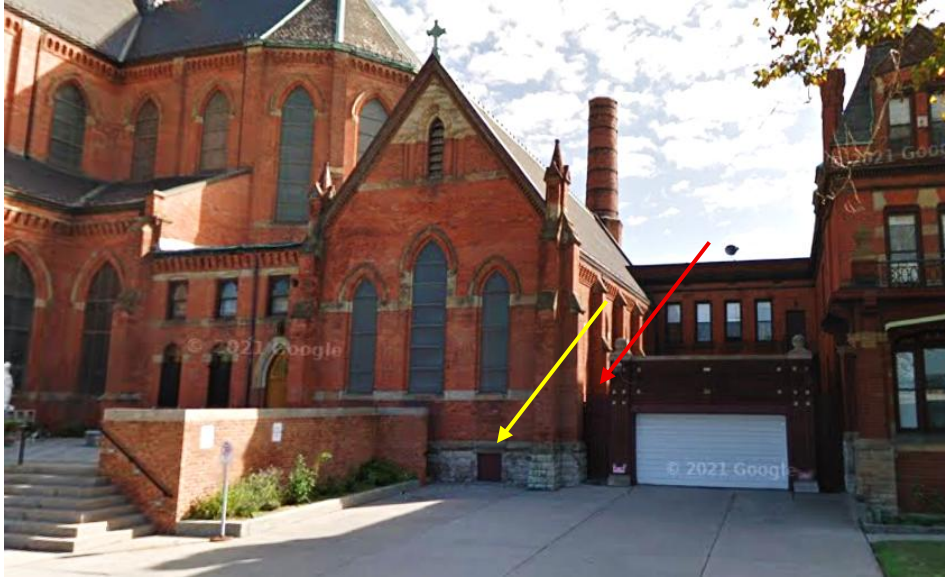
Yellow arrow indicates west elevation opening proposed for enclosure with masonry infill. Red arrow points to south elevation, where openings are proposed for infill with louvered vents (with brickmould to match the existing). One below-grade opening at this location is proposed for masonry infill. The garage blocks the south facade openings from view from the right-of-way. Google Streetview, 2009

- One of the window openings is proposed for infill with masonry (4” rusticated face stone w/ CMU backup) recessed to maintain visual reading of the masonry opening is in a highly visible location at the west façade of the chapel wing (see below). It is currently enclosed with an incompatible plywood panel (window 005). The proposed treatment for this window is not recommended by staff because the window opening is in a conspicuous location of the

building and the work would continue the incompatible opaque enclosure/infill of the character-defining opening. Also, per Element of Design #8. *Relationships of Texture*, “the glazing on all buildings, especially the church, provides a contrasting smooth surface. The scope item does not conform to Element #8.

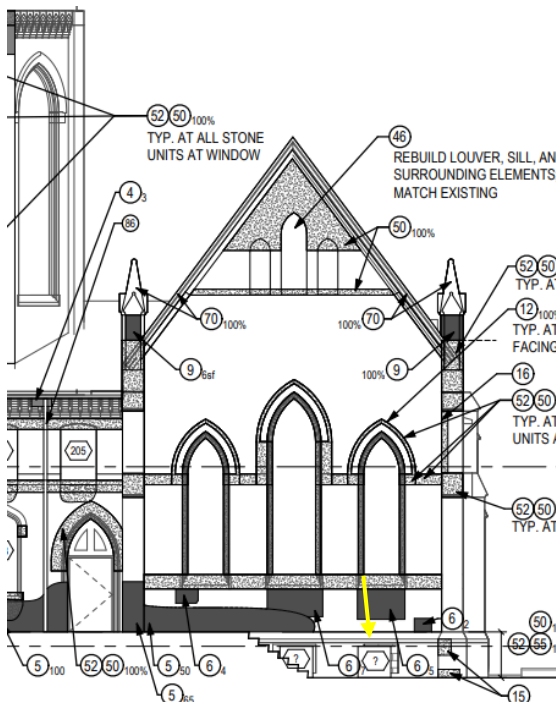
Proposed west elevation. Yellow arrow indicates location of window infill

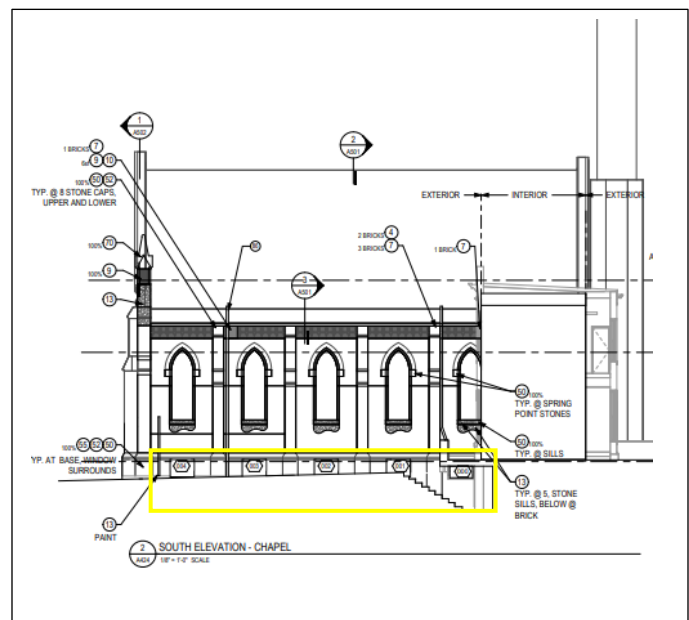
Proposed south elevation. Yellow box indicates location of window infill

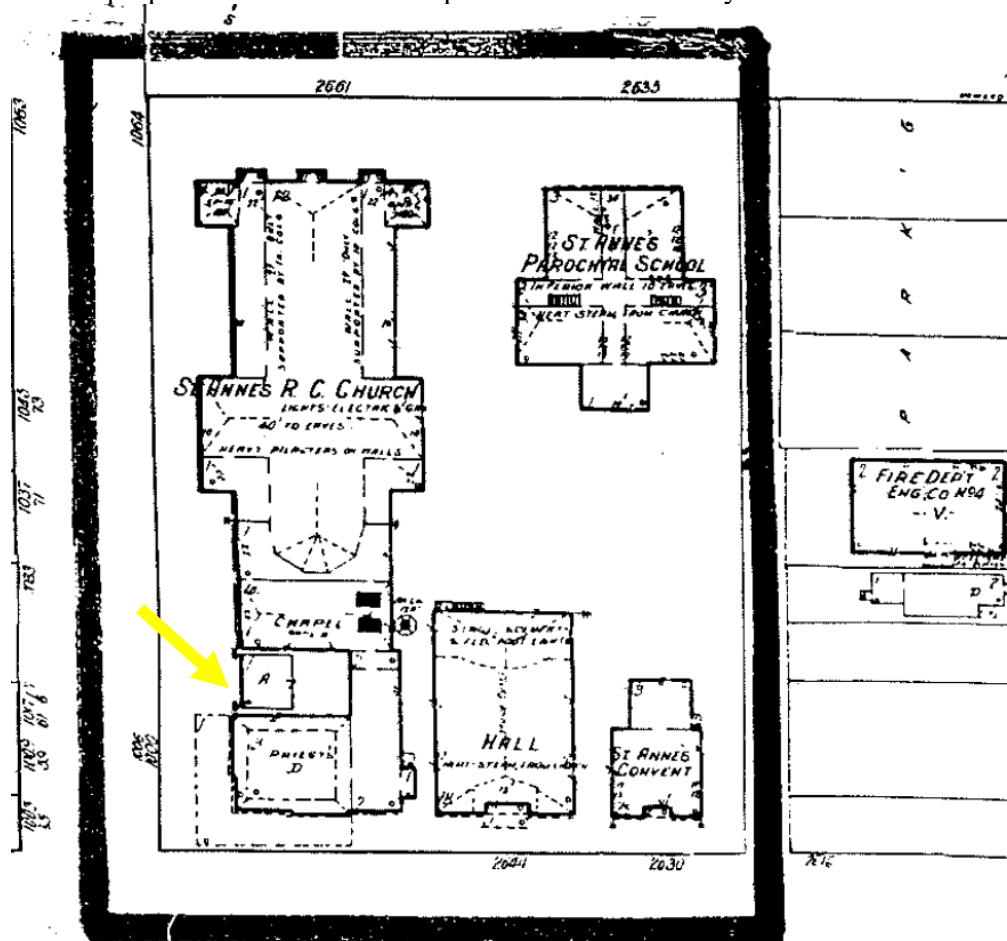
HDAB designation report map, yellow arrow indicating the location of the garage proposed for demolition

- With respect to the garage’s significance, note that the HDAB designation report [Ste. Anne's Parish Complex HD Final Report.pdf](#) clearly states that “...all structures within the boundaries contribute to the historical and/or architectural character of the district.” The report also briefly references the garage, stating that it is located “...between the chapel and rectory” and is a “...two-car garage of tapestry brick and trim.” The below map, excerpted from the designation report, outlines the district boundaries and the footprints of the buildings located within, to include the garage. The garage is contributing to the district as it is located within the district’s boundaries, it retains its integrity of location, setting, design, materials, workmanship, feeling and association to a good degree, and it does not appear to be deteriorated to an extent that merits its demolition. It is therefore staff’s opinion that its proposed demolition and replacement with a courtyard does not meet the Standards.

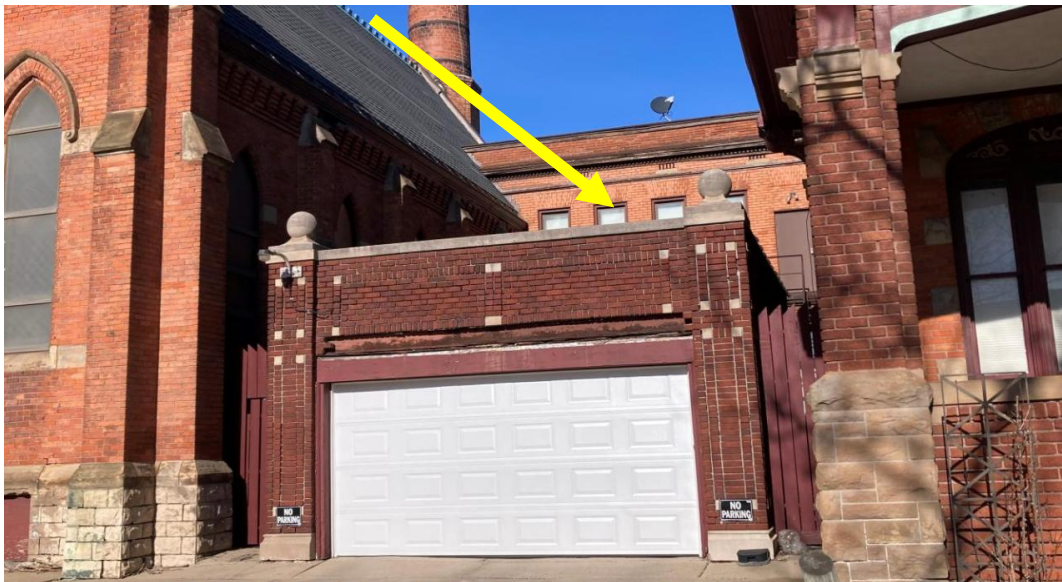
Garage proposed for demolition (yellow arrow). Basilica building(chapel wing) is to the left and Rectory is to the right. Photo by staff

- It is staff’s opinion that the garage plays a role in the wall of continuity along Ste Anne Street (see the below photo) and that it does display architectural ornamentation “typical of a building of a public character.” Therefore, its removal would not conform to the district’s Elements of Design

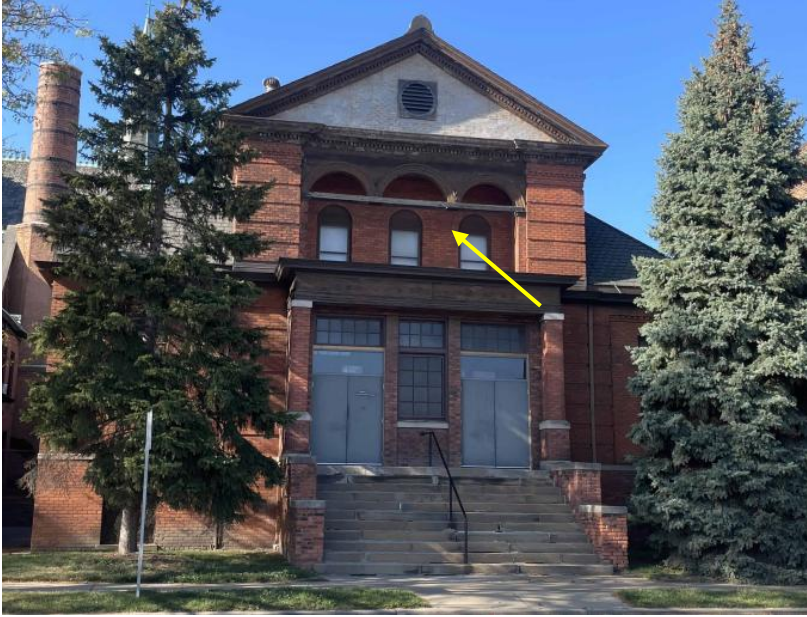
**Parish hall, current appearance. Photo by applicant. Arrow to indicate location of proposed new columns to replace missing historic elements**

- The application proposes to install two new urethane/synthetic columns at the front porch, second story, to replace the missing columns which were originally present at that location (see below). The design of the columns will be based upon a photo of building obtained from the property’s National Register of Historic Places (NRHP) nomination, which was completed in 1976 (see the below). Staff supports this proposal, but recommends that product cut sheets for the columns be submitted for review and approval so that staff might ensure that the work is appropriate to the building’s historic appearance.

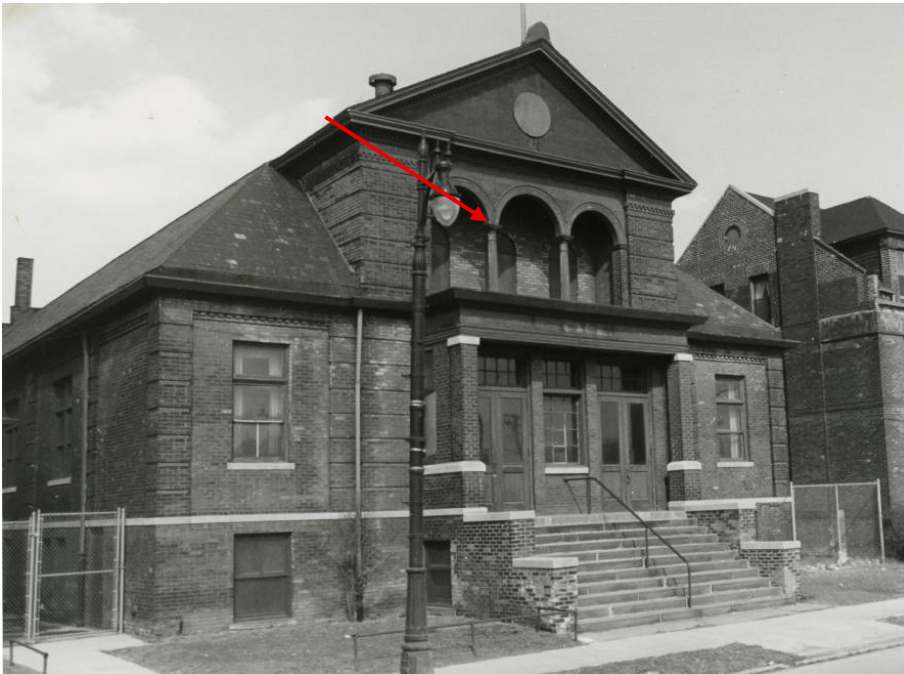
**Photo from the NRHP nomination, showing the historic columns at the second story porch which are currently missing and proposed for replication with new urethane columns (red arrow)**

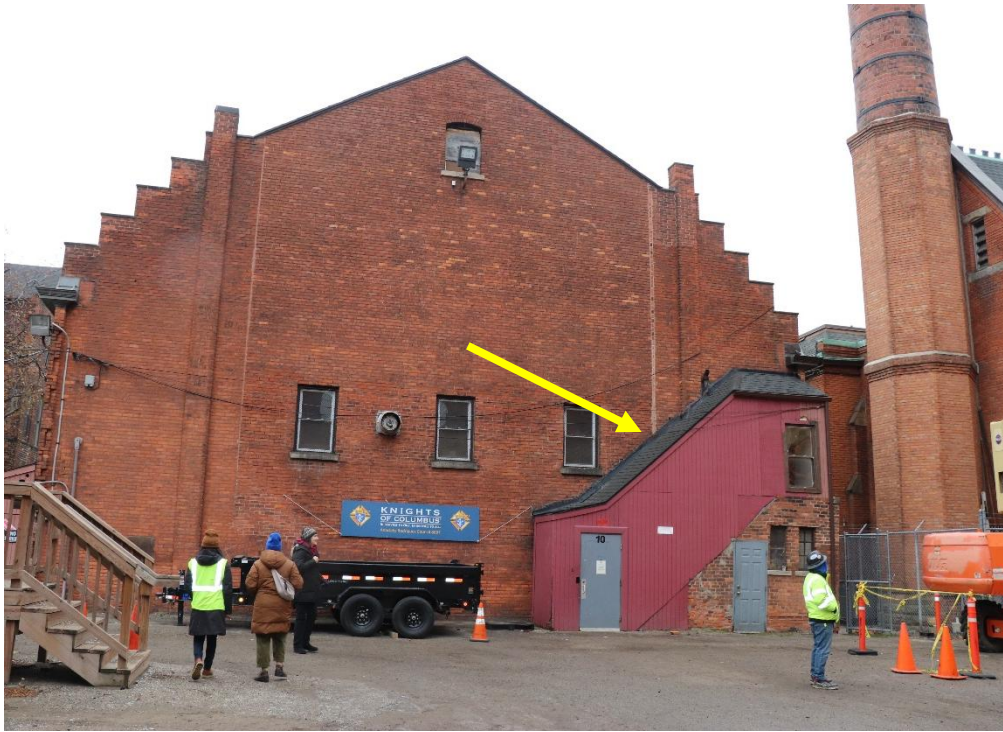
The rear of the Parish Hall, showing the enclosed staircase proposed for removal (yellow arrow). Staff does not find the enclosed staircase to be historic or character defining and does not object to its removal. (Staff photo, November 2025)

- Demolish rear stair enclosure and shed addition near northeast corner (see below). Staff does not find that these two additions are historic or character-defining and therefore supports their removal as they detract from the building's historic character.

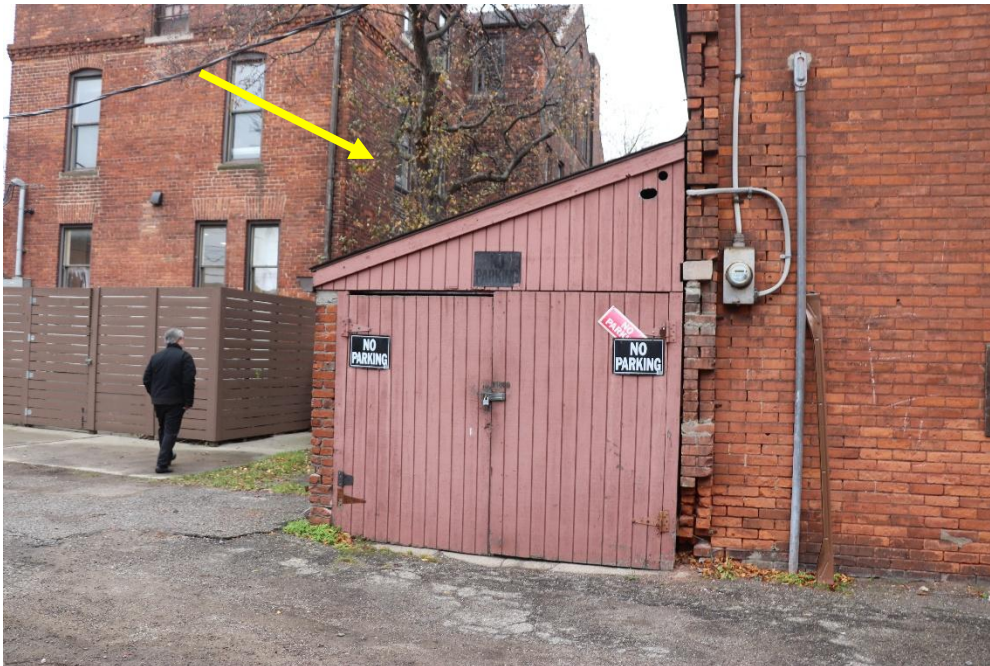
The shed addition at northeast corner proposed for removal (yellow arrow). Staff does not find this addition to be historic or character defining and does not object to its removal. (Staff photo, November 2025)

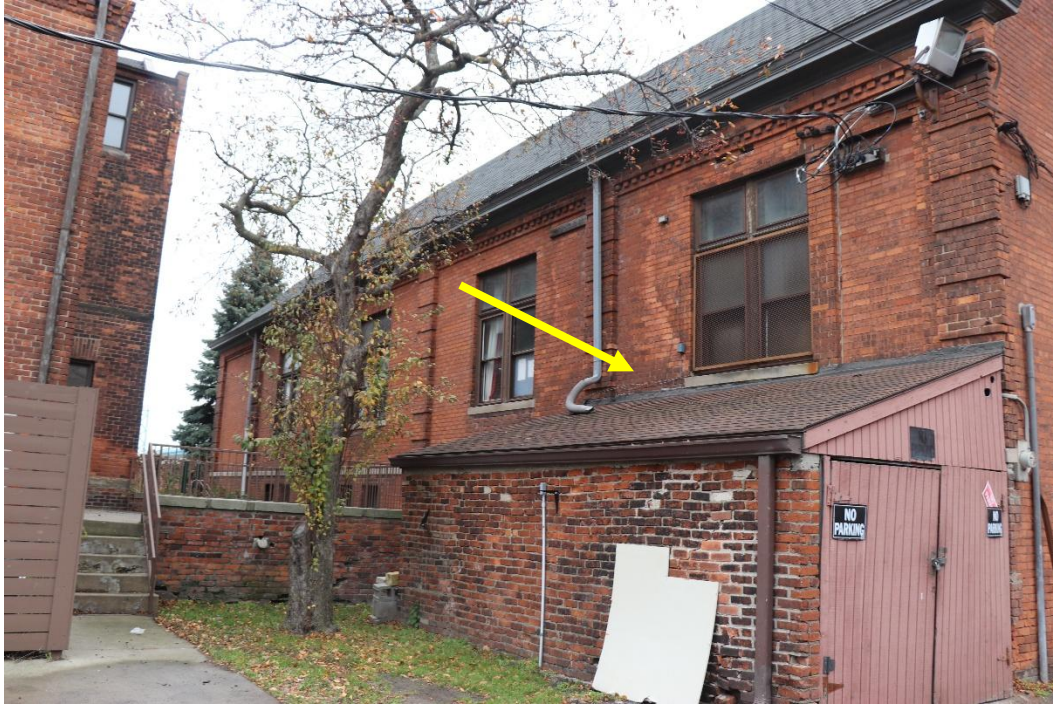
**The shed addition at northeast corner proposed for removal (yellow arrow). Staff does not find this addition to be historic or character defining and does not object to its removal. (Staff photo, November 2025)**

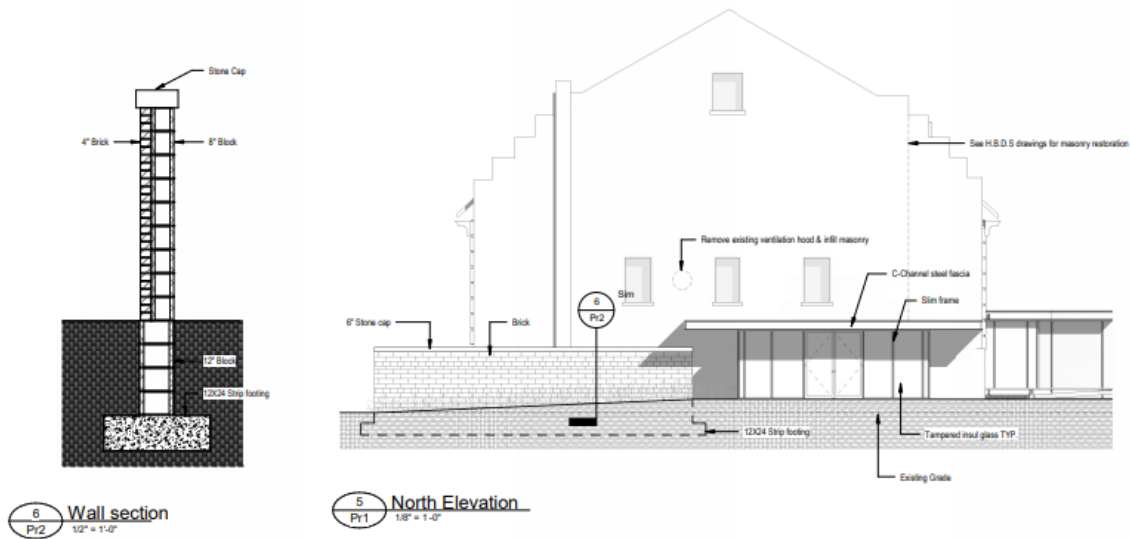
Drawings for the proposed screening wall and the new addition at the rear of the Parish Hall. Note the lack of details re: dimensions, materials and footprint. It is also not clear how the addition and wall will interact with Parish Hall and the Rectory building.

- This application proposes to install utility upgrades at the rear of the building, at the location of the non-historic stair enclosure and shed roof wing which are proposed to be demolished. A screening wall for the utility upgrades and a one-story addition which will connect the building to the Rectory, are also proposed at this location. See the below drawing that was submitted for this scope. It is staff's opinion that additional information/more dimensioned drawings and product cutsheets are needed in order to determine the compatibility of this work item. Specifically, the staff notes that the application is lacking in details re: dimensions, materials and footprint of the new wall and addition. Also, it is also not clear how the addition and wall will interact with Parish Hall and the Rectory building.

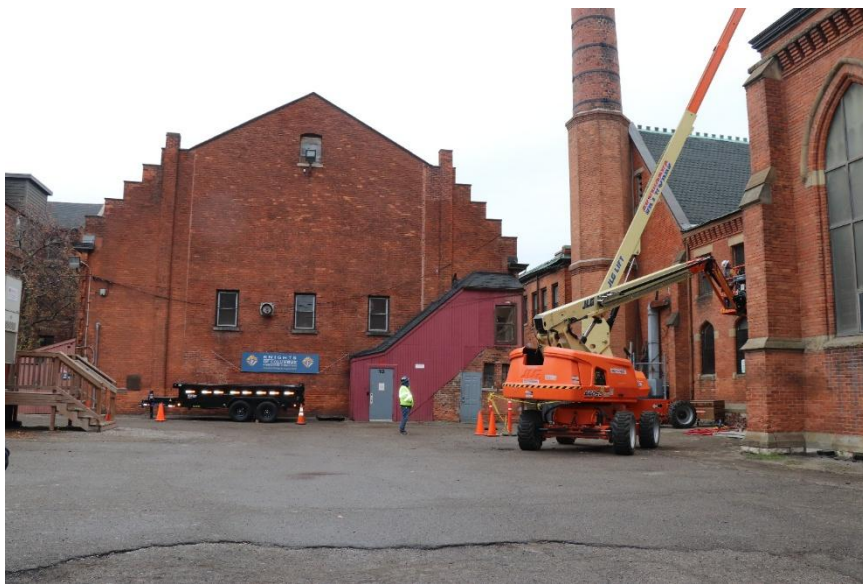
**View of the district's interior from between the Church and the School on the north end of the district looking south. Visible is the east side of the Church and Chapel on the right, the rear of the Parish Hall with the enclosed staircase on the rear, the Wellness Center to the left (east) of the Parish Hall, and also visible is the stair to the non-historic Lafayette Boulevard Portable to the left of the image. (Staff photo, November 2025)**

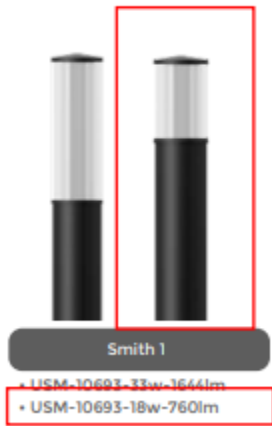
From applicant materials, LB1, custom lattice design will reflect liturgical theme

- See the below images of the proposed new light standards for the site. Note that none of the light elements will be affixed to buildings

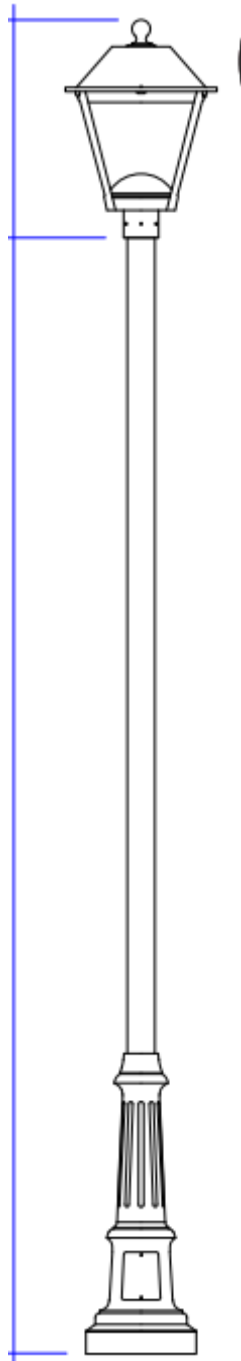
From applicant materials, LP1.

*wn with 12 ft. aluminu.  
alog #: SAL-3H-P-12'*
