STAFF REPORT: JUNE 10, 2020 MEETING

APPLICATION NUMBER: 19-6733

ADDRESS: 421 WATSON

**SCOPE OF WORK: REHAB BUILDING, EXPAND WINDOW OPENINGS,
REPLACE WINDOWS, RAISE ROOF LINE FOR CLERESTORY WINDOWS**

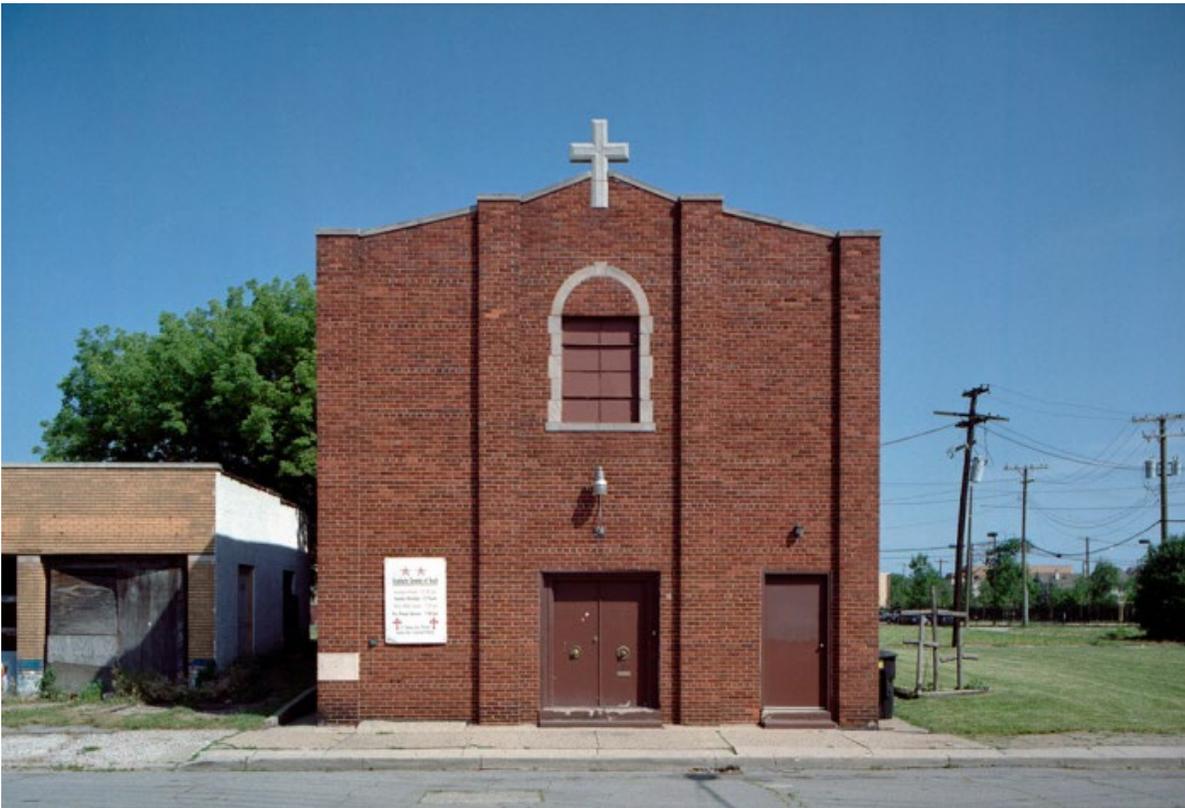
421 Watson a.k.a. Starlight Temple of Truth, 2007, photo by Kevin Bauman, [https://www.coroflot.com/kbauman/Detroit-
Small-Churches](https://www.coroflot.com/kbauman/Detroit-Small-Churches).

The modest, red-brick church located at 421 Watson was built in 1946. Once known as the Starlight Temple of Truth, this church closed around 2005 and the building has been vacant since. **This structure is one of three vacant buildings on an otherwise empty block** at the eastern edge of the Brush Park Historic District. In contrast to the surviving Victorian Mansions that dot the Brush Park landscape, 421 Watson is rather austere. Staff was unable to locate detailed information on the history of the congregation in Detroit, although the **Sanborn Maps indicate that it was constructed as an African American church**. Such small congregations of worship are typical and found across the city.

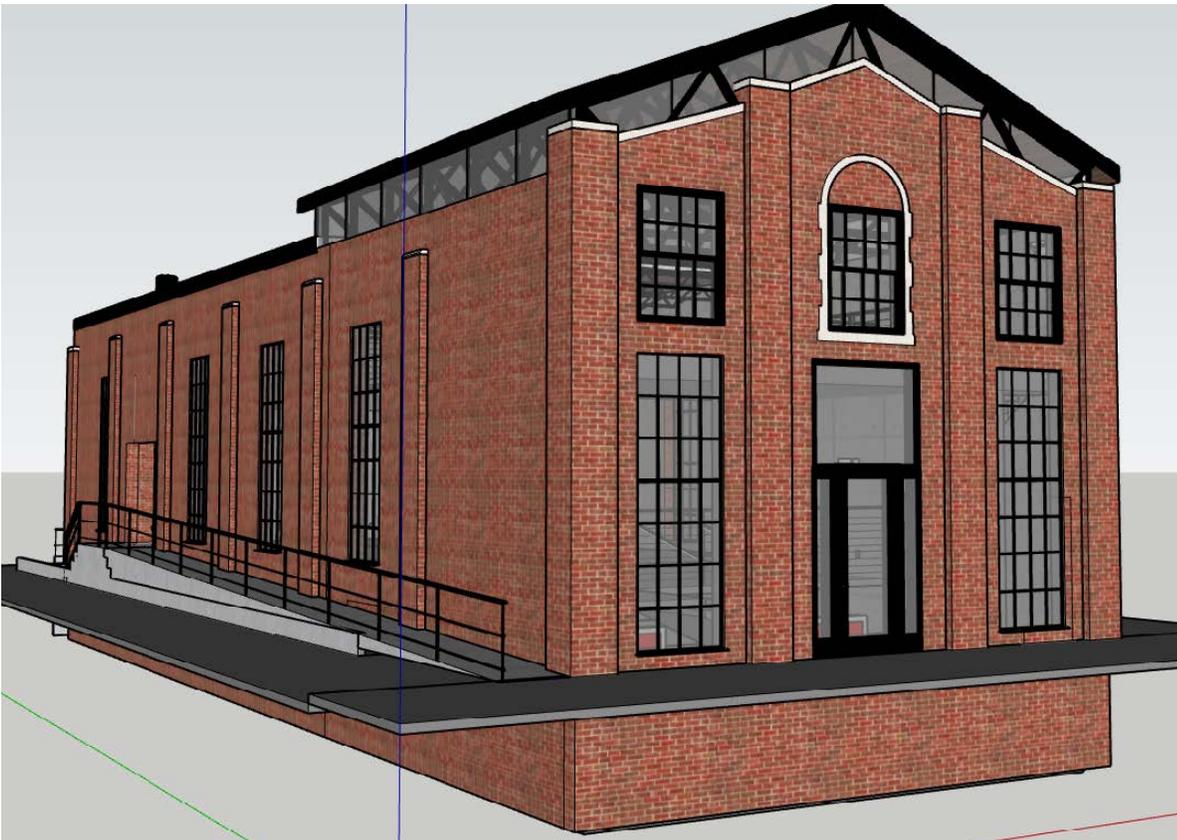
Rendering of proposed work for 421 Watson, supplied by applicant

- The applicant proposes to **install a new, metal gable style roof system** that will create a 2' band of new fenestration at the roof line.
- The **proposed gable roof will span approximately half the length of the building**, the flat portion of the roof will be replaced with typical EPDM membrane treatment.

While the proposed roof is of a contrasting form and material to the existing roof, it does follow the form of the character defining parapet. The adaptive reuse and modification of existing structures in Brush Park is not without precedent. It is staff's opinion that the roof proposal does not detract from any character defining features of the building and therefore recommends the Commission issue a Certificate of Appropriateness for this action based on Secretary of the Interior's Standards for Rehabilitation, specifically numbers 2) *The historic character of a property shall be retained and preserved. The removal of historic materials or alteration of features and spaces that characterize a property shall be avoided* and 9) *New additions, exterior alterations, or related new construction shall not destroy historic materials that characterize the property. The new work shall be differentiated from the old and shall be compatible with the massing, size, scale, and architectural features to protect the historic integrity of the property and its environment.*

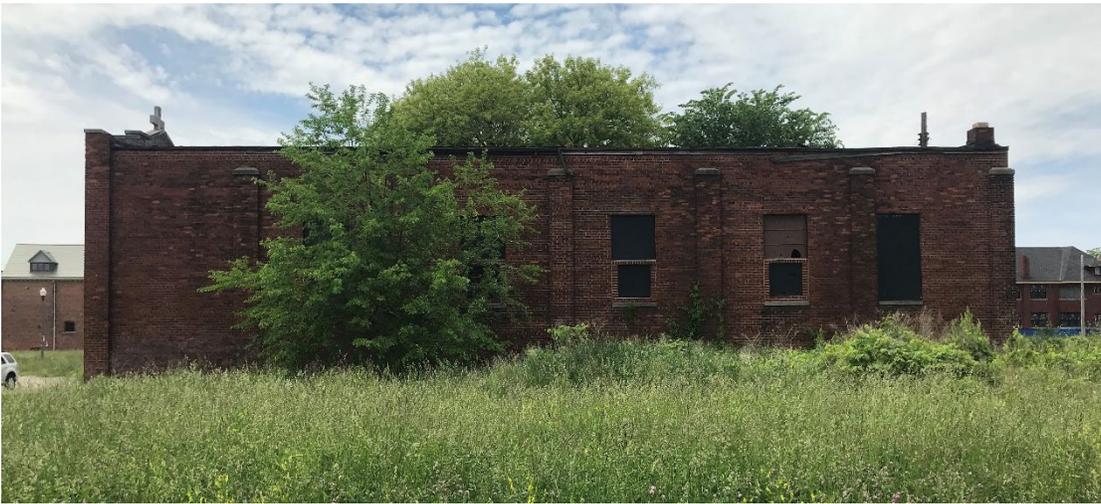
East Elevation, staff photo, 6/4/2020

The **east** and **west** sides of the building are clearly visible from Beaubien and Brush streets, respectively. Brick pilasters are present on the sides of the building, stopping just short of the roof and feature stone caps. The rhythm of the pilasters elevates the building form from a brick box into a place of worship with a modern nod to the classical church forms that were built with segmented construction and relied on buttressing. A doorway is located toward the rear on the west side. The rear of the building has four (4) windows with stone sills and steps leading toward a doorway in the basement.

Five (5) window openings are located in between the pilasters on both sides of the building and are covered in plywood and have been painted black. The applicant has submitted detailed materials that show **significant deterioration to all of the windows, many of them modified significantly from their original configurations**. A letter was also provided from a contractor that states “**we don’t see any way possible to restore the existing windows due to the frames deteriorating beyond the point of restoration**” and recommending replacement (as proposed in the scope of work). Most of the existing doors do not seem to be original based on photos provided.

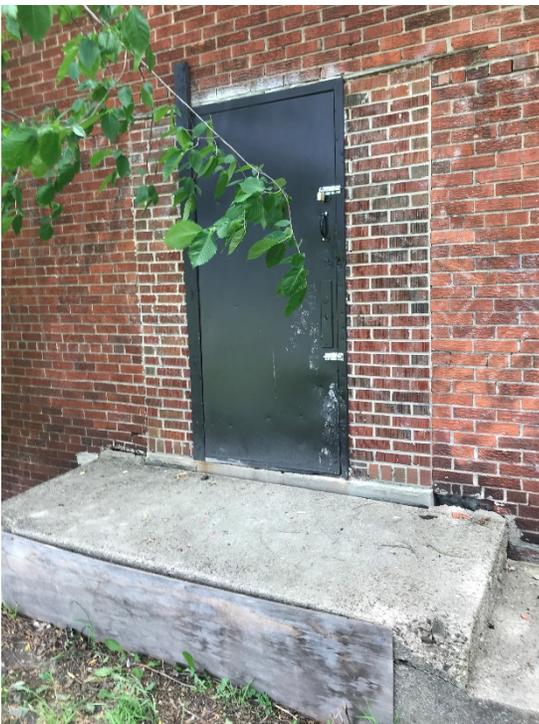
West Elevation doorway, staff photo, 6/4/2020

It is staff's opinion that expanding the doorway opening on the east and west facades will not result in the loss of any character defining features of the building at the south elevation. Staff recommends the Commission issue a Certificate of Appropriateness for these actions based on Secretary of the Interior's Standards for Rehabilitation, specifically numbers 2) *The historic character of a property shall be retained and preserved. The removal of historic materials or alteration of features and spaces that characterize a property shall be avoided* and 9) *New additions, exterior alterations, or related new construction shall not destroy historic materials that characterize the property. The new work shall be differentiated from the old and shall be compatible with the massing, size, scale, and architectural features to protect the historic integrity of the property and its environment.*

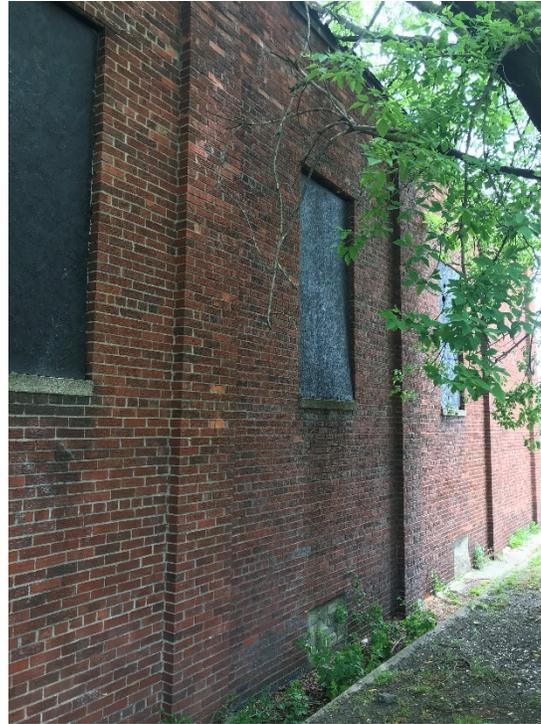
West Elevation staff photo, 6/4/2020

Install new ADA Ramp on West Elevation

- The applicant proposes to **install a new ADA ramp**. Exact dimensions, material and finish not specified.

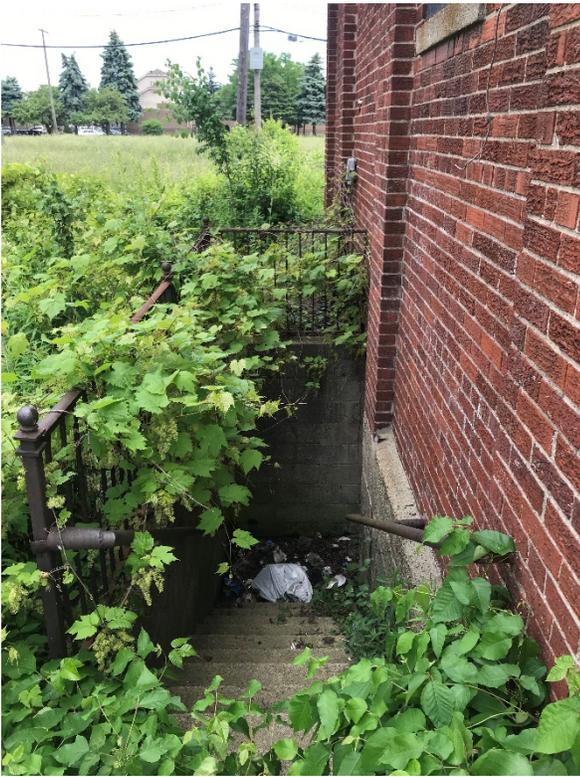
Rear staircase to basement door, staff photo, 6/4/2020
