STAFF REPORT 03-10-2021 MEETINGPREPARED BY: G. LANDSBERGAPPLICATION NUMBER: 21-ADDRESS: 1444-1448 BROOKLYN, 1259 LABROSSE, 1309 LABROSSEADDRESS: 1444-1448 BROOKLYN, 1259 LABROSSE, 1309 LABROSSEHISTORIC DISTRICT: CORKTOWNAPPLICANT: JOHN P. BIGGAR/INTEGRITY BUILDING GROUPDATE OF COMPLETE APPLICATION: 02-12-2021DATE OF STAFF SITE VISIT: 02-03-2021DATE OF STAFF SITE VISIT: 02-03-2021

SCOPE: REHABILITATE EXISTING PARKING LOT, ESTABLISH NEW PARKING LOT TO INCLUDE ADDITION OF CURB CUTS

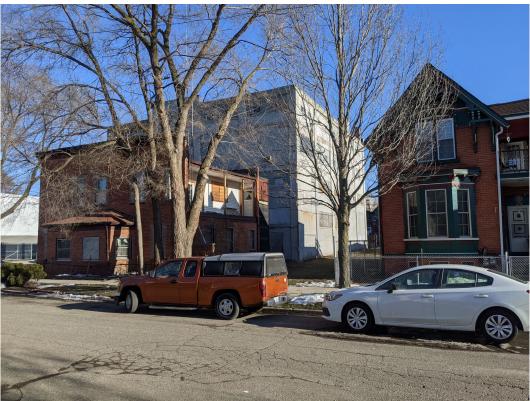
View of vacant lot at 1309 Labrosse (roughly between trees), looking towards the southeast. The orange truck is parked at the approximate location of the proposed curb cut. Staff photo, February 26, 2021.

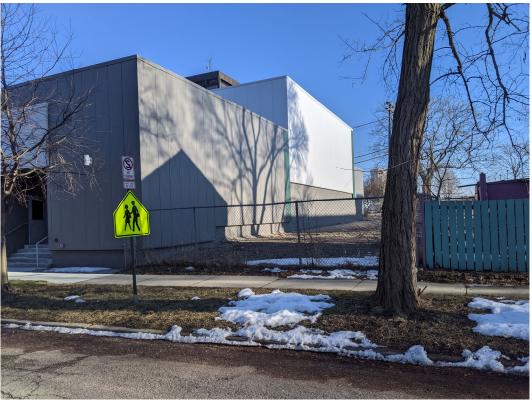
View of 1256 Labrosse (chain link fence) showing location of proposed curb cut. Staff photo, February 26, 2021.

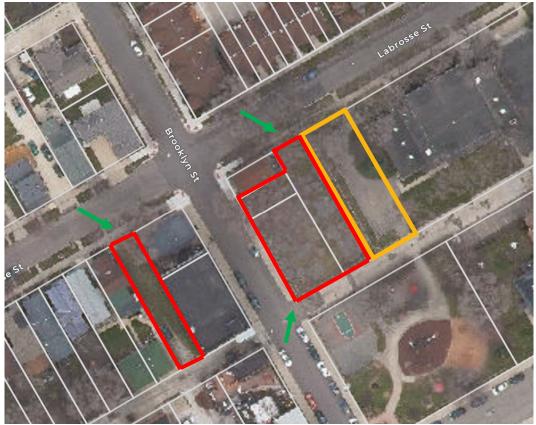
Parcel view of vicinity, with subject parcels outlined in red. The parcel outlined in yellow, 1245 Labrosse, is now occupied by an addition to the adjacent school, approved by the Commission in 2018. Green arrows indicate photo locations of the previous three images.
