ADDRESS: 92 E. FOREST**APPLICATION NO: #22-7853****HISTORIC DISTRICT: SUGAR HILL/JOHN R MUSIC AND ARTS****APPLICANT: JEFF KLATT (ARCHITECT)****OWNER: NEIL CHECK****DATE OF STAFF SITE VISIT: 5/27/2022****DATE OF PROVISIONALLY COMPLETE APPLICATION: 5/14/2022****SCOPE: REPLACE DOORS, WINDOWS & SLATE ROOF****EXISTING CONDITIONS**

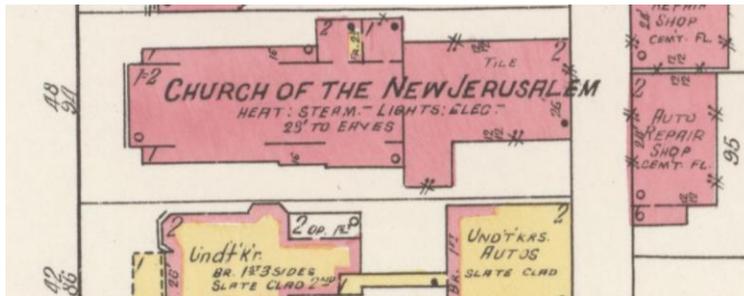
92 E. Forest, current conditions

The building located at 92 E. Forest is a church that was erected in 1915 to house the New Jerusalem (Swedenborgian) congregation. See the below Sanborn Map which indicates that the gabled-roof portions of the building and the side/east elevation, flat-roof wings had been erected by 1921. By 1950, the rear flat-roof portion of the building had been erected and the New Grace Baptist Church congregation had purchased the property. The northern mass/sanctuary has a slate roof while asphalt shingles are located at the rear, gabled-roof addition and the shed-roof, one-story additions at the east and west elevations. The material at the east elevation, flat-roof wings is an asphalt roll. Red brick clads the walls of the building's northern mass and the rear/southwest addition, while stucco walls are located at the southernmost rear gabled portion. The large fixed arched original windows at the building's sanctuary remain at the east, west and north elevations but are covered with wood panels. All other windows are 1/1, double hung wood units. The building's original, monumental front/north elevation doors have been removed and the opening has been enclosed with plywood. A single door has been added within the plywood. A masonry accessible ramp at the west elevation leads to a secondary set of paired, non-historic metal doors.

Sanborn Fire Insurance Maps, 1921

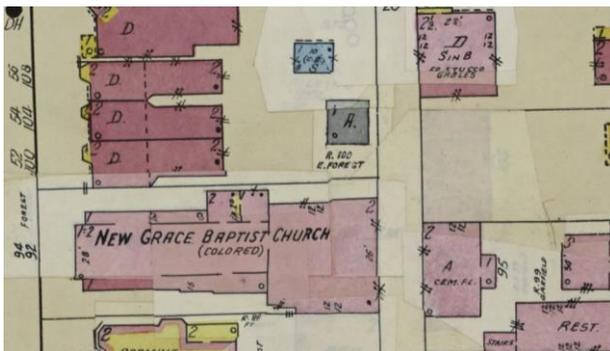
Sanborn Fire Insurance Maps, 1950
