STAFF REPORT: NOVEMBER 16, 2022 MEETING

APPLICATION NUMBER: 22-8101

ADDRESS: 47 WATSON (3100 WOODWARD)

SCOPE: ERECT OUTDOOR DINING STRUCTURE

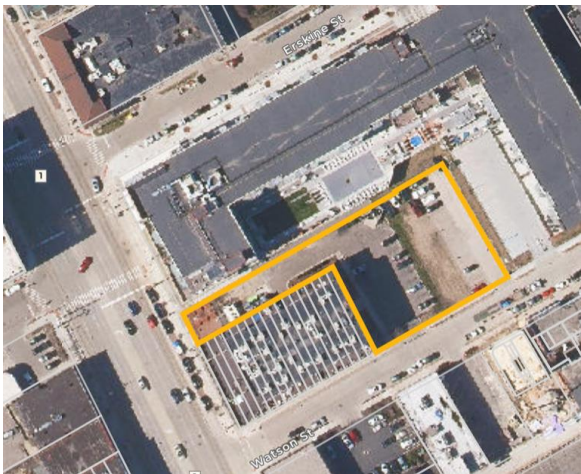
47 Watson is outlined in yellow. 3100 Woodward is at the corner Building at Watson and Woodward. Image from Detroit Parcel Viewer

The parcel for 47 Watson wraps around the parcel at the northeast corner of the Woodward/Watson intersection. The portion of the lot facing Watson is a surface parking lot. The narrow band extending west to Woodward includes a patio at the sidewalk and ancillary uses to the rear/east for the Bakersfield restaurant located within the building at 3100 Woodward.

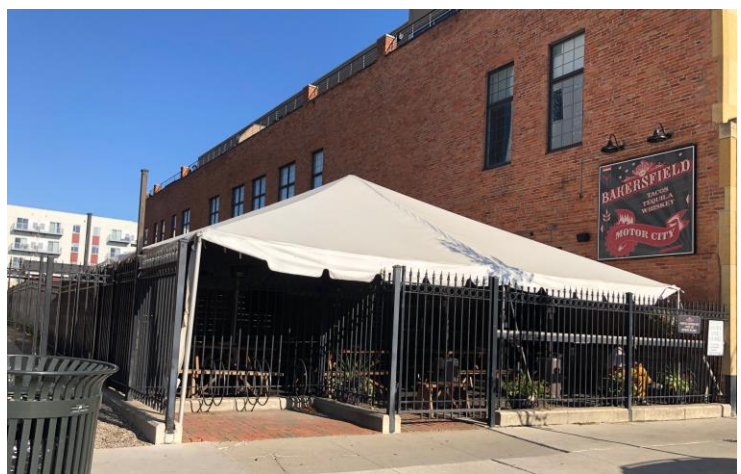
Staff photo, October 21, 2022

The patio is enclosed with an aluminum fence and full-height gate (facing the sidewalk); a recessed area with a bike rack fills the remaining frontage. Horizontal boards cover the fence spindles to further enclose the patio, all of which is covered by a white tent supported by silver-finished posts. Wood picnic tables, a free-standing bar, and counter-height ledge (adjacent the street-facing fence) fill the interior space. Portable heaters and string lights (for which two metal poles were installed with concrete footings) are the remaining patio elements. The existing tent and supporting elements were approved as part of the COVID-19 outdoor dining procedures.

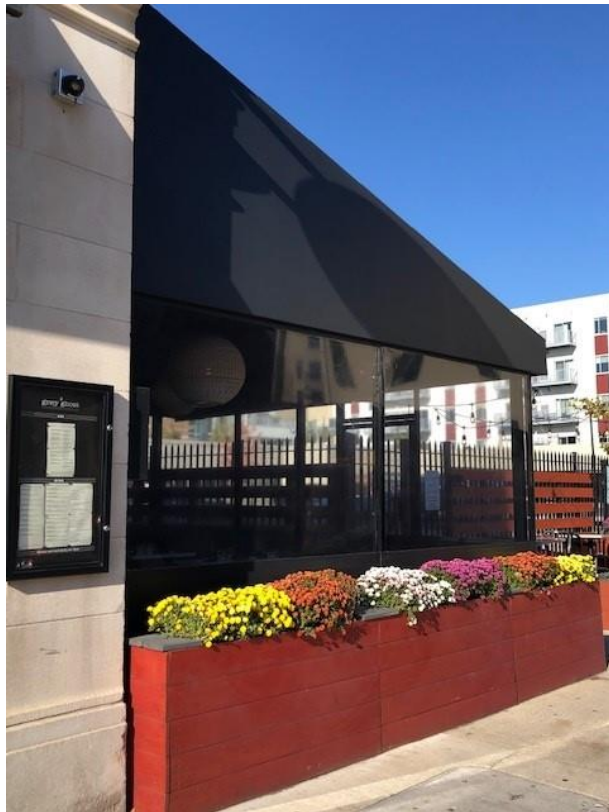
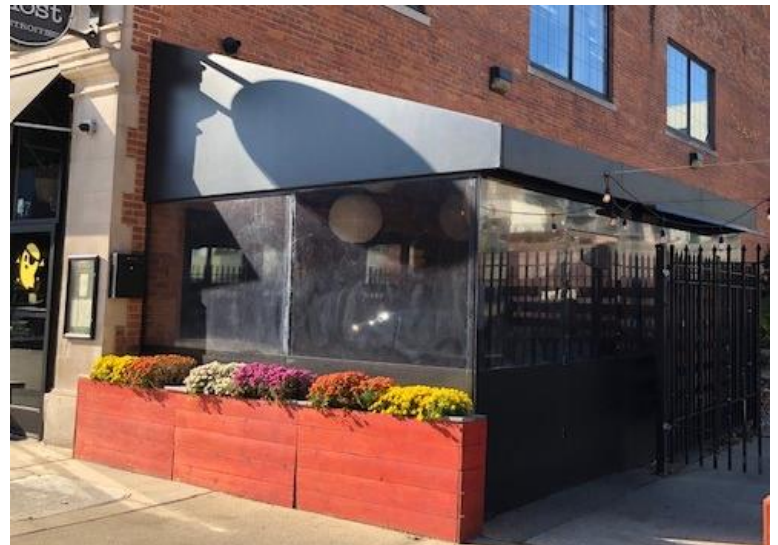
- The location is at the rear elevation, off a side street, and recessed from the building's corner.
 - The upper walls are completely transparent, the only visible framing are two corner posts that are bolted to the concrete floor. BSEED issued an awning permit for this installation.

*Above and top right: Patio walls in place.
HDC staff photos, October 25, 2022.*

*Right: Open patio.
Google street view image, August 2021*

- The applicant references that the current proposal is similar to the installation at Grey Ghost. It is staff's opinion there are many differences between the two projects. The pictures below are of the Grey Ghost installation, which was approved by staff in early 2021.

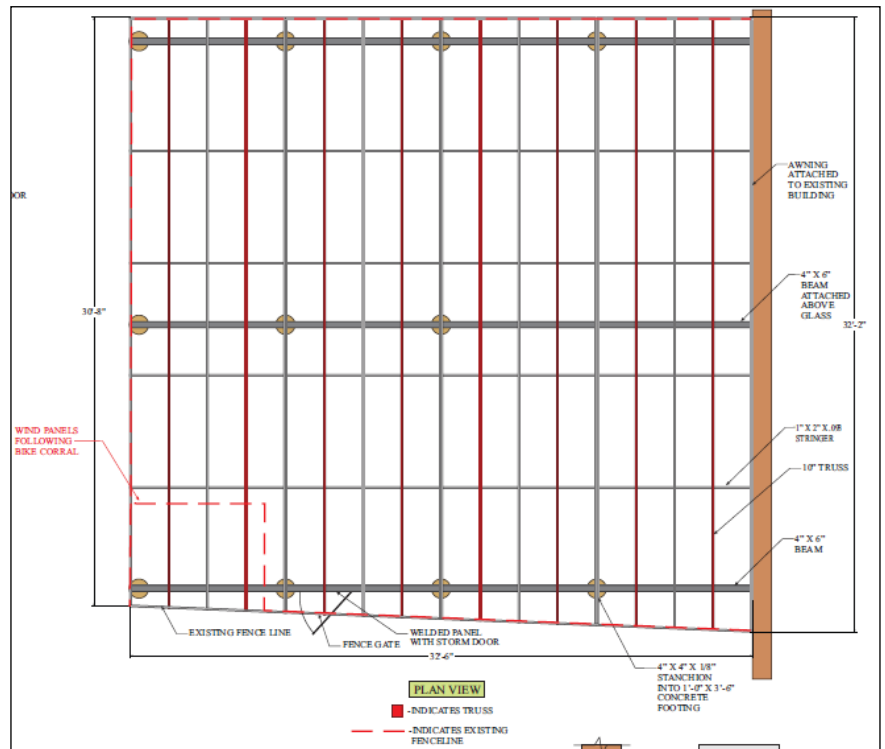
Right: Applicant's site plan showing the interior circulation.

o The 2020 COVID Certificate of Appropriateness approved moveable seating. The submitted site plan shows “stadium seating” (details on method of construction and material/finish is needed) while existing conditions show an erected bar at the SE corner and a counter height table at the west (fence) elevation.

The actual site conditions are inconsistent with the site plan we submitted. Please see updated site plan showing the current type and number of seating.

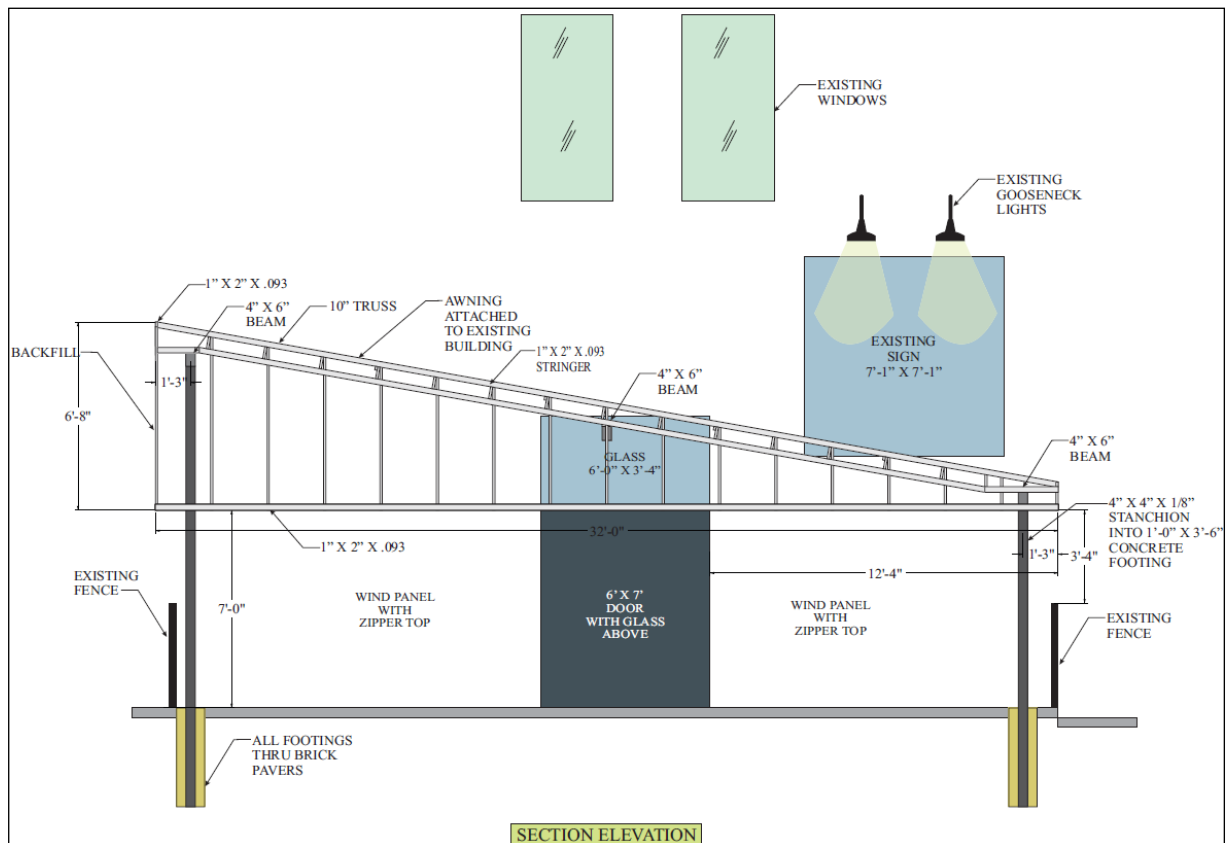
Below: Applicant's section drawing set against the exterior components of the north side of 3100 Woodward.

- The Building Department determined this application is a structure due to the 4 x 3 column grid for support.
- As this proposal is for a permanent structure, it must be reviewed within the context of a new building, which is why this application falls under “Applications subject to public hearing”. Therefore, staff has reviewed the proposal on how well it fits within the existing district and conforms to the Elements of Design.

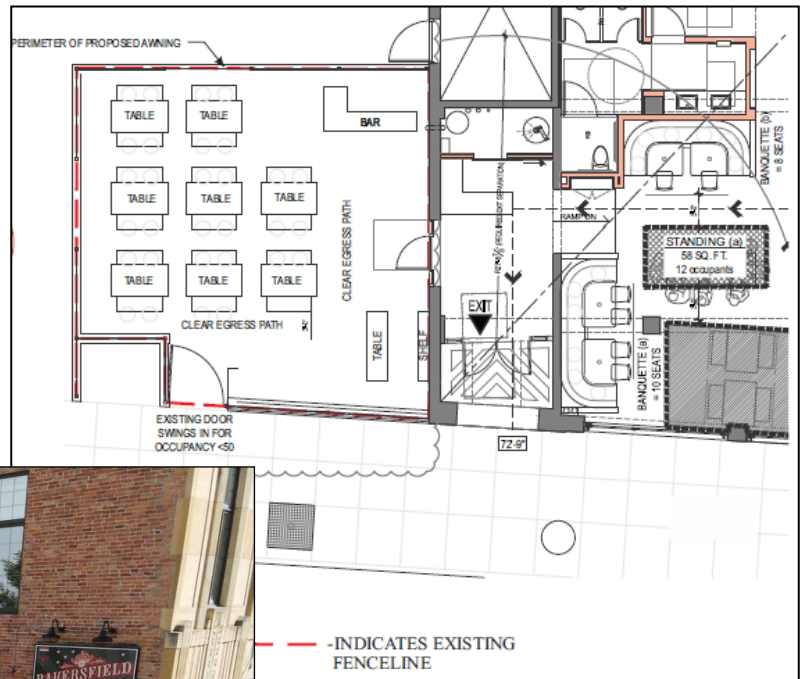
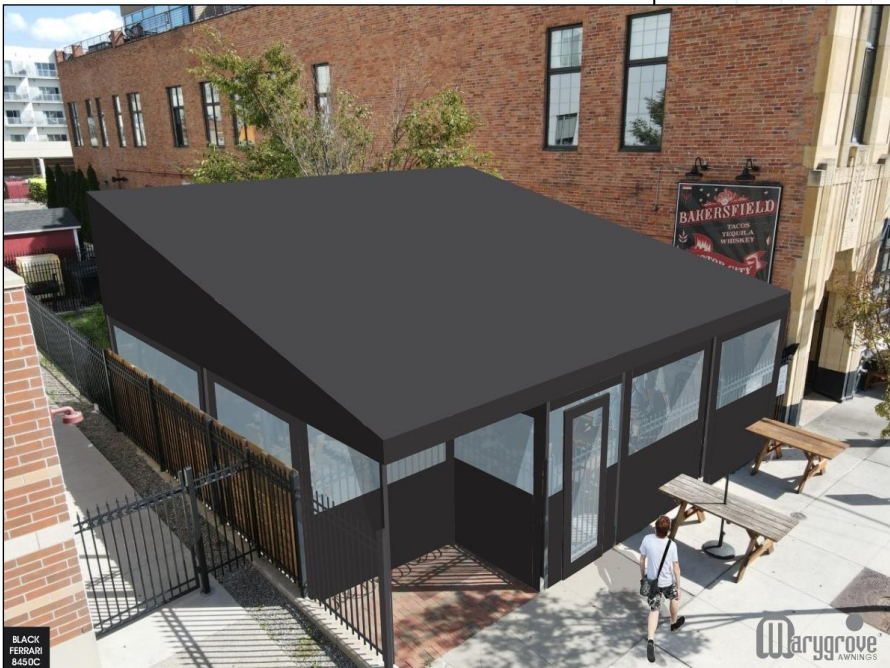
Applicant documents.

Erect a 32'-6" x 31'-6" welded frame canopy over the existing outdoor patio area. Seasonal enclosure consists of fabric panel "walls" with clear vinyl sections. The vinyl sections can be rolled up and attached at the top by Velcro.
