STAFF REPORT: NOVEMBER 16, 2022 MEETING F APPLICATION NUMBER: 22-8105 ADDRESS: 4871 CORTLAND HISTORIC DISTRICT: RUSSELL WOODS-SULLIVAN APPLICANT: LINDA HRIBAR, WEATHERGARD WINDOWS PROPERTY OWNER: CAHUNTE & JOHN DAVIS DATE OF PROVISIONALLY COMPLETE APPLICATION: OCTOBER 17, 2022 DATE OF STAFF SITE VISIT: OCTOBER 25, 2022

# SCOPE: REPLACE WOOD WINDOWS WITH VINYL WINDOWS

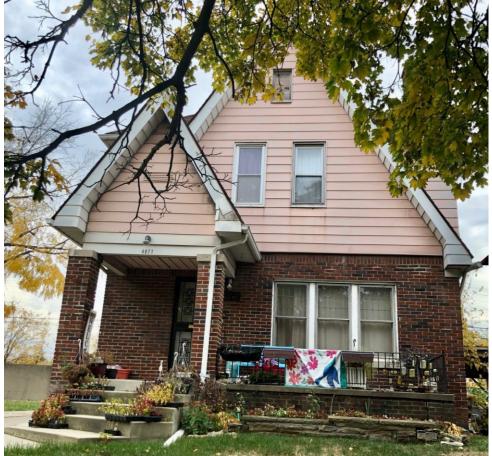
HDC staff photo, October 25, 2022

Erected in 1925, this Tudor Revival-style dwelling is clad in dark red and black brick at the first floor; pink and white aluminum siding at the second floor covers wood shake shingle siding (which is visible on the east wall where a portion of aluminum siding is no longer in place). The roofing material is dimensional asphalt shingles. A large front-facing gable fills the width of the primary elevation. A smaller gable, supported by square brick piers and stone tops, projects from the house and creates a vestibule for the front entry. Angled concrete steps lead from the front walk to the raised open porch. A low black railing runs the perimeter edges of the front and west sides of the porch.

Leaded glass wood windows are located on the front and side elevations. Three mulled double-hung units with a 15over-1 pattern fill the front elevation first-floor window opening, and a small casement (or fixed) 12-light (3 wide by 4 high) leaded glass unit remains at the upper area of the large gable. Small leaded glass window units are on each side of the house, near the front elevation. The remaining windows appear to be wood-framed double-hung units or white vinyl double-hung replacement units.

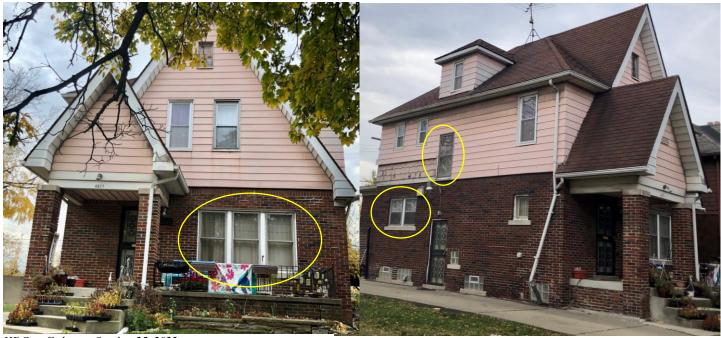
HDC staff photos, October 25, 2022

Replace six windows: five on the first floor, and one at the second floor. Openings are circled below.

- The Russell Woods-Sullivan Historic District was established in 1999.
- The three front elevation double-hung windows have a 15-over-1 pattern. The lead cames create a subtle division to the glass making the windows distinctive character-defining features. The aluminum-framed storm windows cover the wood frames but do not obscure the full historic sash.
- The windows on the side elevation proposed for replacement are one-over-one wood double-hung units and are covered with aluminum-framed storm windows that match the operation of the windows.
- The total price on the submitted window order is \$7843, which is roughly \$1300/window. A repair estimate from a company experienced in repairing wood frame and leaded glass windows was not submitted. Exterior and interior photographs show the six windows are fully intact and appear to be in good condition.

- The leaded windows give authenticity to the time of the dwelling's construction and can't be duplicated in any way by the proposed vinyl windows. Furthermore, the flat between-the -glass grids would take up so much space for a fifteen-light division that there would hardly be any visible glass surface in the upper sash of the front windows.
