STAFF REPORT: 2/8/2023 MEETING

ADDRESS: 1310 LABROSSE

HISTORIC DISTRICT: CORKTOWN

SCOPE OF WORK: CONSTRUCT SECOND STORY ON APPROVED GARAGE

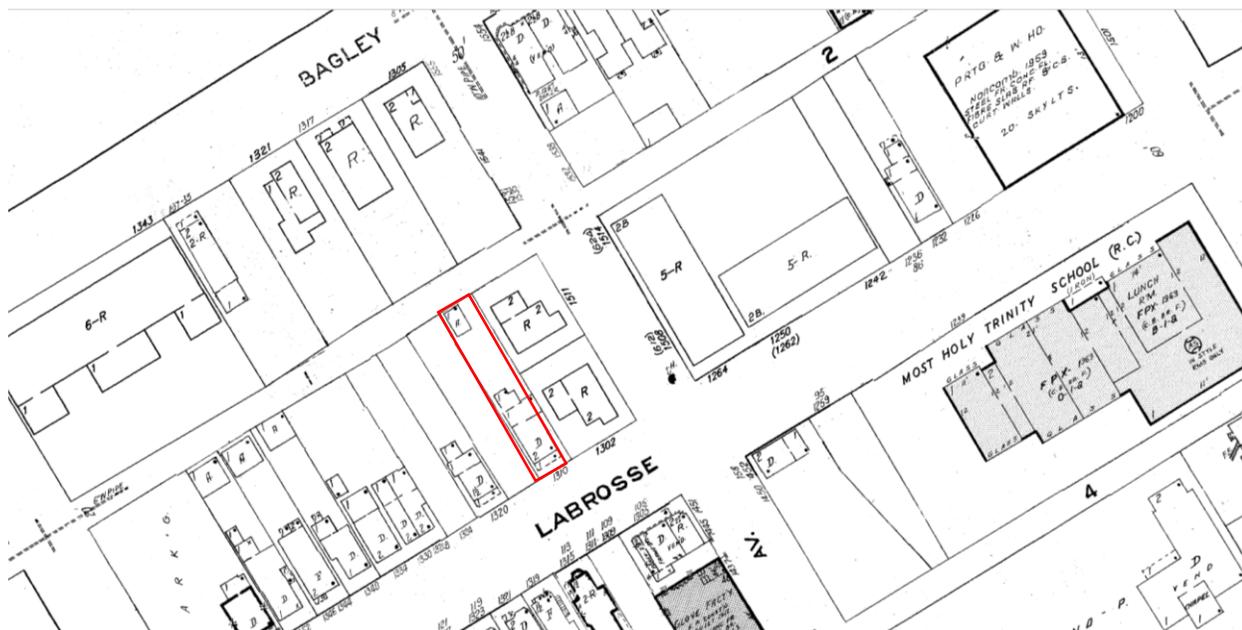
- A Sanborn Fire Insurance map from 1971 indicates that a garage had been extant in the rear yard, at the location of the proposed new garage. Currently, only a slab remains at this location. It is unclear to staff when the garage was demolished/if it was demolished prior to the district's designation

1310 Labrosse, Sanborn Map 1971

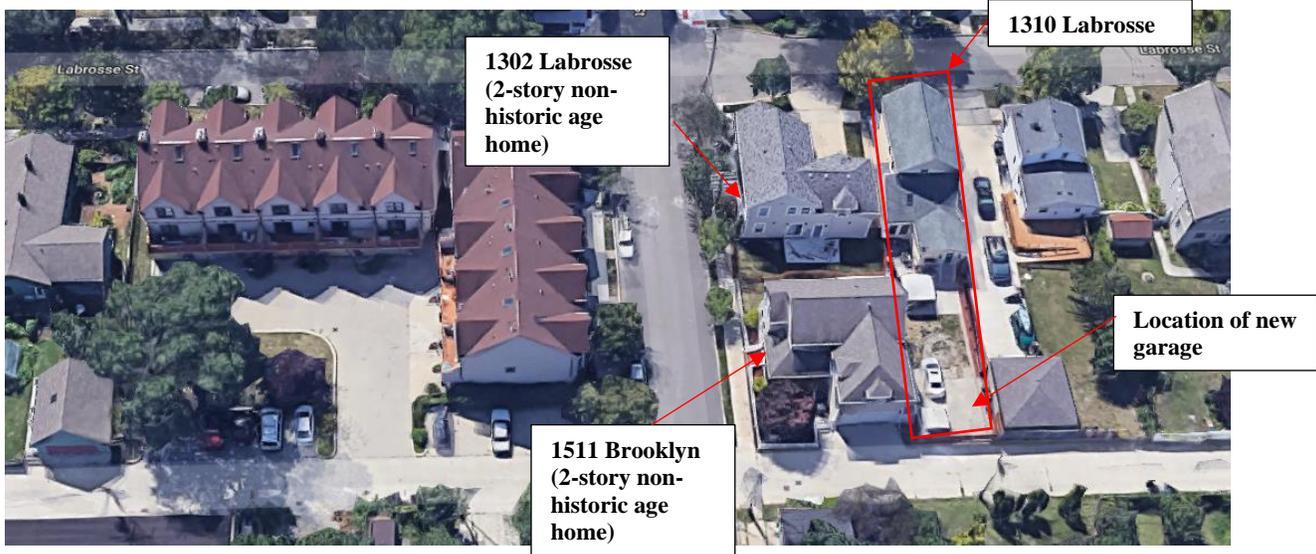
- The width of the new garage will be reduced by 2" vs the previously approved design. The depth of the new garage will increase by 1.6" vs the previously approved design. The height of the new design has been decreased by 1'-6".
- The new garage will be minimally visible from the public right of way due to the length of the home and the width of its rear additions, the close proximity of the home to the east of 1310

Labrosse (addressed as 1302 Labrosse), and the location of the 2-story home at 1511 Brooklyn (which largely blocks the view of 1310 Labrosse’s rear yard from Brooklyn) per the below aerial.

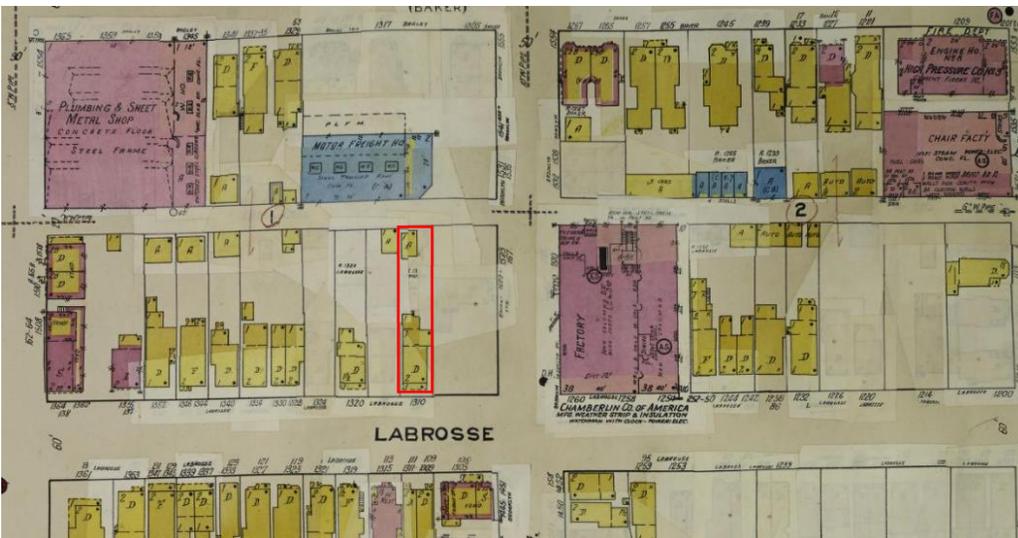
- The new garage will be located in roughly the same location as the existing concrete slab associated with the site’s former garage
- A review of historic Sanborn Maps indicate that a small, one-story garage was located in 1310 Labrosse’s rear yard as early as 1921. However, a review of Sanborn Maps of the wider neighborhood revealed that 1 ½-story and 2-story auxiliary buildings existed within rear yards in 1951 and earlier.

1310 Labrosse, Sanborn Map 1921 (revised in 1951)
