**STAFF REPORT: 3/8/2023 REGULAR MEETING**

**APPLICATION NUMBER: #23-8238**

**ADDRESS: 2200 (2600) EAST ATWATER**

**SCOPE: INSTALL SIGNAGE, ALTER LANDSCAPE**

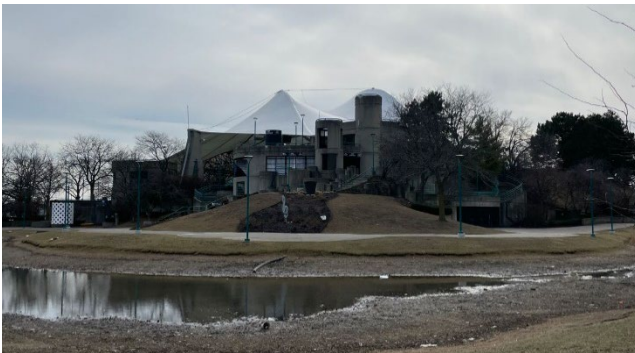
*Site Photo 1, by Staff February 20, 2023: (North) Front elevation, showing evergreens to be saved from demolition to the right.*

Figure 2, by applicant, illustrative proposed planting plan. Note that some of the existing evergreens at the top of the hill, marked "lawn" near the northwest side of the amphitheatre, have since been marked to be retained since staff met with the applicant this past week. This plan has not yet been updated to reflect this. (See site photo 1)

- Upon review of the initial application, the planting plan called for removal of nearly all evergreens along the west and northwest areas of the property. During the site visit, staff, the applicant and city staff studied the health of these trees and determined that a large population of the evergreens (Austrian pines and blue spruce) along the west edge of the property has communicable disease and were dying of needle cast and diplodia blight. However, towards the top of the hill, closer towards the more public vantage of Atwater, the stand of larger Austrian pines are

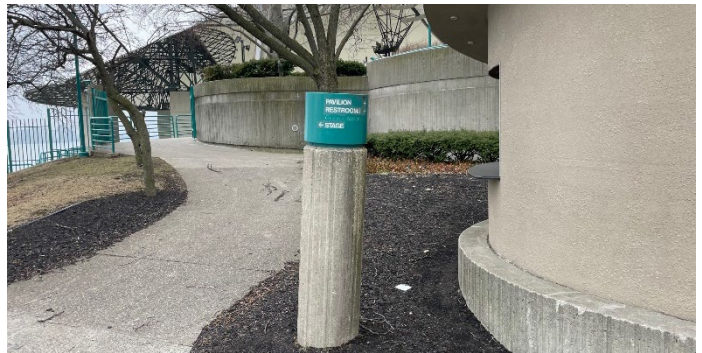
*Site Photo 2, by Staff March 2, 2023: (East) Pavilion entrance showing pylon #11 and distinctive character-defining concrete surface finish treatment that complements the architectural composition of the site.*

- It is staff’s opinion that the removal of the 4 concrete pylons (#2, #5, #7, #11) conflicts with the Elements of Design:
  - **7) Relationship of materials.** “The building materials are generally composed of concrete... Landscape elements, including sidewalk, planters and retaining walls, are concrete. Lighting fixtures outside the amphitheater area, benches, signage, and trash receptacles are metal mounted on concrete bases.”

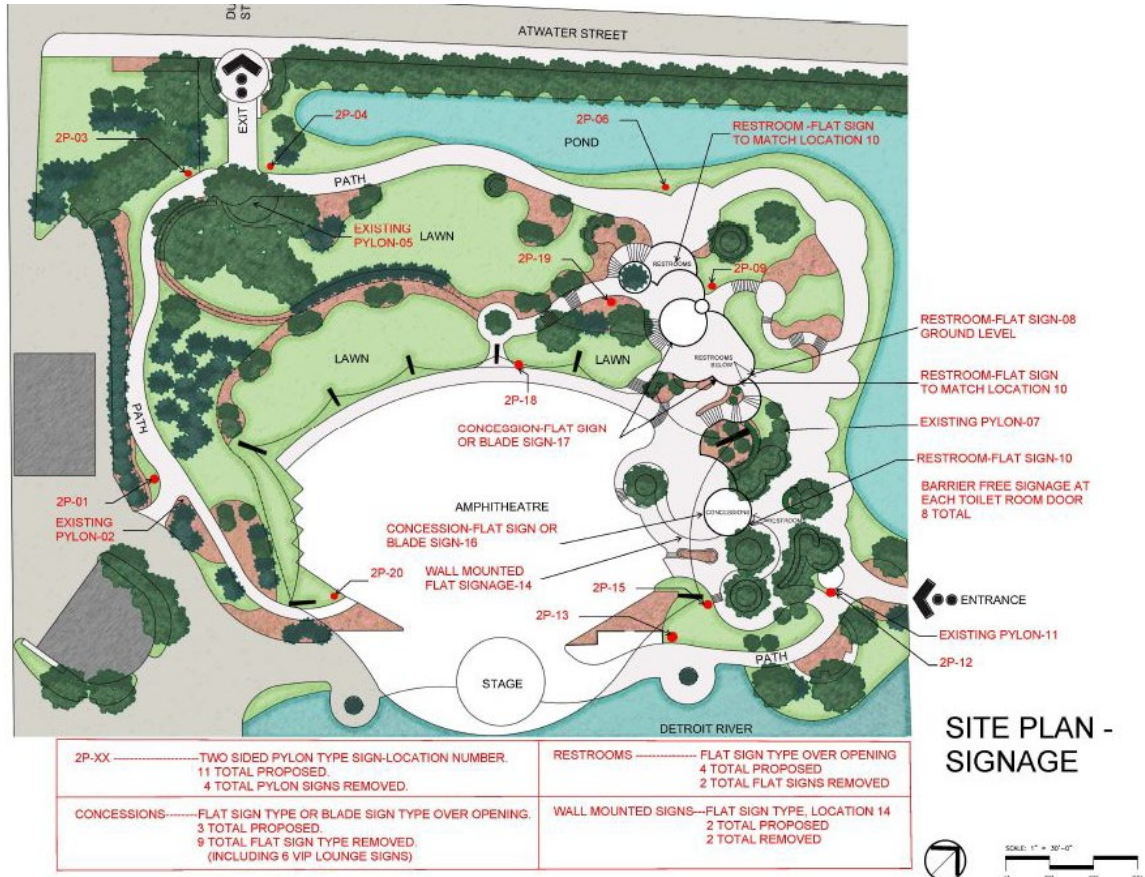
Figure 1 by Applicant: Signage Site Plan, showing totals and locations for proposed installation and removal of the four signage types.

1. Refurbishment of existing signage as described in HDC Sign Guidelines for those signs that are located at seating areas and original historic signs cast in walls as marked in the site plan.
2. Removal of signs as indicated in the site plan.
  - a. Removal of 4 concrete pylons indicated on the site plan as (#2, #5, #7, #11)
  - b. Remove 3 flat restroom signs
  - c. Remove 6 concession and VIP lounge signs
  - d. Remove 2 wall mounted restroom signs
3. Installation of new signs as indicated in the site plan

- a. Install 11 new pylons as indicated on the site plan.  
New pylon signs are 7' high, 16" diameter, with 10" wide banner 9" from the top of the exposed aggregate concrete material. The deep lagoon color sign will be either painted metal or composite with raised lettering to match existing site colors and elements. (See attached drawings.)

- b. Install 3 new flat restroom signs  
The 10" high by 10' long flat signs are painted metal or composite, color deep lagoon with raised letters to match existing site colors and elements.

- c. Install 3 concession flat or blade type signs over concession openings  
The 1" thick metal or composite sign is two-faced, 2' 5" diameter, with black metal 6" support between the sign faces. Color to be deep lagoon with raised letters to match existing site elements. These will be mounted above concession venues as shown in the sign plan.

- d. Install 2 wall mounted restrooms signs  
Door/wall mounted signs are 8" by 9" in size painted metal or composite, color to be deep lagoon with raised letters and braille to match existing site elements. To be placed at pedestrian information scale as shown in the sign plan.

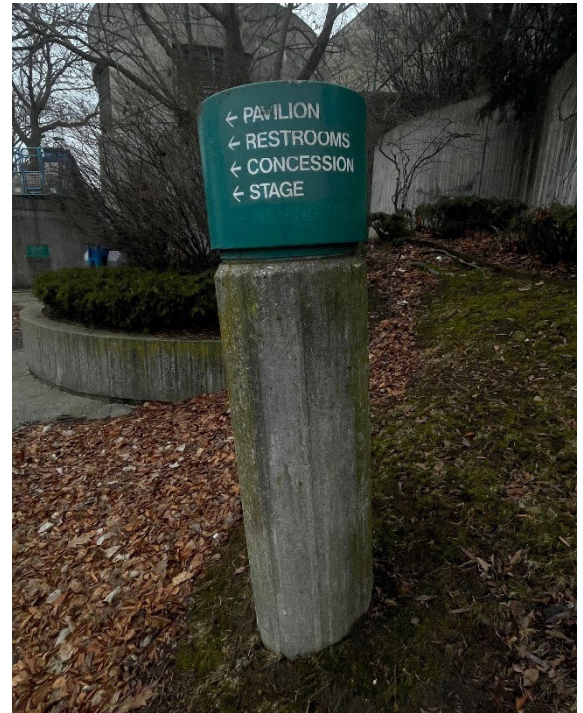
*Site Photo 3, by Staff March 2, 2023: (East) near restrooms showing pylon #7 and how the striating concrete is aging like the surrounding concrete walls and complements the patterns of the surrounding landscape.*

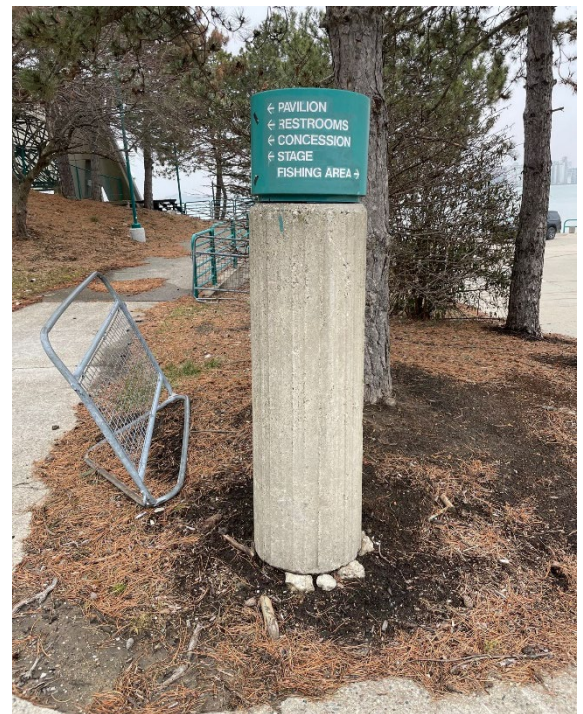
*Site Photo 4, by Staff March 2, 2023: (West) Pavilion entrance showing pylon #2 and evergreens in the background that are proposed to be replaced due to disease.*

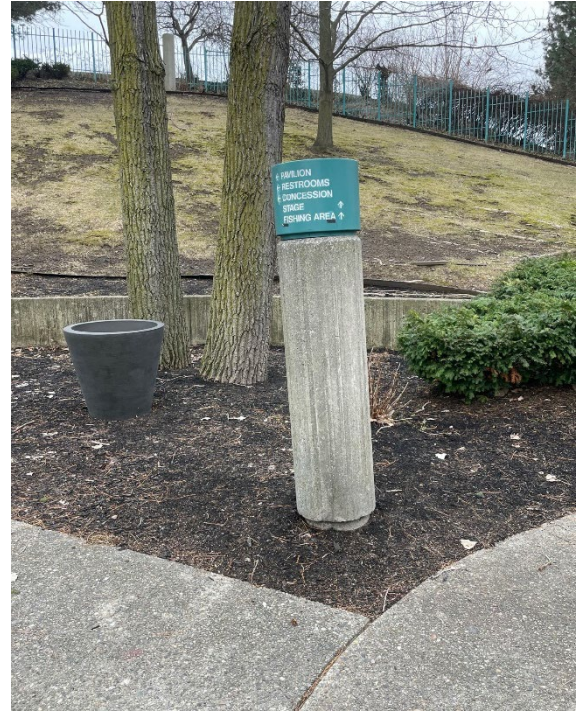
Site Photo 5, by Staff March 2, 2023: (North) entrance showing pylon #5.
