STAFF REPORT 05-10-2023 MEETING

APPLICATION NUMBER: 23-8325

ADDRESS: 2998 IROQUOIS

SCOPE: ERECT HOUSE

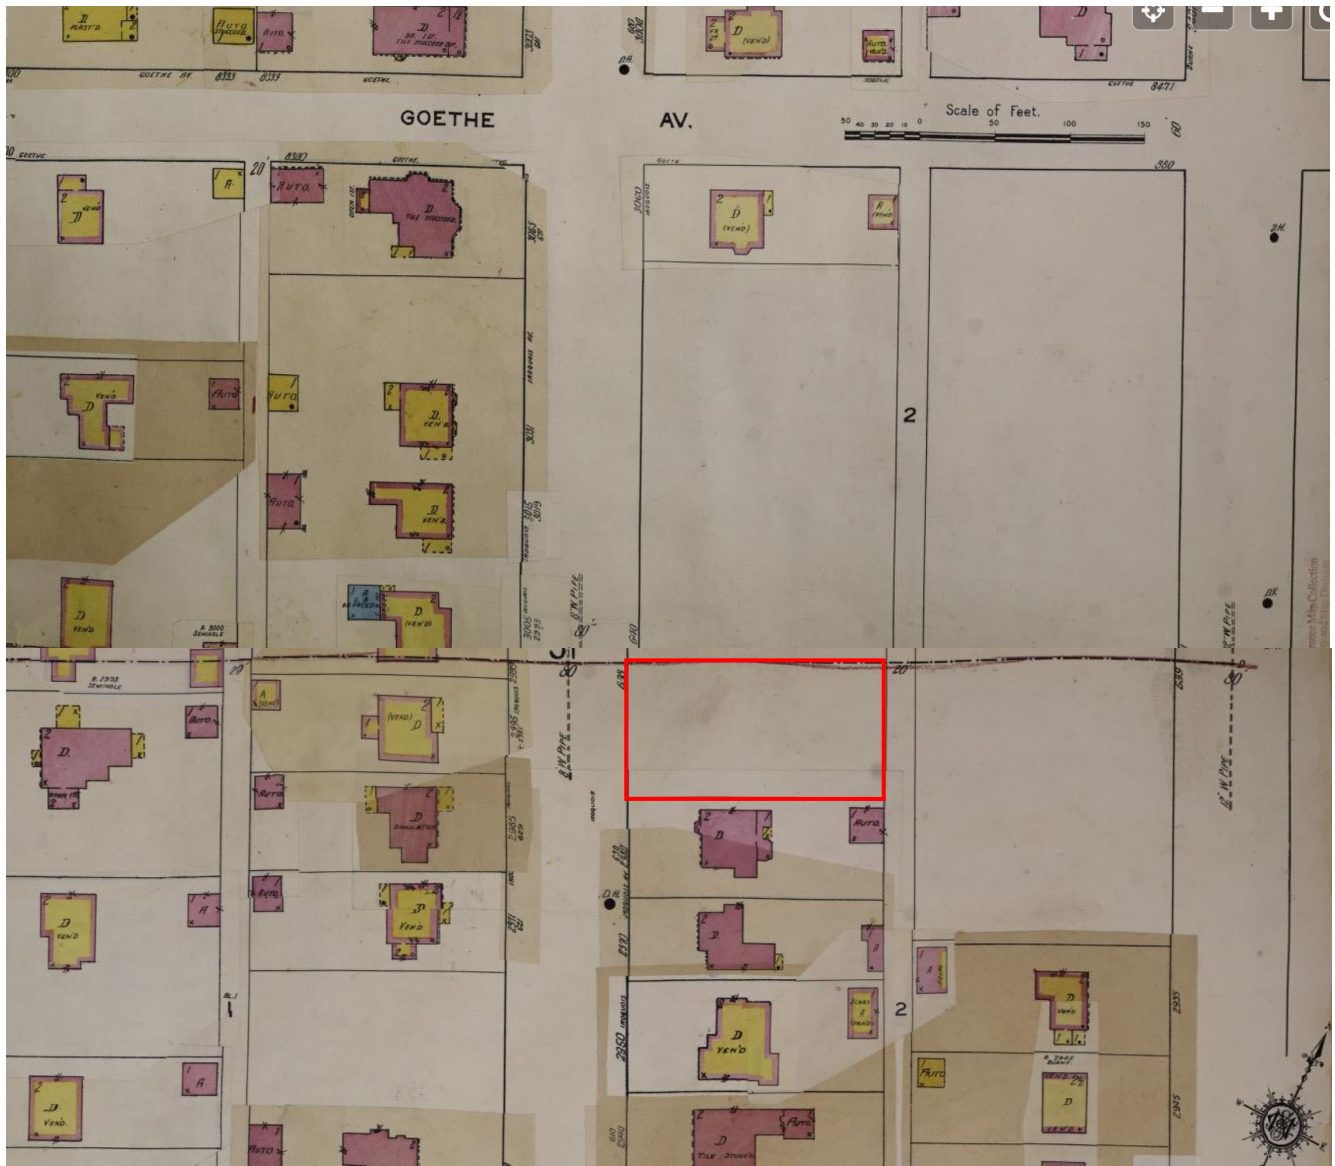
Sanborn map of conditions circa 1951. Approximate extents of subject property outlined in red. The contemporary home built circa 1960 does not yet appear to the north. Frame houses with brick veneer depicted in yellow; homes with a brick structure in red.

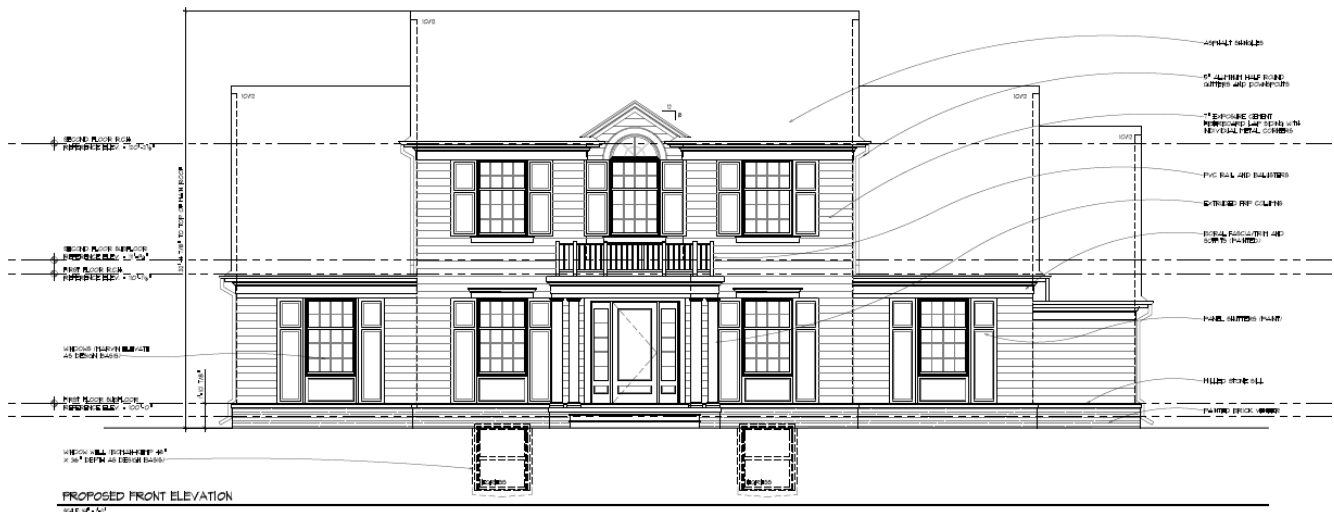
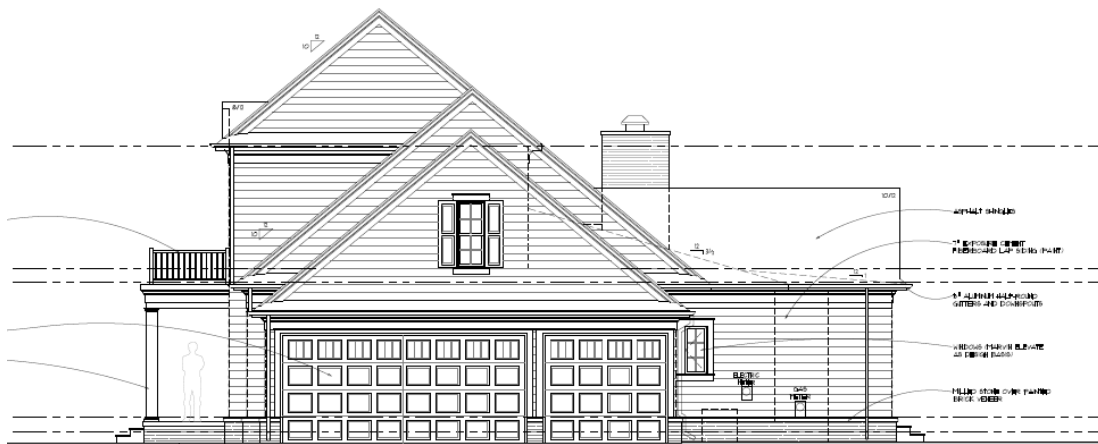
Front (east) and side (south) elevations. Note projecting front porch. From submitted materials.

- **HDC Staff Assessment:** The proposal for 2998 Iroquois, a Colonial Revival design based on classical precedents, has a centered front porch projecting forward from the main façade/setback line, consistent with many neighborhood examples. A change from a recessed porch offered in the preliminary design was made at staff request. Staff assesses that this Element has been satisfied.

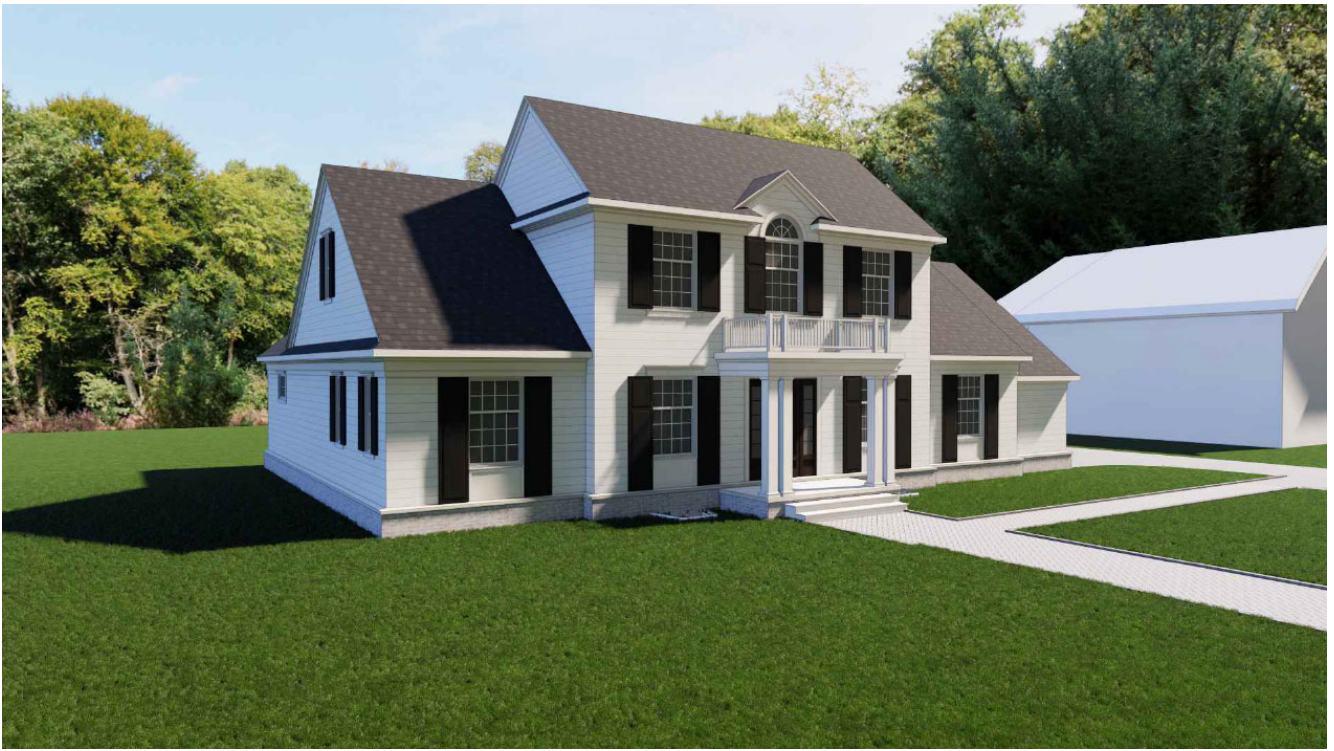
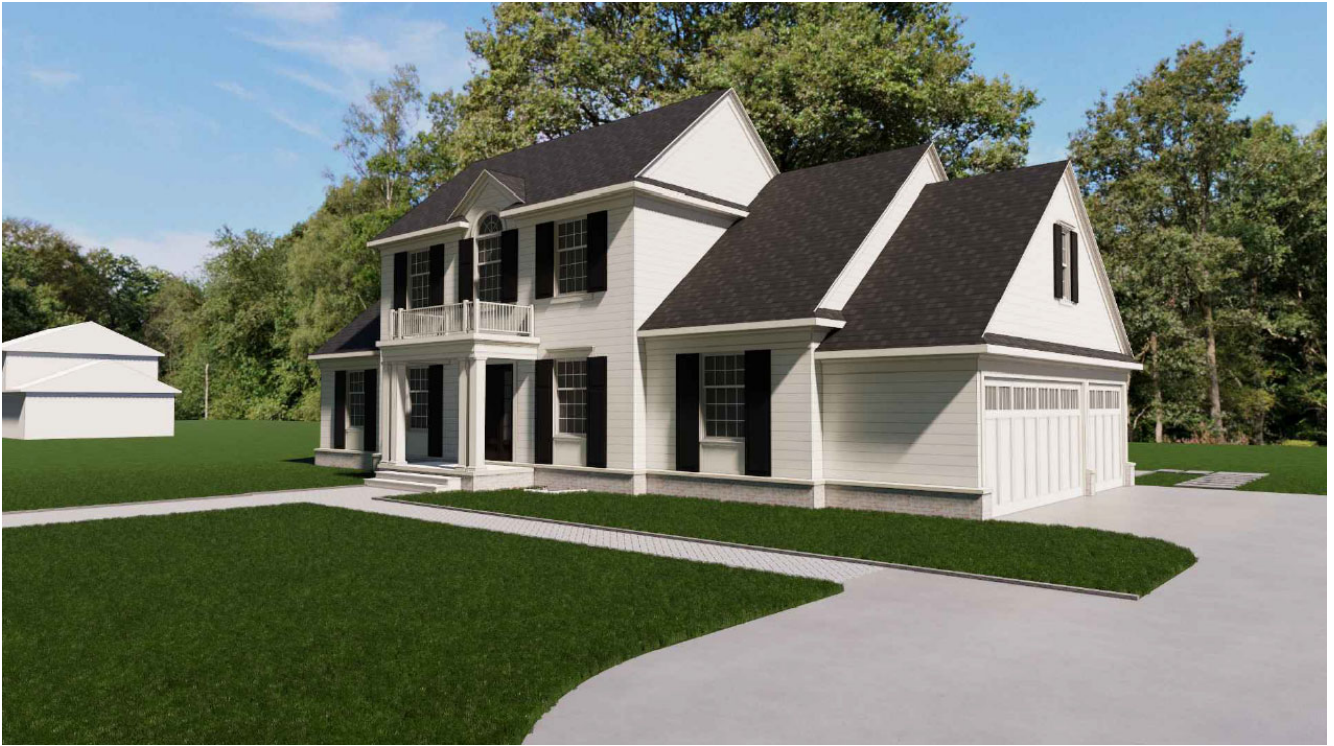
Renderings from NW (top) and SW (bottom). From submitted materials.

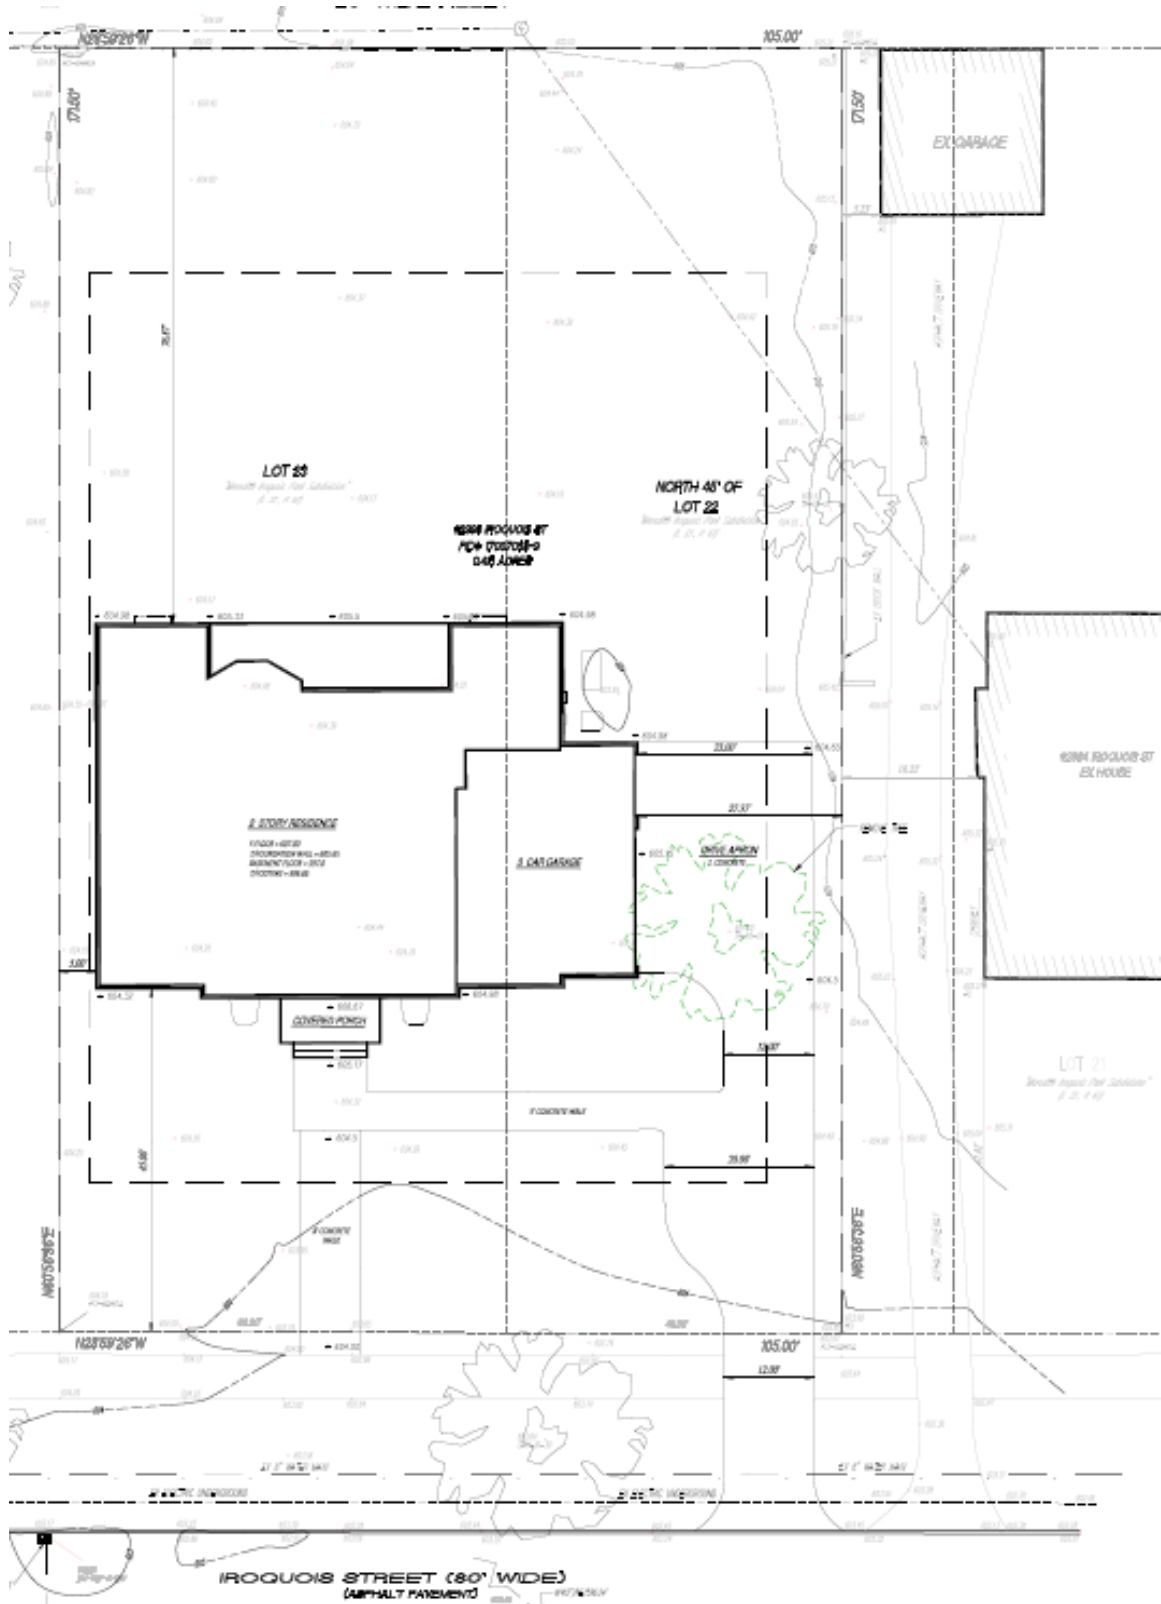
Survey/site plan. From submitted materials.

For the site, the applicant proposes a driveway of varying width leading to the south end garage, with a 5' concrete walk extending laterally to the front porch. An existing tree on site will be removed to accommodate the driveway apron. Another concrete walk, 8' in width, is proposed from the door to the street. Other than lawn areas, no additional landscaping is depicted.

- **HDC Staff Assessment:** The proposal for 2998 Iroquois is devoid of landscape elements, excepting a note that it will be “primarily lawn” in the applicant’s submitted narrative (letter). One existing tree is to be felled to accommodate the driveway. The proposed landscape is not adequate and this Element has not been satisfactorily met. Robust foundation plantings, and locations for new shade trees, including in the front yard to continue existing block patterns, should be added to the scope of work, at a minimum. Additional hedges, shrubs, and planting beds may be necessary to fully integrate the house into the historic context. Additionally, the northward “bump-out” of the driveway (just prior to the lateral walk) is inconsistent with existing driveways and should be eliminated.

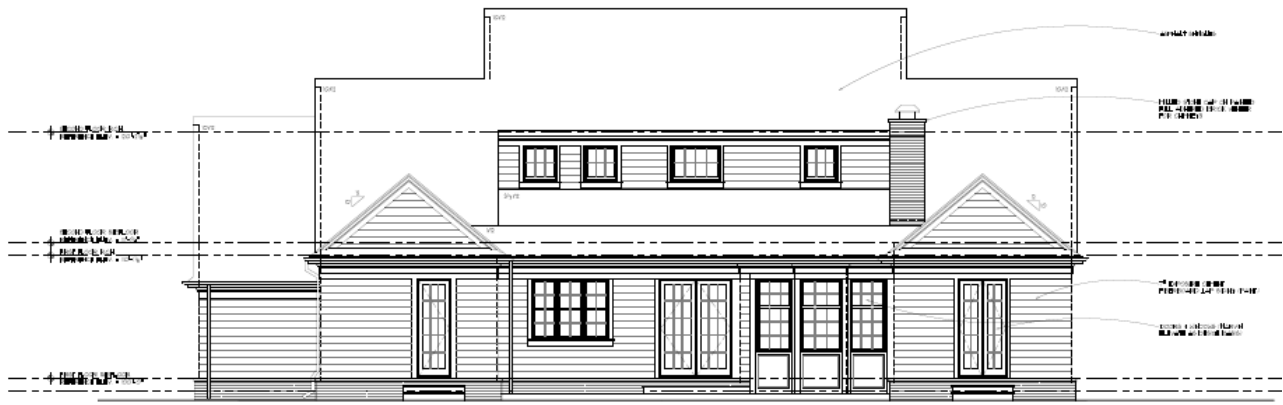
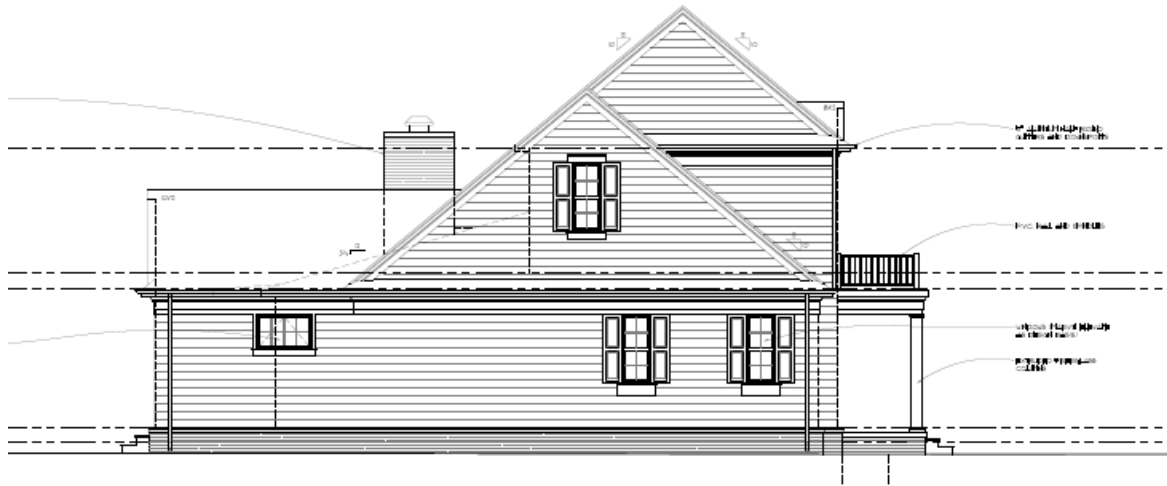
PROPOSED REAR ELEVATION

Rear (west) and side (north) elevations. From submitted materials.

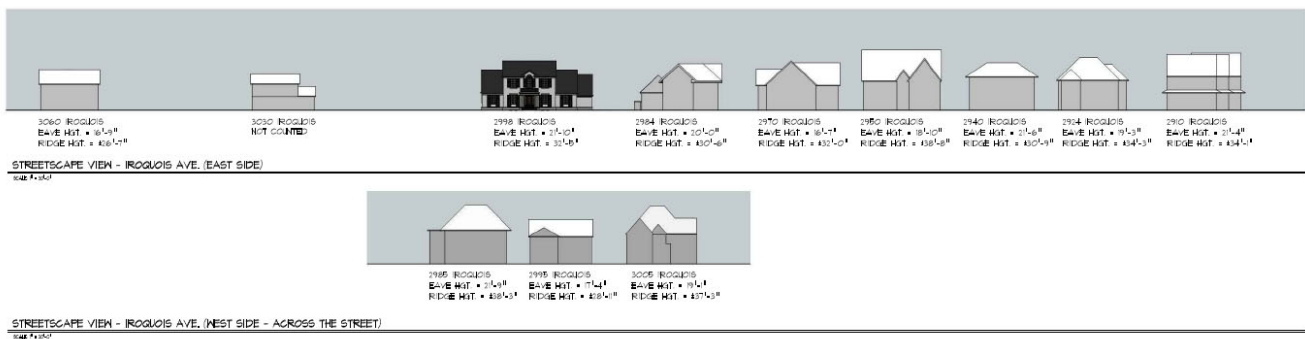
Block length elevations showing roof heights, eaves, and massing. From submitted materials.

- **HDC Staff Assessment:** The proposal at 2998 Iroquois shows a top of roof height of approximately 32½ feet above grade. The architect has prepared a block elevation as part of the drawing set showing the proposed roof and eave height with respect to the neighboring homes, excepting the non-contributing 3030 Iroquois to the north. An excerpt is shown below. Staff assesses that this Element of Design has been satisfied.

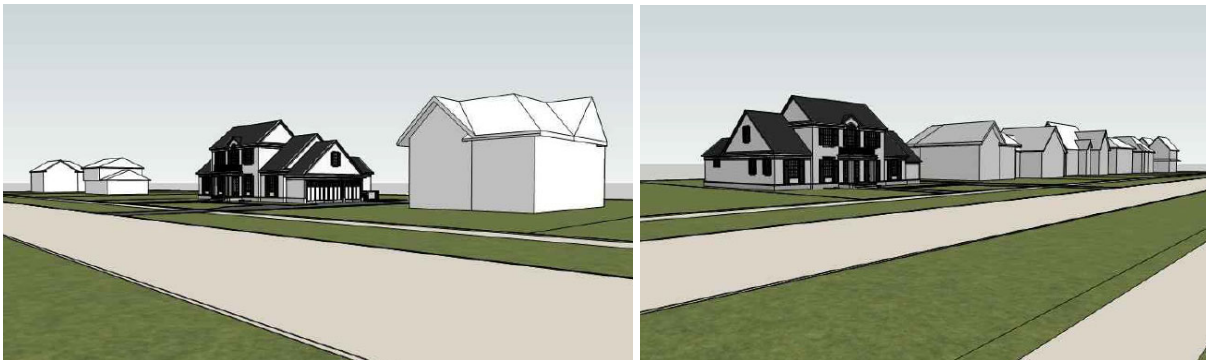
- **HDC Staff Assessment:** The proposal for 2998 Iroquois has too many similarly gabled roof lines, in staff's opinion, especially within the limits of a classically-inspired design. Four different roofs "echo" each other at varying levels in a manner inconsistent with Neo-Georgian precedents. The resultant effect is somewhat of a mash-up between a Colonial Revival core and modern "ranch"-style book-ends. Historic Neo-Georgian houses with flanking "dependencies" (i.e., the subordinate masses to the main central mass, commonly sun rooms or sun porches) are typically flat-roofed, or low slope at most. The pronounced steep gables of the flanking masses in the proposal, in staff's opinion, do not meet this Element's requirements, as they create a horizontal effect that conflicts with the primacy of the central block and detract. The few examples of pitched roof subordinate masses in Indian Village are on much larger houses, and thereby do not conflict with the main mass. Although dormers are common in the district, and on Colonial Revival precedents, there are enough examples of houses without them for the proposed main roof design to be appropriate.
