STAFF REPORT: MAY 10, 2023 MEETING

APPLICATION NUMBER: 23-8330

ADDRESS: 85 CHICAGO

SCOPE: ERECT FRONT YARD ~~FENCE~~ HEDGE, INSTALL ASPHALT SHINGLE ROOFING, REPLACE FRENCH DOORS WITH WINDOWS, ~~ERECT REAR YARD FENCE AND DRIVEWAY GATE (WORK COMPLETED WITHOUT APPROVAL)~~

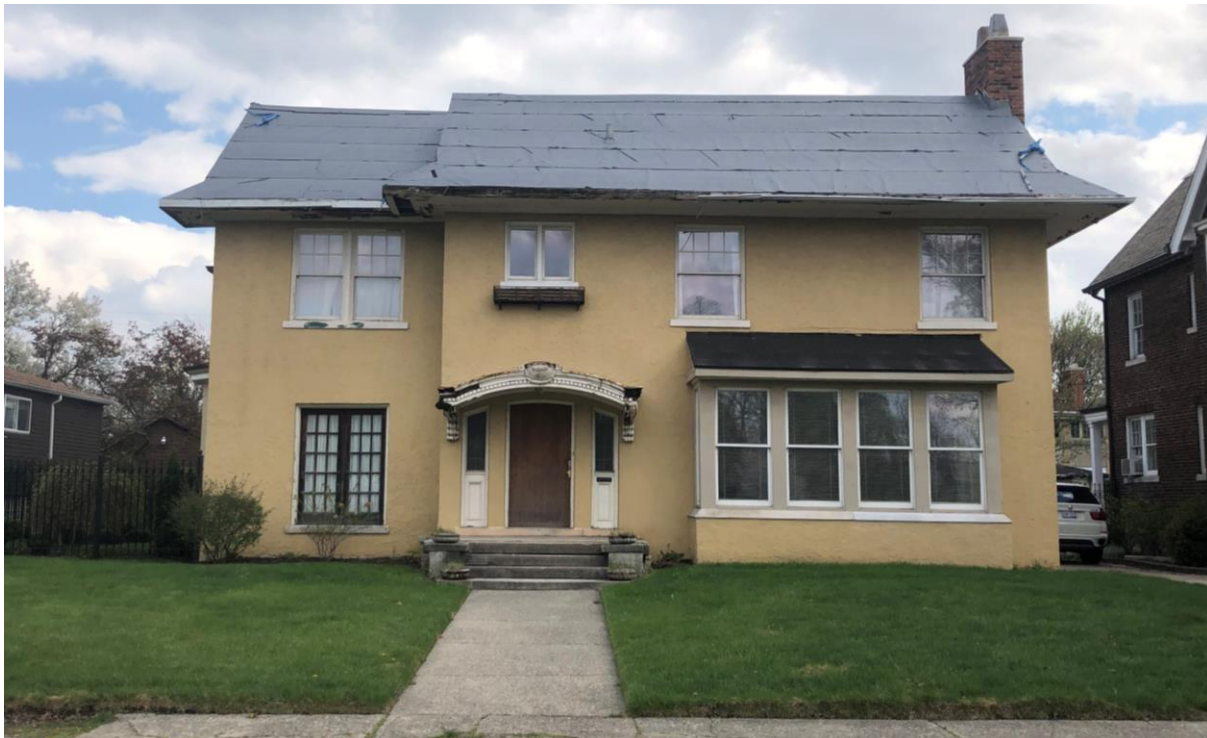
Staff photo, April 26, 2023

Double-hung windows at the front elevation second floor are six-over-one wood units, while the first floor windows are one-over-one vinyl units. A double casement opening is centered above the entry, under which is a metal flower box. The front entrance doors are replacement units: the front door is a solid unadorned wood door, and the wood French doors have a 15-glass panel design.

A straight concrete front walk leads to a raised entrance porch; the steps are flanked by low wing walls. The roof is currently wrapped and has been in place since mid-2021 (following the issuance of a permit for new underlayment). A single-story flat roof attached garage is located at the southwest end of the rear elevation.

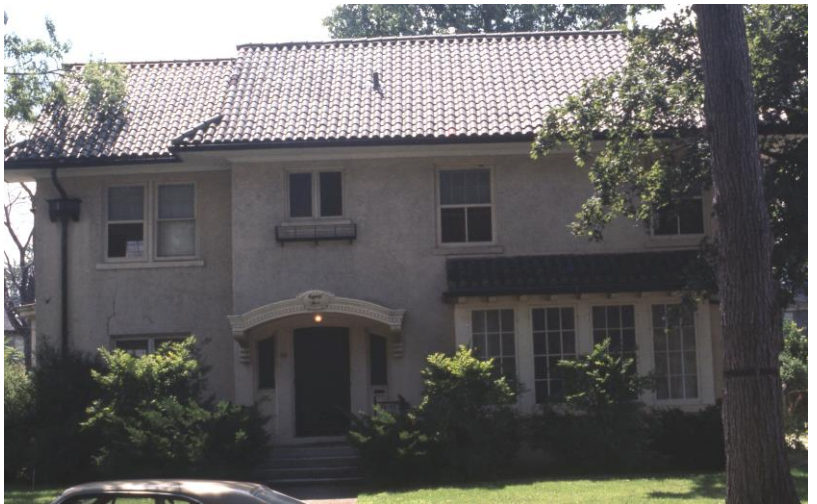
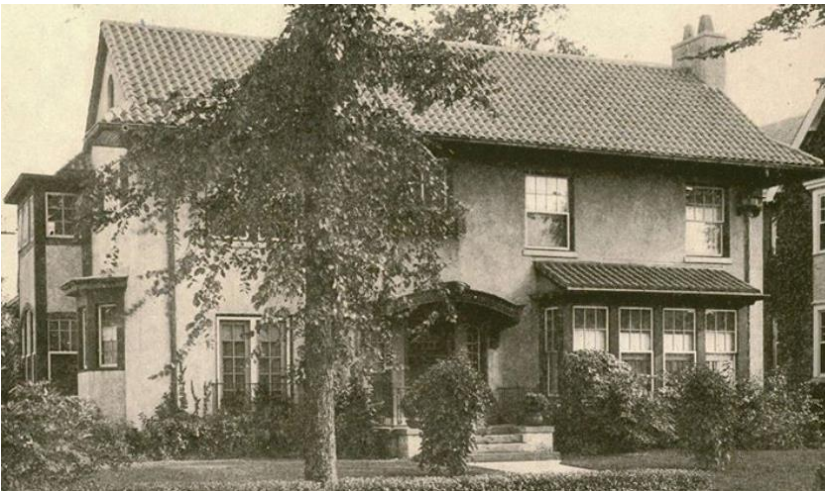
- The Boston-Edison Historic District was established in 1974.
- The 1974 designation photo confirms that most of the original features of this house were still intact, however it appears that the double-hung windows in the box bay had been replaced with casements (due to the flat appearance and lack of a meeting rail).

- The dimensionality, patterning, profile, and saturation of color of tile roofs make them character-defining features of a building. At this residence, the use of barrel tiles offered a dramatic contrast against the minimal ornamentation of the stucco walls. When comparing the circa 1920 photograph to the 1974 designation photo as well as with a 2023 photo, a gradual loss of architectural details is noticed and include the exposed rafters on the box bay, iron railings at the front entry and French doors, the gutter collector boxes and the six-over-six wood windows in the box bay. The dark paint/stain used on the wood trim and fascia boards added a depth to the house that has also been lost with the current monochromatic paint palette. The front yard doesn't have any trees and very little landscaping. Based on staff's research of the electronic and paper files, all the details listed here were likely removed/alterd without HDC approval.

Top: Designation photo, 1974, HDAB.

Bottom: Photo from "Beautiful Homes from Detroit and Vicinity, 1920.

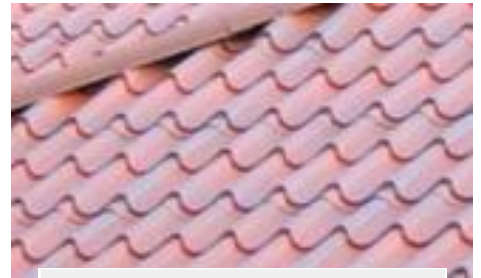
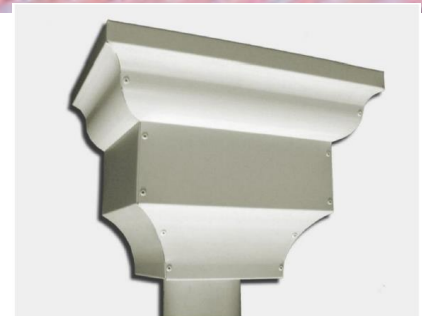
- *April 14, 2021:* At the HDC meeting, the Commission approved:
 - Roofing
Isaiah Industries, Classic Metal Roofing System, GrandeTile
Color: Reviewed by staff
Tile will be installed on all the roof surfaces, including the front elevation shed roof, that offers a 3:12 or greater roof pitch.

Photos of approved material, 4/14/21 HDC meeting

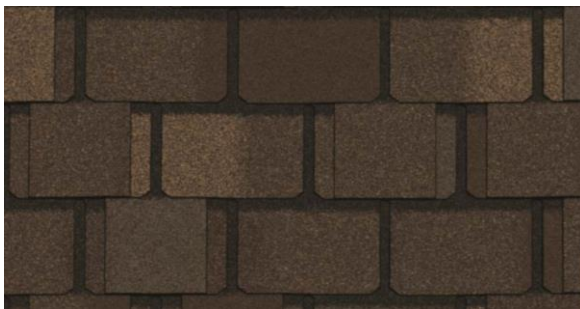
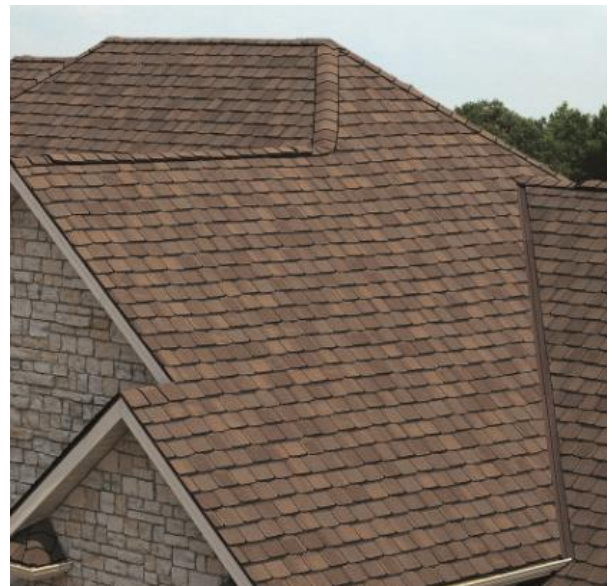
- The product proposed is **CertainTeed, Belmont asphalt shingles, color: Shenandoah. GAF, Grand Canyon (a line within the company’s “designer collection”) asphalt shingles, color: Stonewood.** The reason for the product change is due to estimated project cost.

*Above: CertainTeed photos.
Left: Shenandoah color
Above: Installed Belmont shingles, color: Brownstone (staff couldn’t find a clear installed photo of Shenandoah).*

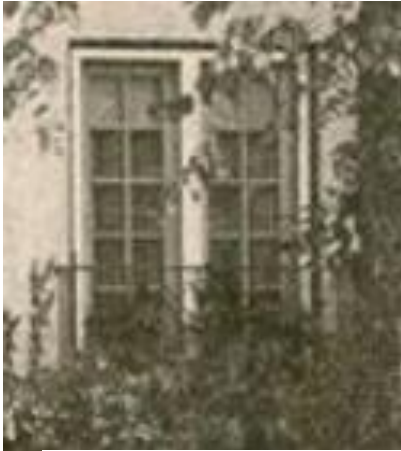
- Staff agrees with the homeowner’s assessment that the existing French doors are not original to the house. The historic photo clearly shows each door having a 2w x 5h glass pattern. It appears that these doors were intact at time of designation; the center muntin bar is visible in the left/eastern door in the 1974 photo. **However, the exterior framing of these glass units suggest they may have been full length casement windows with affixed screens as the exterior framing doesn’t show a wide mullion separating the units.** Staff didn’t find any HDC approval on file for their removal and replacement with the existing 3w x 5h panel wood doors, nor a date on when they were installed.

Circa 1920 photo

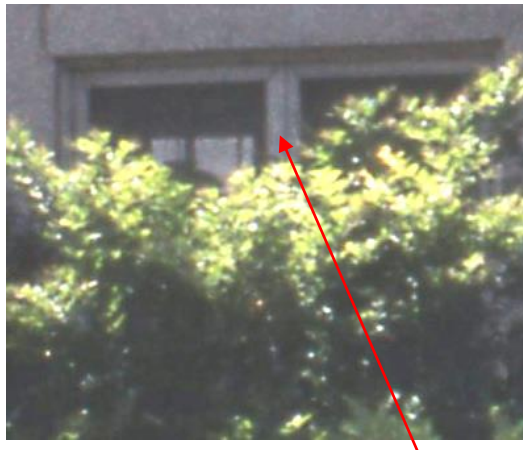
1974 designation photo. The exterior (screen?) framing is interesting and suggests a very thin mullion.

- The selected cladding color is brown. It is staff's opinion the dark color is not appropriate for the house as the frames would offer too much of a contrast against the stucco. Italian Renaissance houses typically have lighter colored window frames and trim, similar to the exterior wall material. As the stucco has been painted, staff isn't recommending the new windows match the existing stucco, rather a more neutral tone be selected for the window frames. Also, a factory mullied double window unit is proposed. Based on the historic photo of the exterior screen framing, staff believes a thin factory mullion is appropriate in this location.

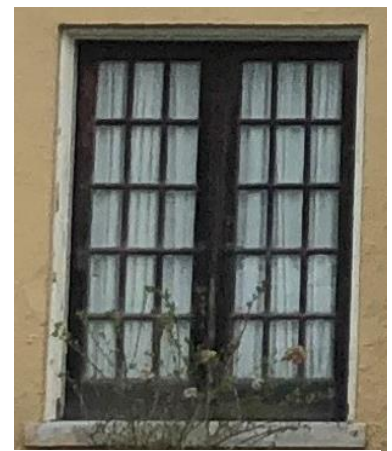
2023 staff photo

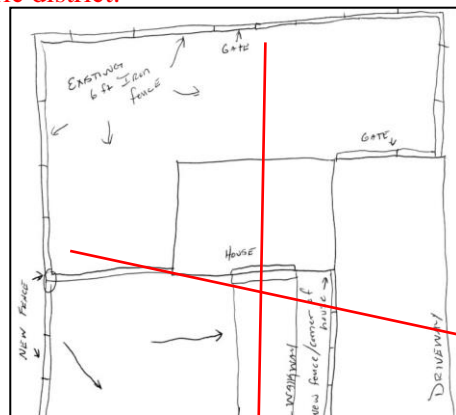
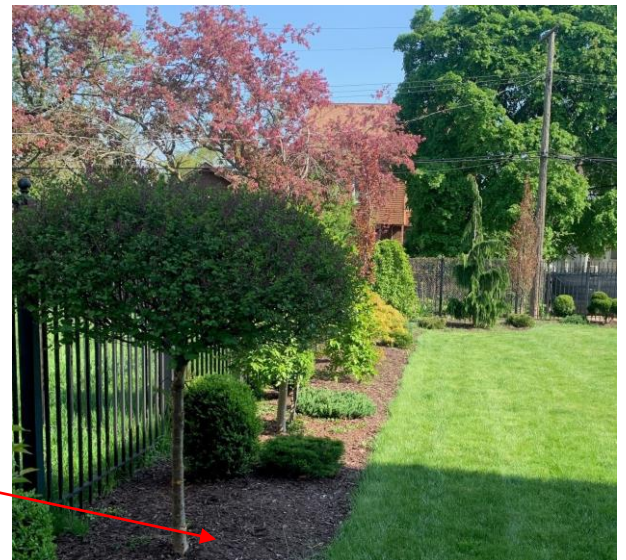
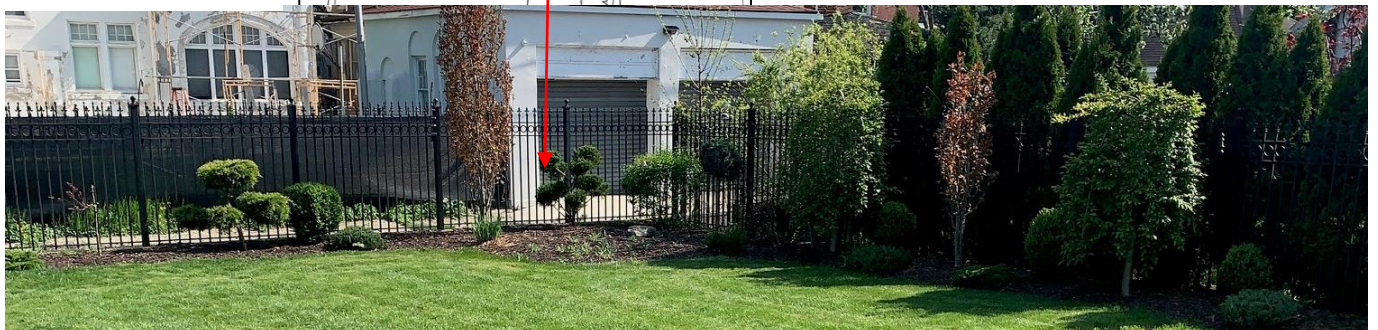
Site plan and photos provided by applicant.

Fence appears to comply with the HDC’s Fence and Hedge Guidelines.

Location of fence and gate is at the side and rear yards.
Height is 6 feet.

- The property owner confirmed the rear yard fence and driveway gate was installed without approval in 2008, because as a new owner, she wasn’t aware of being located within a local historic district.

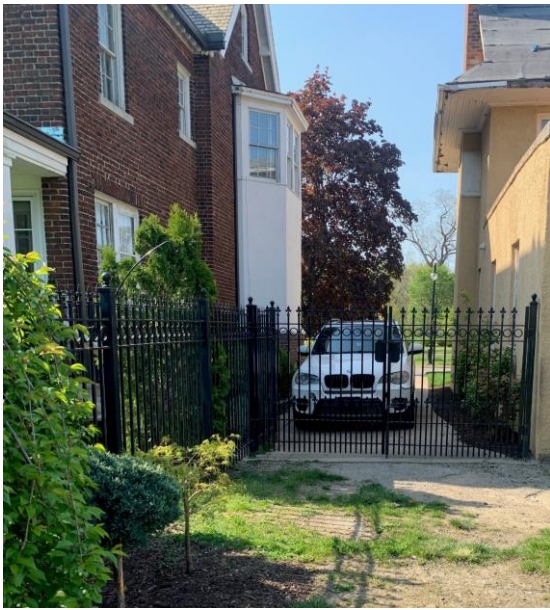
Gate meets southwest/rear corner of house.

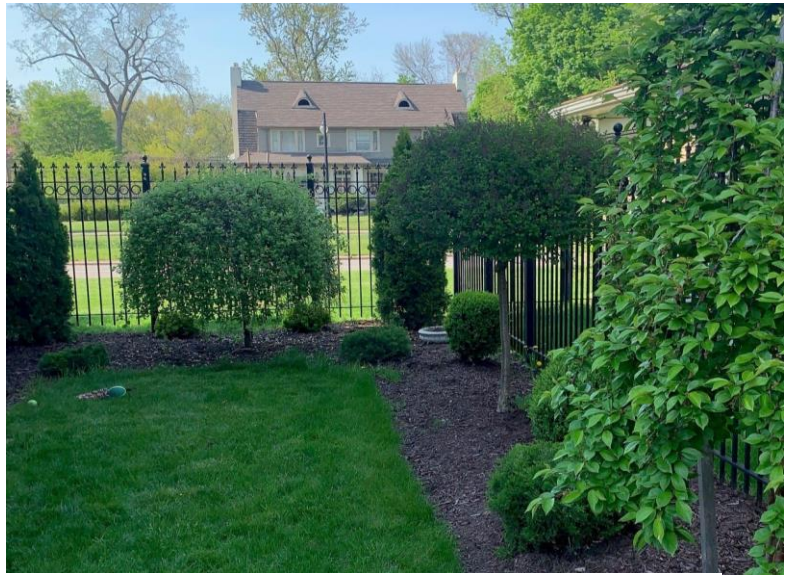
Front-facing gate at side yard, meets northeast corner of house.
Applicant photos.

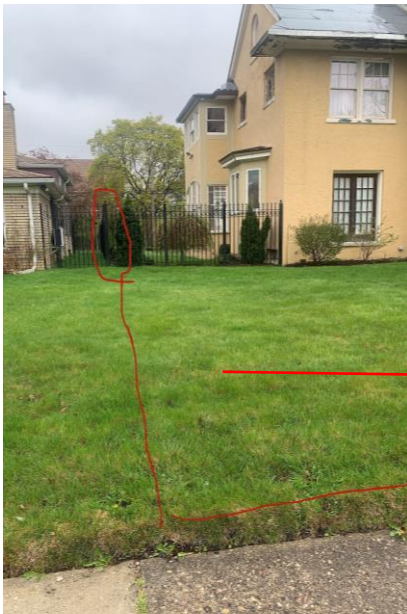
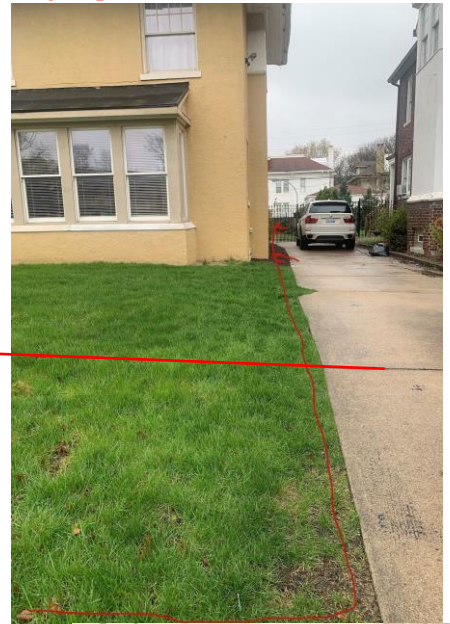
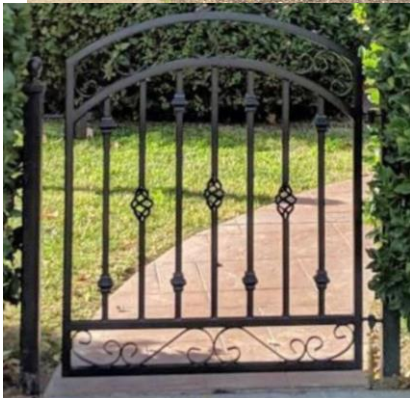
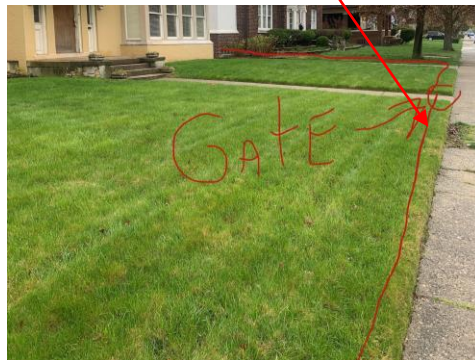
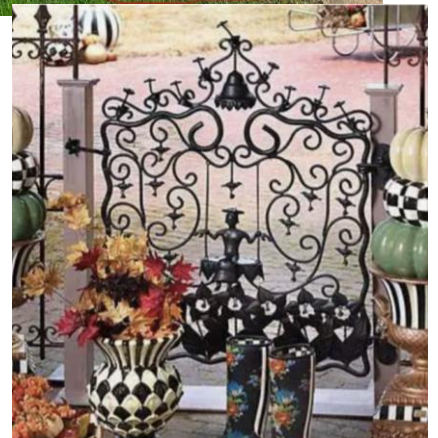
- The applicant revised the scope of work to include the installation of a continuous row of hedges (finished height 3' - 0") at the perimeter of the front yard, replacing the previously proposed fence. A gate at the front walkway is still proposed. Applicant submitted the two gate photos as design options.

Applicant photos and site plan.

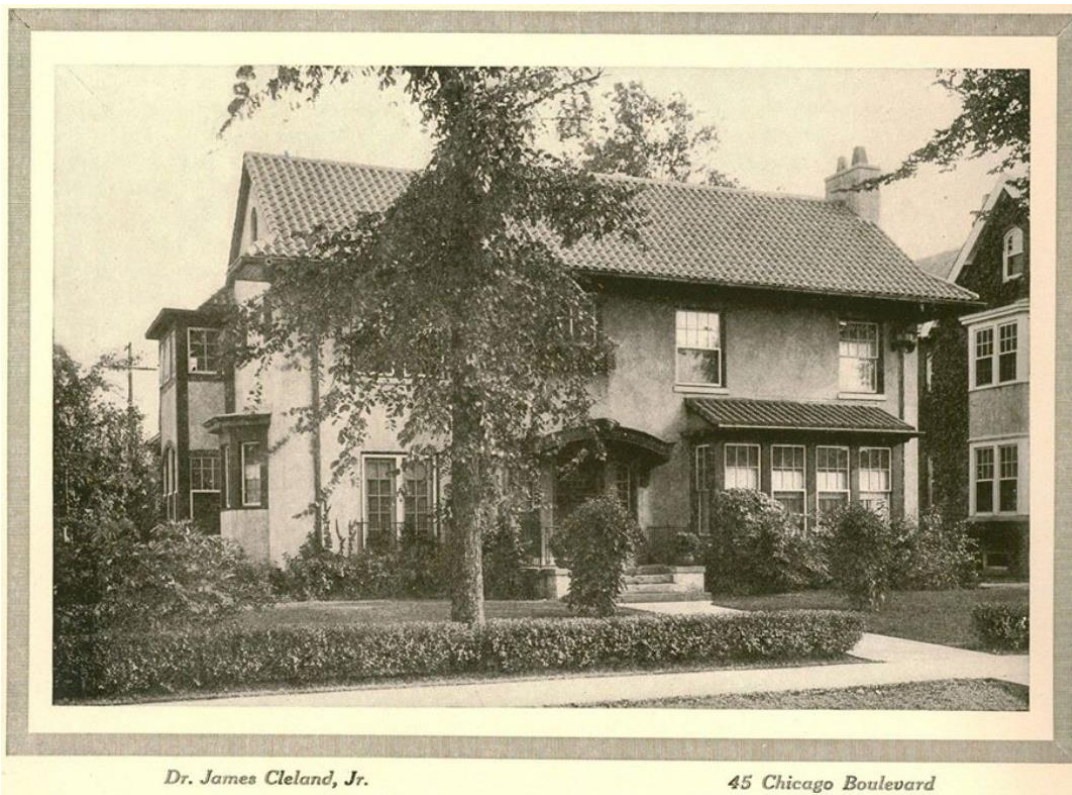
Image from Beautiful Homes of Detroit and Vicinity, circa 1920.

- The historic photo shows a hedge separating the front yard from the sidewalk. You also see a tree lawn was present, whereas it is now concrete (as shown in the following photographs).

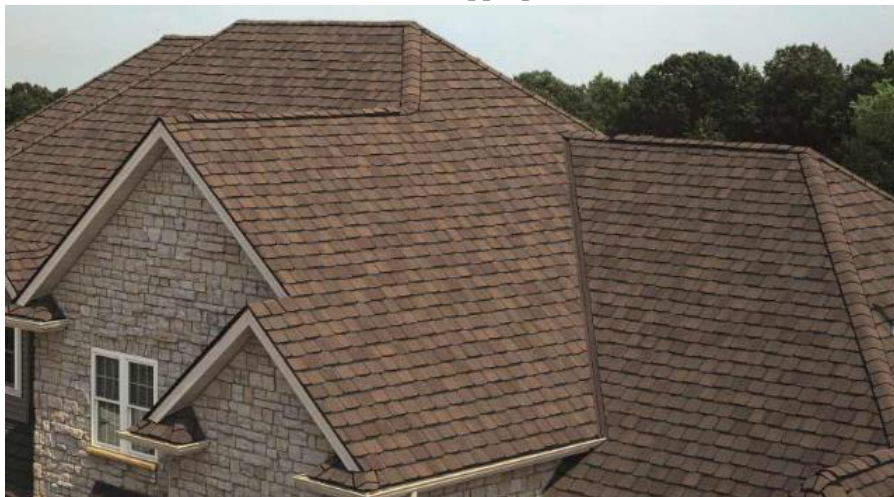
- Based on staff's recent research, there doesn't appear to be an asphalt roofing company that currently produces an asphalt shingle that attempts to mimic the heavy vertical and rounded angular look of clay tile.
- Should the Commission consider an asphalt shingle, staff believes it must offer predominant vertical and horizontal lines and consistent color like a tile roof. It is staff's opinion the current proposal meets these criteria; the dark brown color is an appropriate choice for the architectural style of the house.

Left: CertainTeed, Camelot. Barkwood is shown, which is lighter brown than selected color).

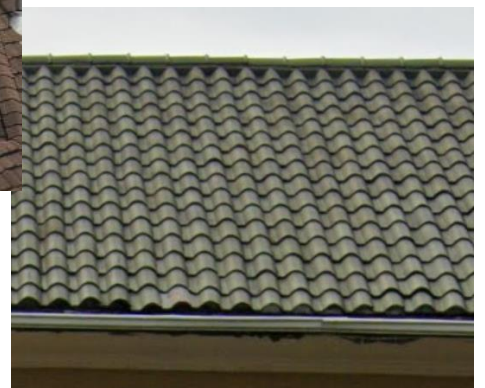
Below: photo of tile roof at 85 Chicago prior to removal.

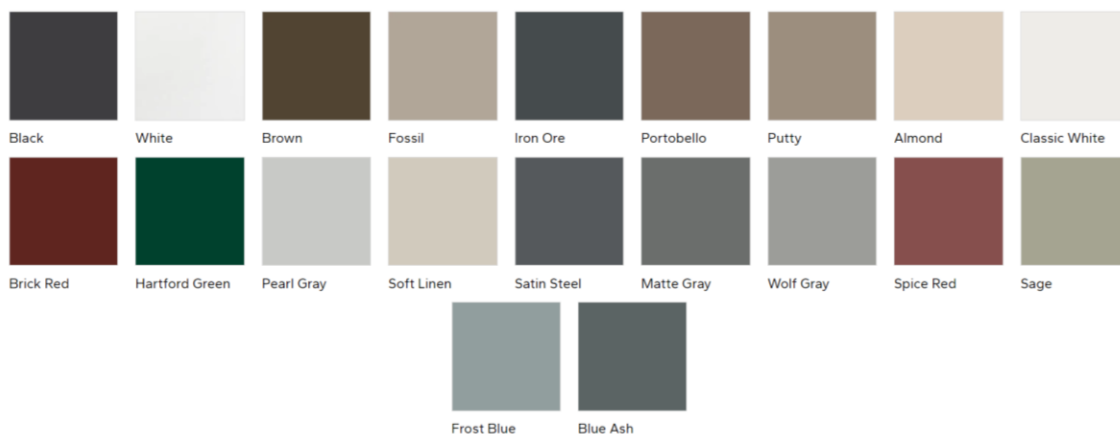
Above right: rendering from Pella window order. Above: exterior cladding colors from Pella brochure.
