**STAFF REPORT: JUNE 14, 2023 REGULAR MEETING**  
**APPLICATION NUMBER: 23-8401**  
**ADDRESS: 2984 IROQUOIS**  
**HISTORIC DISTRICT: INDIAN VILLAGE**  
**APPLICANT/OWNER: MARK REYNOLDS**  
**DATE OF PROVISIONALLY COMPLETE APPLICATION: MAY 7, 2023**  
**DATE OF STAFF SITE VISIT: MAY 25, 2023 AND JUNE 5, 2023**

**SCOPE: INSTALL DRIVEWAY GATE**

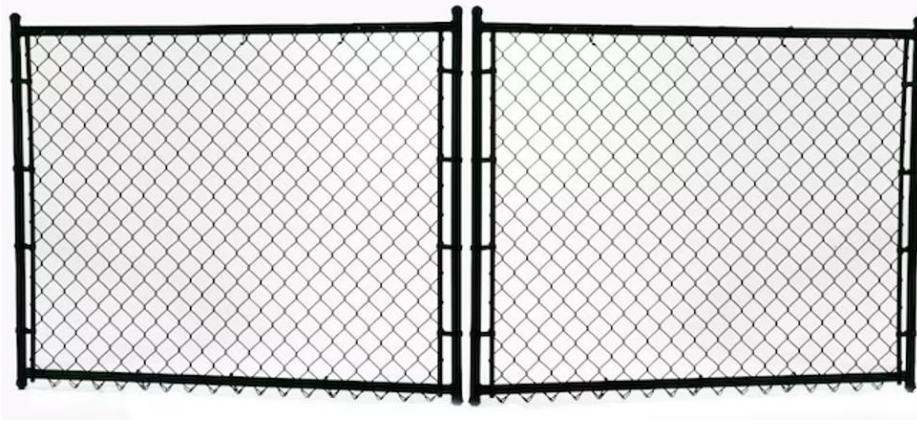
*Proposed gate. Image from application.*

The applicant proposes to alter the masonry wall by installing a chain-link driveway gate where no gate is currently present. The proposed gate is a Lowes Model #58090322, black powder-coated gate measuring 5' high and 9.5' wide.

- The proposed chain-link gate is a clearly mass-produced, machine-made product that is visually incongruous with the rustic and picturesque subtype of Tudor Revival described above, and is not appropriate for the style. A simple, wood gate would likely be the most appropriate option for this particular property.
- A chain-link gate is not appropriate for a masonry wall, in general. A wrought-iron-style aluminum or steel gate, commonly found in connection with masonry walls or piers within Indian Village, would likely be minimally appropriate.

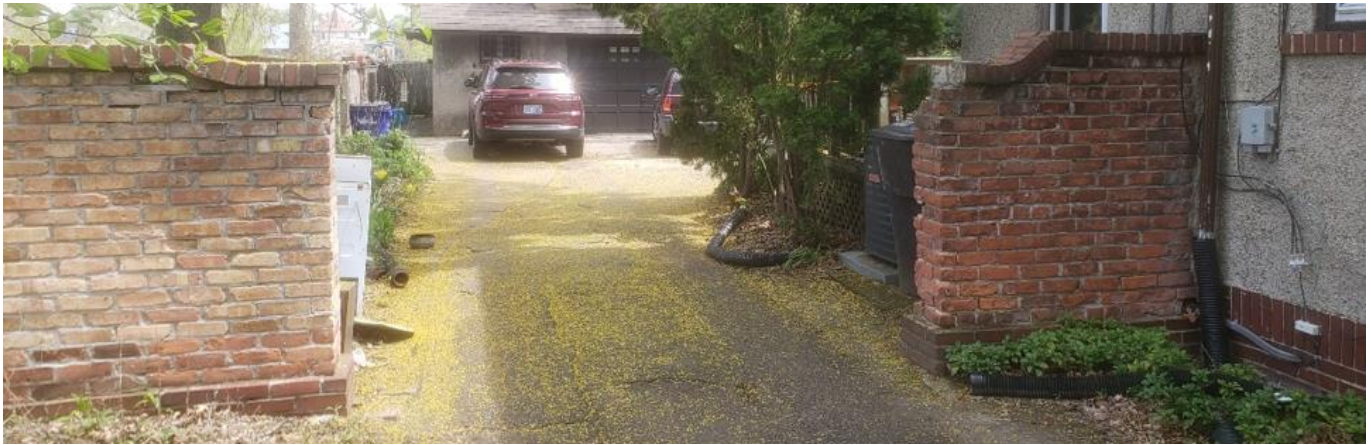
*Existing wall opening. Image from application, cropped by staff.*

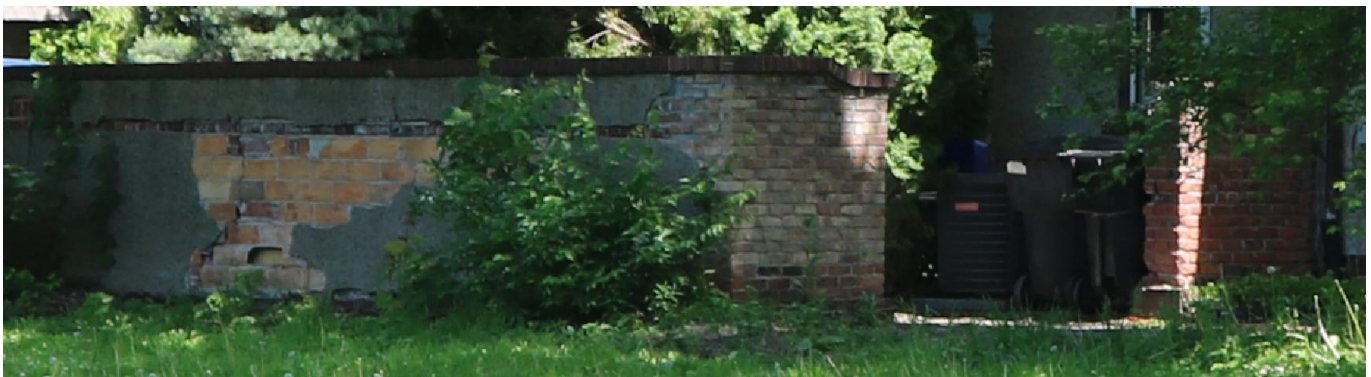
*North and west faces of existing wall viewed from Iroquois. May 2023 photo by staff.*

- The existing wall is largely parged with concrete or stucco, though some of this material has detached. Staff suggests that the street-facing plane of the wall, now showing exposed brick, was once similarly parged. The use of common brick, combined with the rough nature of the mortar joints, implies that the brick was intended to be concealed, consistent with the other elevation of the wall.

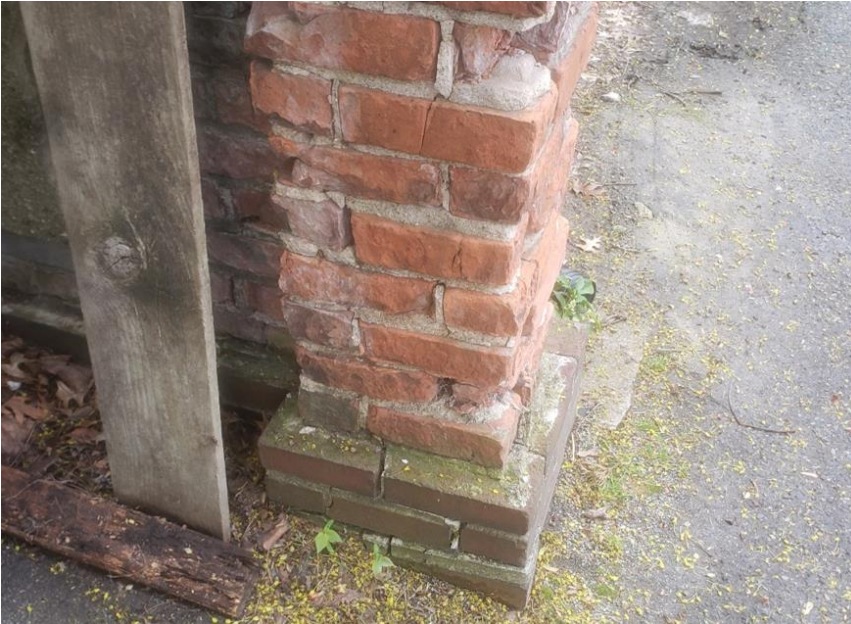
*Interior view of southernmost pier. Image from applicant.*

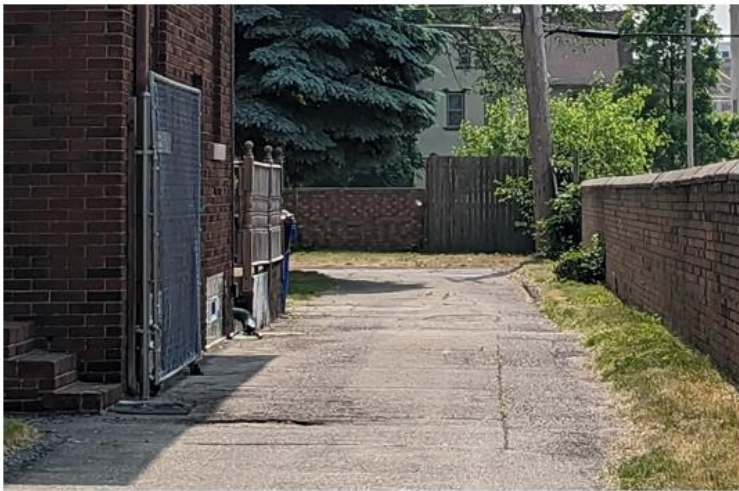
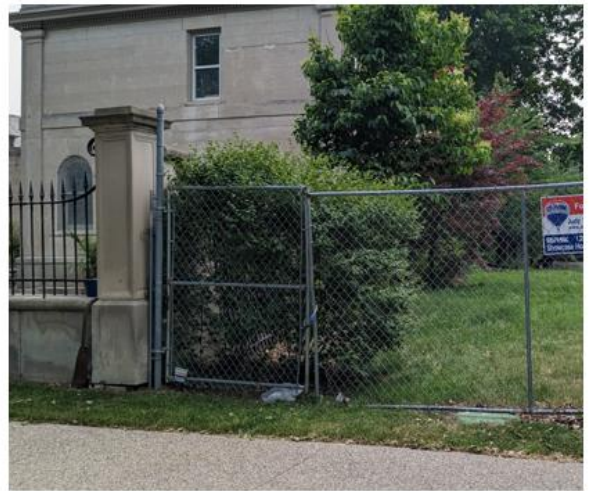
Left: a chain-link gate abutting the masonry wall of an adjacent property. Right: A chain-link gate abutting a masonry pier. A third gate could not be clearly photographed. June 2023 photos by staff.

- Staff surveyed the entire length of Iroquois, Burns, and Seminole streets in the Indian Village Historic District and identified a total of twenty-nine instances where a gate is set within a masonry wall or abutting one or more masonry piers. (East-west streets were excluded from the survey, as they are less representative of the subject property.) Of these gates, twenty-five are wrought-iron-style or cast-iron-style metal gates. One is a composite of metal and wood. Staff observed only three instances of chain-link gates; of these, one is a pedestrian-sized gate concealed from view by vegetation, one appears to be part of a temporary construction enclosure, and only one appears to be both prominent and permanent.

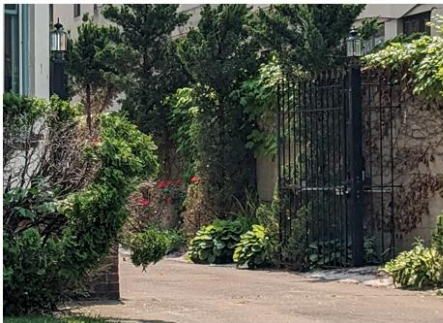
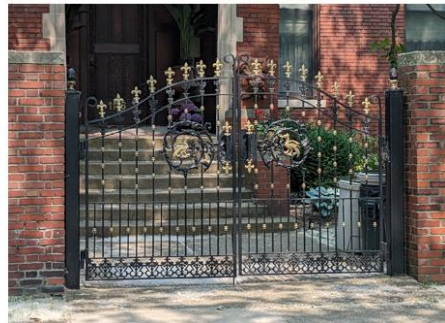
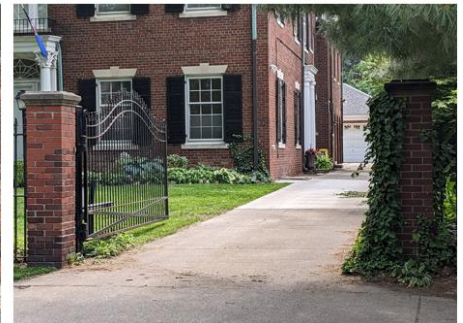
Photos of wrought-iron-style gates abutting masonry walls or piers. June 2023 photos by staff.

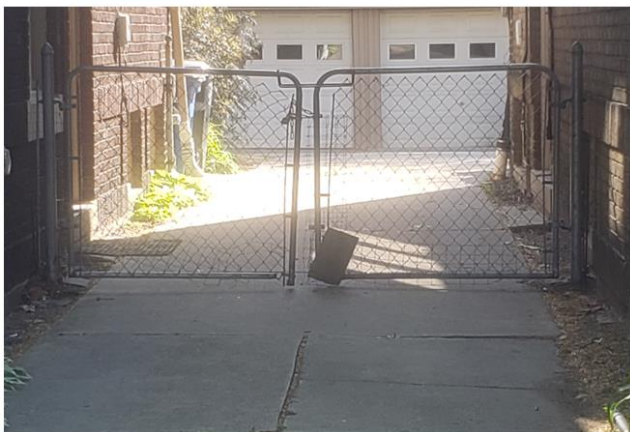
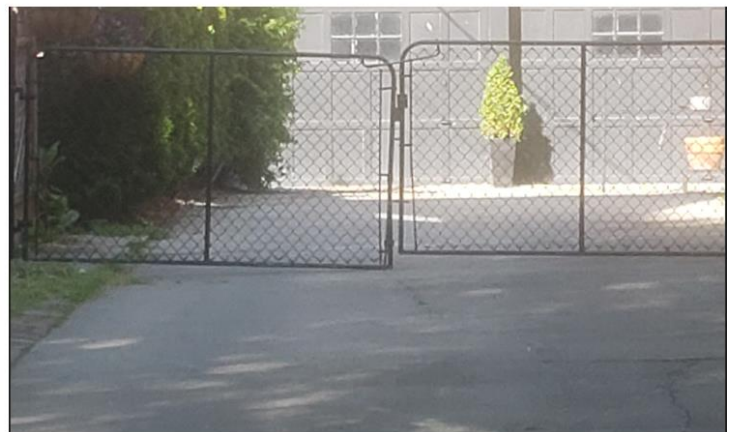
Example Indian Village chain-link gate images provided by the applicant.

- Staff also observed two instances, including the subject property, where an opening in a masonry pier or wall lacks a gate.
- When chain link gates are employed, it is almost always as part of a complete chain-link fence or abutting the wall of a building (including spanning the gap between two buildings or used within a porte-cochere). This situation is common, as observed by staff and noted in photos provided by the applicant. As noted above, however, chain-link gates are seldom employed within masonry walls.
