**STAFF REPORT: 8/9/2023 REGULAR MEETING**

**APPLICATION NUMBER: #23-8484**

**ADDRESS: 2485 BURNS**

**SCOPE: ALTER FRONT PORCH**

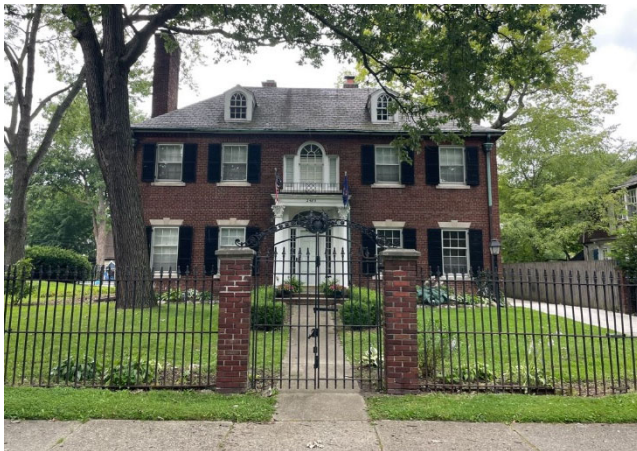
*Site Photo 1, by Staff July 20, 2023: (East) front elevation, showing the existing front porch.*

- Staff observed that the existing front porch features cast stone capping and matching brick underlay detailing that matches the material, scale and color of the house (See photos 1-3). Staff offers the opinion that the rectangular shape and material of the porch, especially the top step that supports the columns, is a character defining feature that supports the symmetry and geometry of this Georgian Revival architecture.

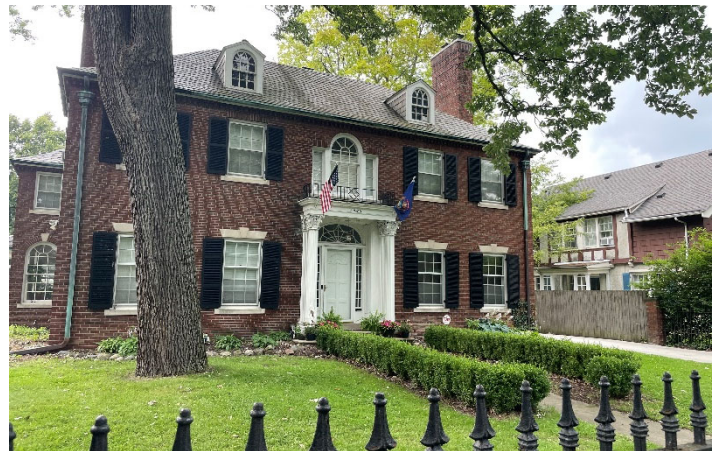
*Site Photo 2, by Staff July 20, 2023: (East) front elevation, showing the existing front porch.*

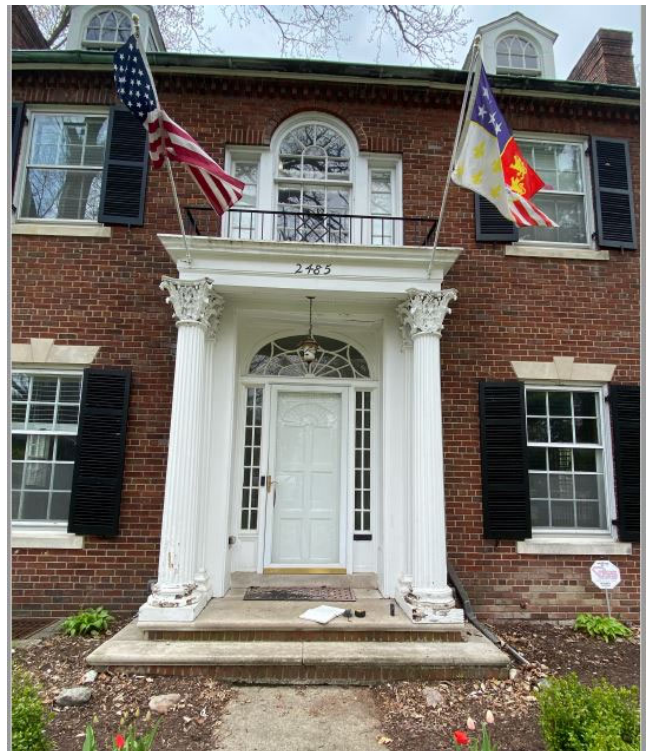
Site Photo 3, by Applicant: (East) front porch existing conditions.

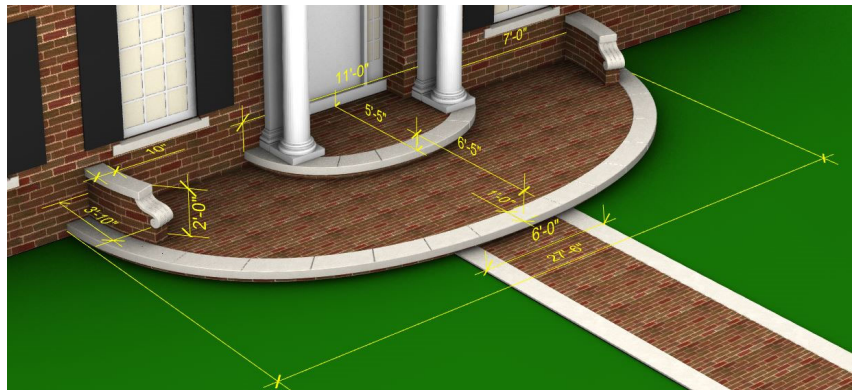
Figure 1, by Applicant: proposed front porch

- Expand Porch:
  - Demolish, excavate and haul away existing front porch decking, setting aside the columns their bases for replacement upon completion.
  - Compact infill
  - Install Fendt pavers with sand infill at two levels:
    - Expand first step level in a semi-circle, 27’ 6” wide
    - Expand the second step/landing, which supports balcony columns, into a semi-circle, 5’ 5” wide
    - Install limestone perimeter with crushed limestone infill for both steps
- Install Wingwalls:
  - At each end of new first level porch, install two (2) partial wing walls (3.5’ long, 2’ high, 10” wide) terminating with curved scroll ends and 10” wide limestone caps.
- Replace front walkway:

- It is staff’s opinion that the introduction of 4x8 cement pavers, replacement of the square form with circular forms, and the introduction of wingwalls destroys the character defining features of the front elevation critical to an understanding of the building’s style by introducing a new style and historically anachronistic material, scale and design that is not appropriate.

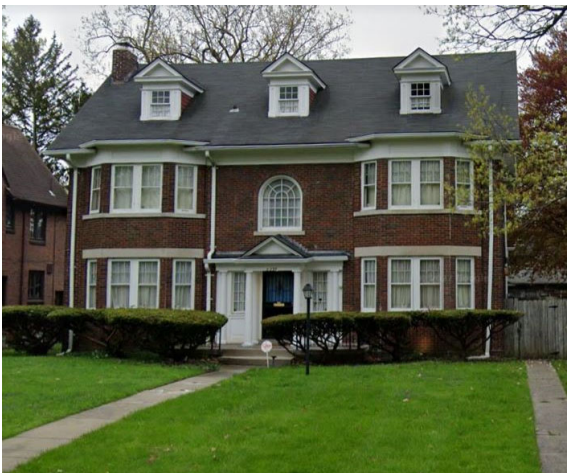
Site Photo 6, by Google Street May, 2019: 2239 Burns showing rectilinear porch expanding to the window line.

- Staff observed other colonial-style homes in Indian Village and recognize that while there were some incidents of a circular form in some of the steps and porches, most held to a rectangular form and all were at a modest scale that supported the particular architecture and scale of the house, rather than call undo attention to itself (See images below).

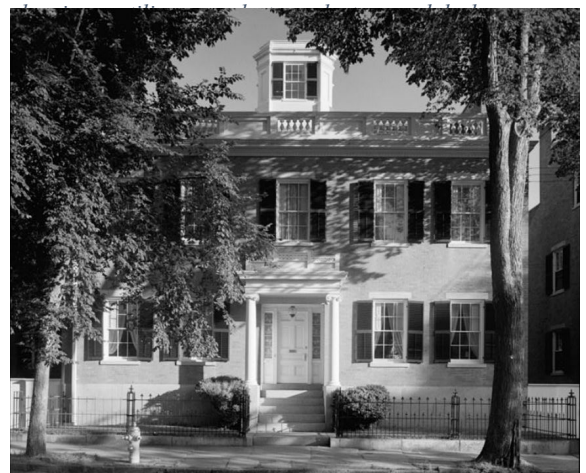
Photo 7, by Library of Congress: 95 Main Street, Nantucket, showing similar front entrance features.
