STAFF REPORT: AUGUST 9, 2023 MEETING

APPLICATION NUMBER: 23-8486

ADDRESS: 686 SELDEN

SCOPE: PAINT MURAL ON BRICK AREAS AT SIDE

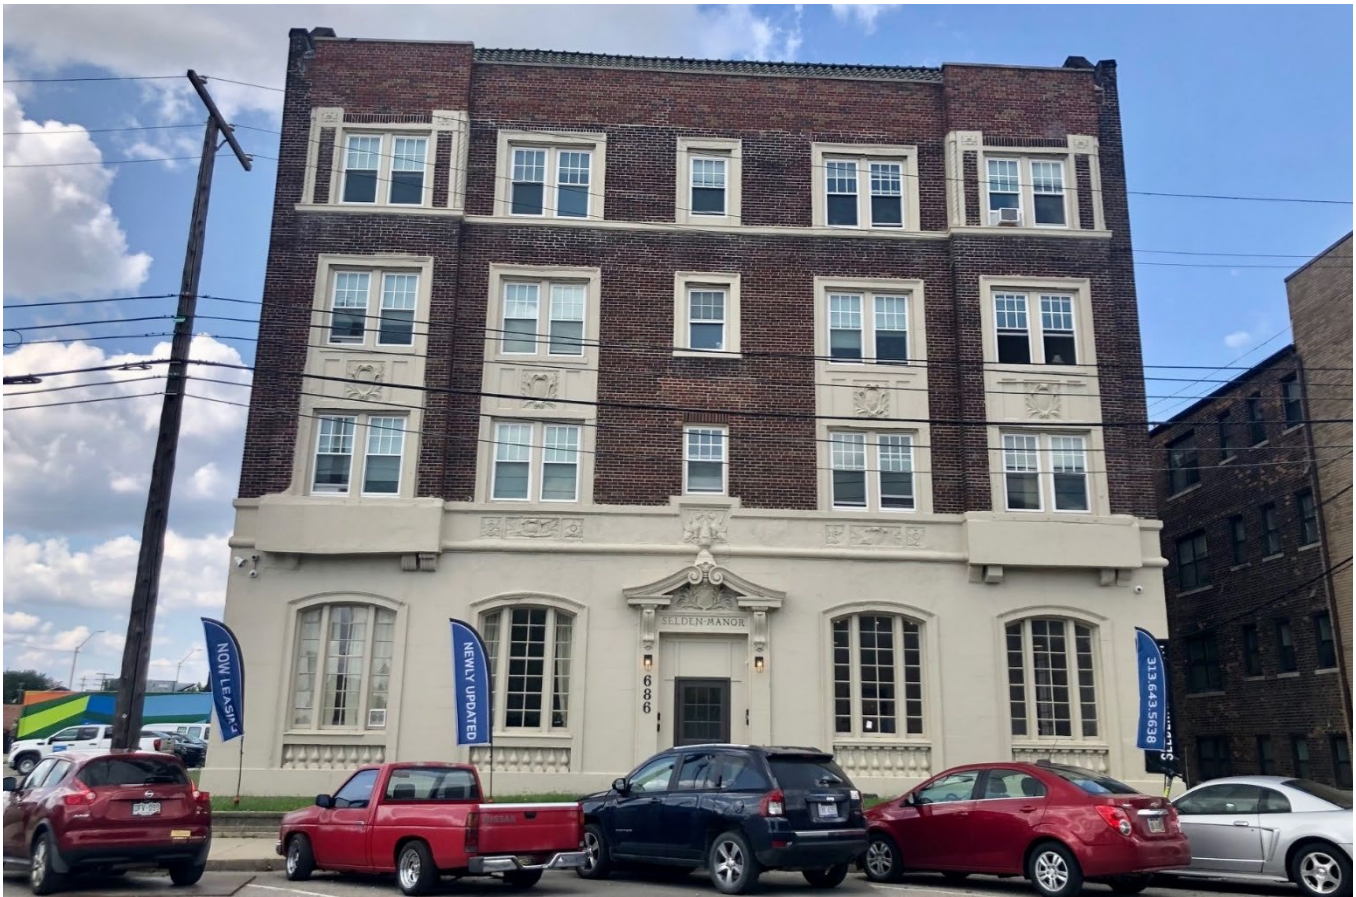
Staff photo, July 21, 2023.

Erected ca. 1924, Selden Manor is located at 686 Selden, on the north side of the street between Second and Third Avenues. The four-story masonry structure was erected to the lot lines, except for the small setback at the rear elevation. The front elevation retains some of its original classical revival detailing, including the tile roof.

The first-floor exterior was likely faced with limestone and wraps around both sides of the building. The remaining side walls and rear wall are faced entirely with dark brown brick; the only ornament consists of the window openings with stone sills. The alleys to the east and north, and the three alcoves within the west elevation, have single, double, and triple window openings.

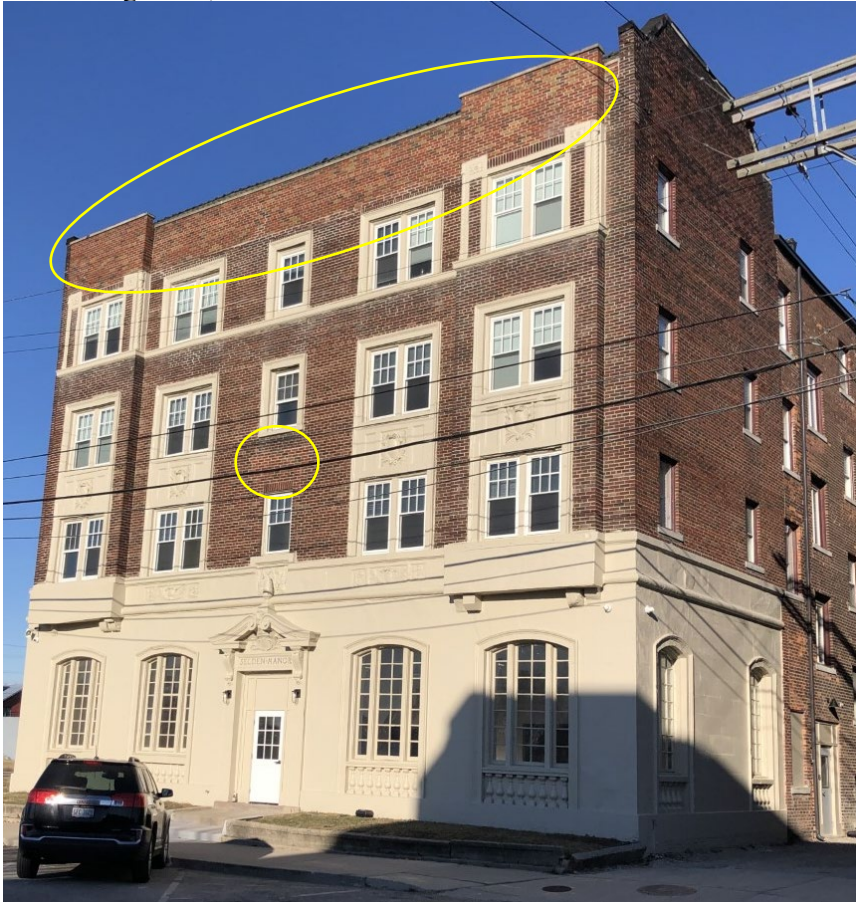
Staff photo, January 21, 2022

- The Willis-Selden Historic District was established in 2011.
- The contrasting-colored brick denotes where the cornice and small balcony were removed; only a few original corbels remain below the extending walls at the second floor. A building permit was issued on August 25, 1958 for the removal of the cornice and related wall repair.

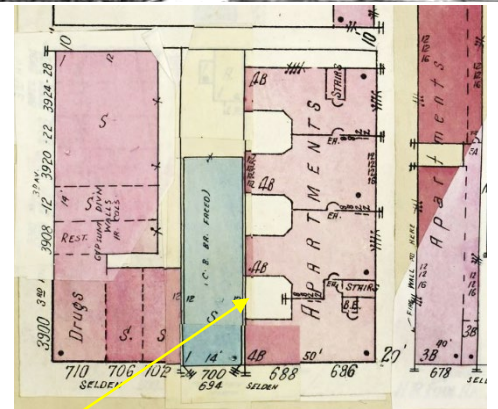
Sanborn Map, Vol. 2, 1921 – 1950

- The Sanborn map shows that the block on which 686 Selden sits was filled with structures that obscured the now exposed west elevation. The outline of the building that had been erected at 694 Selden remains evident on the west-facing walls of 686 Selden.
- The stone wall at the first floor does not appear to have included windows (unlike the east wall), but it remains an integral component of a distinctive character-defining feature of the building. Furthering this point is the fact that face brick was used on the upper wall, while the remaining bays were covered with common brick.

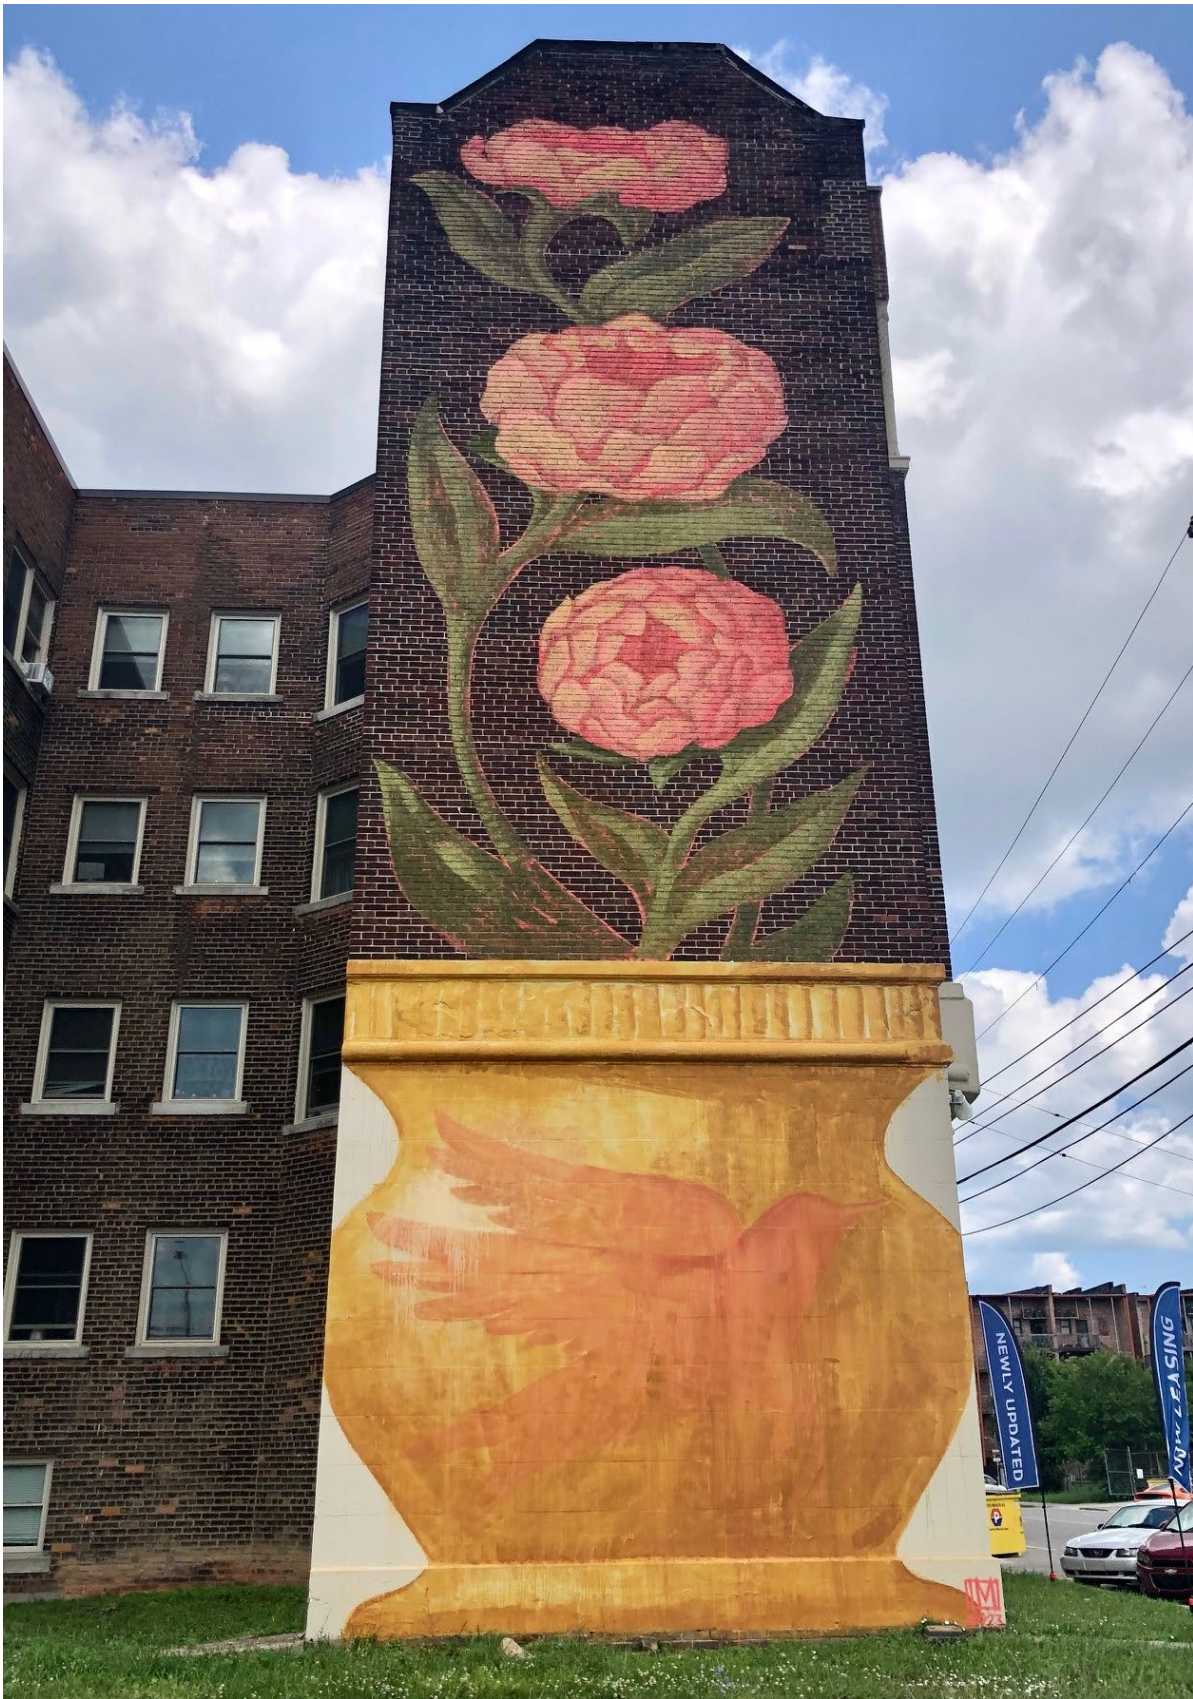
Staff photo, July 21, 2023. Note that this southernmost elevation at the street incorporates face brick and finished stonework, as distinct from the other three areas. The artist here used the ornamental band of stone as the rim of the painted vase.

Recommendation One – Denial – Application of mural to southernmost west-facing bay
