STAFF REPORT: 10/11/2023 REGULAR MEETING
APPLICATION NUMBER: HDC 2023-00048
ADDRESS: 14551 WARWICK
HISTORIC DISTRICT: ROSEDALE PARK
APPLICANT/ PROPERTY OWNER: STEVEN MITCHELL
DATE OF PROVISIONALLY COMPLETE APPLICATION: 9/18/23
DATE OF STAFF SITE VISIT: 6/22/23, 9/21/23

SCOPE: ERECT GARAGE ADDITION

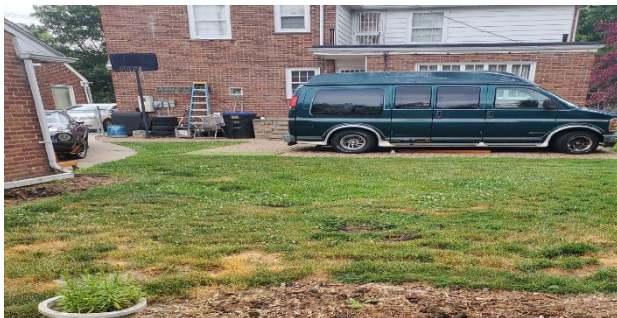
Site Photo 3, by applicant: garage site, rear yard, looking east.

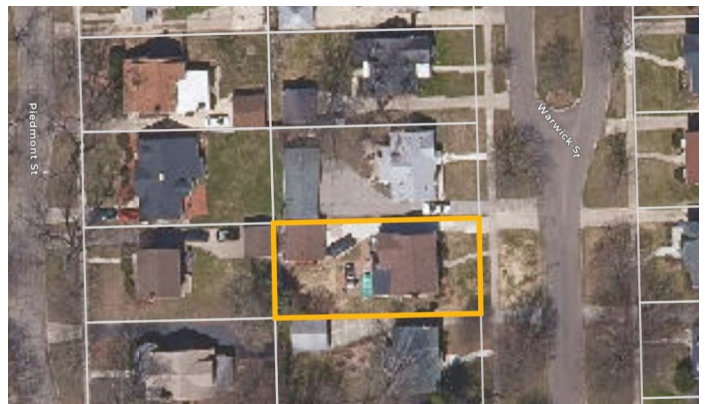
Aerial#1 of Parcel # 22086433, showing existing garage and patio (with vehicles parked on it) behind the house.

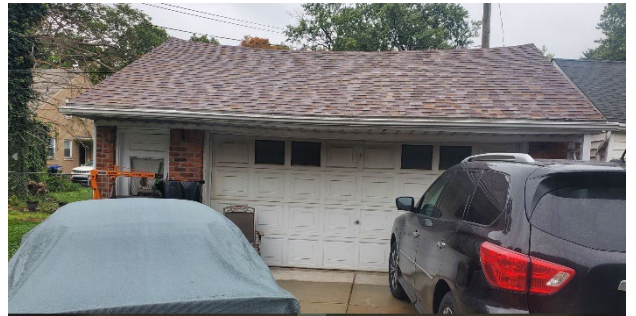
Site Photo 4, by Applicant (East elevation): showing existing garage.

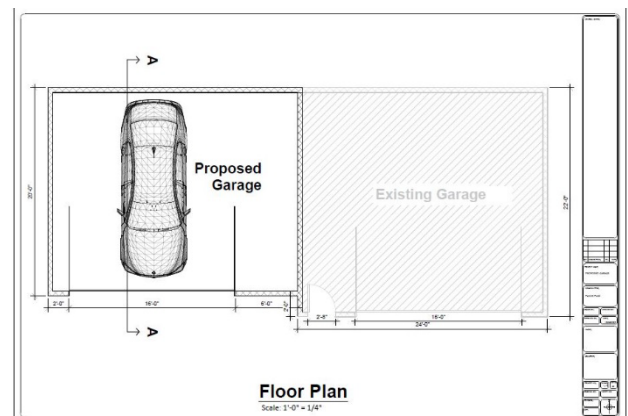
Figure 2, by Applicant: showing proposed floor plan for the garage addition. Note that existing garage wall appears to remain in place, but the existing window opening is not shown.

- Staff noticed that the existing garage’s south facing wall and window appear to be untouched by the proposal’s drawings. Staff requested confirmation that this is true but did not receive a response at the time of this report.

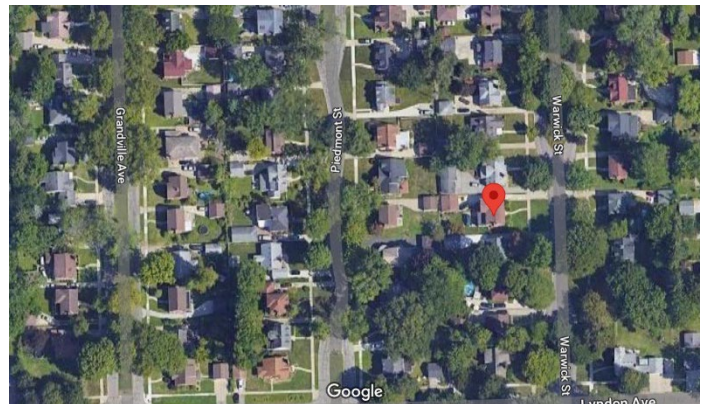
Aerial #2 of Rosedale Park HD, showing applicant's location in the context of other resident's back yards.

- A review of aerial images of the district revealed that most of the space within rear yards is typically dedicated to grass turf/landscaped open lawns with minimal hardscape intrusions to include walkways, patio, and narrow driveways. (See Aerials #1 & 2) When detached garages are present within the district, staff noted that parcels typically include only one such structure of a footprint/scale that is minimal in relationship to the home, leaving ample open green space in the rear yard. The current project will result in modest removal of the open lawn space within the rear yard. It is staff's opinion that these conditions are compatible with the home's and the district's historic character. The work therefore meets the SOI Standards.
