**STAFF REPORT:** NOVEMBER 8, 2023 REGULAR MEETING      **PREPARED BY:** T. BOSCARINO  
**APPLICATION NUMBER:** HDC2023-00071  
**ADDRESS:** 1200 LONGFELLOW  
**HISTORIC DISTRICT:** BOSTON-EDISON  
**APPLICANT/OWNER:** IVAN ALEXANDER  
**DATE OF PROVISIONALLY COMPLETE APPLICATION:** OCTOBER 15, 2023  
**DATE OF STAFF SITE VISIT:** OCTOBER 21, 2023

**SCOPE:** ERECT GLASS DOME STRUCTURE AND FENCE (REVISION TO PREVIOUSLY APPROVED APPLICATION)

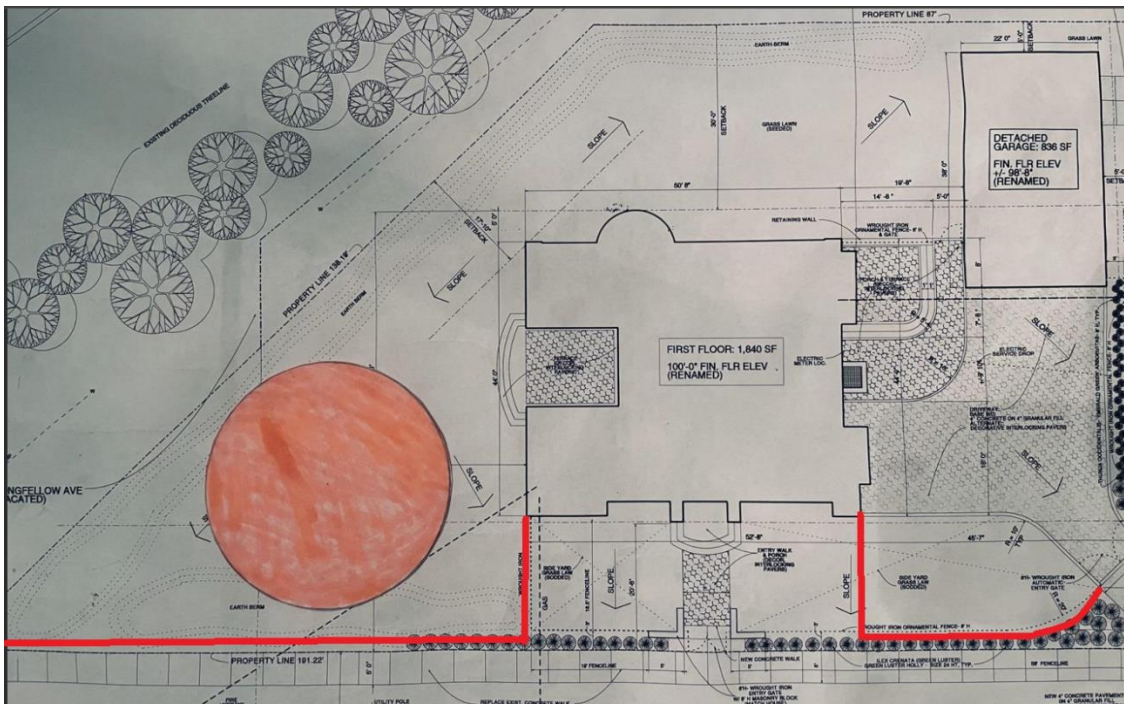
Site plan from application documents with proposed dome shown in orange; red lines added by staff to show approximate location of proposed fence.

The applicant proposes to erect a 19’ geodesic dome with aluminum structure and glass panels. The structure would be located partially in the front yard. Also proposed is a 6’ fence of wood, possibly with brick or stucco posts.

- In addition to the architectural incompatibility, the proposed dome is also partially located in the front yard, interrupting a character-defining open space and disrupting the wall of continuity that is “created by the buildings with their uniform setbacks within the blocks” and “generally consistent within each block or area” as noted in the Elements of Design quoted above.

- Further, the proposed dome location is partially within the former Longfellow right-of-way. Even if partially concealed behind a fence, it would be readily visible along the length of Longfellow to the east, and would further the disruption of the traditional street grid that began with the construction of the expressway.

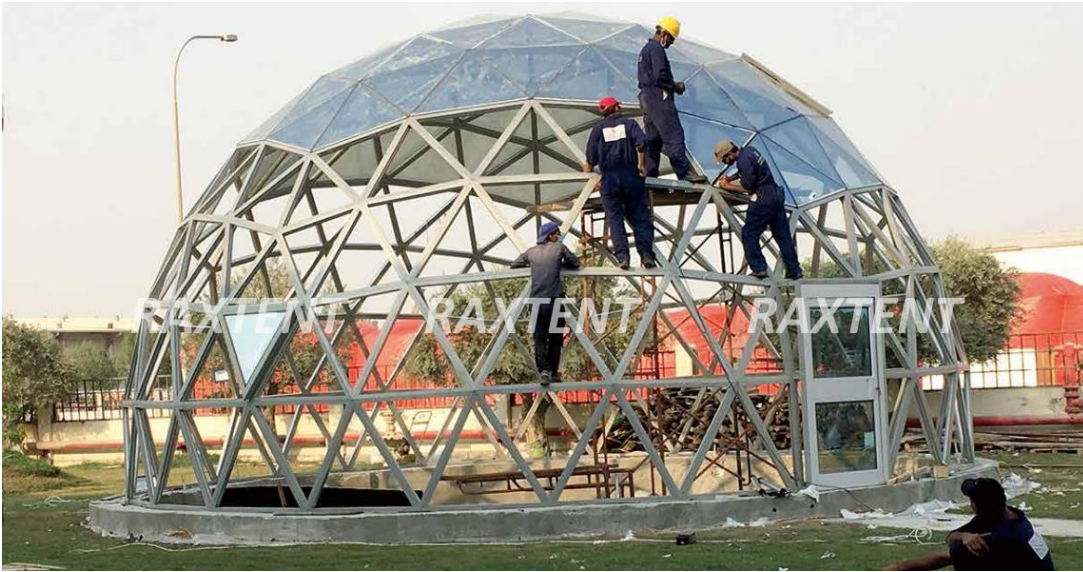
*Photo of example dome from submitted product brochure.*

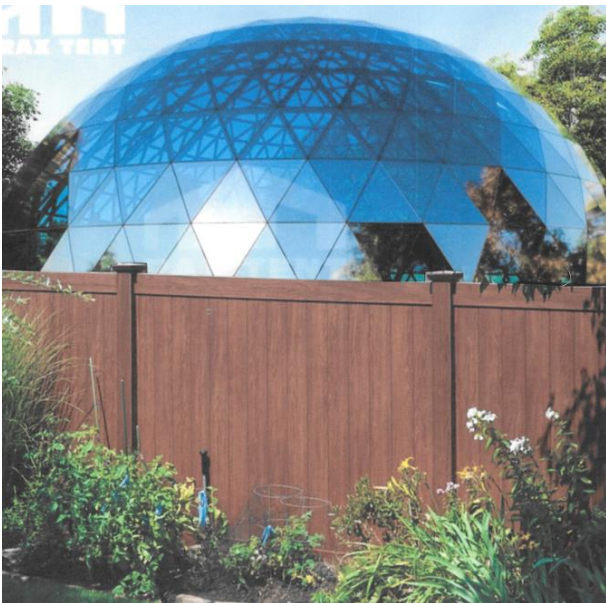
*Rendering of dome screened by fence, submitted by applicant.*

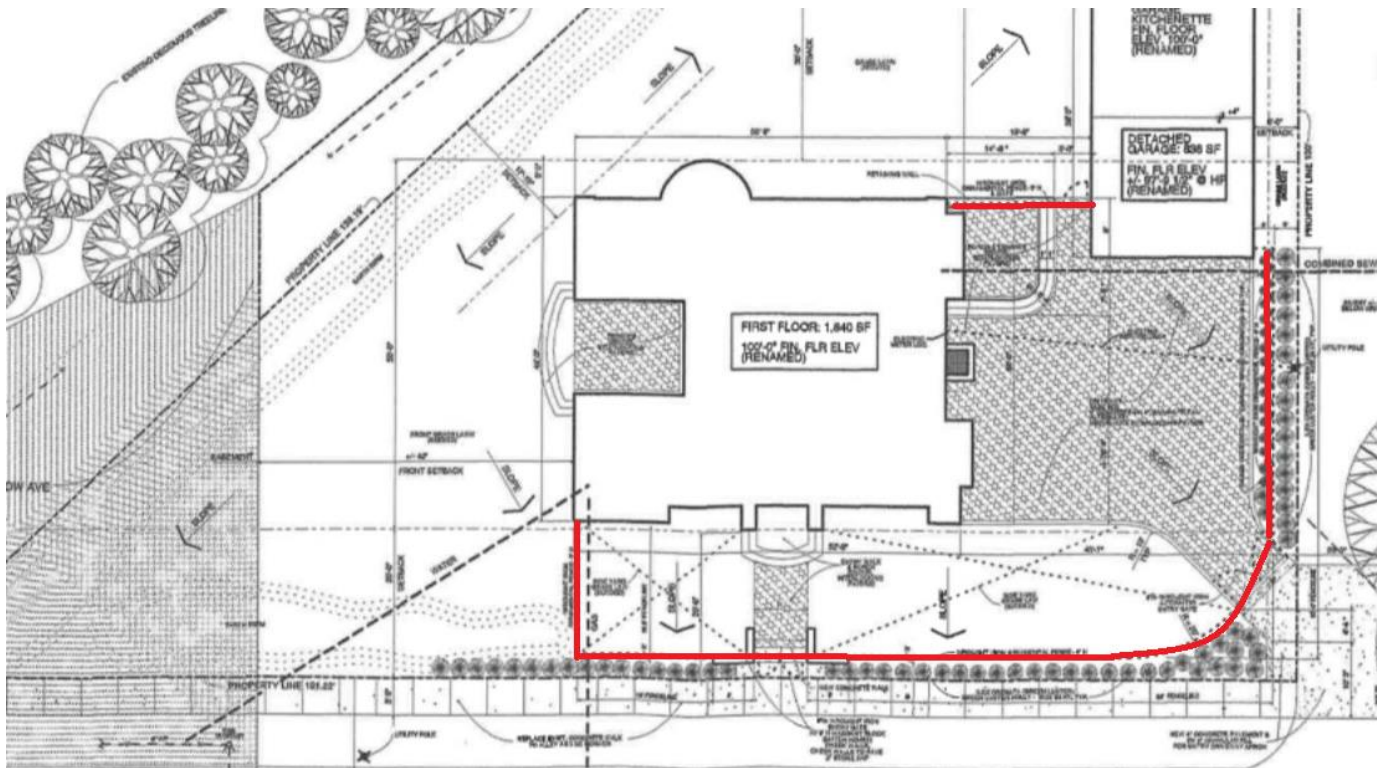
Red line drawn by staff indicates 2008 fence proposal for which a Denial was issued. Site plan from 2008 application documents.

- The staff report associated with the 2008 Certificate of Appropriateness and Denial states “fences should start at the front face of the house and surround the rear yard” and opines that the fence should be no more than six feet tall. This is consistent with the Historic District Commission *Fence and Hedge Guidelines*. The 2008 staff recommendation was that the fence be approved with the condition that it be set back at the plane of the façade of the house. The Commission subsequently issued a Denial for the fence but did not specify a reason for the decision other than a finding that the proposed fence failed to meet Standard #9 of the Secretary of the Interior’s Standards for Rehabilitation (quoted below).
