STAFF REPORT 02-07-2024 MEETING

APPLICATION NUMBER: HDC2024-00020

ADDRESS: 477 WEST ALEXANDRINE

SCOPE: ERECT MULTI-FAMILY BUILDING WITH REAR PARKING LOT

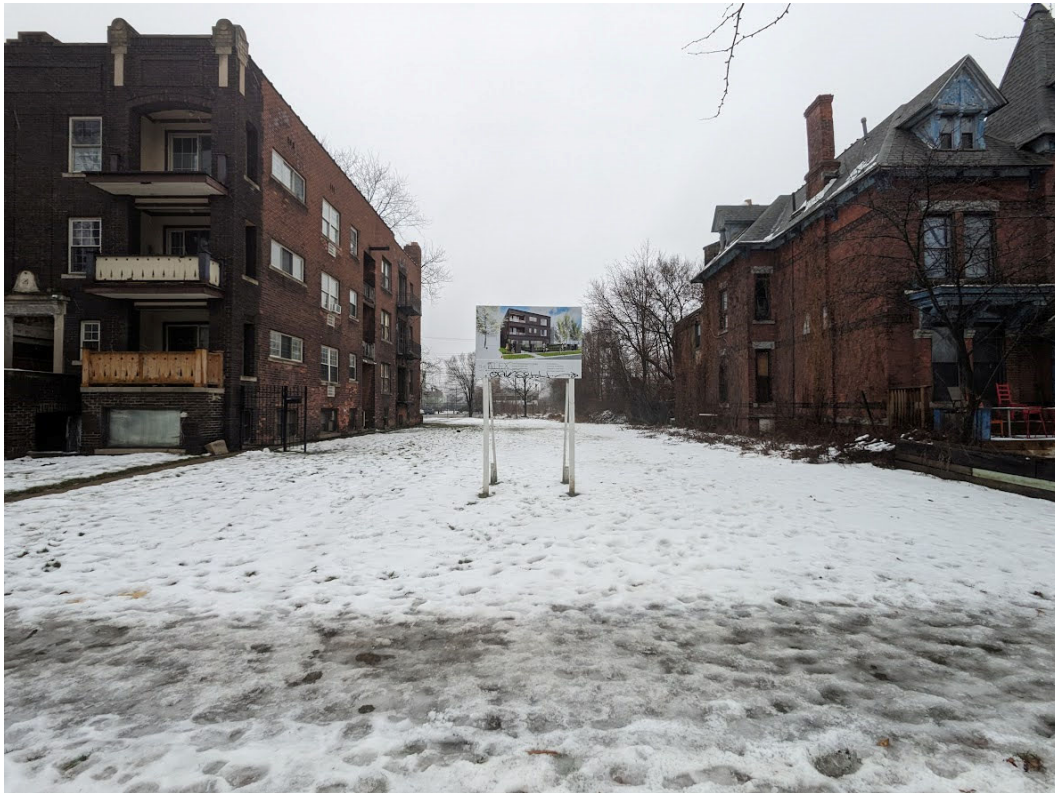
View of 477 West Alexandrine, looking to the south, Staff photo, January 24, 2024.

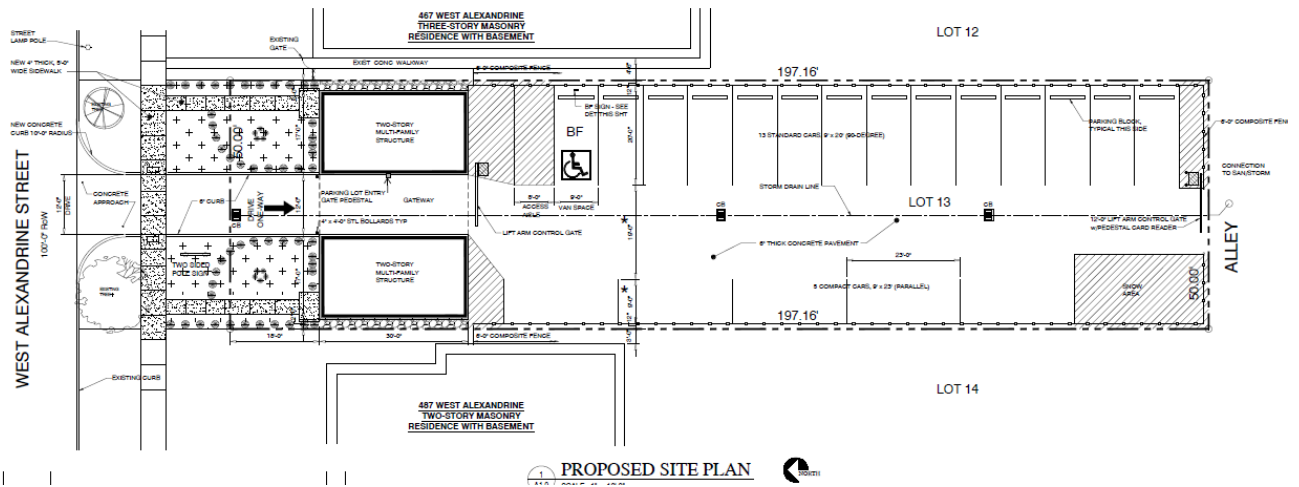
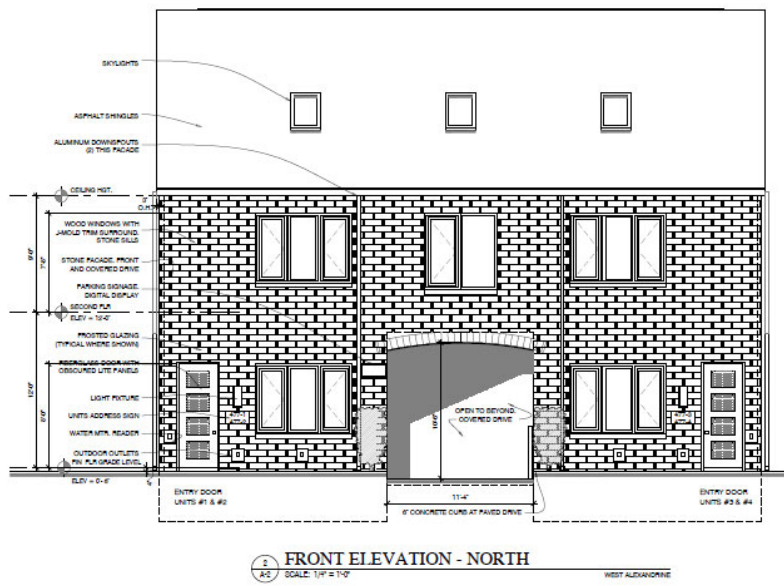
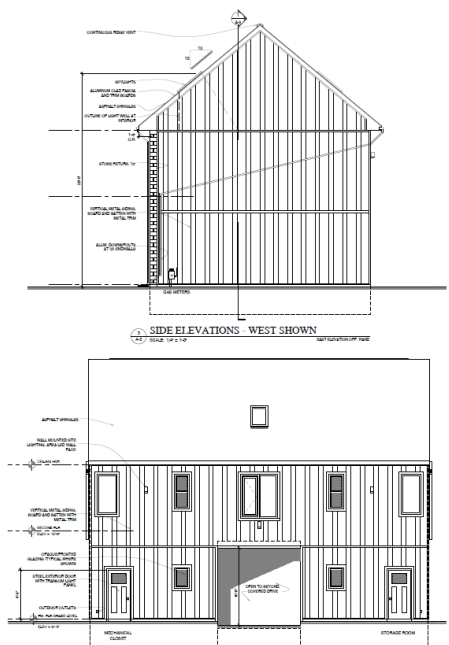
Application submissions, including site plan (above), front elevation (below left), and side/rear elevations (below right). Note side/rear elevations are proposed to be metal panel. Images not to scale. Compare architectural front elevation here, featuring coursed stone, to the rendered elevation on the next page.

- However, what is less compatible, in staff’s opinion, are some of the details proposed for the building. For instance, Element 6, which describes entrances and porch projections, notes that entrances are often set beneath gable-roofed or arched openings. The proposal features a basically flat front elevation with no projections – a projecting gable or arch canopy over the entry drive, sensitively handled, would address this deficiency and move the building towards conformance. Similar projections should appear over the flanking residential entry doors to add interest and depth to the façade.

- Element 11 highlights the important complexity found in roof shapes and related details, including chimneys. The proposal offers a very plain side-gabled roof, with only gutters and skylights offering minimal visual interest. The metal panel sides have no windows at all. In staff’s opinion, the proposal should add additional complexity and detailing to the roof to conform to this Element.

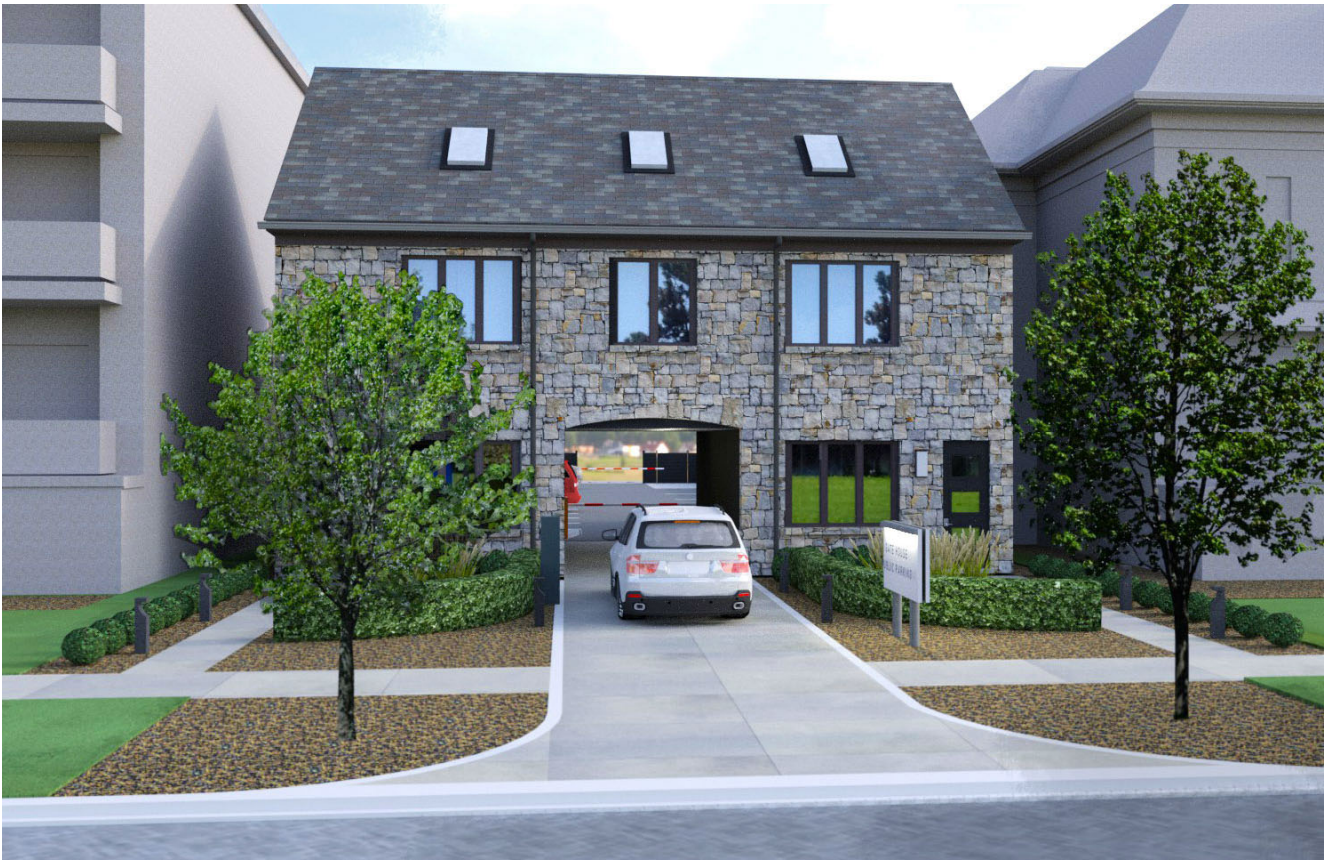
Rendering of proposed project provided by the applicant. Note that the stonework depicted here is of a substantially different character (i.e., contemporary) than the more traditional coursed stone depicted in the front elevation (previous page). The windows are depicted with a high degree of reflectivity, almost as mirrors, which would be inappropriate, in staff's opinion.

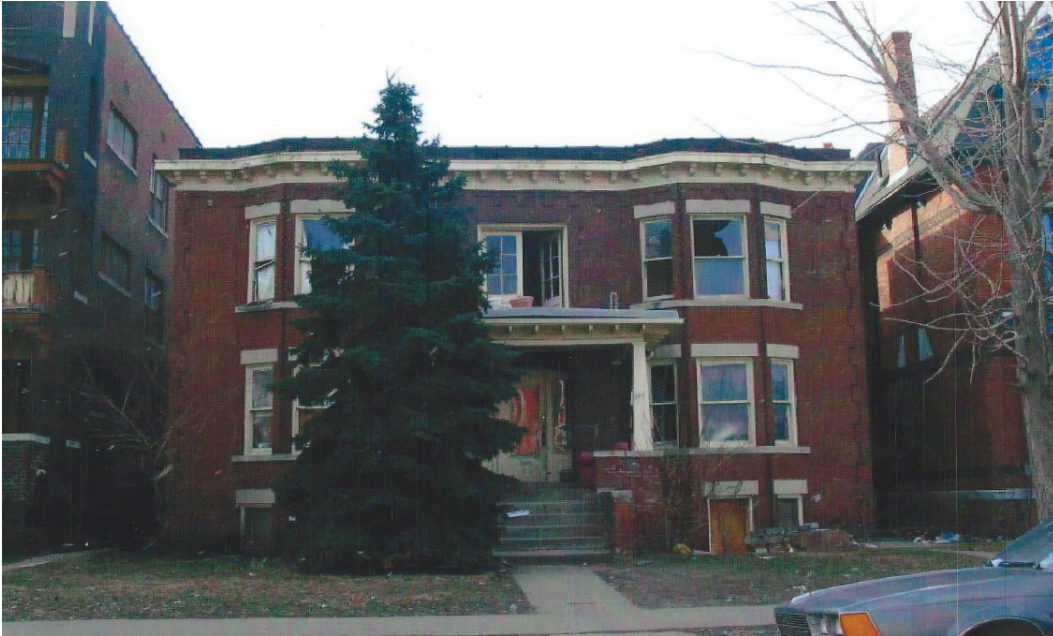
View of original historic building on the site, photo from 2004. Demolished 2018 as an emergency demolition. Staff notes that the proposed new building, subject of this application, has a similar scale, though a different design.

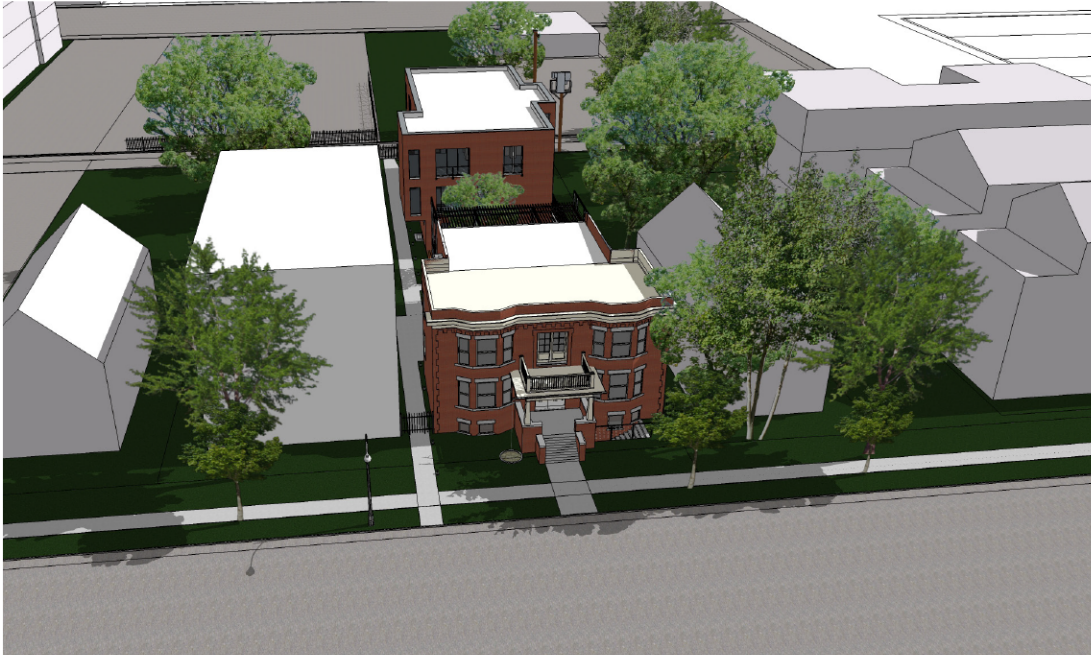
Aerial view of the existing Bretton House with new Garden Apartment Building

Rendering from application for this parcel as approved by the Commission in 2016, two years prior to the demolition of the historic Bretton House building.
