STAFF REPORT: AUGUST 14, 2024 MEETING

APPLICATION NUMBER: HDC2024-00358

ADDRESS: 15035 ASHTON

SCOPE: ERECT ADDITION

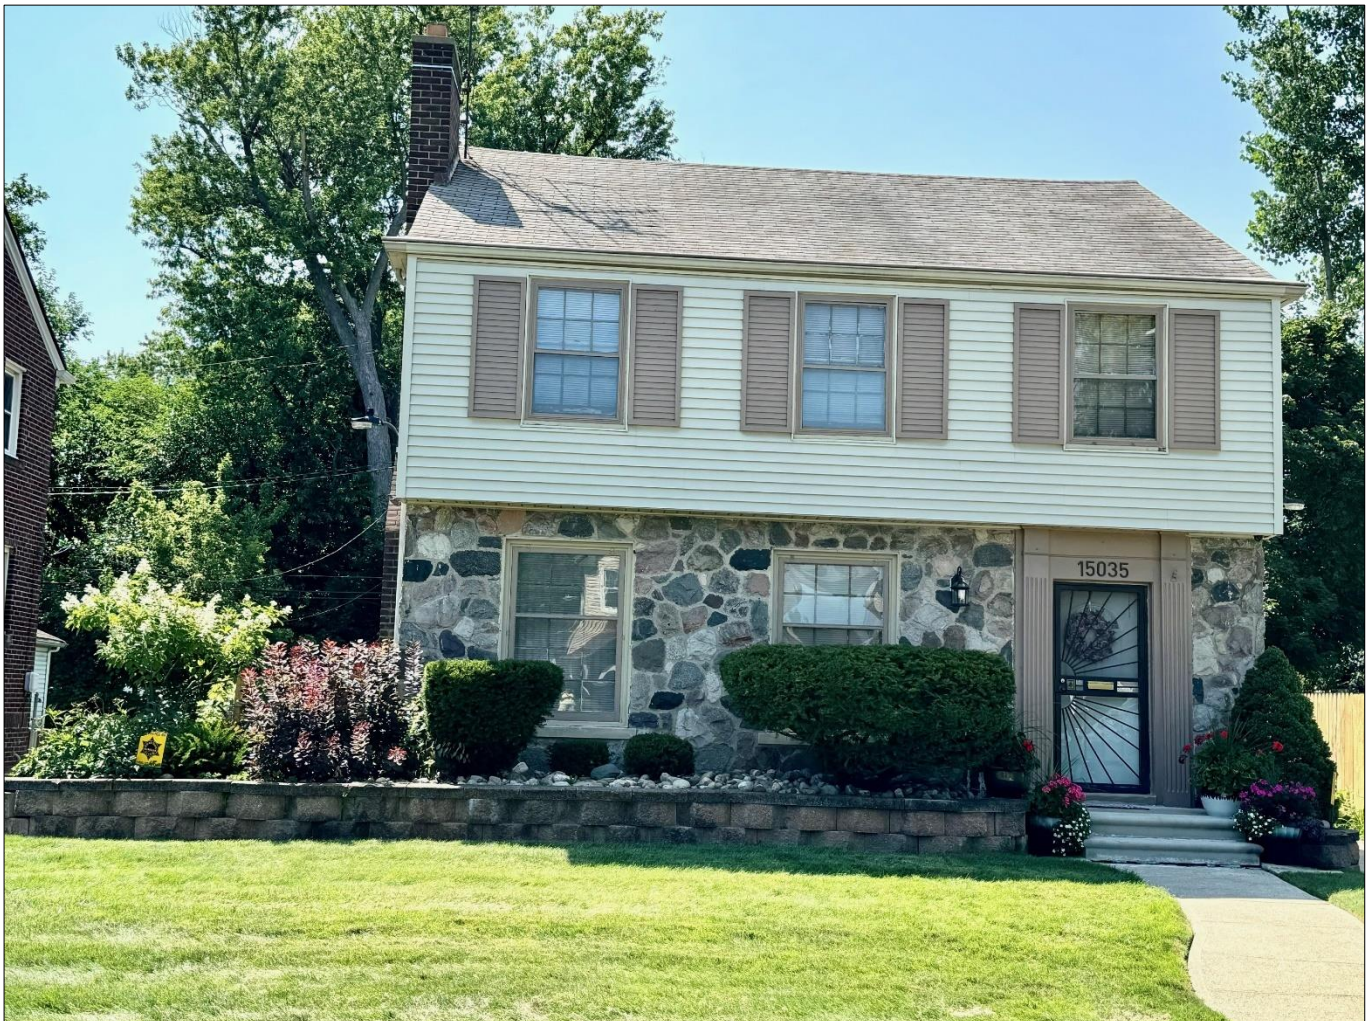
Staff photo, July 26, 2024.

The two story dwelling located at 15035 Ashton was erected in 1950. This Garrison-style Colonial Revival design features a second story overhang which projects slightly outward from the first floor. The front walls of the house are clad with stone veneer at the first floor and vinyl siding at the second floor; the side and rear walls are clad with dark red brick. Asphalt shingles cover the reverse gable roof. The wood windows have multi-light upper and lower sashes. The first floor front windows are cottage-style with a six-over-nine pattern, while the windows at the second floor are equally-sized double-hung units with a six-over-six pattern. The entry door is adorned by fluted pilasters that extend to the underside of the second floor overhang.

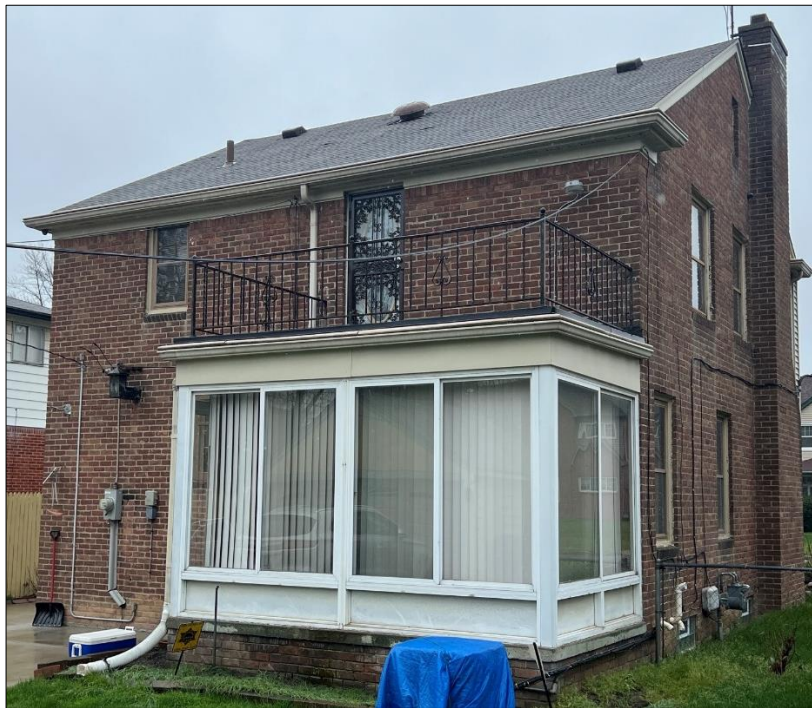
A three-season porch, with open porch above, is located at the southwest corner of the rear wall. The porch's foundation walls are covered with matching dark red brick and topped with a concrete pad. A low framed wall supports full height sliding windows on the rear and south side of the structure, while the north side has a sliding door and small side light. The upper porch is enclosed with a black metal railing.

Applicant photo shows the rear/west wall and south/side wall.

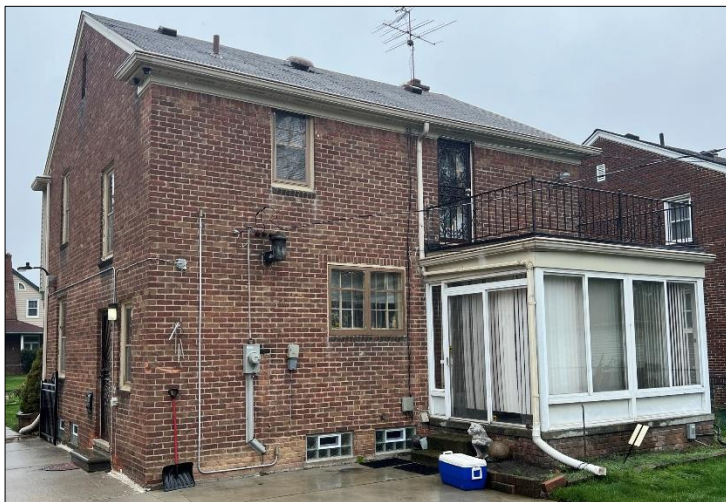
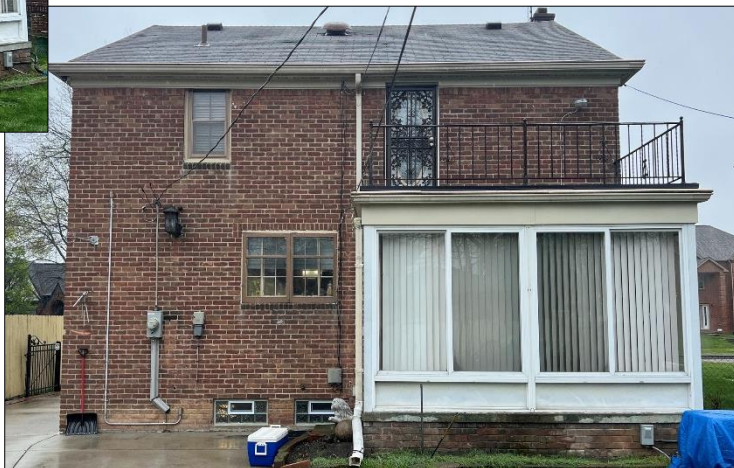
Applicant photos of the north/side wall (above), and the west/rear wall (right).

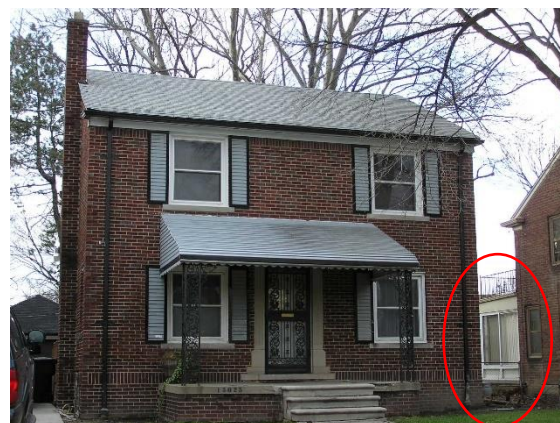
Right: Designation photo of neighboring house (15025 Ashton) which shows the rear of 15035 Ashton, confirming the three-season porch was in place in 2007.

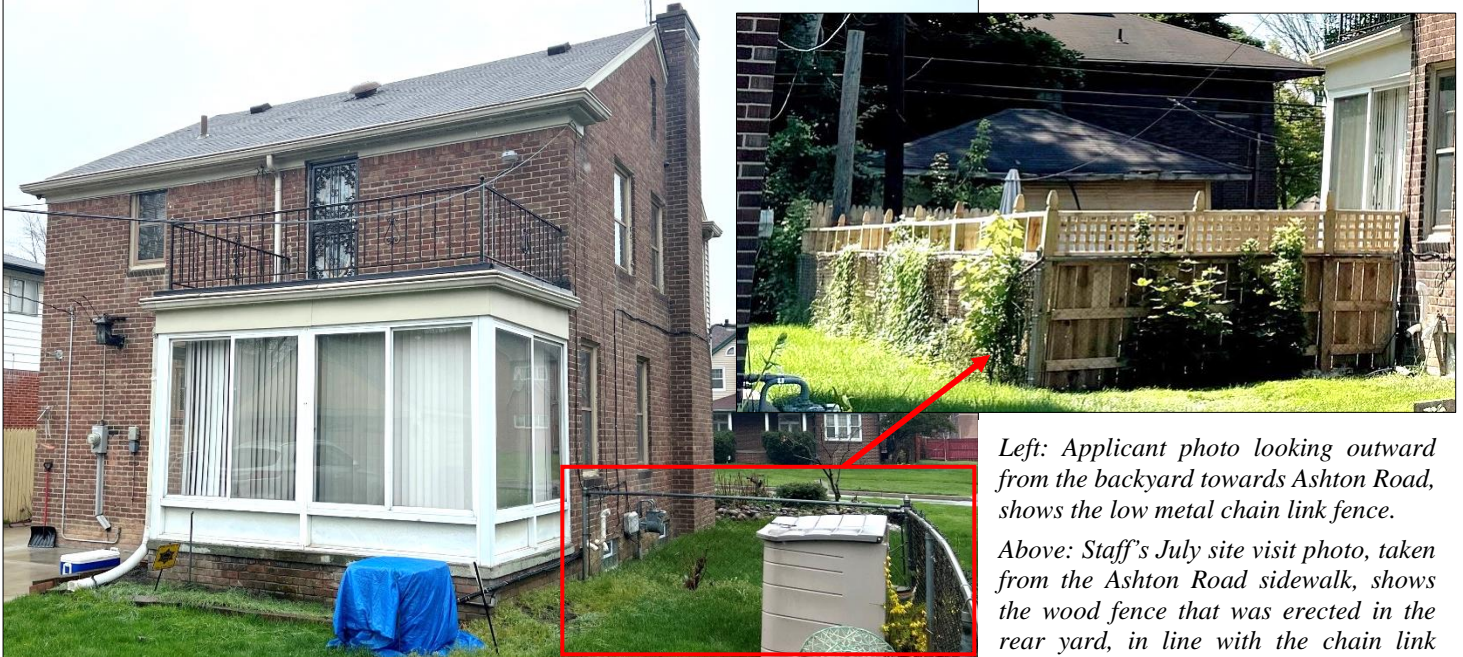
Left: Applicant photo looking outward from the backyard towards Ashton Road, shows the low metal chain link fence.

Above: Staff’s July site visit photo, taken from the Ashton Road sidewalk, shows the wood fence that was erected in the rear yard, in line with the chain link fence.

- Undated photos submitted by the applicant show the southern portion of the rear yard is enclosed by a chain link fence, which staff confirmed was in place at the time of district designation.

However, recent staff photos show a wood privacy fence, topped with wood lattice, has been erected. There is no record of HDC approval for the wood fencing. It is staff’s opinion that the location, wood material, and design fall within the Commission’s fence guidelines, as the lattice element has a square, rather than diamond-shaped pattern. However, the unpainted finish and outward facing support members do not meet the guidelines. Staff has contacted the applicant about this non-approved work.

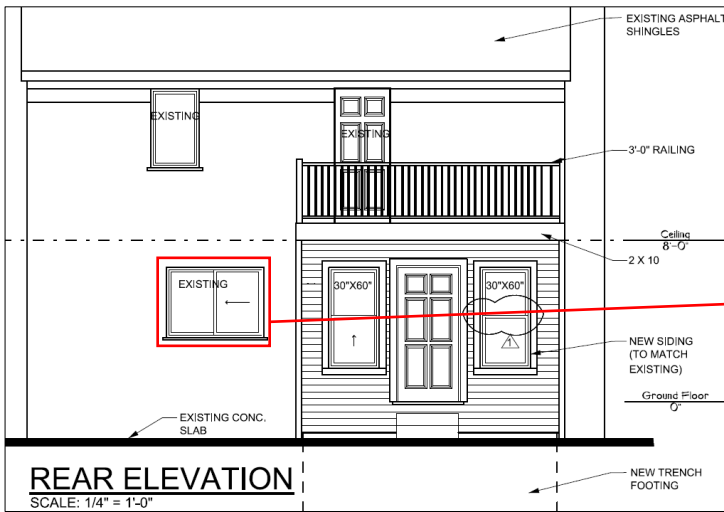
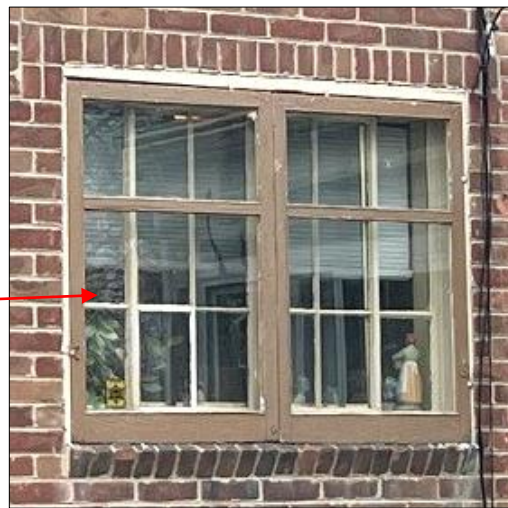
Applicant drawing and photo. Note: the kitchen window is wrongly identified as a sliding window. The existing window is a divided-light wood double-casement unit with single-width sidelights. Staff identifies this window as a character-defining feature of the house.

- The identification of the rear wall window as a slider window must be removed.
 - The stairs and landing required at the new rear door must be fully detailed and include notation(s) for material, finish and color. If this element is constructed of wood, a paint color will be selected and noted on the drawings.

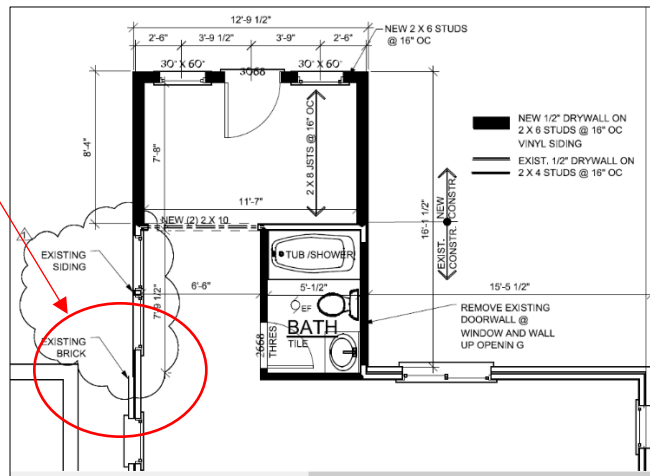
Applicant drawing.

- The porch's southern wall is inset from the house's side masonry wall by 1-2 inches.

There is very little wall framing for the existing porch walls due to the full height sliding windows and sliding door. Therefore, new walls will be constructed within the existing porch's footprint, retaining the small setback from the house's masonry wall.

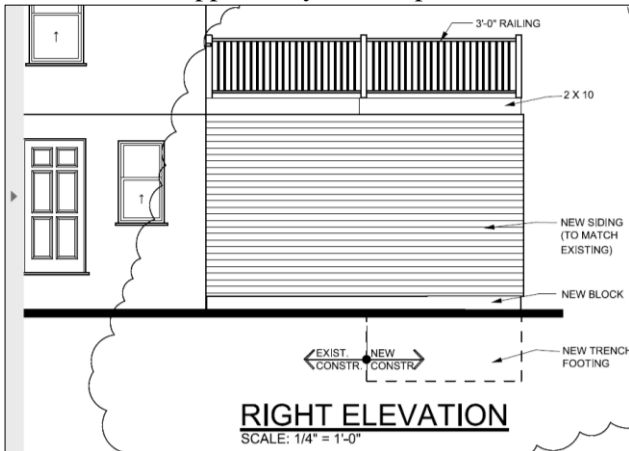
Applicant drawing of north wall.

- The proposed north/side wall will become a solid wall, partially due to the interior design of a full bathroom. The other two walls will have multiple window openings, and the rear entry door will now face the backyard. The above aerial view shows how the interior/north wall is tucked in behind the house and is entirely hidden from public view.

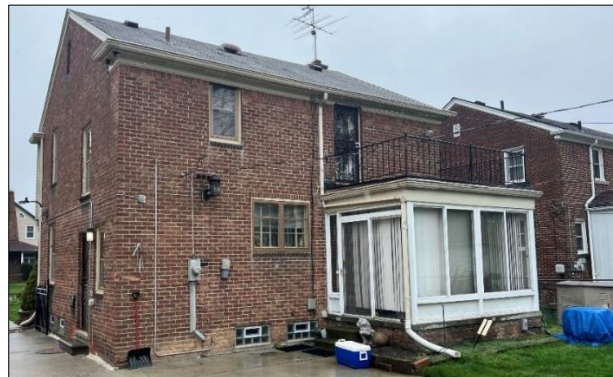
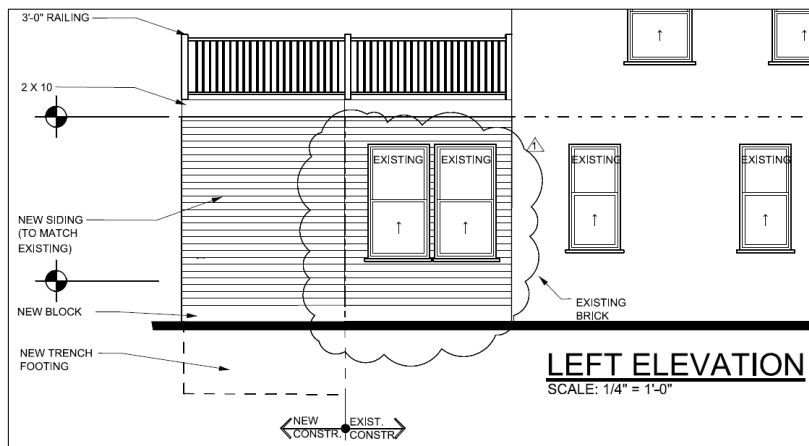
South-side elevation.

- The south/side elevation drawing shows solid walls and smaller double-hung windows, but the drawing states the existing full height windows will remain.
- The application says that vinyl siding “to match existing” will be installed. Vinyl siding is present on the front wall and has been in place since district designation. It is staff’s assumption the vinyl siding covers the original historic wood siding. The Commission consistently doesn’t approve the installation of vinyl siding, so there will be the opportunity to re-expose the wood siding when the vinyl deteriorates to the point of replacement.

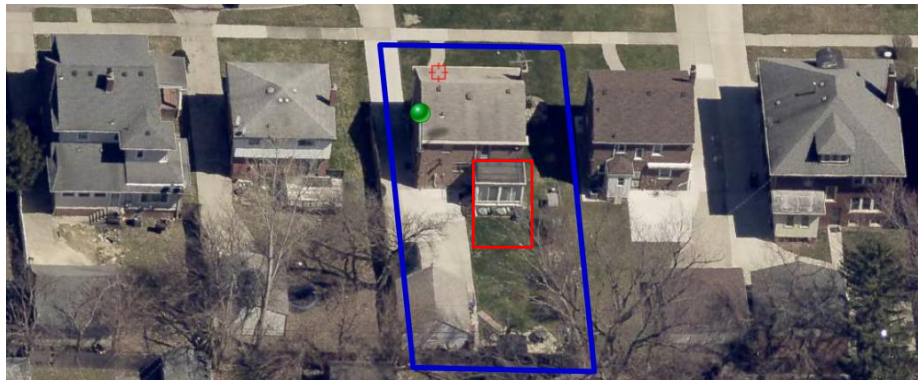
Aerial photo, April 2022. EagleView. Location of proposed work to be within red box.

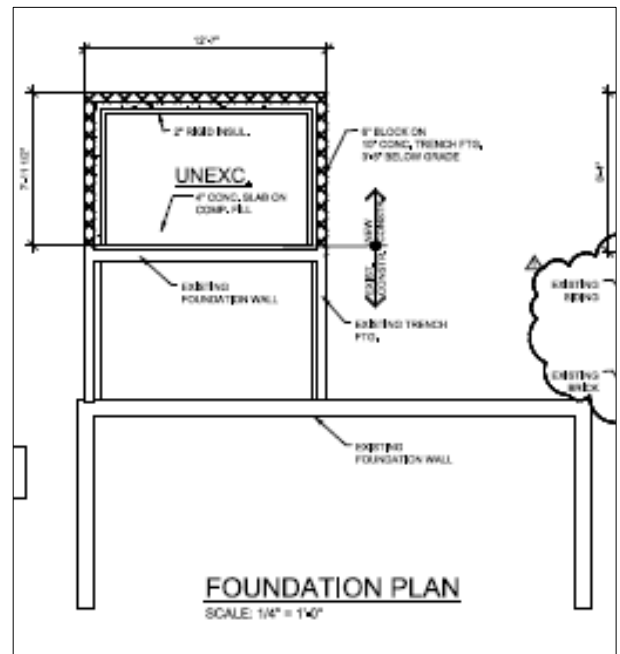
Applicant drawing.

It is staff’s opinion the proposed alteration to the three-season porch and erection of the addition meet the above criteria, with exception of the proposed vinyl siding and vinyl windows.
