STAFF REPORT: 9/11/2024 MEETING

ADDRESS: 1815 SEMINOLE

APPLICATION NO: #HDC-2024-00473

SCOPE: ERECT ADDITION, ALTER CHURCH BUILDING

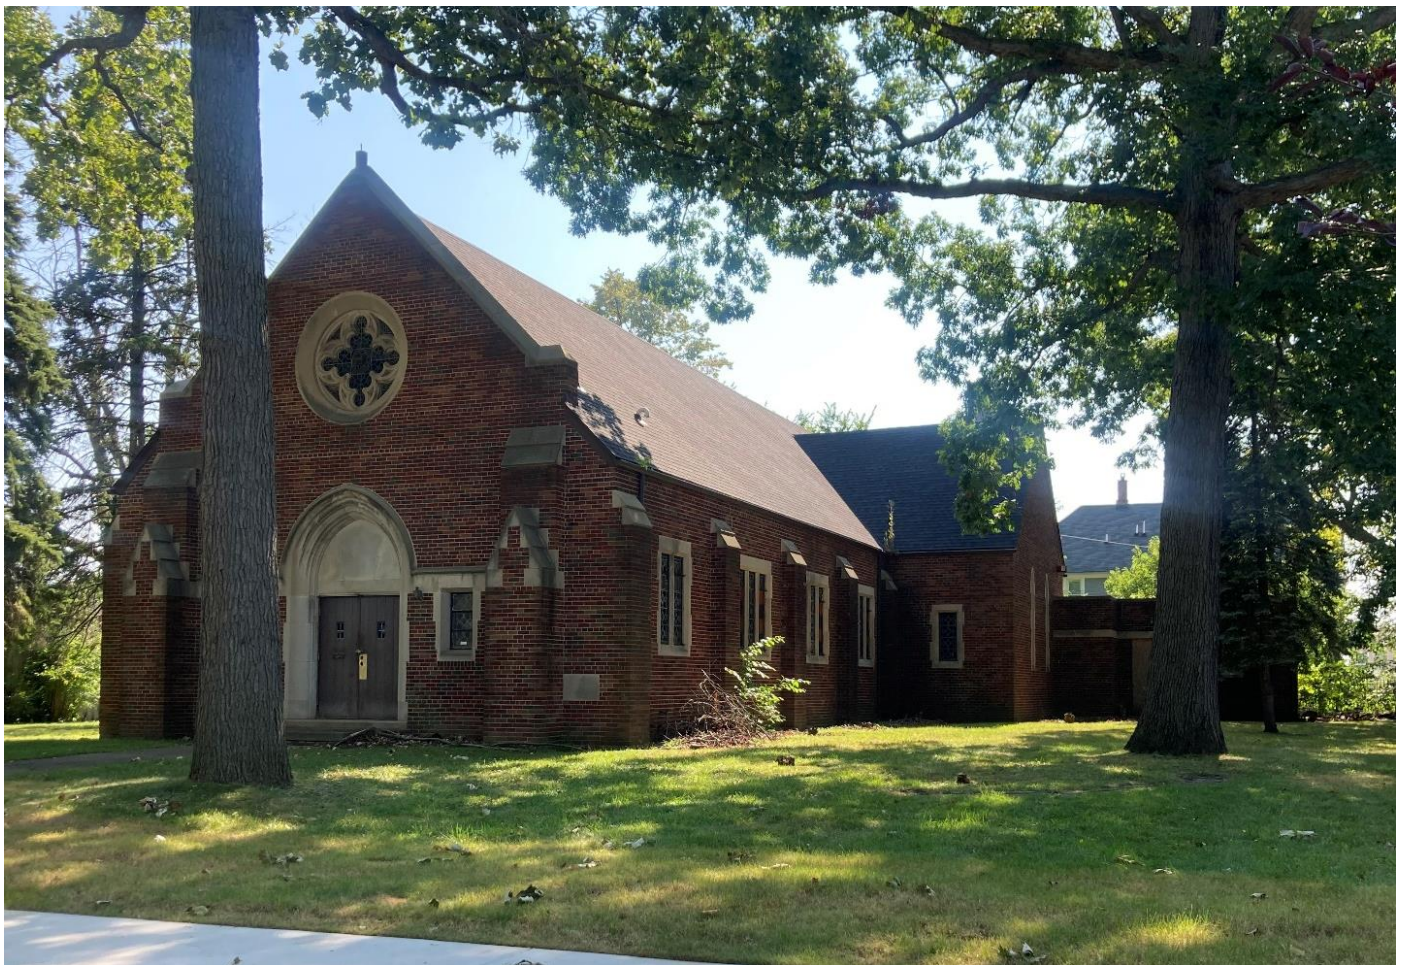
1815 Seminole, current conditions. Photo by HDC staff, 8/31/2024

The building located at 1815 Seminole is a Norman-Gothic style church that was erected at the southwest corner of Seminole St. and Kercheval Avenue in 1949. Known originally as the St. Luke Evangelical Luther Church, the building houses approximately 5,000 square feet and features a cruciform plan, with a projecting gabled-roof central mass with lower, intersecting gabled and flat-roof wings to the rear. Exterior walls are red brick with buff-colored stone detailing around windows and doors. Stone accents are also present at the end and side buttresses. Windows are the original steel casement units and feature both decorative lead coming and multicolored-glass panes. One glass block window is located in the rear southwest side of the building. The front/west façade retains the building's original vertical wood plan doors.

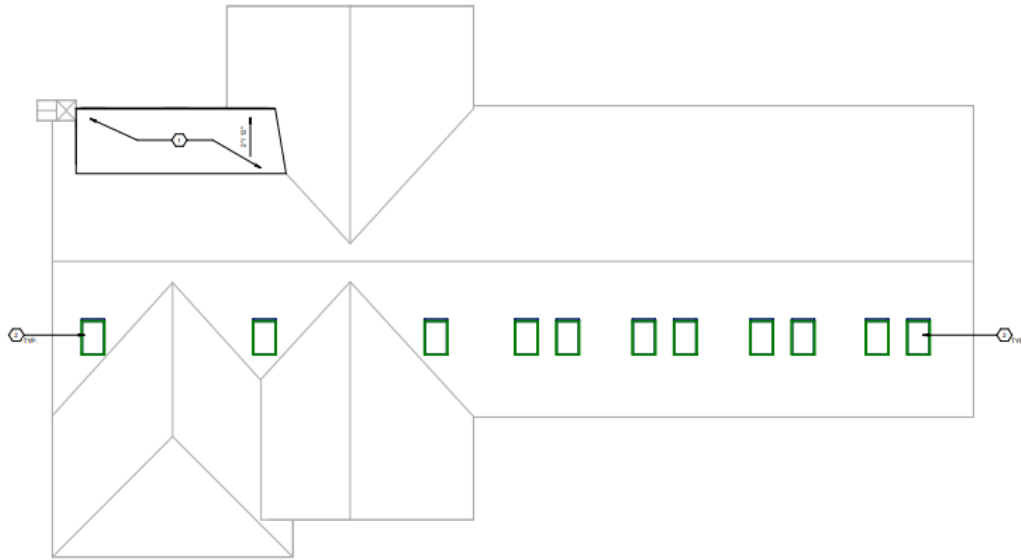
- Install 11 new 30" x 60", fixed aluminum skylights at main roof surface, on the south side
- At rear, flat roof wing roof, establish a rooftop patio to include installation of composite decking and guard railing (minimum of 36" in height)

1815 Seminole, proposed roof plan

- The application does propose to install new skylights at the south roof surface while retaining most of the building’s original windows. Per the submitted roof plan, the skylights will not extend past the roofline. The product cutsheet indicates that the skylights will be fixed and each will include a flat, clear glass vision panel. Although the skylights each measure 30”x60”, the applicant is seeking to install a row of 11 skylights, which will extend the full length of the south roof surface. When viewed from the public right-of-way facing west/northwest, the proposed grouping of 11 skylights will present as a highly-visible modern intrusion that is not compatible with the building’s historic character. Staff recommends that the number of skylights be reduced/the row of skylights be pushed back to the west so that the element will be less conspicuous from the street/sidewalk.

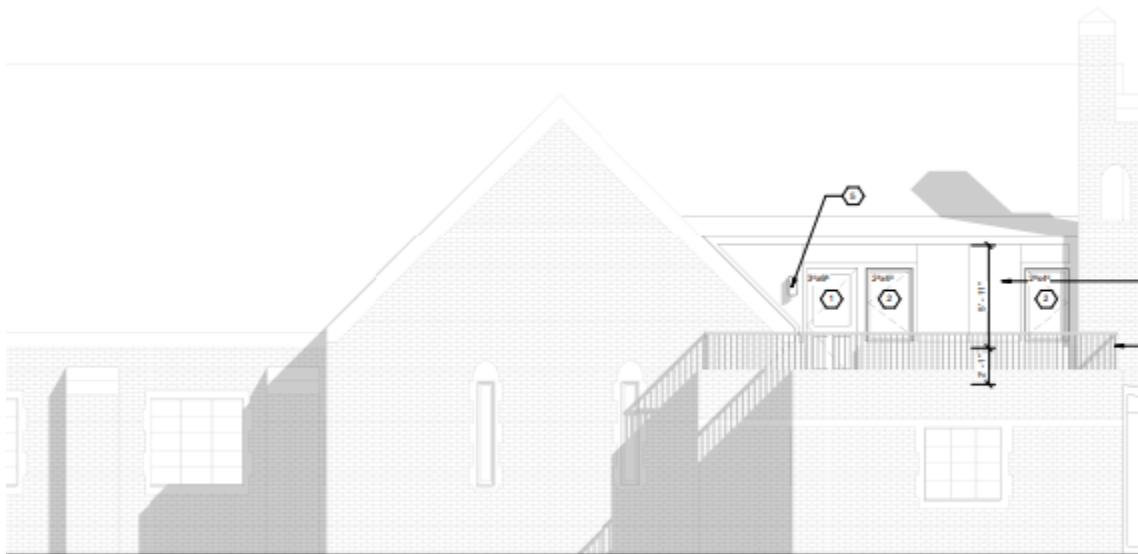
- At the rear/northwestern edge of the roof, above the flat roof wing, install a 5’-11” high, shed-roof dormer which shall be clad with lapped composite siding. A single wood door and two aluminum-clad wood casement windows will be located at the dormer’s north wall.

Proposed north elevation, showing new dormer which will be added to the roof, at the building’s rear/northwestern corner

- The application does propose to restore the primary, street-facing Seminole and Kercheval elevations, including rooflines, stone detailing, leaded ornamental (stained) glass, and the steel casement windows. The only new work proposed for these elevations is the new dormer, which will be inconspicuously located in the roof's northwest/rear corner, above the flat-roof, one-story wing.

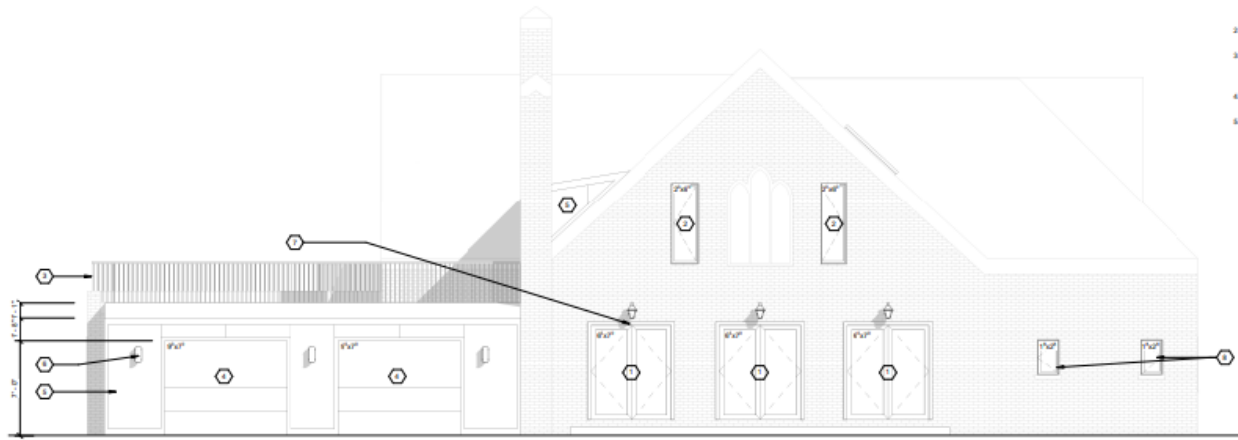
- Demolish rear/west wall of flat-roof, one story wing (which includes three historic steel casement windows with non-historic, multi-colored glass panes) and install new 9’-9 high, 6’-7” deep, shed roof extension/addition to rear wall of flat roof wing. Exterior walls of the new addition will be clad with composite lapped siding. Two flush panel steel overhead garage doors and contemporary sconces (cutsheets which depict specific style not provided) will be located at the addition’s west wall

- Replace two original 3-lite steel casement windows with colored glass panes with single lite aluminum clad wood casement windows
- At second story, in gable end, add two new 2’x6’ window openings to accommodate new single lite aluminum clad wood casement windows

- At first story, add three new 6’x7’ door openings to accommodate three sets of paired aluminum-clad wood French doors
- Install a new “traditional style” light sconce over each of the three sets of French doors (cutsheets which depict specific style of sconces not provided)

Proposed rear/west elevation

- The application does propose to utilize the less significant, flat-roof former administrative wing of the building for a new garage with the integration of a small, shed-roof addition to its rear/west wall, facing the alley. It is staff's opinion that the extension will be minimally visible from the public right of way and generally is compatible with the property's historic character due to its placement and scale. However, note that the addition of the extension will result in the removal of three steel casement windows (with non-historic multi-colored glass panes) at the wing's west wall (see the below photos). While the windows are historic age, they are located at the rear wall of the less significant administrative wing of the building. Also, the window openings at the wing's rear wall do not display the same decorative stone surrounds as those found at its more publicly visible front and side walls. Finally, note that the decorative stone course which appears above the window and door openings on the wing's front and side walls is not present at its rear wall. As this wing's rear wall does not reflect the overall design features which distinguish this building in regards to detailing and instead presents a more utilitarian appearance, and its demolition is necessary to accommodate the location of a garage extension, it is staff's opinion that the demolition the wall, to include the removal of the three casement windows is appropriate within the context of the proposed rehabilitation.

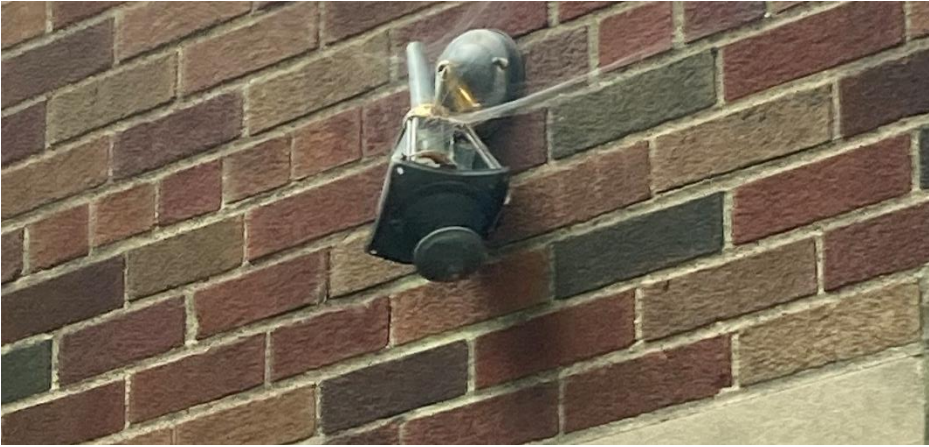
1818 Seminole. Facing light at east wall of the rear flat roof wing which is proposed for replacement. Staff photo taken on 9/6/2024

- The Indian Village Historic District was designated in 1970
- The application is seeking to replace three light fixtures with new sconces (see below). While possibly historic in age (ie., over 50 years old), it is staff’s opinion that they are not distinctive character-defining elements of this church building as their design is utilitarian in appearance and does not reflect the Norman Gothic detailing which distinguishes the resource. Staff therefore supports their removal/replacement.

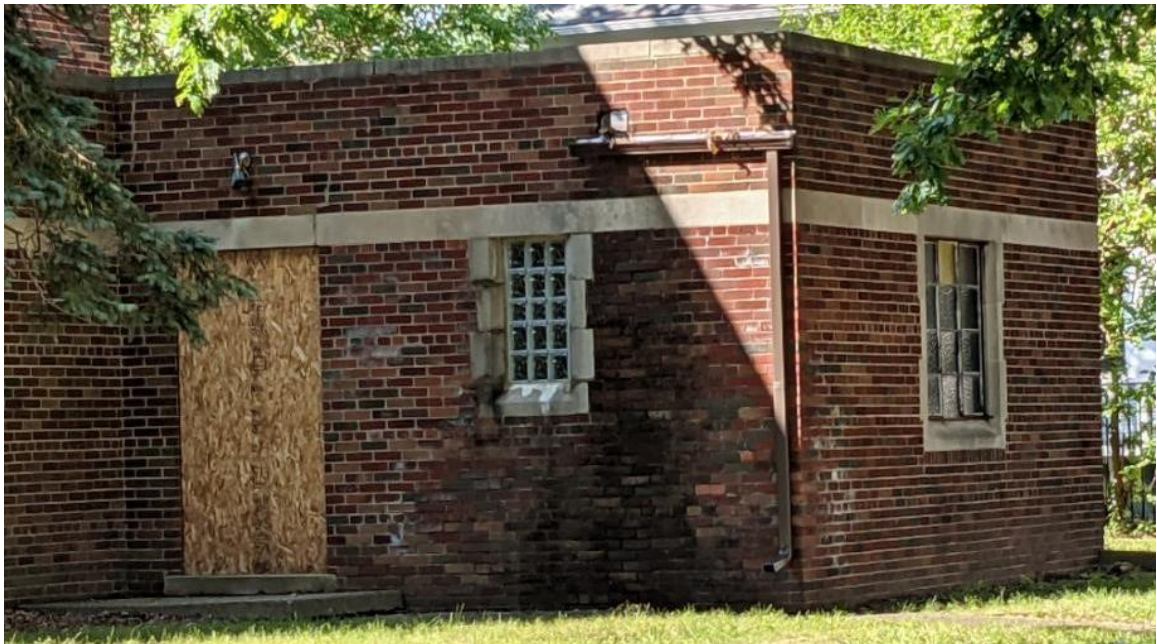
Front and side wall of rear, flat roof wing. Note decorative stone surrounds and stone course above door and window openings. Staff photo taken 9/6/2024

- Note that a steel casement window at the rear, flat-roof wing’s east wall was replaced without HDC approval with glass block in 2023. However, the window opening size, stone sill, and decorative stone surrounds remains intact.

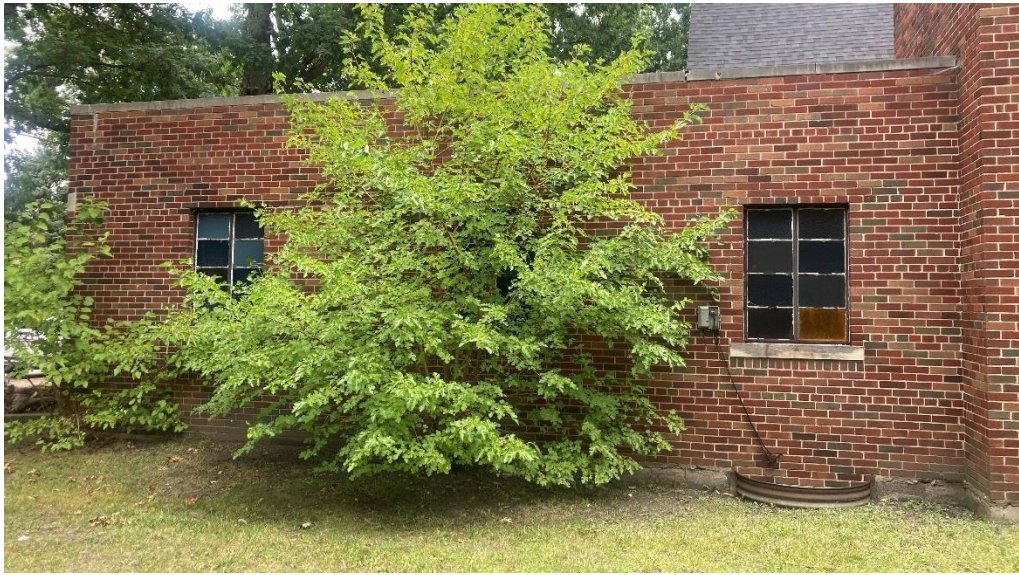
Rear wall of flat-roof wing proposed for removal in order to accommodate new garage extension. Note lack of detailing at window surrounds and wall.

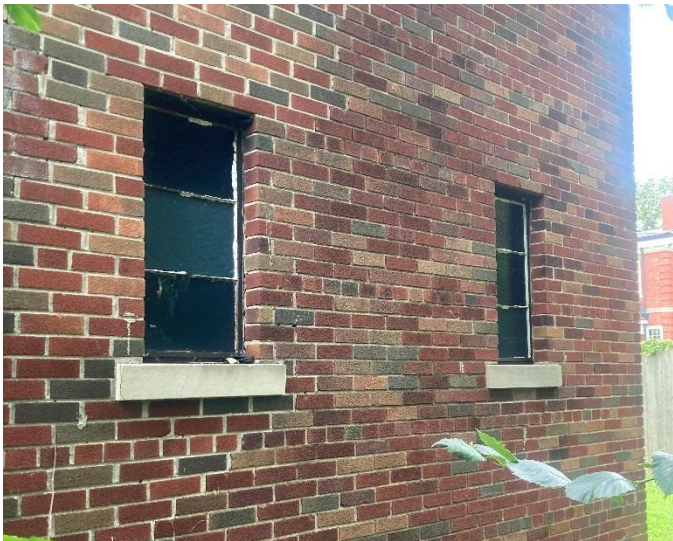
These 2 windows at the rear/southwest corner of the building’s sanctuary are proposed for replacement with aluminum-clad wood casement units. Staff photo taken 9/6/2024

- The new doors and windows proposed for location at the rear/west wall and south wall/ the lower hipped-roof southwest wing of the building will result in the removal of three original steel casement windows with non-historic, multi-colored glass panes (see the below). As is the case with the windows at the flat-roof wing, these windows lack the decorative leaded glass detailing and stone surrounds of the more prominent, significant windows as they are located in a wing that are off the sanctuary, to the rear of the church. It is staff’s opinion that their replacement is appropriate because windows do not reflect the overall design features which distinguish this building in regard to detailing and instead present a more utilitarian appearance than the character-defining windows which are present the building’s sanctuary walls.

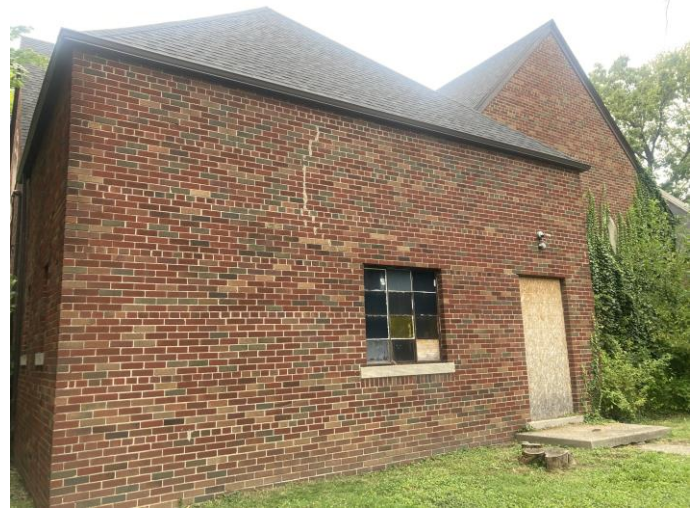
This window at the rear of the sanctuary’s south wall is proposed to be replaced with a fixed aluminum clad unit.

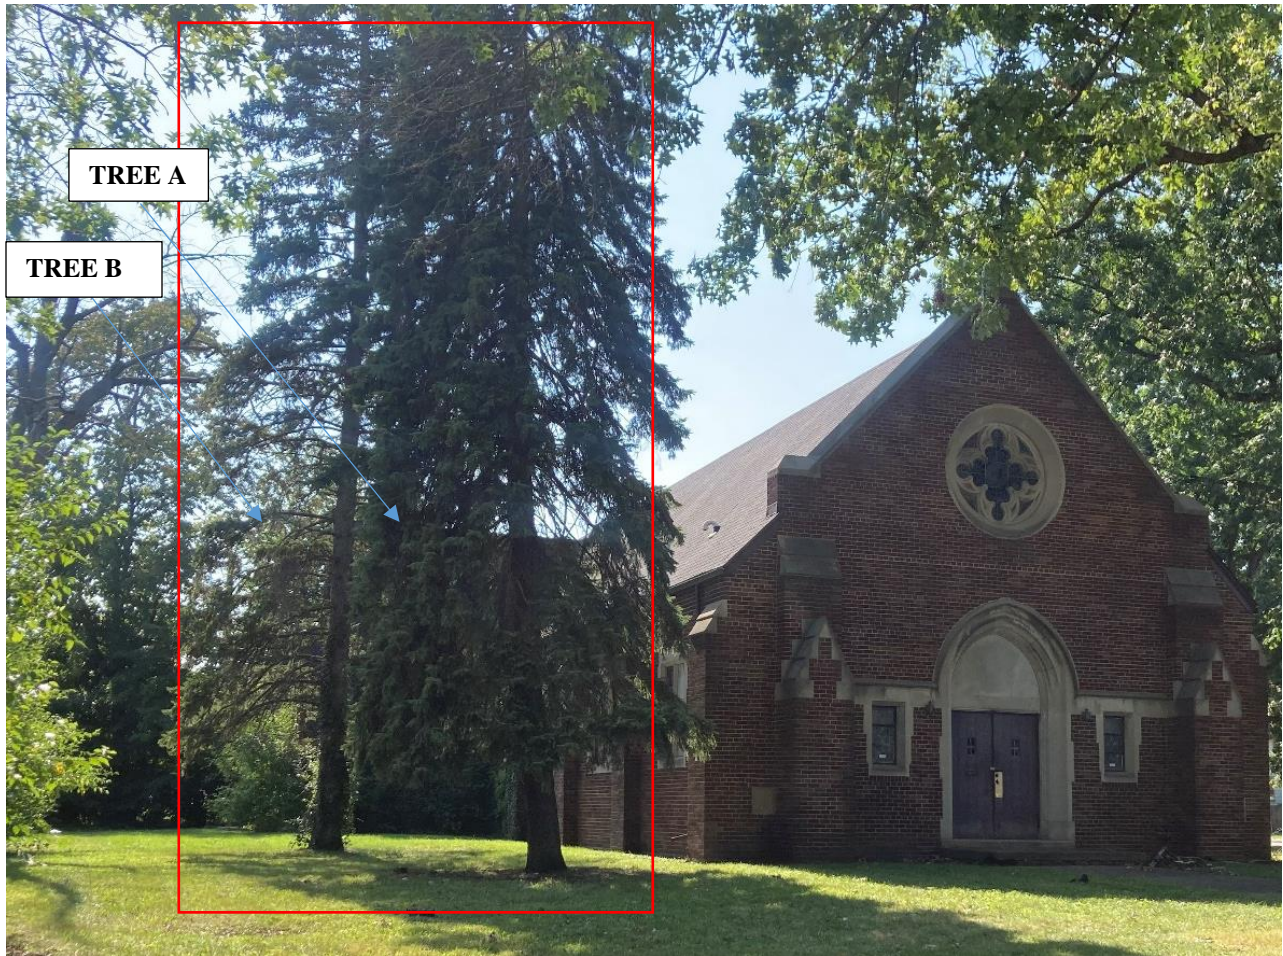
These two trees proposed for removal, facing northwest towards front yard. Staff photo taken on 9/6/2024

- The application is proposing to remove Colorado Spruce trees because they have a fungal disease called Rhizophæra Needlecast per a letter supplied by a landscape designer. Staff’s Landscape Architect did confirm that the diseased trees should be removed because the fungus could spread to other trees on the property. The applicant has also noted that the sick/dying trees could fall on the building and/or neighboring properties. Staff therefore supports the proposed tree removal with the condition that three new replacement trees be planted at the property.

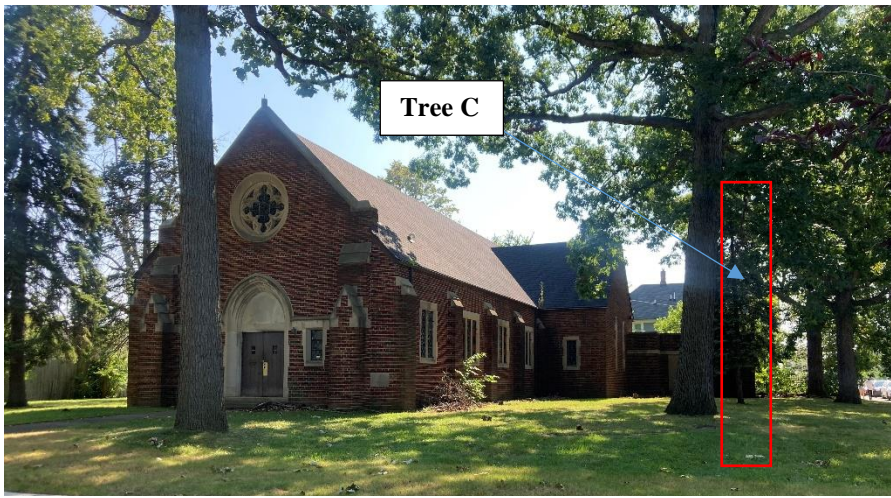
Tree proposed for removal. Facing southwest. Staff photo taken on 9/6/2024
