STAFF REPORT: SEPTEMBER 11, 2024, REGULAR MEETING PREPARED BY: T. BOSCARINO

**APPLICATION NUMBER:** HDC2024-00440

**ADDRESS: 311 WATSON**

**SCOPE**: ERECT CARRIAGE HOUSE

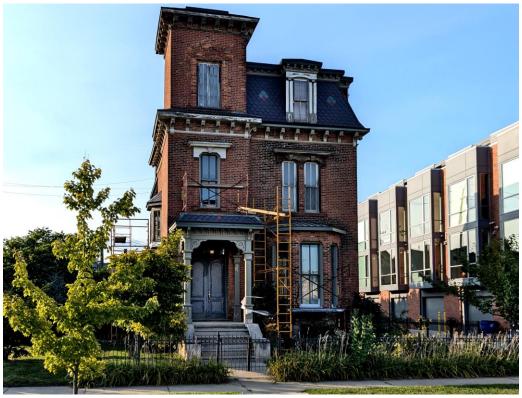
311 Watson viewed from the south. August 2024 photo by staff.

311 Watson is a two-and-one-half-story, Second Empire house built in 1885 and facing south onto the street. Character-defining features include a rusticated stone foundation, elaborate wood first floor porch and brick bay window, wood two-over-two windows, limestone sills and stone window hoods, offset masonry tower, decorative eave brackets, Mansard roof clad in slate, and shed-dormer attic windows.

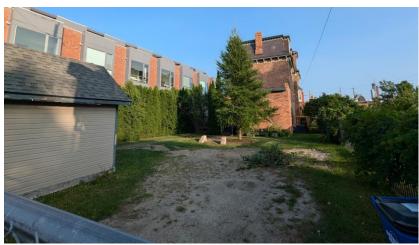
The subject property viewed from the alley. August 2024 photo by staff.

Subject of this application, the back yard contains a small shed and is otherwise not developed or landscaped.

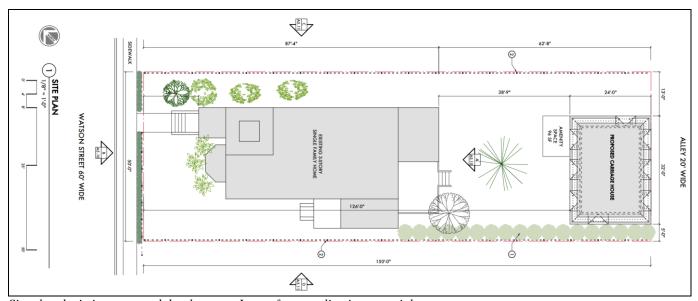
Site plan depicting proposed development. Image from application materials.

The applicant proposes to demolish the existing shed and erect a new building, described as a "carriage house," at the rear of the property.

- The overall site plan and location of the proposed building, at the rear of the yard and opening to the alley, is consistent with the character of the district and supported by the "relationship of significant landscape features and surface treatments" and "relationship of lot coverage" elements quoted above.
- The form, massing, and detail, especially the Mansard roof, wood trim, and dormers lie within the "invention within a style" preservation approach and are compatible with the property and its setting, in staff opinion. The copper cladding of the dormers, which employs a historic material in a non-historic manner, along with the rectangular slates depicted in construction drawings, provide the differentiation required by Standard #9 of the Secretary of the Interior's Standards for Rehabilitation.<sup>2</sup>

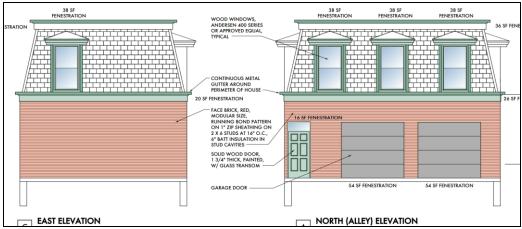
Elevations of proposed new building. Image from application materials.

The proposed carriage house is a one-and-one-half-story building with red, stretcher bond, face brick on the lower story and a fenestrated Mansard roof, clad with true or synthetic slates, on the attic story. The building would feature wood eaves, cornices, and other trim, and will employ Anderson 400 Series double-hung, aluminum-clad wood windows. Doors would be wood, plus a glass transom on the alley-facing pedestrian door. Dormers would be clad in copper.

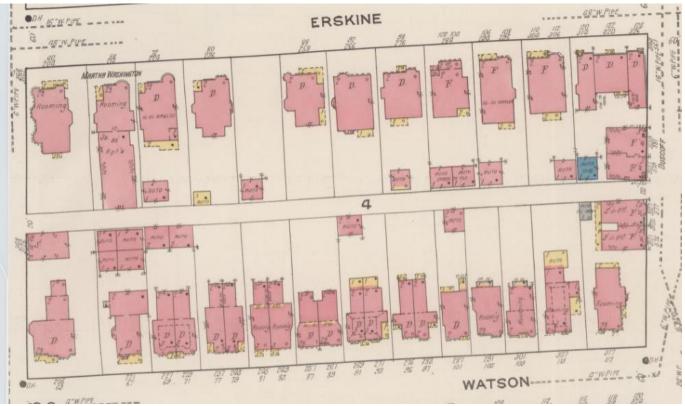
The subject block depicted in a 1921 Sanborn map; "AUTO" indicates a garage or carriage house. What is now numbered as 311 Watson is labeled here as 307.

- The shed is not a historic resource; its demolition is appropriate.
- Sanborn maps and City of Detroit building permit records indicate that garages and carriage houses were once very common in the vicinity of 311 Watson (this property once had an attached, wood garage). The construction of a new carriage house is consistent with the historical character of the area and supports Brush Park as an "intensely developed urban area" as described in the "orientations, vistas, overviews" Element of Design.
