STAFF REPORT: 9/11/2024 MEETING

ADDRESS: 7873 VAN DYKE PLACE

APPLICATION NO: #HDC-2024-00471

SCOPE: REHABILITATE DWELLING, ERECT GARAGE

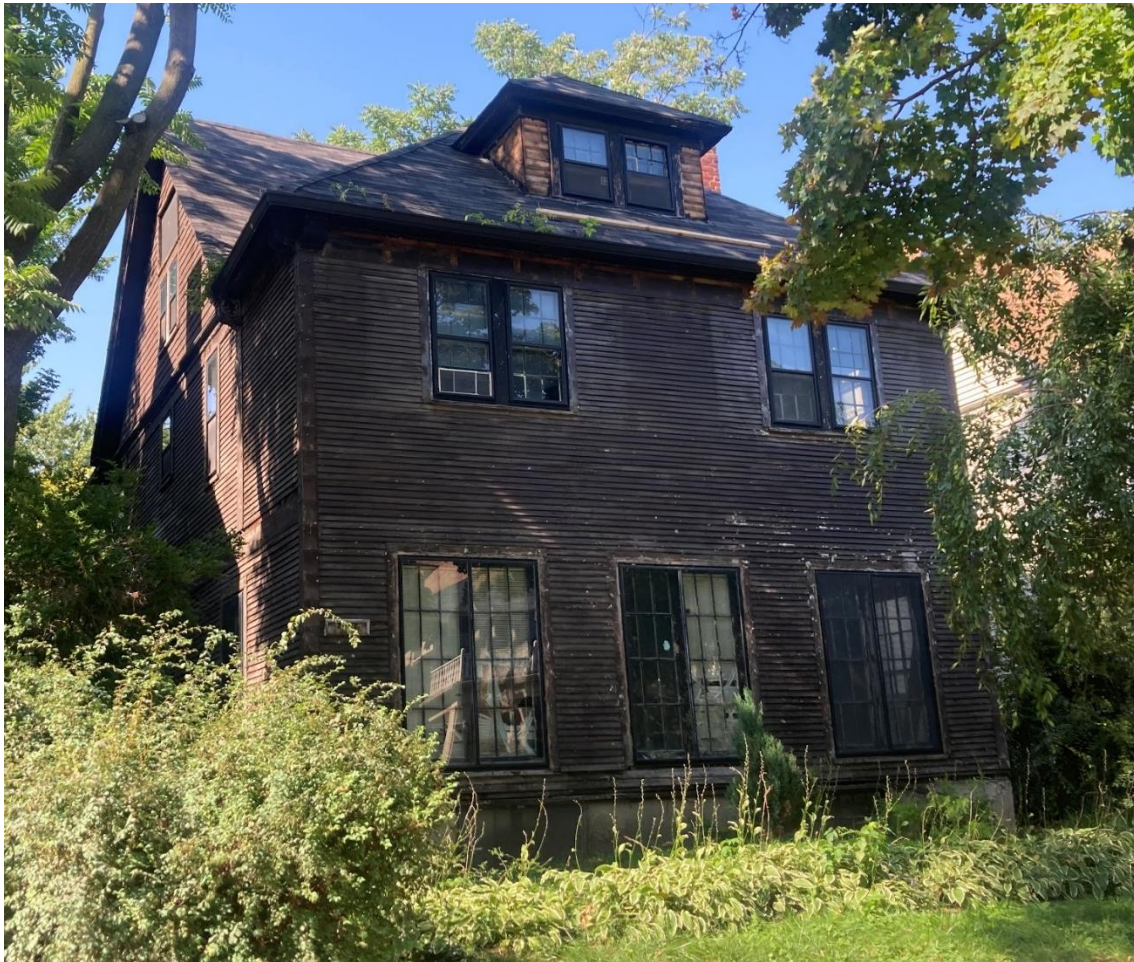
7873 Van Dyke Place, current appearance of front facade. Photo taken by staff on 8/30/2024

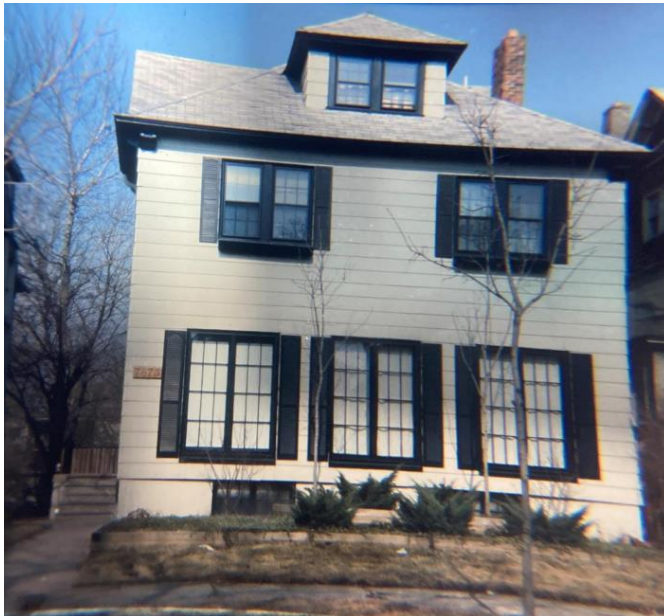
7873 Van Dyke Place, designation slide taken in 1983. Photo taken by HDAB staff

- The West Village Historic District was designated in 1983
- See the below designation slide for 7873 Van Dyke Place which shows that the building was clad with non-historic asphalt shingles. On 7/18/2024, staff issued a COA to the applicant for the removal of the asphalt shingle siding as well as a deteriorated non-historic rear wood deck/porch. While the siding has since been removed per the COA, the rear deck remains but will be removed per the current drawings.

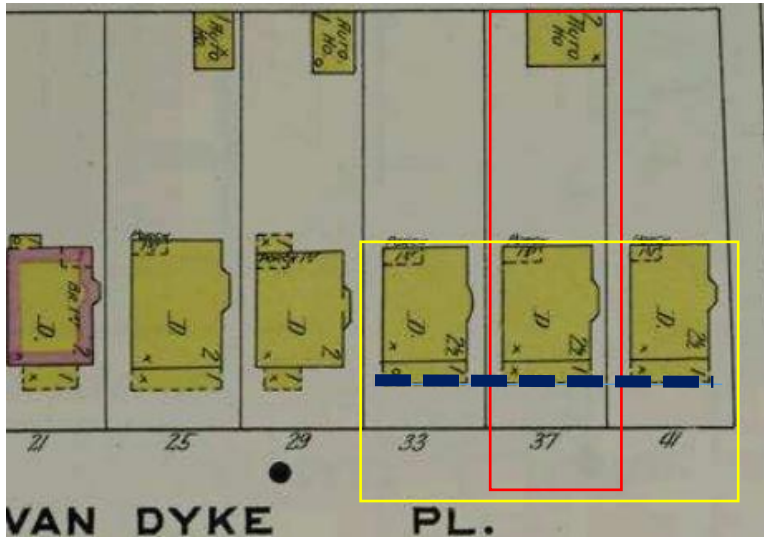
Sanborn Map, 1915. 7873 Van Dyke Place outlined in red. Note that the houses outlined in yellow and addressed as 33, 37, and 40 Van Dyke (the pre 1925 addresses) all share a similar plan and setback. See the consistent southmost edge of the porches (per the purple dashed line)

- The below Sanborn Fire Insurance map from 1915 indicates that the building originally had a projecting one-story porch which extended the front wall's full width. Note that the houses to the east and the west appear to share a similar height, plan/footprint, porch design, and setback.

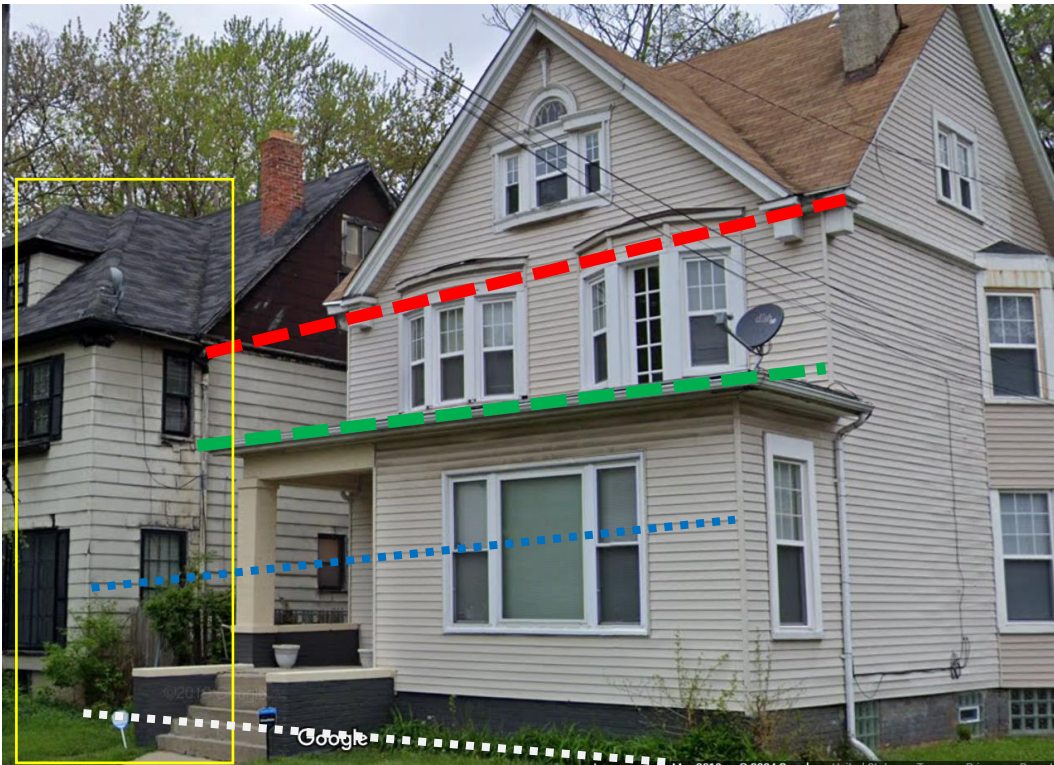
7873 Van Dyke Place (left) and 7881 Van Dyke Place (right). Per the above Sanborn Map from 1915, both houses were similar in plan, form, and setback. By 1951 the porch at 7874 Van Dyke Place had been infilled and second story added (see area outlined in yellow). The red dashed line indicates matching gable end/peaks, the green dashed line indicates matching south gable edges, the dashed blue line indicates matching front/south wall face, and the white dashed line indicates matching south foundation wall. Face/setback, Source, 2022 Google Streetview

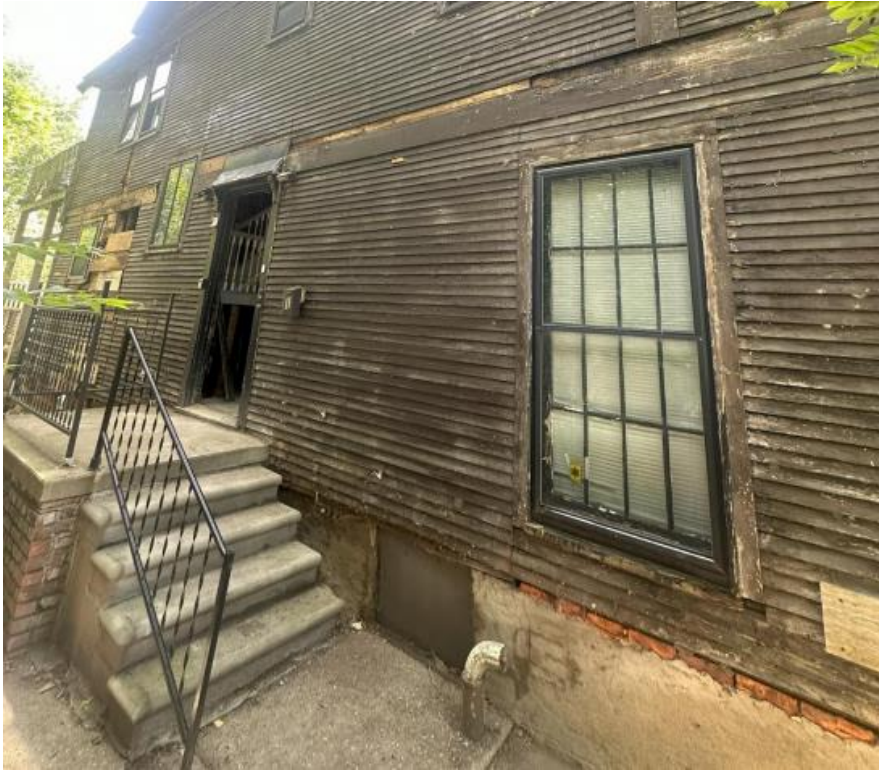
7873 Van Dyke Place, west/side wall. Location of current primary entry door. Photo taken by staff on 8/30/2024

- Note that the building's primary entry door is currently located on its side/west wall while the front/south façade lacks a door at the first story. Rather, the south/front wall, first story has three sets of historic-age, multiple-lite wood French doors (see below). Interior photos indicate that a centrally placed entry door was originally located at the

building's front/south wall when 7873 Van Dyke Place served as a single-family dwelling. The above Sanborn Map from 1951 does not depict the current west side porch and indicates that the house was a single-family dwelling at that time. It is therefore likely that the house was converted to a multiple-family use and the primary entrance was moved to the west side/its current location side by 1955.

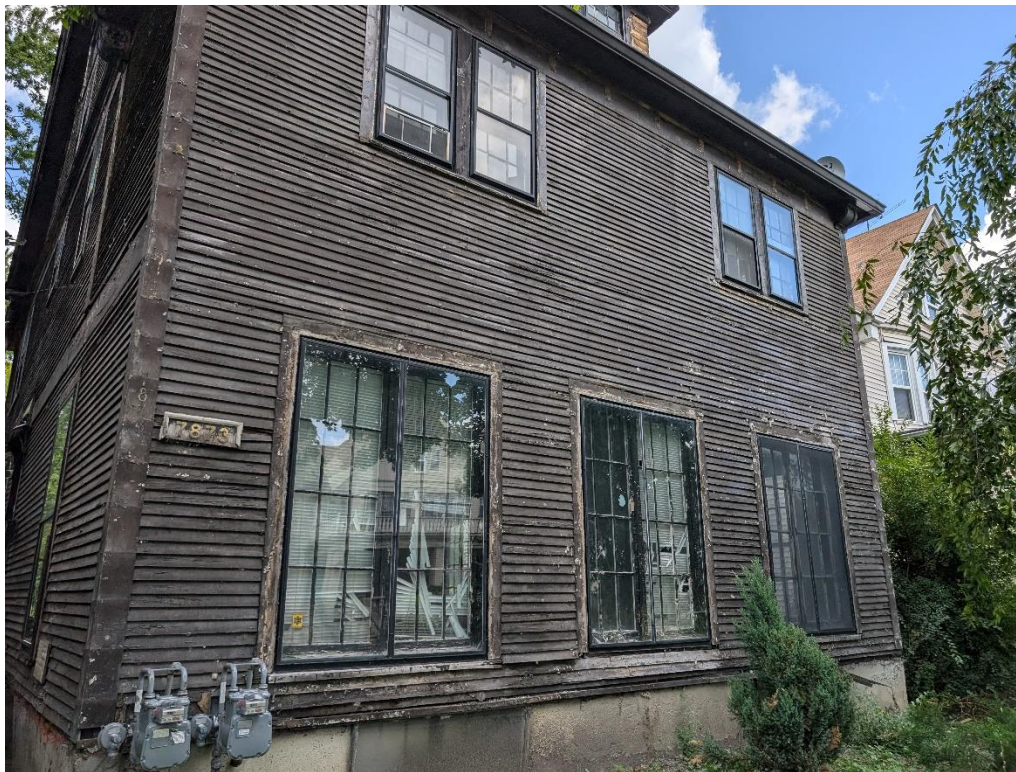
7873 Van Dyke Place, south/front facade. Photo taken by staff on 8/30/2024
