ADDRESS: 1819 LEVERETTE

APPLICATION NO: HDC2024-00560

HISTORIC DISTRICT: CORKTOWN

SCOPE: ERECT A REAR ADDITION

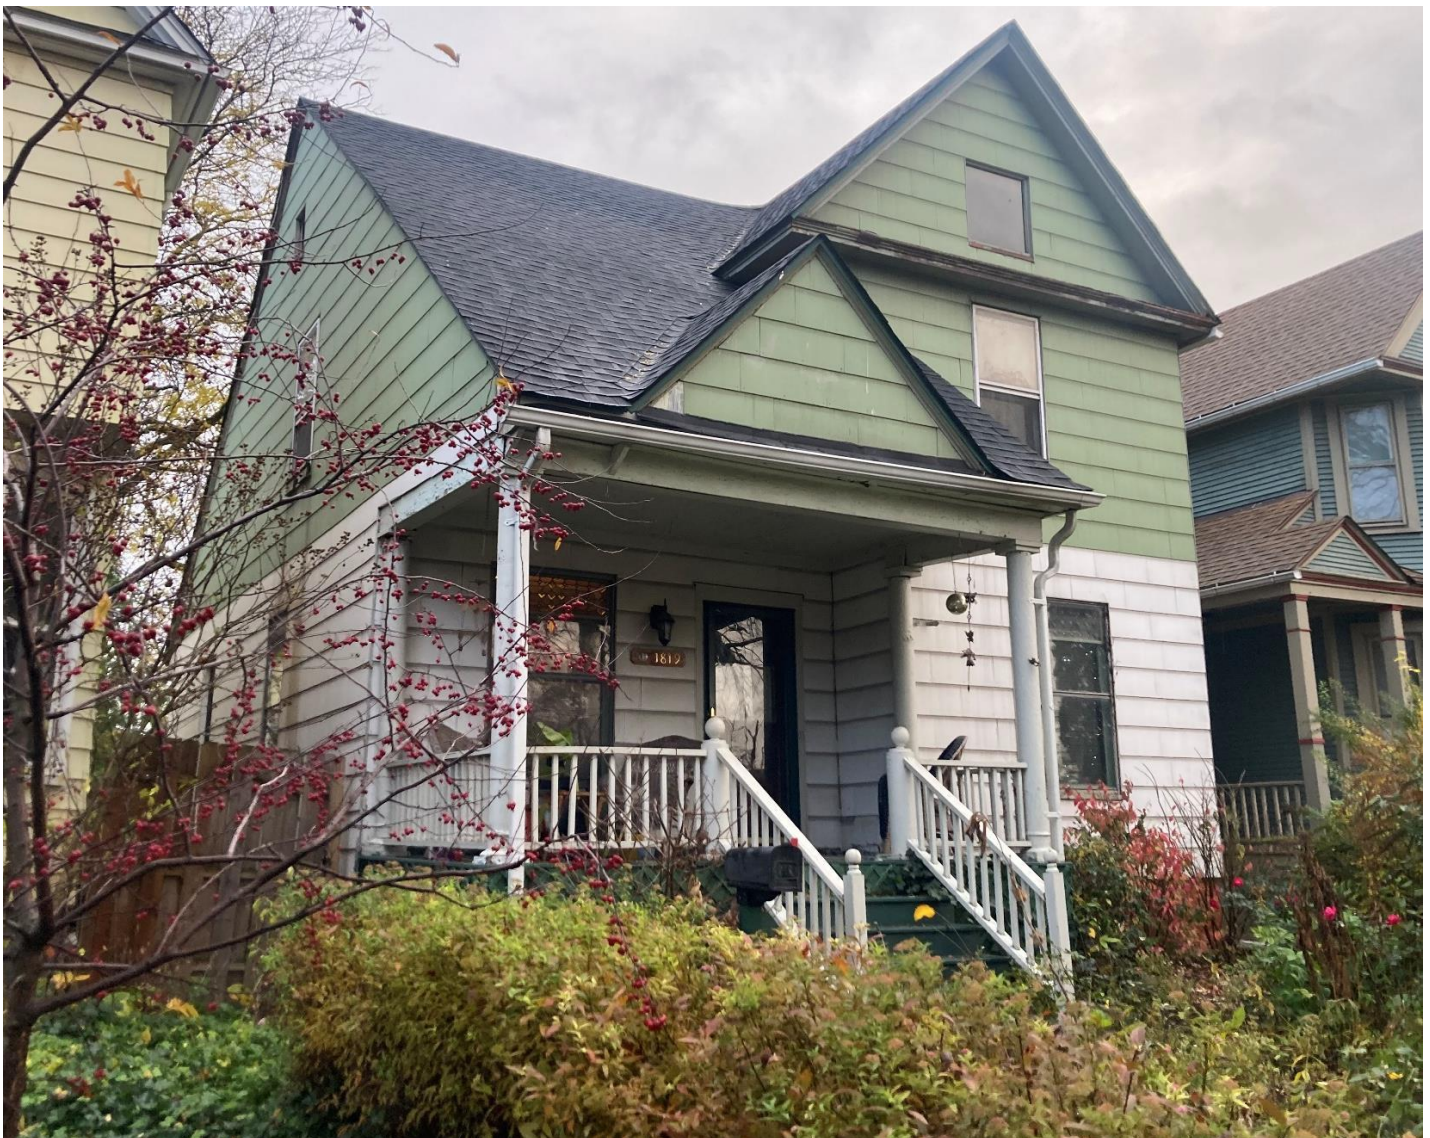
1819 Leverette, Staff photo of current conditions. Photo taken on 11/20/2024

The building located at 1819 Leverette is a 2-story, single family dwelling that was erected ca. 1910. Exterior walls are clad with synthetic siding, present since the district was designated in 1981. The roof is side gabled, with a projecting front gable at the primary façade and a projecting hipped roof wing at the rear. A partial width porch with round wood columns, wood steps, and wood handrails is at the primary façade. A deteriorated wood porch is located at the rear. Windows are wood at the front and side walls and vinyl at the rear.

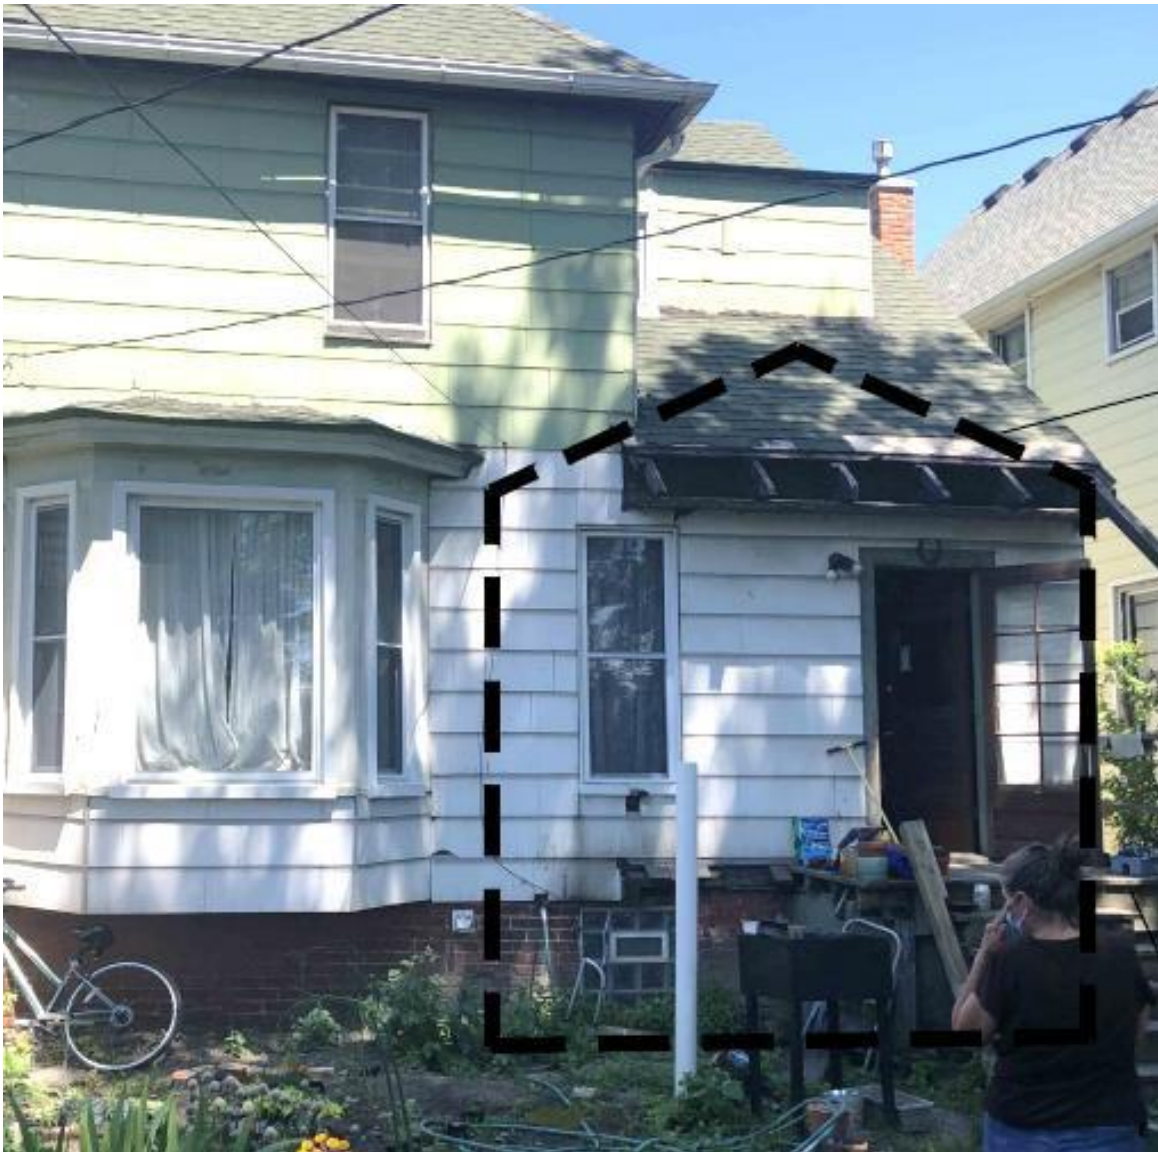
1819 Leverette, rear. Area outlined by the black dashed line indicates location of proposed new addition/area of historic house. Photo provided by applicant

- The Corktown Historic District was designated in 1981
- Per the below photo which was provided by the applicant, the new addition will result in the removal of one vinyl window, an historic-age wood door, the existing wood porch, and a portion of the rear wall and roof.

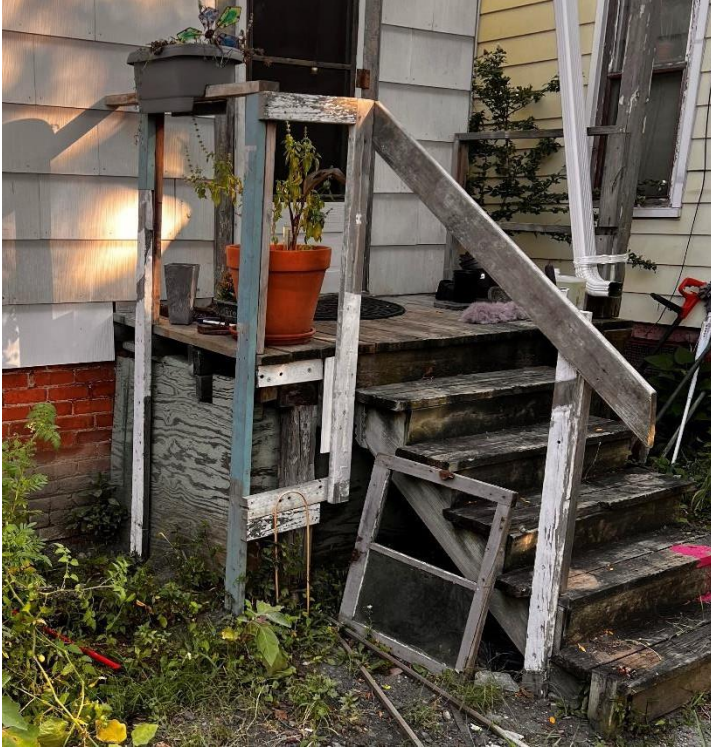
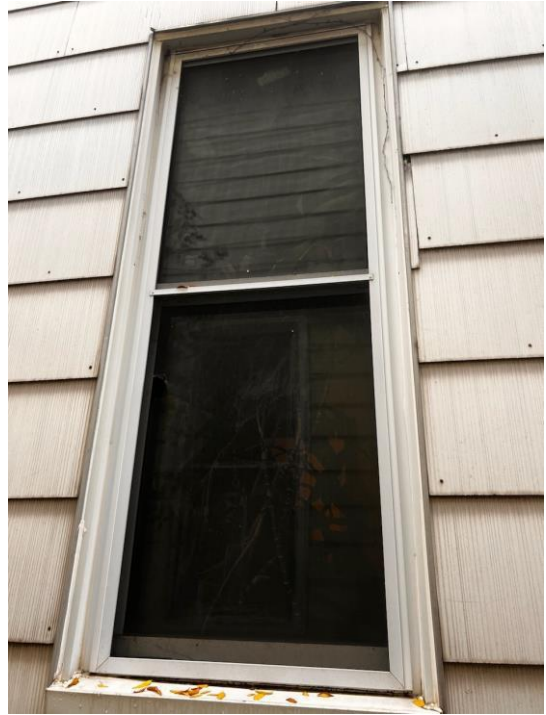
Rear porch (left) and window (right) proposed for removal. Photos provided by applicant

- Please see the below photos of the rear porch, door, and window that will be removed as a result of the current addition. A review of the photos revealed the following:

- The existing rear porch is utilitarian in nature and includes wood steps (wood risers, treads, and stringer), wood decking, plywood skirting, and an open wood handrail. The porch appears to have been haphazardly constructed, is in poor condition, and likely does not date from the building's original construction. It is staff's opinion that the porch proposed for removal is not a distinctive character-defining feature which merits retention.

- The vinyl window which is proposed for removal is not historic age and detracts from the building's historic character
 - While the door is of historic age, it is utilitarian in nature and does not display detailing which meaningfully contributes to the building's historic character

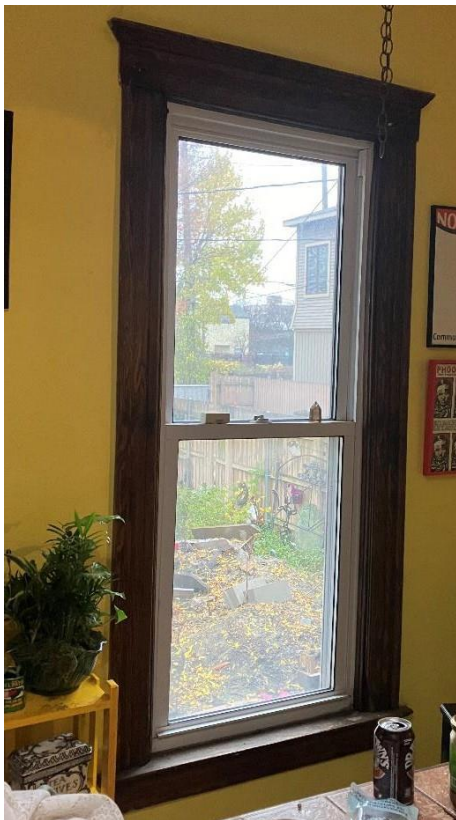
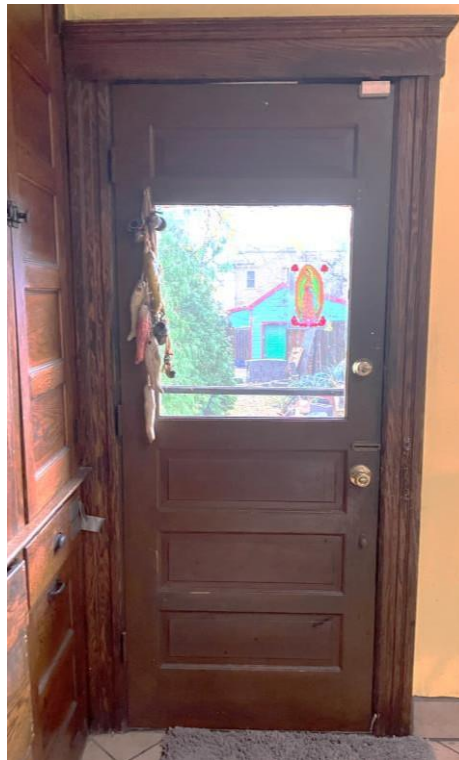
Interior. Vinyl window (left) and wood door (right) which will be removed as a result of the erection of the new addition. Photos provided by applicant

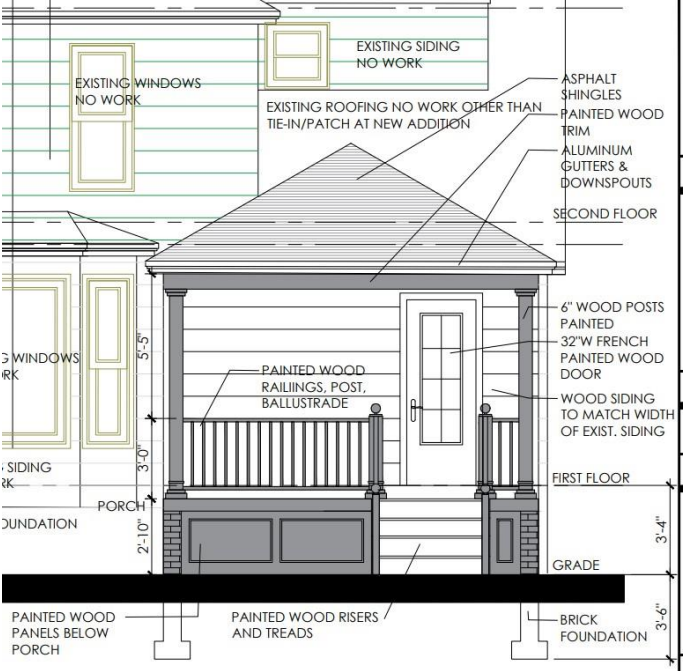
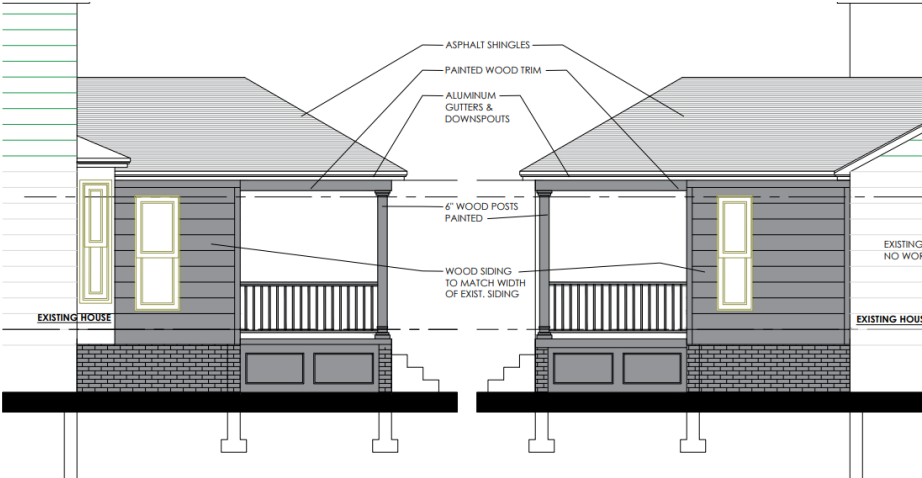
Proposed new rear bathroom extension/porch. Provided by applicant

- Demolish the existing rear wood porch
- Install a one-story, hipped roof bathroom extension/addition with an attached porch. The new bathroom wing with attached porch will have a 16'-8"x14'-0" footprint. The addition/extension's walls will be clad with wood siding and a new wood French door will be installed at the south wall. The attached porch will include wood columns, steps, decking, handrails, and guardrails.

- Please see the below images which outline the new addition's design. It is staff's opinion that the new addition is generally compatible with the historic character of the house in terms of scale, location, roof shape, material, height and architectural details. However, note that the architectural drawings do not provide the material of the addition's 1/1 windows, nor do they specifically outline window operation. Staff did reach out to the property owner and requested that she provide information which would outline the material and operation of the windows at the addition. Although the elevation drawings indicate that the windows will display a 1/1 configuration, the owner sent the below image, which indicates that she wishes that the windows be vinyl, horizontal-sliding units. It is staff's opinion that the 1/1 configuration depicted in the project drawings is more compatible with the house's historic character versus horizontal sliding units. Also, vinyl is less sturdy than other window materials when exposed to physical stress, such as harsh weather and temperature changes, and can become brittle and crack. Vinyl can also fade over time when exposed to direct sunlight. Staff therefore recommends that the addition's windows not be vinyl and match the design outlined in the submitted drawing set.

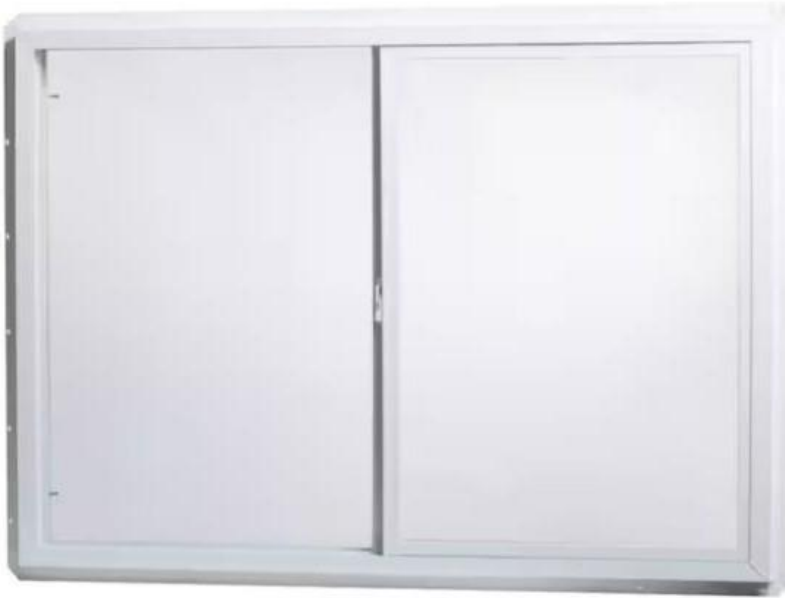
Rear addition window type proposed by owner/applicant. Not compatible with the historic character of the building

- The applicant/owner has submitted documentation which note that she wishes that the windows at the new rear addition be vinyl. Note that vinyl as it is less sturdy than other window materials when exposed to physical stress, such as harsh weather and temperature changes, and can become brittle and crack. Also, vinyl can fade over time when exposed to direct sunlight. Staff therefore recommends that the addition's window not be made of vinyl.
- Sliding operation is not a compatible window type for additions to an historic property.
