STAFF REPORT: 02/12/2025 MEETING

ADDRESS: 264 WATSON

APPLICATION NO: HDC2024-00666

SCOPE: DEMOLISH EXISTING PORCHES, ERECT REPORT (ON REASSIGNMENT FROM APPEAL FOR HEARING OF ADDITIONAL EVIDENCE)

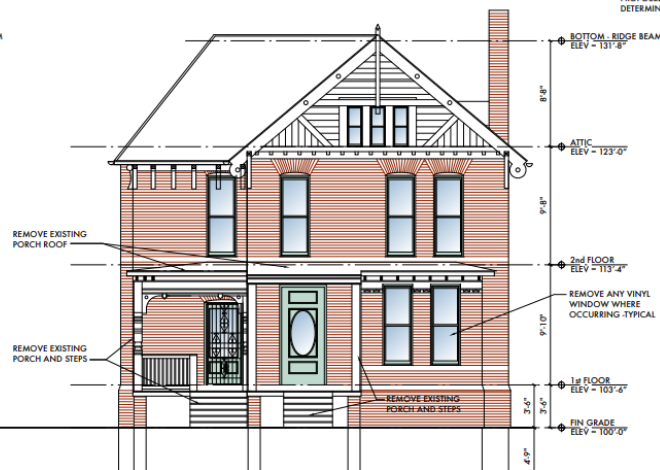
North elevation. Porch proposed for removal

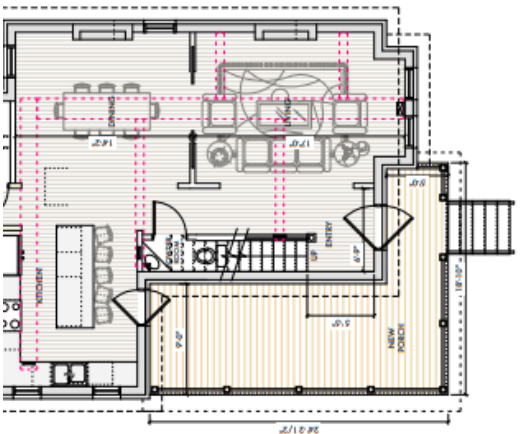
Floorplan, showing proposed new wrap-around porch

- Demolish the existing non-historic porch at the front façade
- Demolish the existing historic porch at the east side/façade
- Erect a new porch which would wrap around the front and east/side facades to include:
 - A hipped roof which would be covered with asphalt shingles
 - Wood posts, trim, guardrails, handrails, and steps
 - Wood lattice skirting
 - Brick supporting piers
 - Composite floors

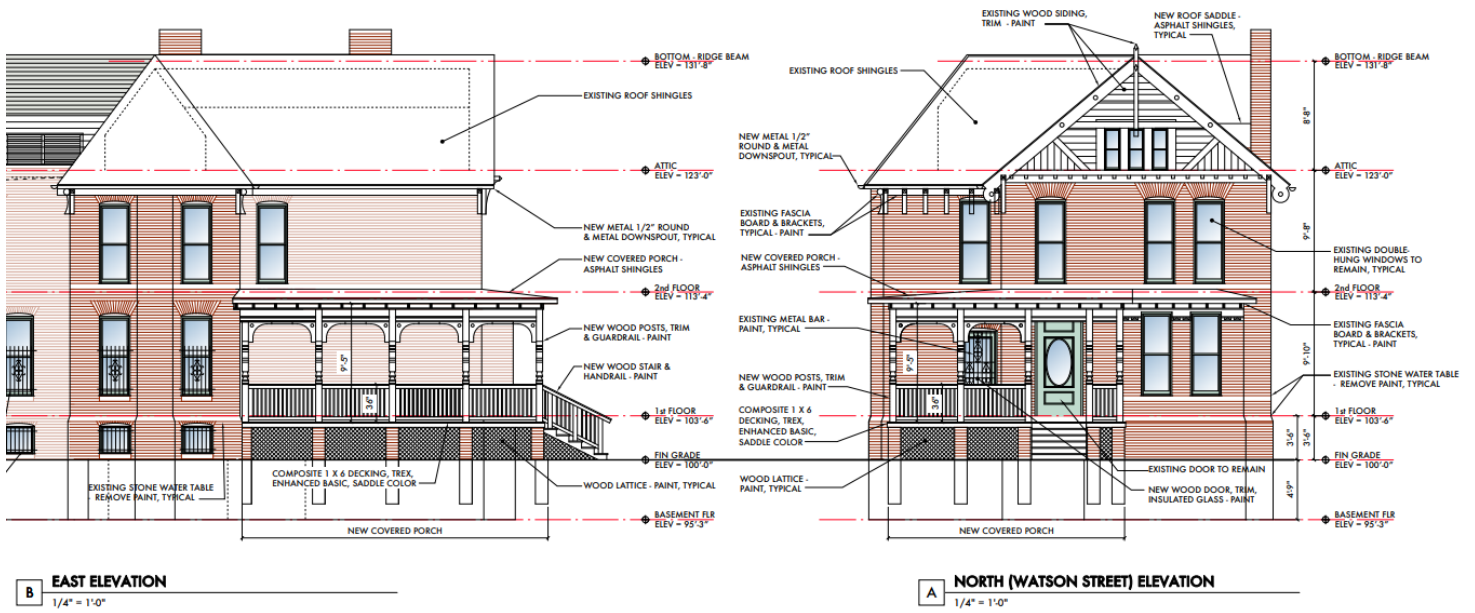
Elevation drawings, showing proposed new wrap-around porch. Applicant's 12/11/2024 submission

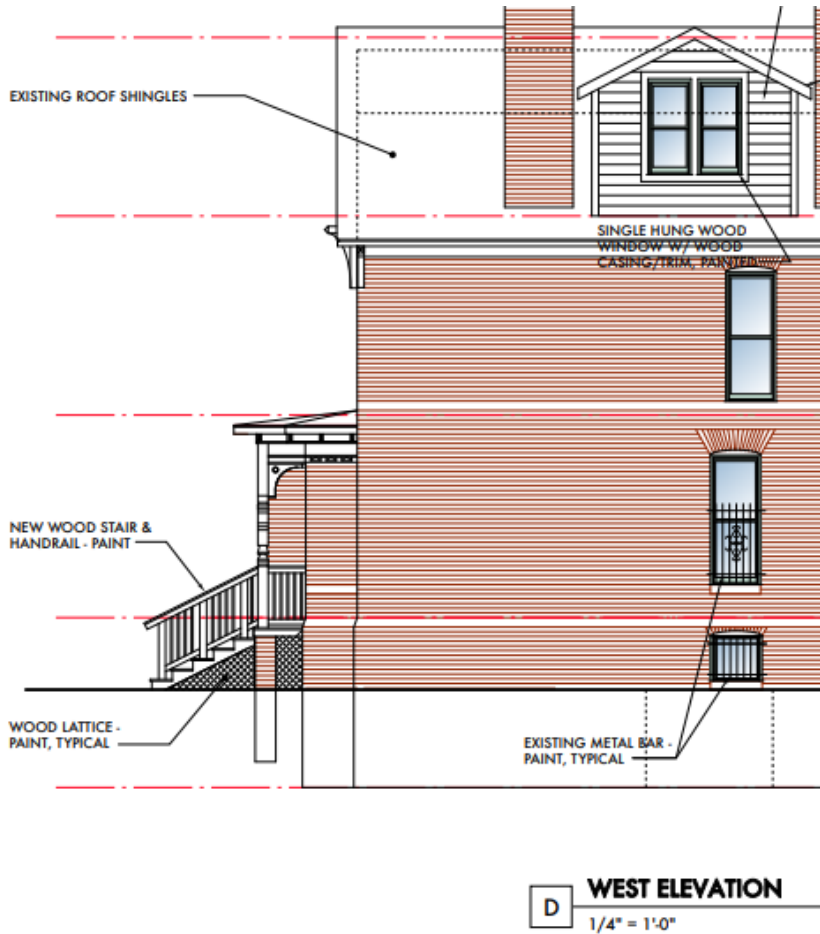
Elevation drawing, showing front porch of proposed new wrap-around porch. Applicant's 12/11/2024 submission

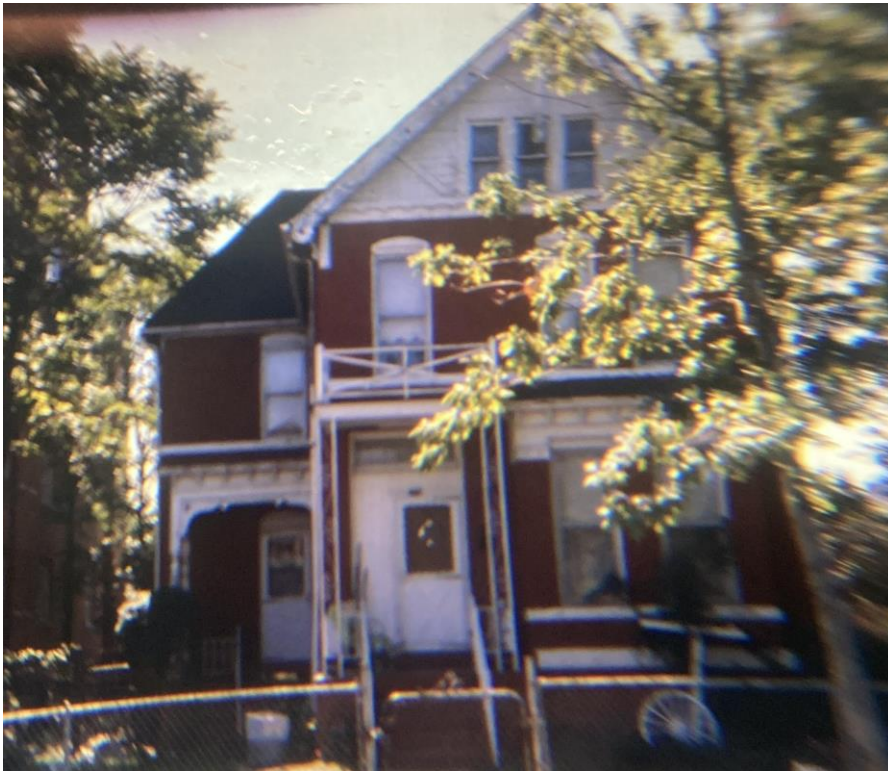
264 Watson, designation slide dating from 1980.

- See the below photo of the house, taken in 1980 at the time of the district's local designation to note the following:
 - The east side porch which is proposed for demolition was present and appears to be of historic age/original to the date of the house's construction

- The front porch is not of historic age

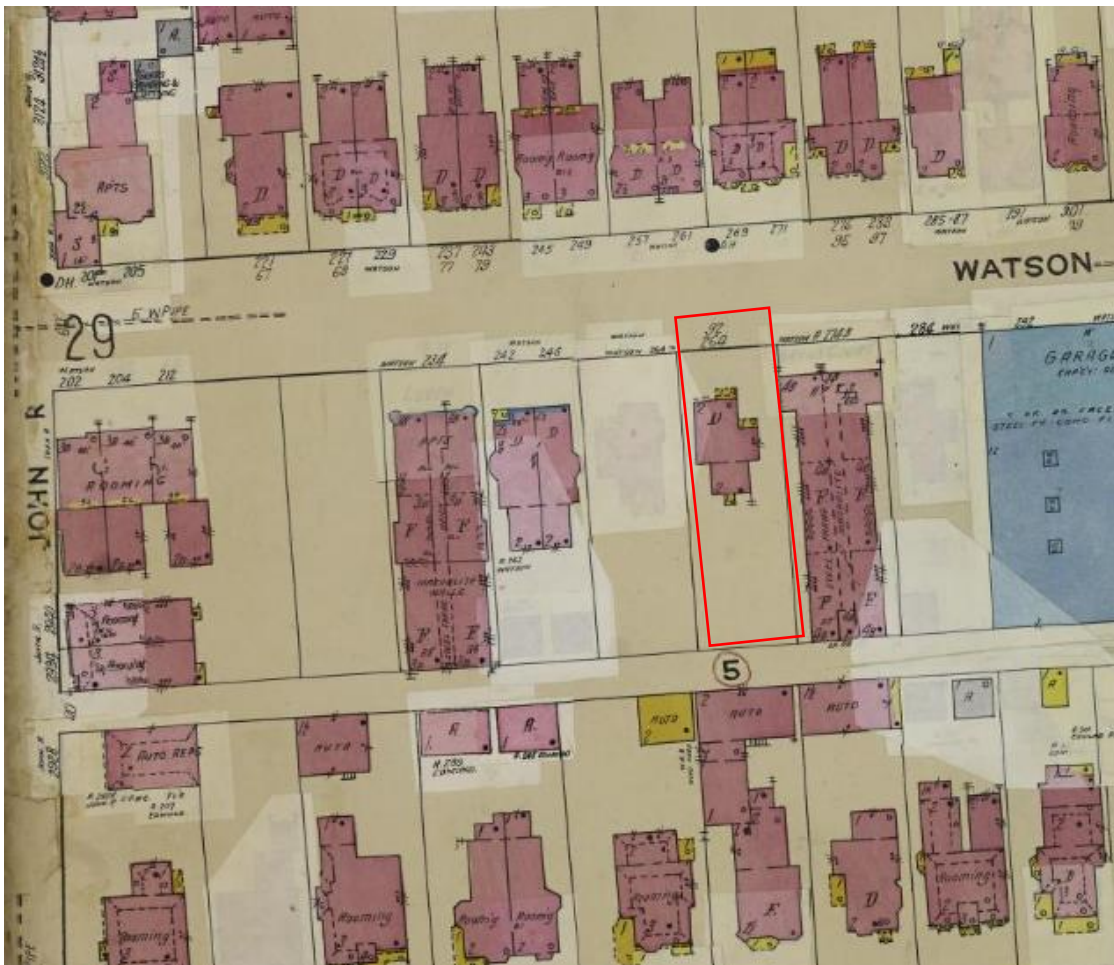
Sanborn Insurance Fire Map. 264 Watson, 1950

- The below Sanborn Maps indicate that the building had an east side and a front porch as early as 1887. This condition continues to the current day.

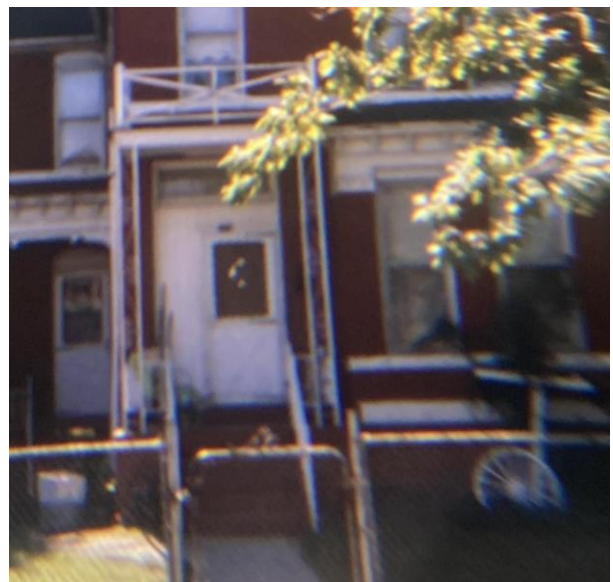
Front porch in 1980, at time of local designation, prior to the 1981 rehab

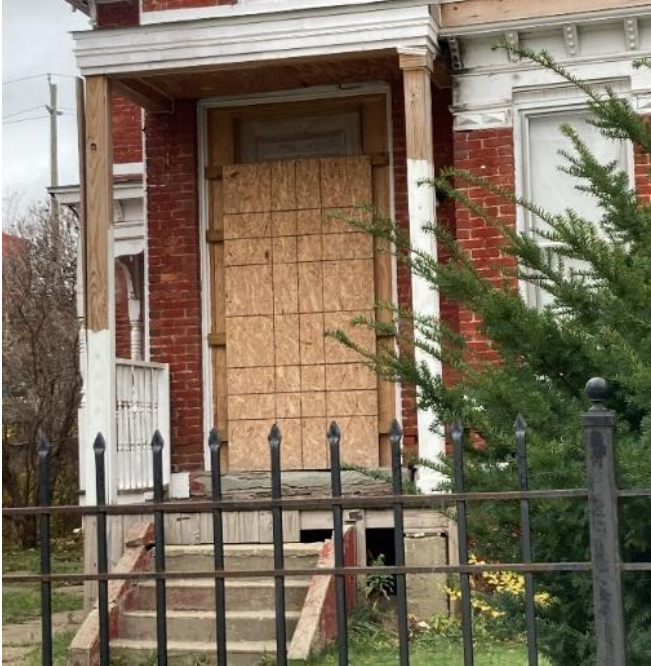
Front porch, current conditions. Photo by staff, 11/25/2024

was erected in 2021 (see below). The application that was submitted to the Commission in December 2024 proposed to demolish this non-historic front porch, in addition to the historic east side porch, and replace both with a single new wraparound porch with details that echoed those found at the existing historic east side porch. Staff supported the proposal to remove the existing front porch because it remained as an unapproved, incompatible replacement of an earlier porch which had been erected in 1981 to replace the non-historic front porch that was present at the time of the district's designation. However, staff did not support the removal of the historic east side porch.

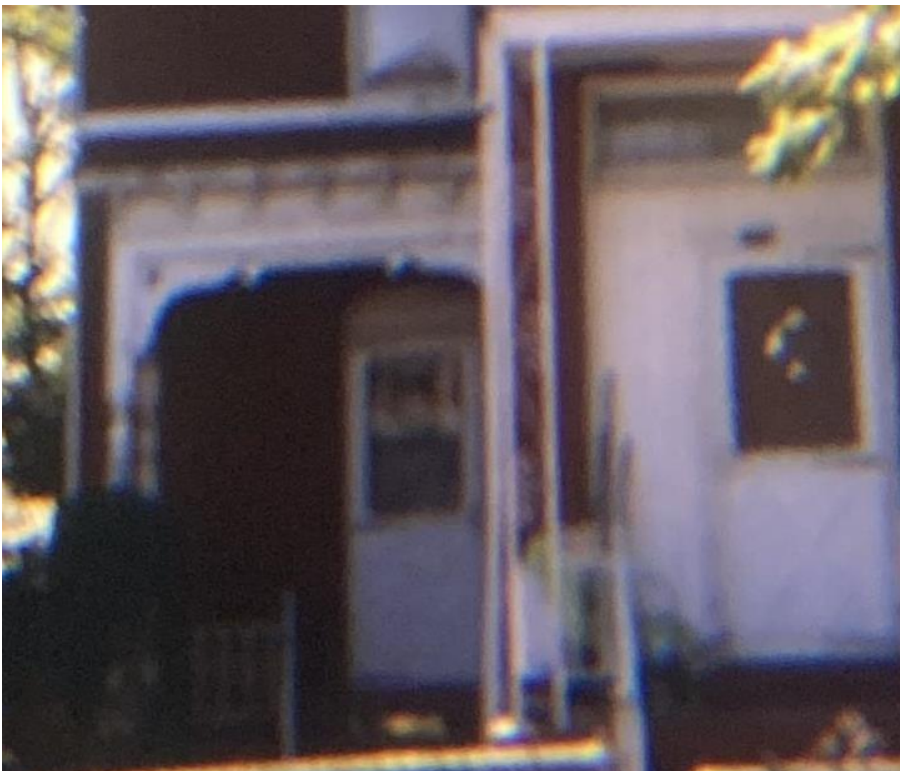
Appearance of east side porch in 1980, at time of local designation. Photo provided by HDAB

- Please see the below photos and drawing to note that the east side porch appears much as it did at the time of local designation/when the building was identified as Contributing to the historic district, despite some deterioration and repairs.

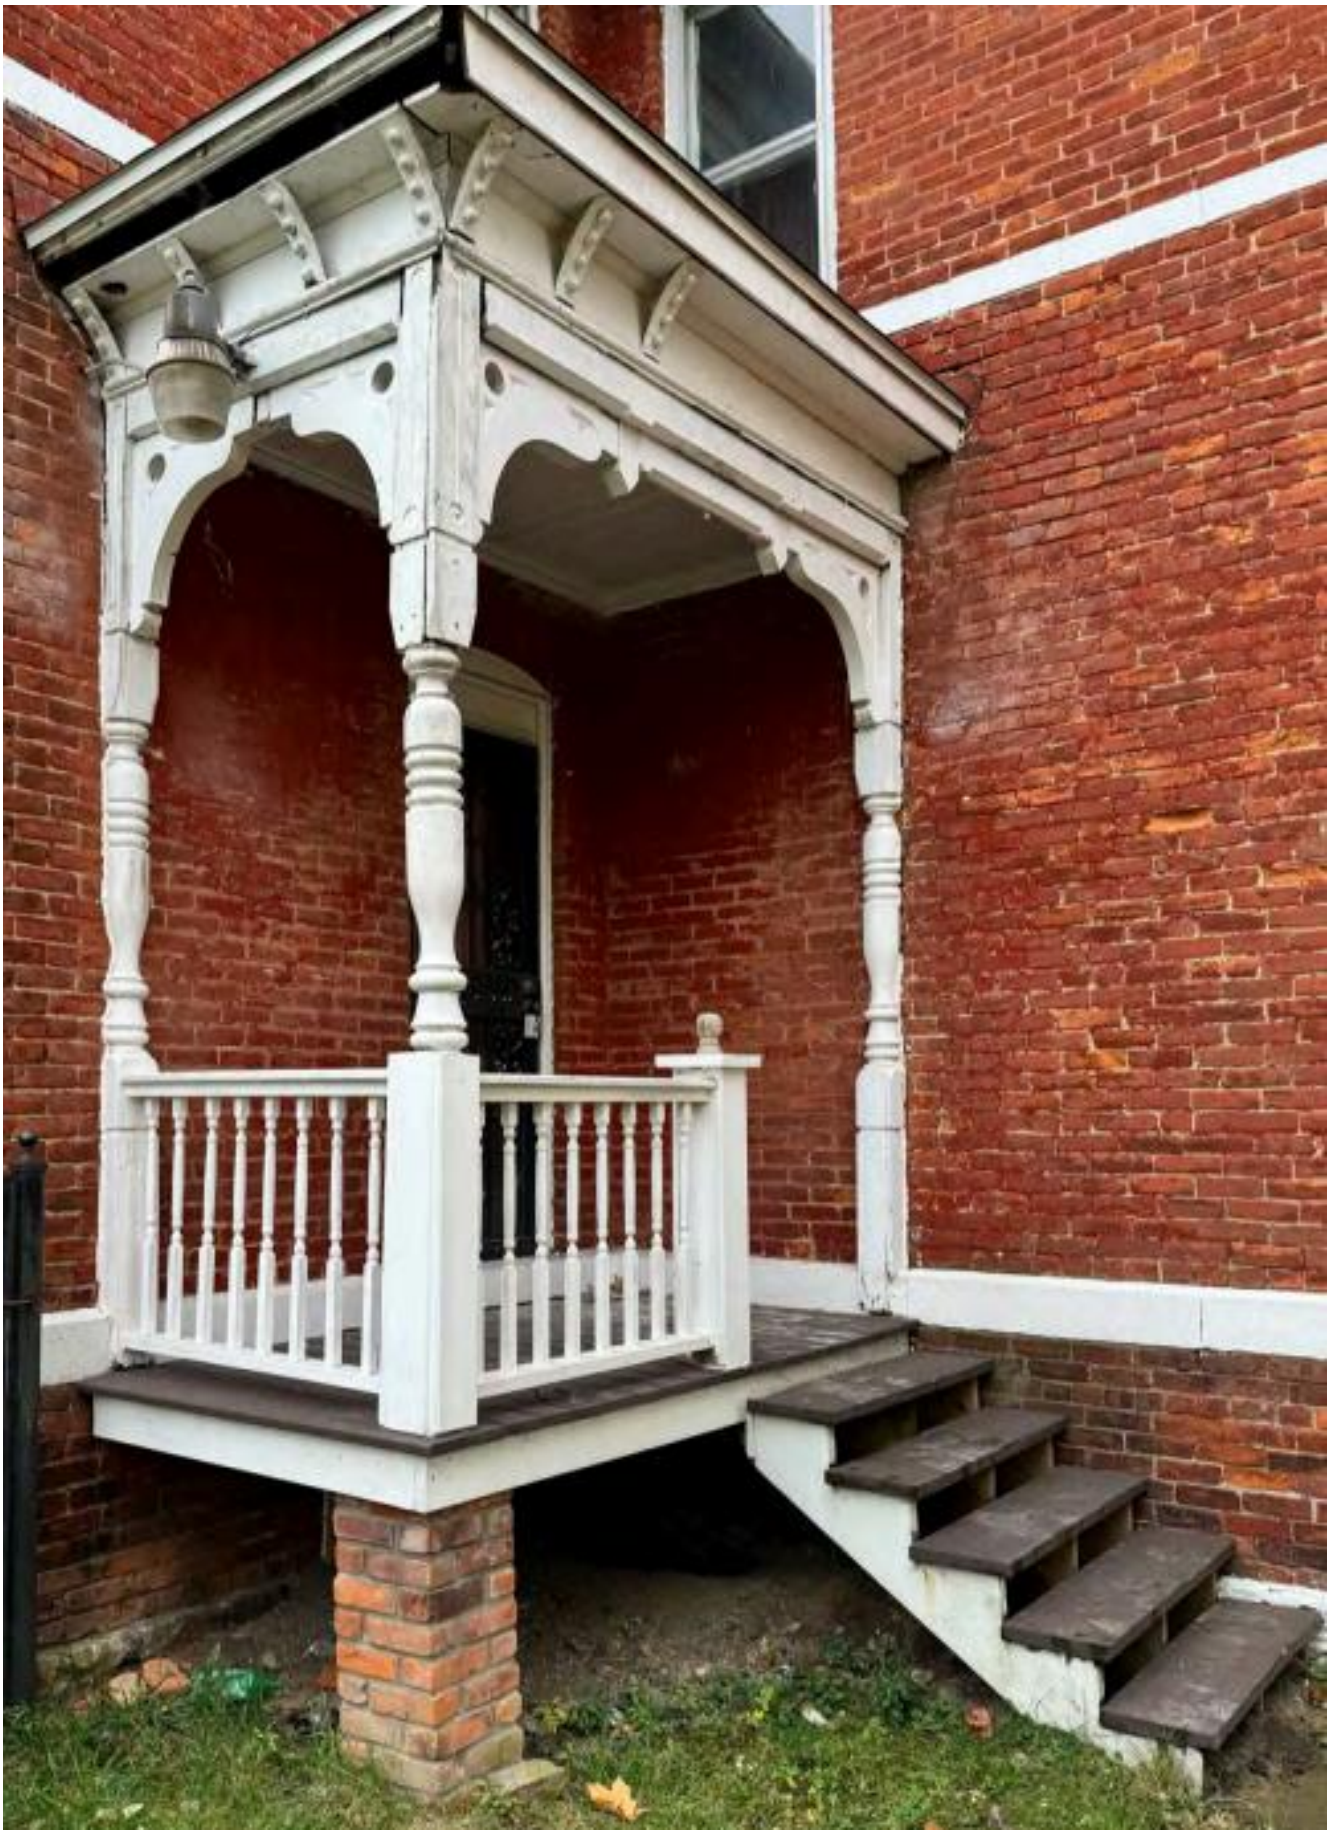
East side porch. Current appearance. Photo provided by applicant as new evidence

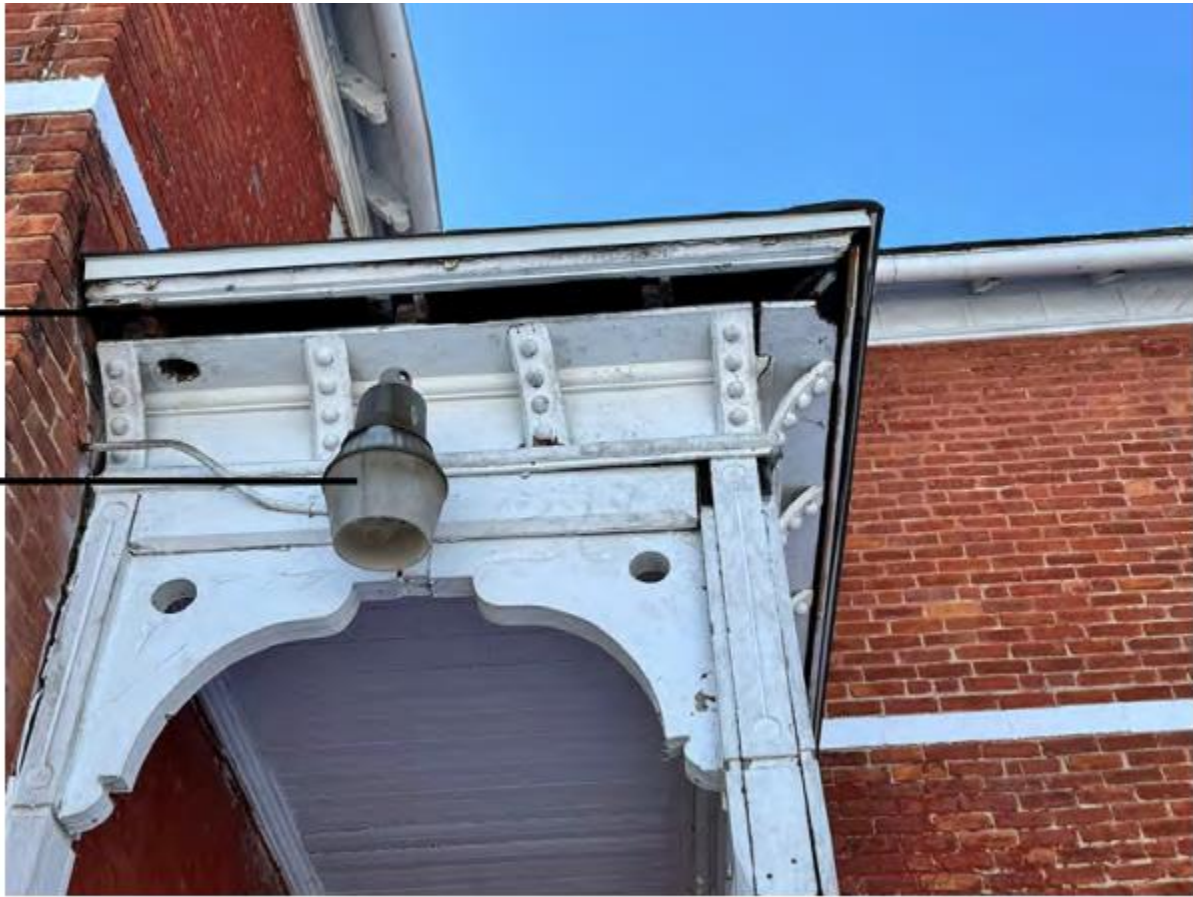
East side porch. Current appearance. Photo provided by applicant as new evidence

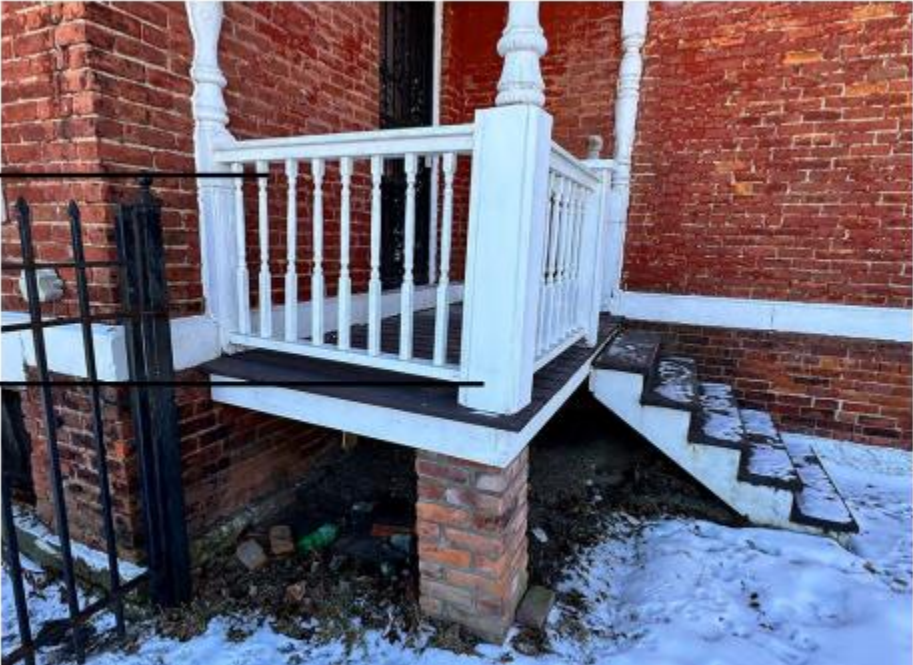
East side porch. Current appearance. Photo provided by applicant as new evidence

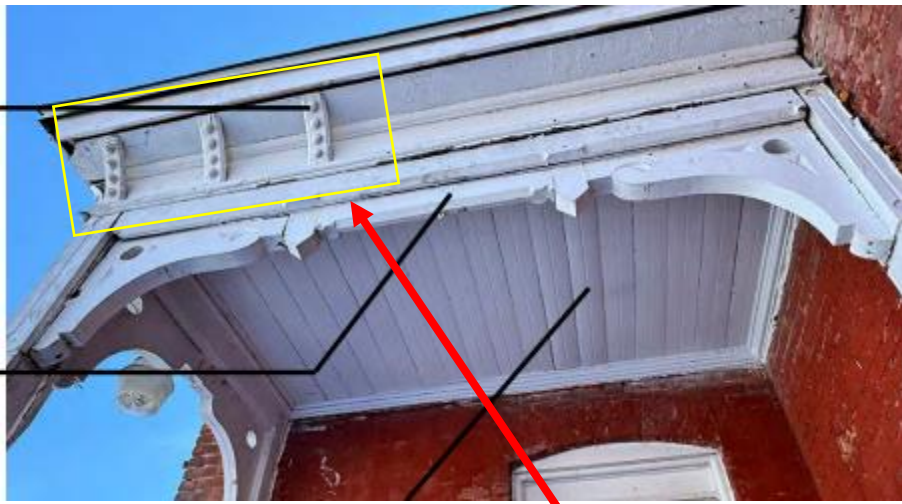
East side porch, current appearance. Note that the east side porch's decorative details match those at the front façade's bay window. Specifically, the brackets at the porch soffit/eave area match those at the front facade bay (outlined in yellow). Provided by applicant as new evidence

- The existing side porch is a distinctive character-defining feature of the building as it displays historic-age details which are associated with the Queen Anne style and are reflective of decorative detailing elsewhere on the building. Also, as noted above, the porch has been present since 1887 and is a significant element which contributes to the overall visual character of the building. Finally, it is staff's opinion that the documentation provided by the applicant further highlights the significance of the porch's distinctive detailing and that in-kind repair is both feasible and reasonable given the porch's scale and material.

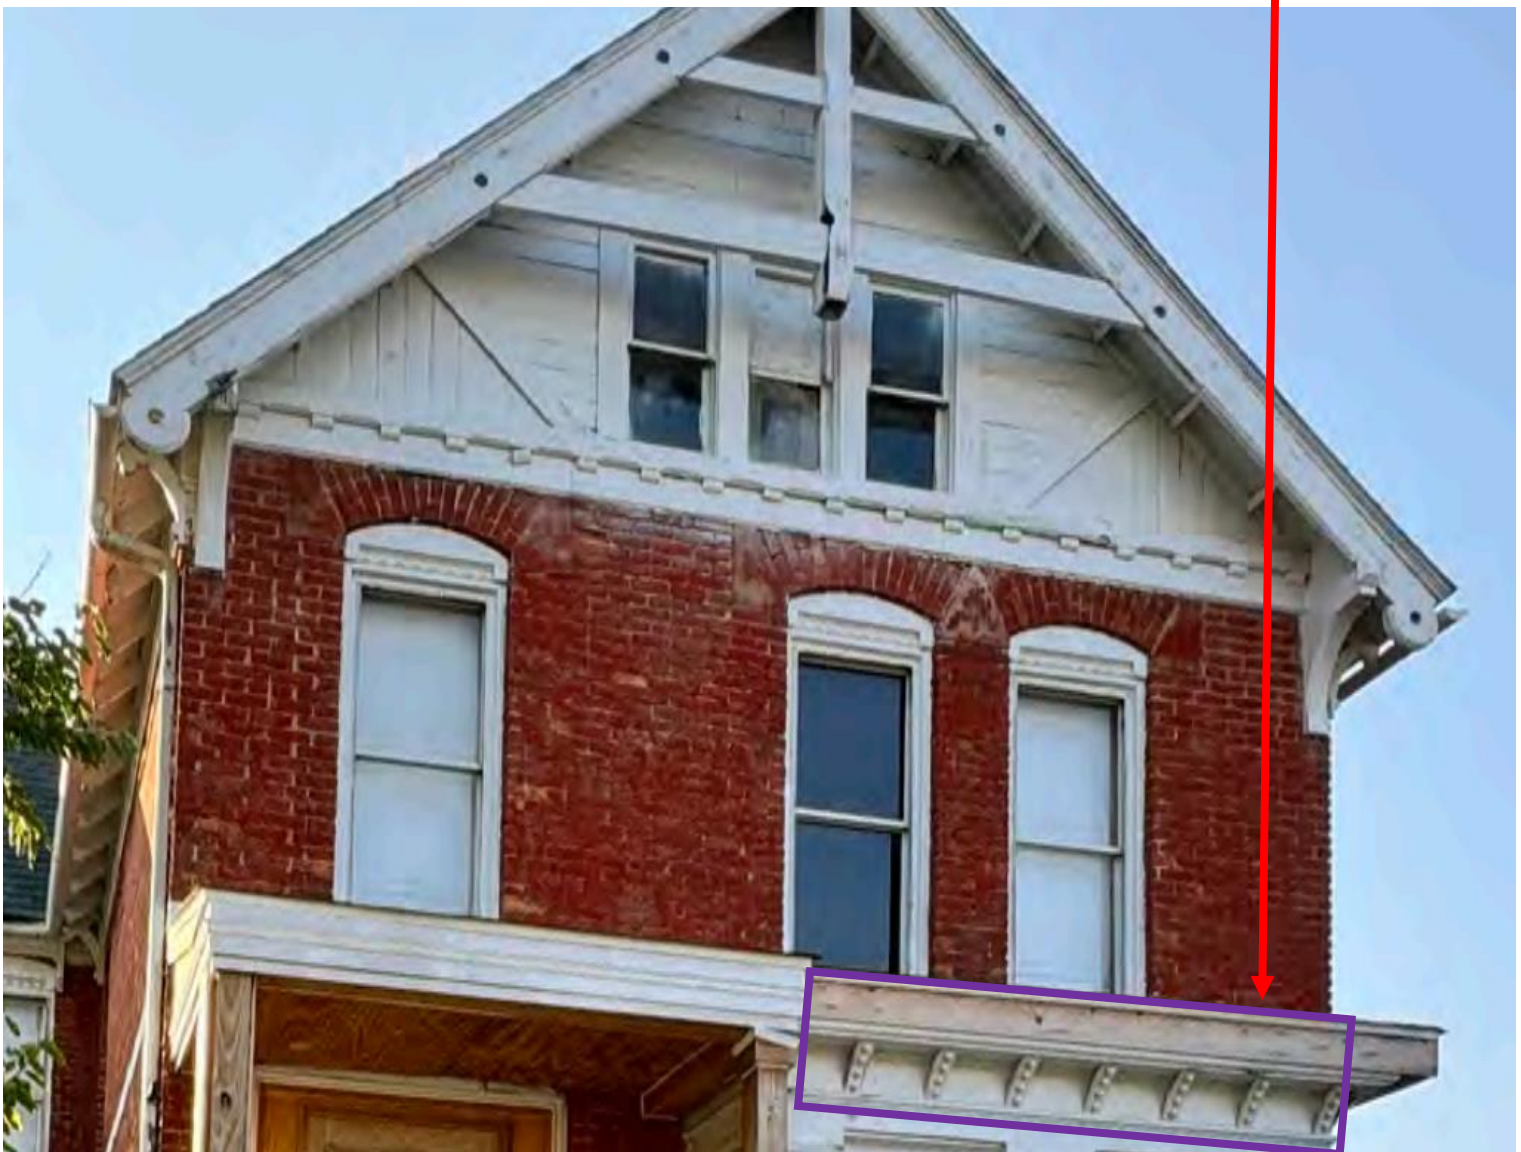
Front façade, current appearance. Note that the east side porch's decorative details match those at the front bay window. Specifically, the brackets at the porch soffit/eave area match those at the front facade bay (outlined in purple). Provided by applicant
