STAFF REPORT MARCH 12, 2025, REGULAR MEETING

APPLICATION NUMBER: HDC2024-00706

ADDRESS: 618 ARDEN PARK

SCOPE: ERECT DWELLING AND GARAGE

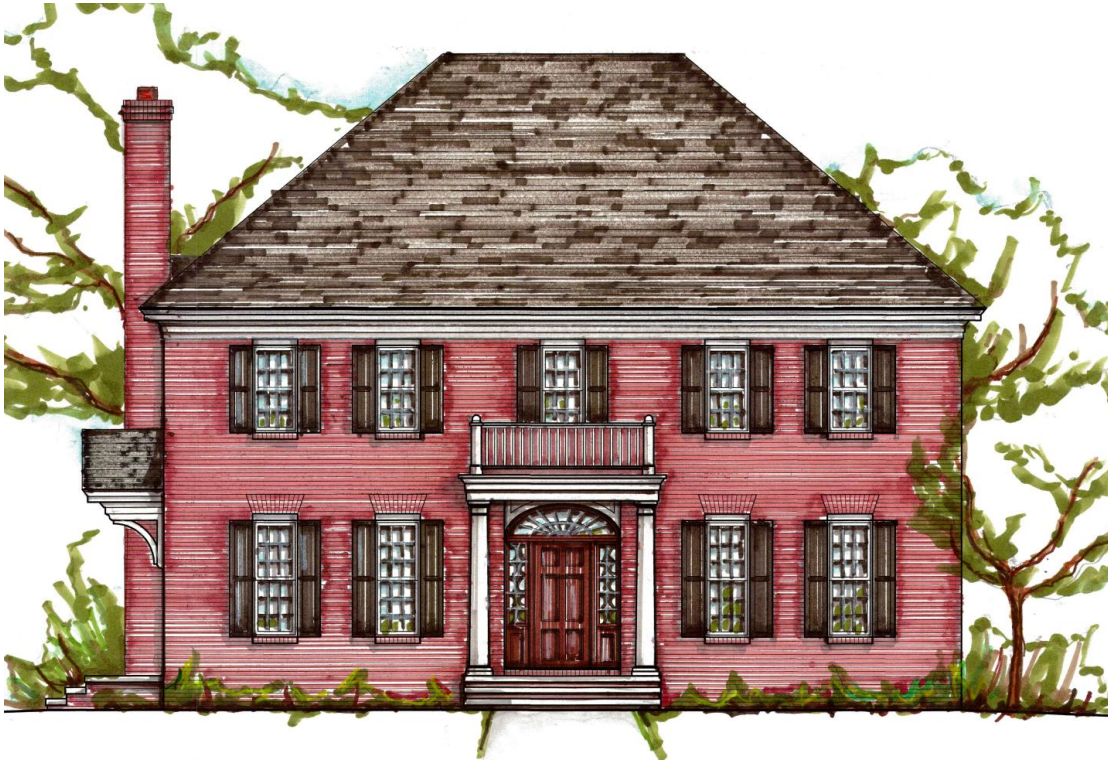
Rendering of proposed house, from application materials.

Facing north, the proposed house consists largely of a two-story, hip-roof, rectangular mass. It presents a symmetrical composition towards the street. The façade balances horizontal and vertical elements: windows are relatively tall and narrow and topped with pronounced jack arches, with applied shutters adding a sense of weight; a single-bay porch consists of Tuscan columns supporting a flat roof with balconet; a simple entablature runs along the porch roof and beneath the eave line of the building's hip roof. The roof would have a steep pitch, with a ridge height of 33 feet, 9 inches. A wide wall chimney and secondary entrance canopy project from the east wall of the proposed building. On the rear (south) is the only subsidiary mass, a single-story, gable-roof sun porch beside a raised patio.

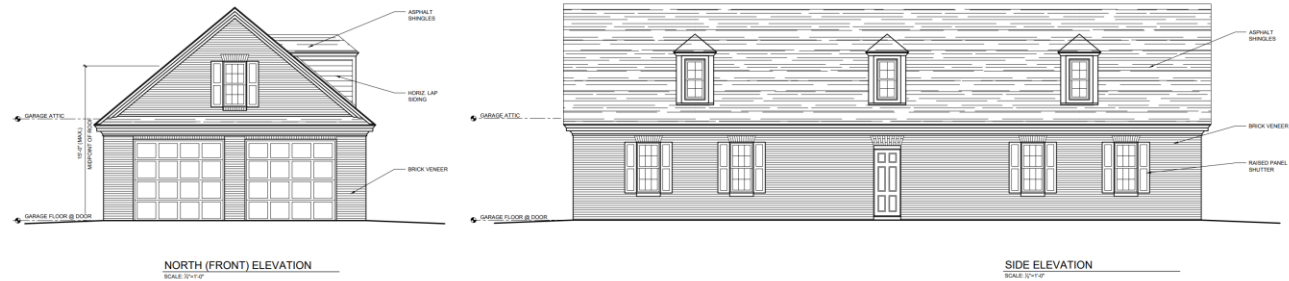
The garage presents a two-bay, front-gable, front elevation facing the street, with a single window centered with

the attic story of its front elevation. It is uncommonly deep: 61 feet, ten inches from front to back. It has three dormers on side (west) elevation. The materials and details are comparable to that of the house, with a jack arch above its front-facing window opening and flat, brick lintels above its vehicle doors.

Elevation drawing of proposed garage, from application materials.

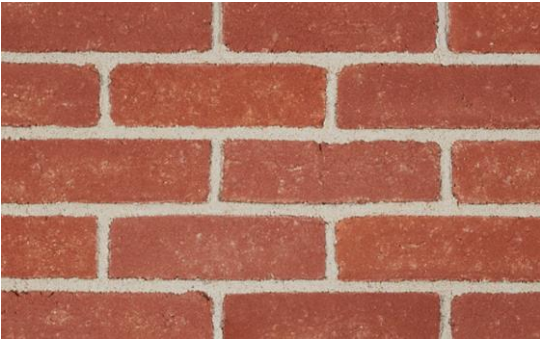
The primary exterior material for both buildings would be Belcrest 500 modular face brick. Other materials include Marvin Elevate fiberglass windows with simulated divided lites, cellular PVC trim boards, fiber-cement siding for the sun porch and garage dormers, fiberglass reinforced polymer columns, a prefabricated polyurethane balustrade, wood doors, and asphalt architectural shingles.

Belcrest 500 face brick. Image from product website. (The flush joint depicted is discussed under “Staff Observations and Research,” and “Issues,” below.)

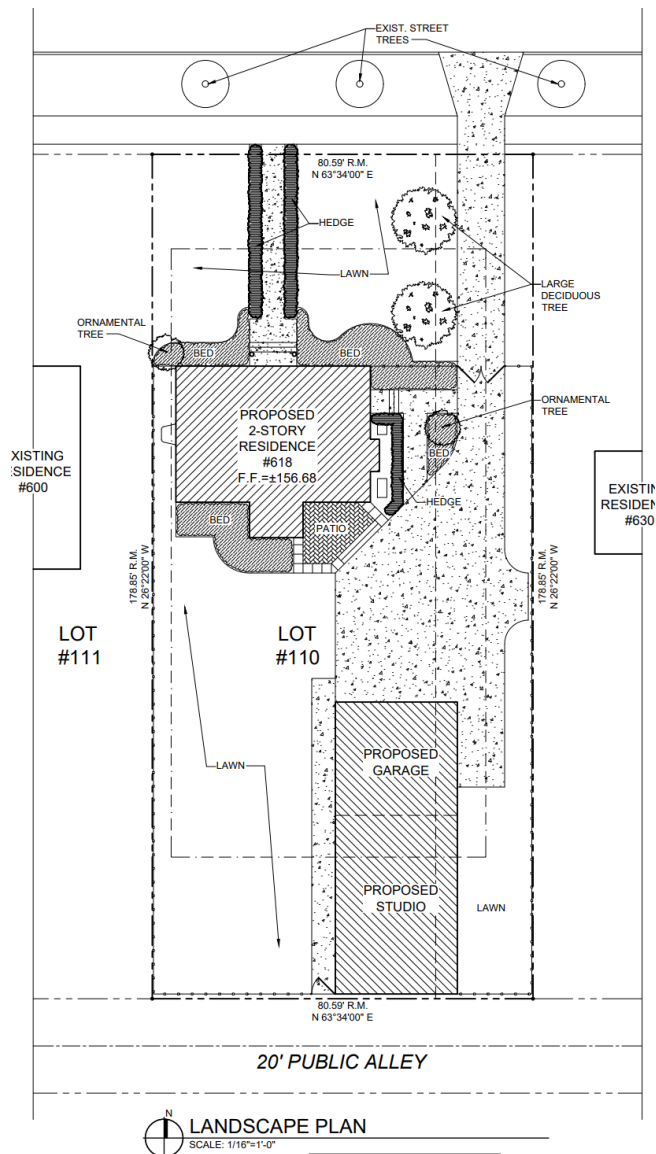
The site plan includes a straight concrete walkway, flanked by hedges, leading to the front entrance, a concrete driveway with apron, foundation planting beds, and several ornamental and shade trees.

Site plan. Image from application documents.

Staff assessment: The proposed site plan includes a large grass lawn area, subdivided by a straight concrete walkway leading to the front entrance of the building. Foundation plantings are depicted around the front, rear, sides of the house. The driveway is straight and located to the side of the house. This element is satisfied.

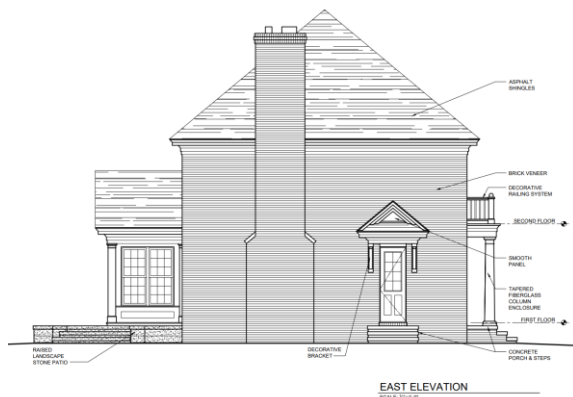
East elevation. Image from application documents.

- Further, although not connected to a specific element, staff suggests that the lack of fenestration on the sides (east and west elevations) of the proposed house is a concern. The west elevation (see image on page 4 of this report) has only two, centered window openings, with large expanses of blank wall on either end. The east elevation has one door but no window openings. Staff opinion is that these large expanses of unfenestrated wall area result in an appearance and overall lack of detail and complexity that is incongruous and incompatible with the Colonial Revival style of the proposed building and is inconsistent with other buildings within the district.
